# AIRCRAFT ACCIDENT REPORT

APL//2019/11/05/F

**Nigerian Safety Investigation Bureau**

**Final Report on the Incident involving a Boeing 737-500 aircraft with nationality and registration marks 5N-BUJ Operated by Air Peace Limited, which occurred at FL230 en-route Sam Mbakwe Airport, Owerri; Nigeria on 5 November 2019.**

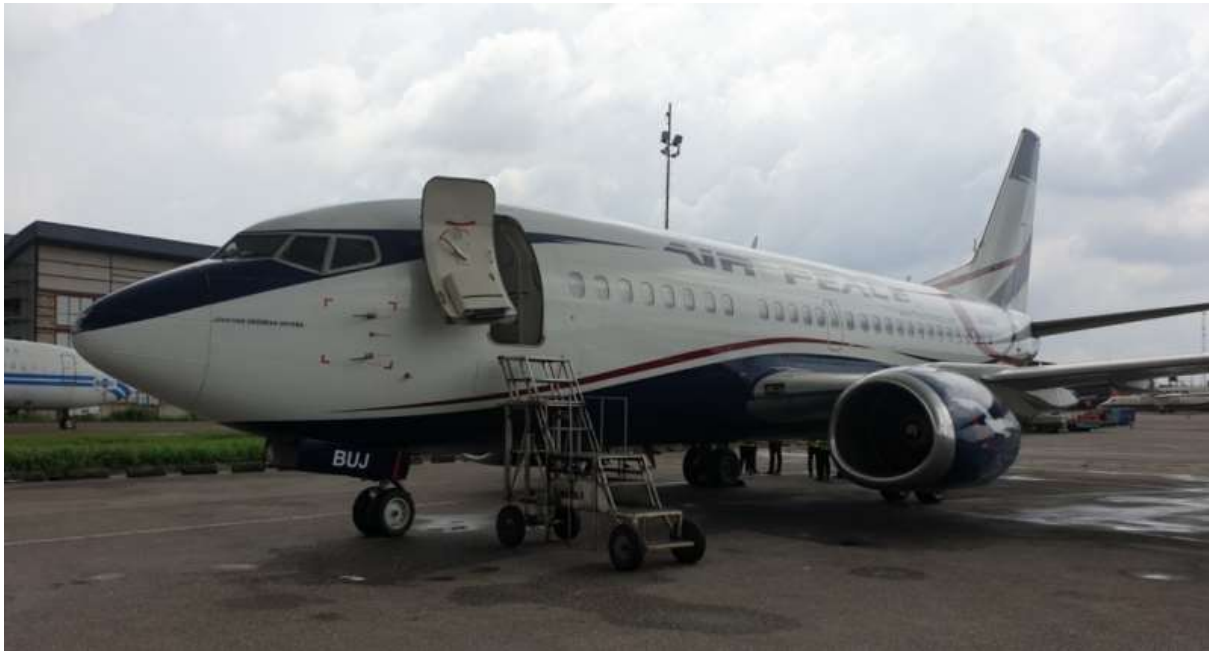
**Figure 1:** The aircraft parked at G.A.T apron after the Air Return

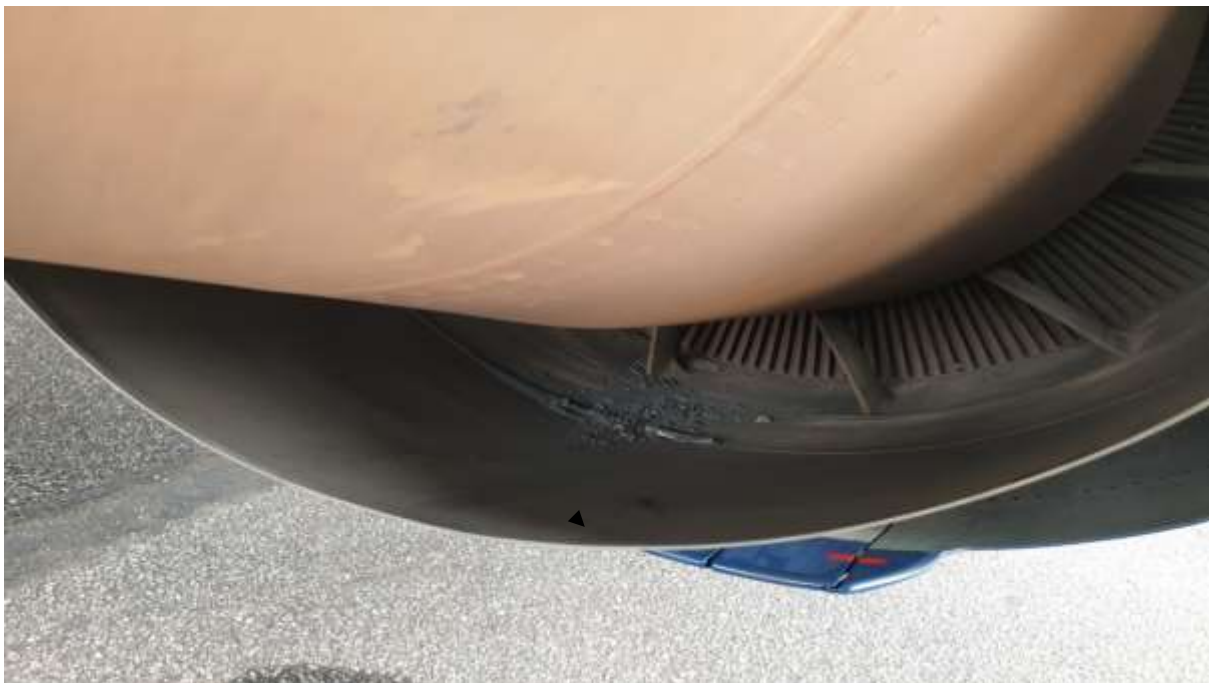
Metal debris were found around the tail cone of Engine No. 2 during post-occurrence inspection. See Figure 2 below.

**Figure 2:** Metal debris in the tail cone of No. 2 engine during post occurrence inspection

*Referring to above inspection results, no signs for any FOD, engine entrance from fan blades up to booster blades are not damaged, the damage just started from No.3 bearing, all five main line bearing (#01 to #05) in good condition except the No.3 bearing found completely damaged.*

*From all inspection results and above situation of engine front modules, the only reason for engine damage and IFSD situation is the failure of No.3 bearing.*

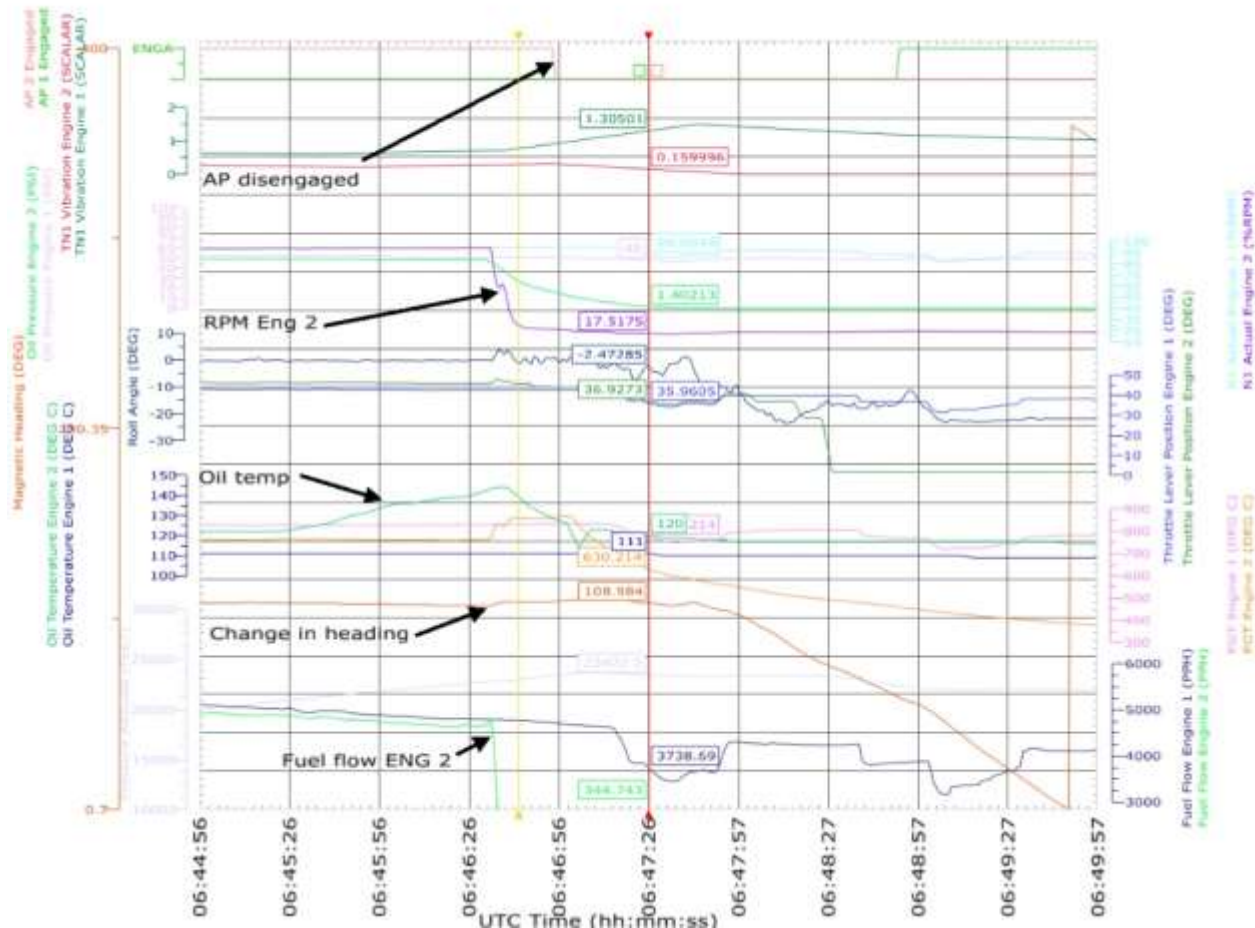
**Figure 4: The FDR Plot 2**

At 06:45:26 UTC, Engine 2 oil temperature began rising from 122°C to a maximum value of 144°C, and about a minute later the exhaust gas temperature (EGT) from 761°C to 869°C. Simultaneously, the Engine 2 N1 speed began to decrease from 60% and remained stable at 17%.

At 06:46:26 UTC, the autopilot (AP2) was disengaged. A slight increase in both Engine 1 and Engine 2 vibration was recorded just prior to 06:47:26 UTC.

At 06:46:35 UTC, at 22,187.3 ft (pressure altitude), there was a sudden decline in Engine Number 2 parameters ( $N_1$ ,  $N_2$ , Fuel flow and EGT) while still Climbing.

The initial indication of the abnormal condition was a rise in Engine 2 oil temperature, increasing from 122°C to a peak of 144°C. This significant increase suggested a possible failure within the engine's lubrication system

Approximately one minute later, a sharp increase in Engine 2 Exhaust Gas Temperature (EGT) was recorded, rising from 761°C to 869°C. This coincided with a rapid reduction in Engine 2 N1 speed, dropping from 60% to 17%, which suggests that the engine was no longer producing normal thrust. The combination of high oil temperature and rising EGT is typically associated with internal engine damage or failure of one or more rotating assemblies.
