# AIRCRAFT ACCIDENT REPORT

SAHCO-MAL/2021/11/21/F

**Nigerian Safety Investigation Bureau**

**Final Report on the Incident involving a ground collision between a Lavatory Service Truck with fleet number 9/5 operated by Skyway Aviation Handling Company Plc (SAHCO) and a parked Boeing 737-300 aircraft with nationality and registration marks 5N-DAB operated by Max Air Limited which occurred at Nnamdi Azikiwe International Airport Abuja on 21 November 2021.**

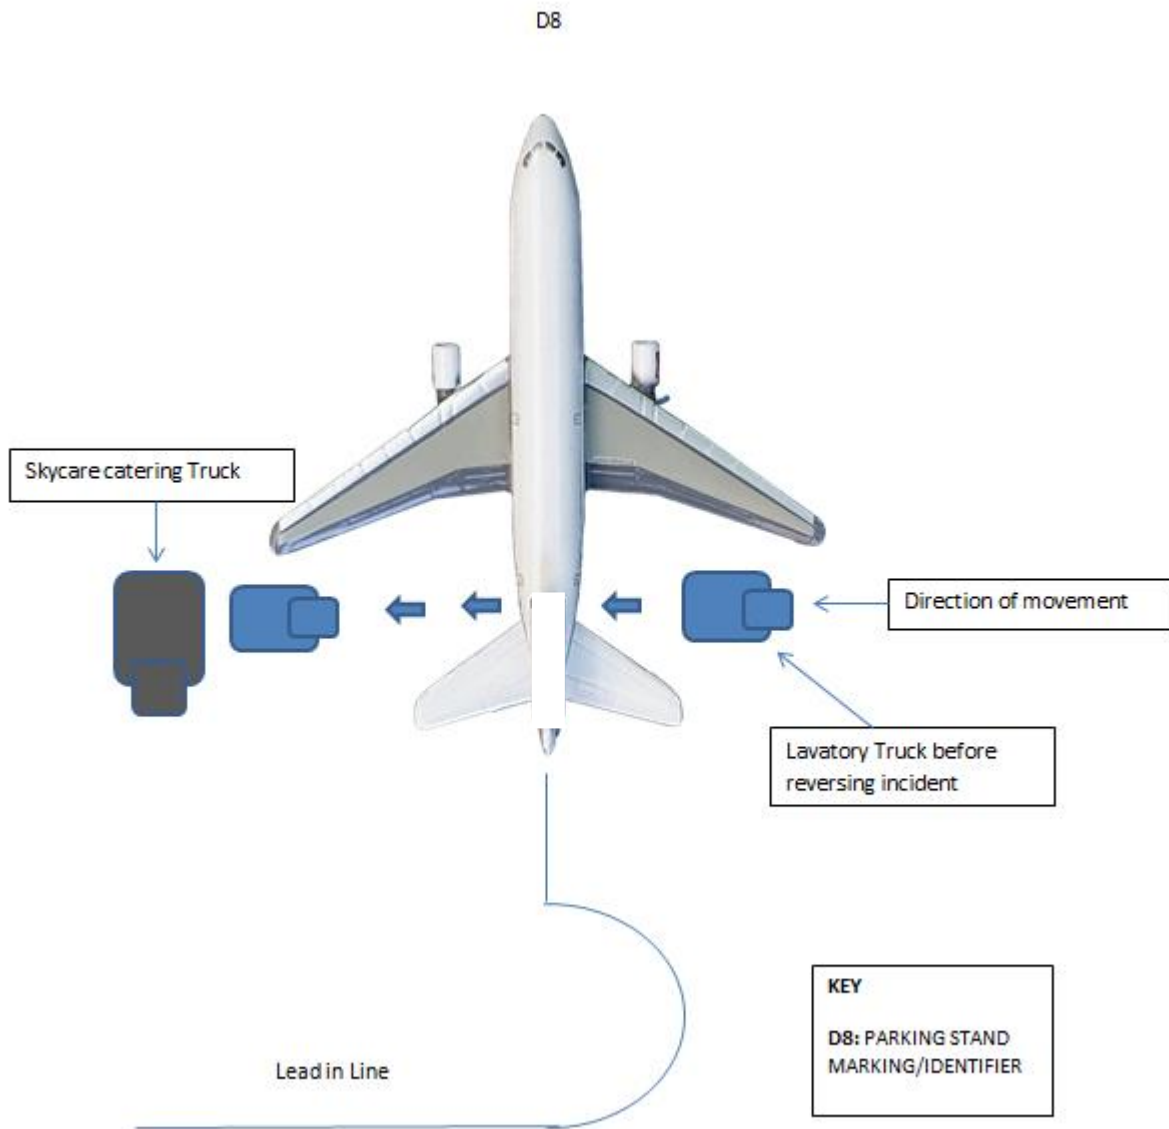
As the GSE driver attempted to reposition the Lavatory Service Truck, it moved (in reverse), passed underneath the rear bulkhead section of 5N-DAB, and continued moving until it eventually hit and was stopped by the Skycare Catering Services Truck on the left side of the Aircraft. The 5N-DAB, lavatory, and catering service trucks suffered various damage.

**Figure 1:** Sketch of the impact sequence.

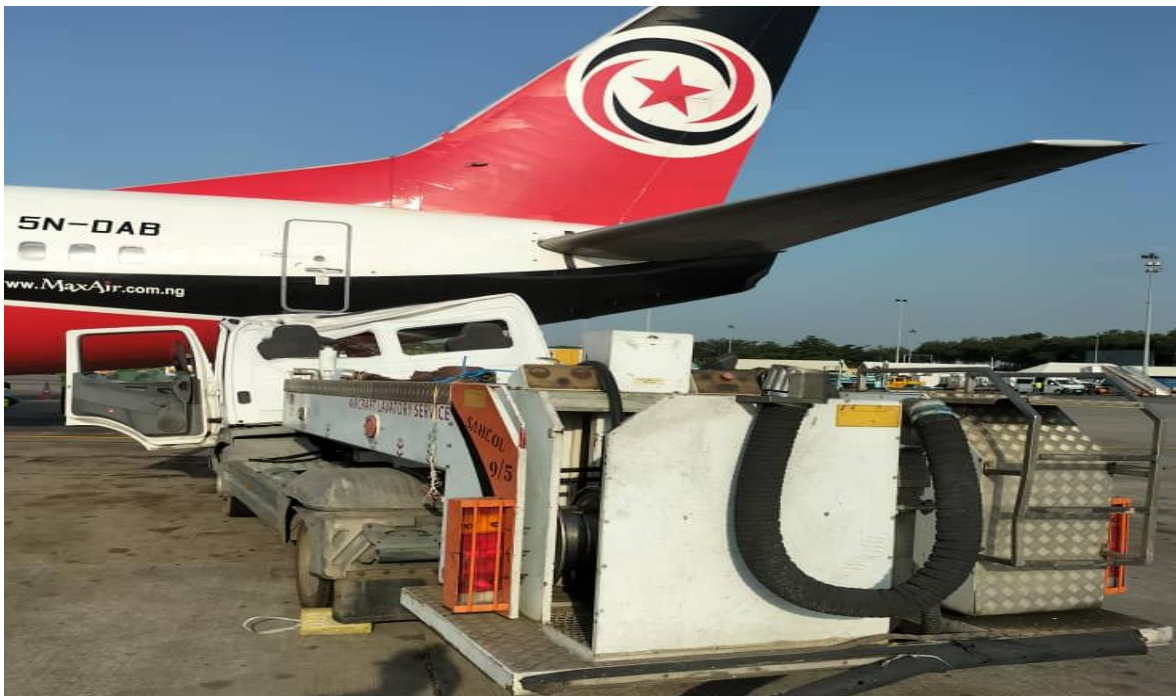
**Figure 2:** The aircraft and lavatory service truck after the occurrence.

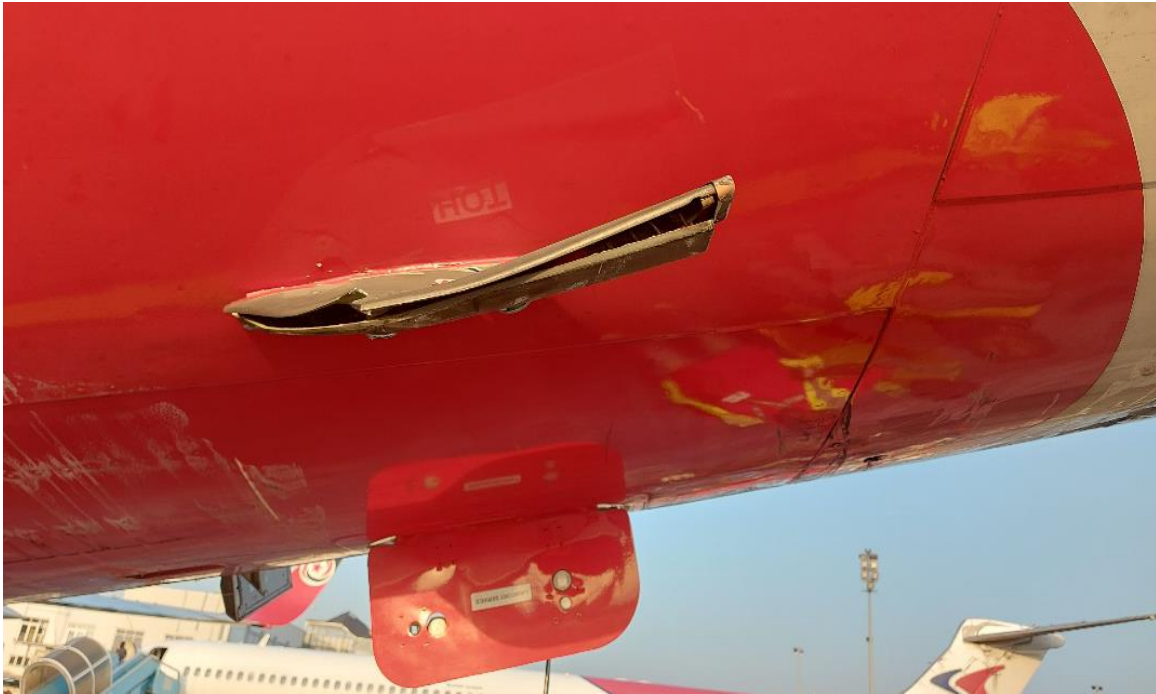
1. Three holes on the Aft section of the fuselage unpressurised area
2. Dents on the pressure bulkhead area

**Figure 3:** Dent around the rear pressure bulkhead area.

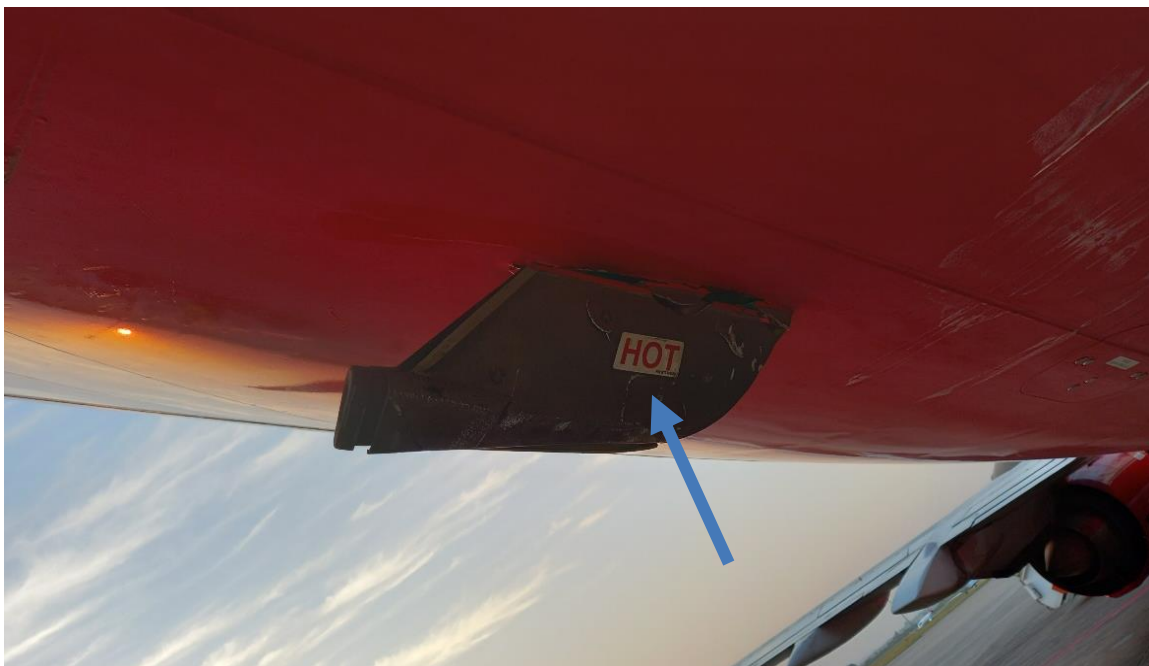
3. Broken rear outflow valve.
4. Broken lavatory service truck door
5. Broken drain valve handle and a damaged rear galley drain mast.

**Figure 4:** Damaged rear galley drains mast.

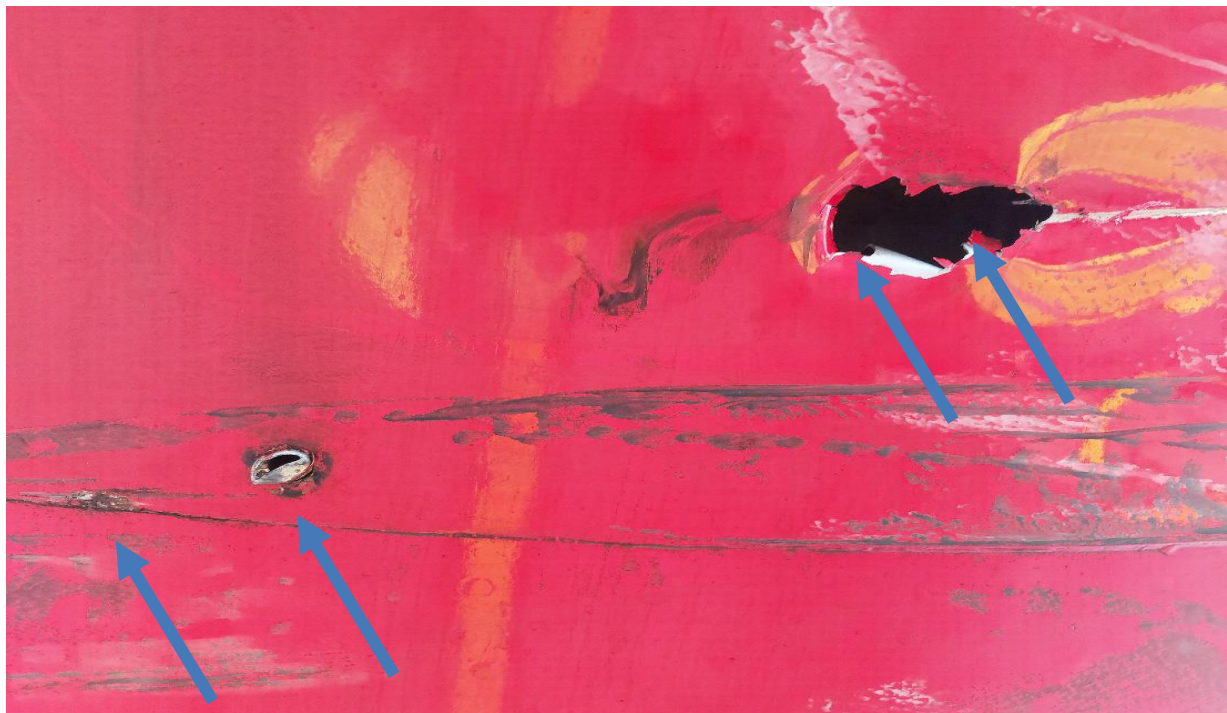
**Figure 5:** Three holes on the aft of the fuselage unpressurised area.

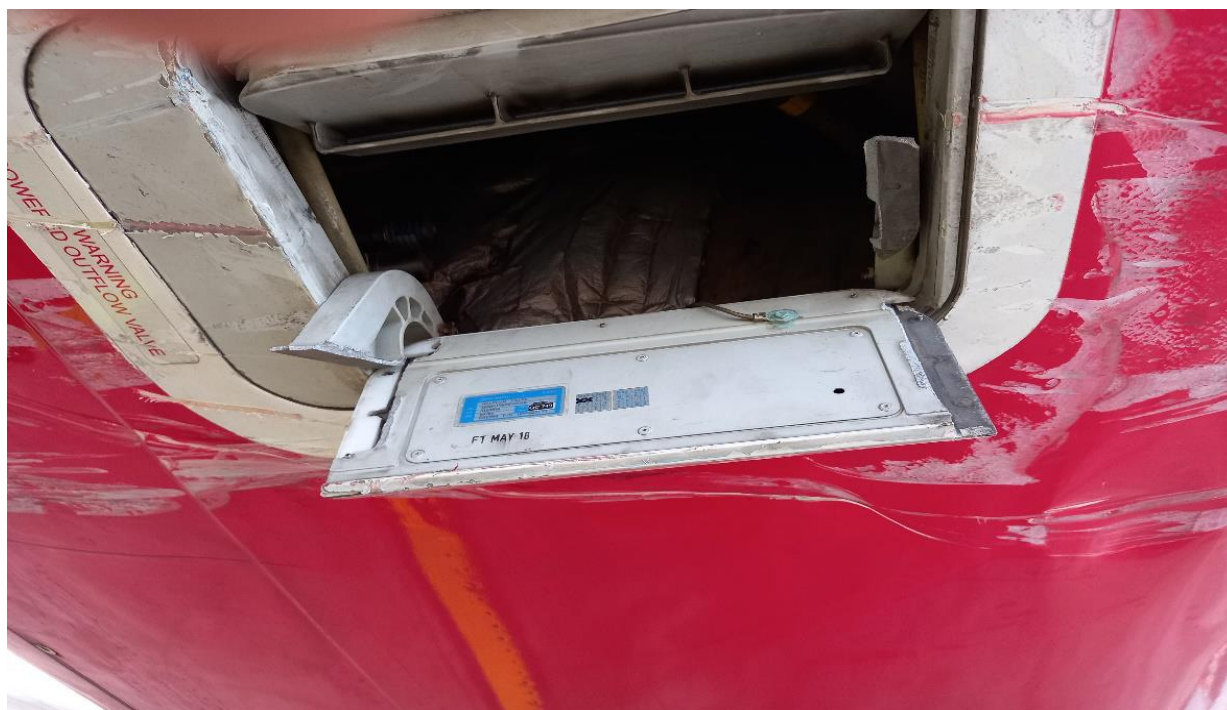
**Figure 6:** Broken outflow valve.

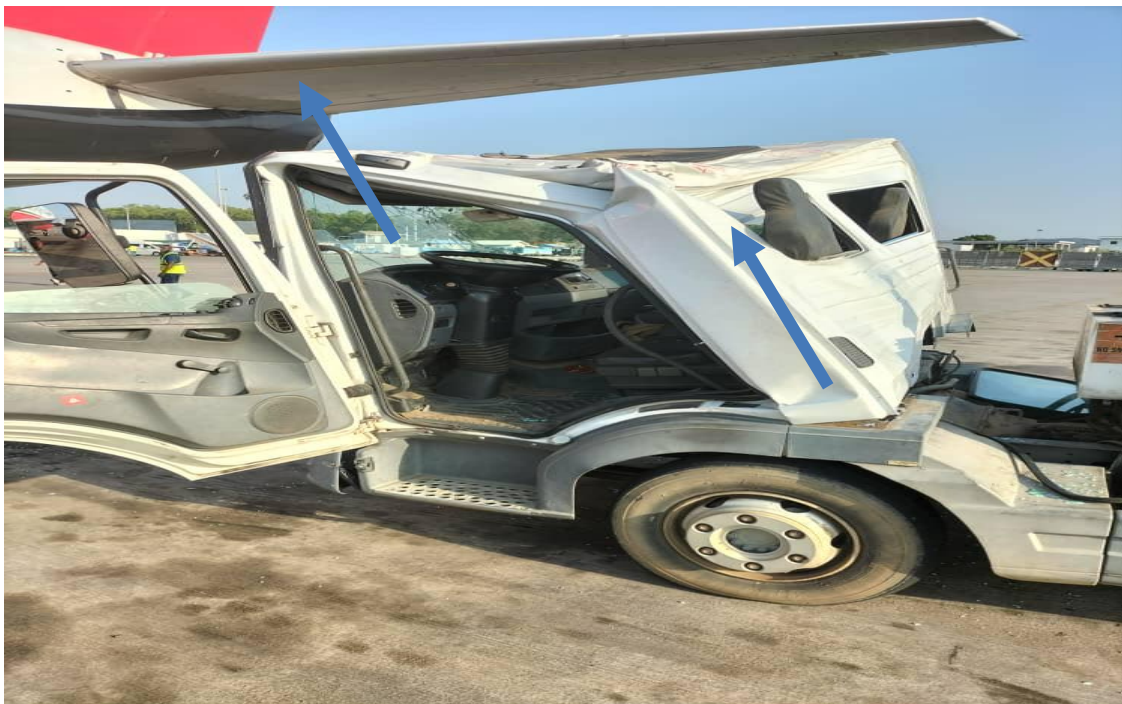
1. The SAHCO lavatory service truck head was substantially damaged.
2. The Skycare Catering Service truck was slightly damaged.

**Figure 7:** Damaged lavatory service truck after the incident.

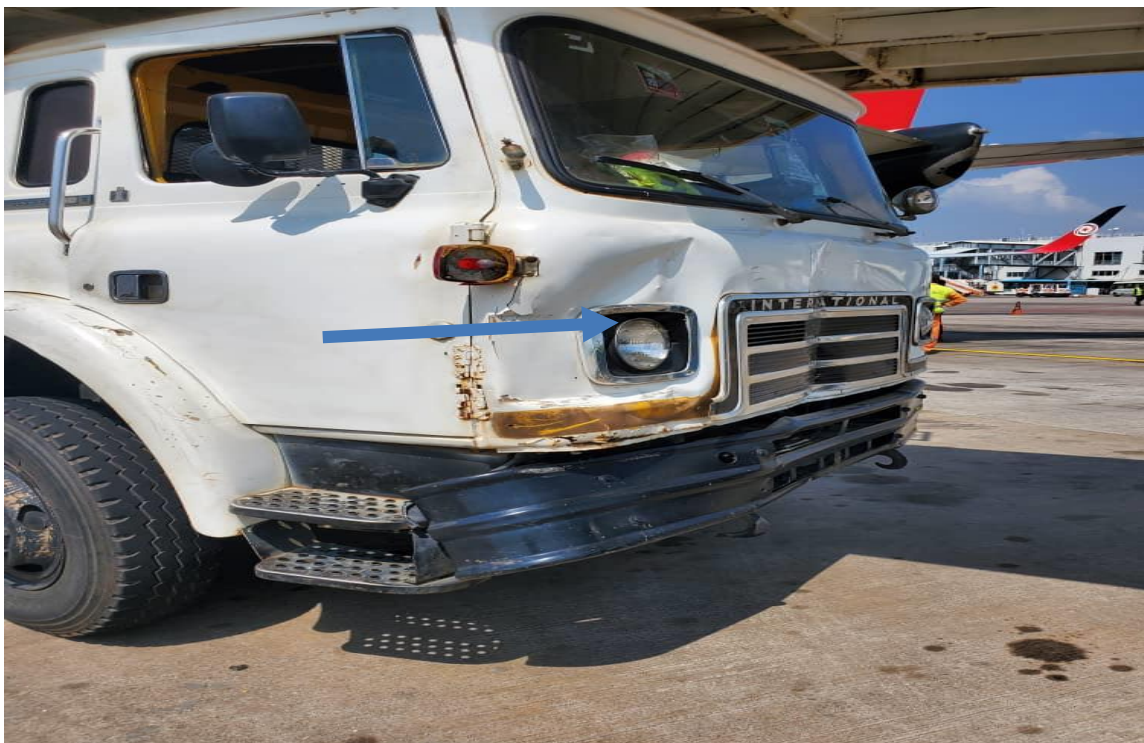
**Figure 8:** Dent on the catering service truck.
