# AIRCRAFT ACCIDENT REPORT

AIRPEACE/2018/12/14/F

**Final Report on the Serious Incident involving Boeing  
737-300 aircraft belonging to Air Peace Limited with  
nationality and registration marks 5N-BUO which  
occurred at FL 310 enroute Enugu from Lagos  
on 14th December, 2018**

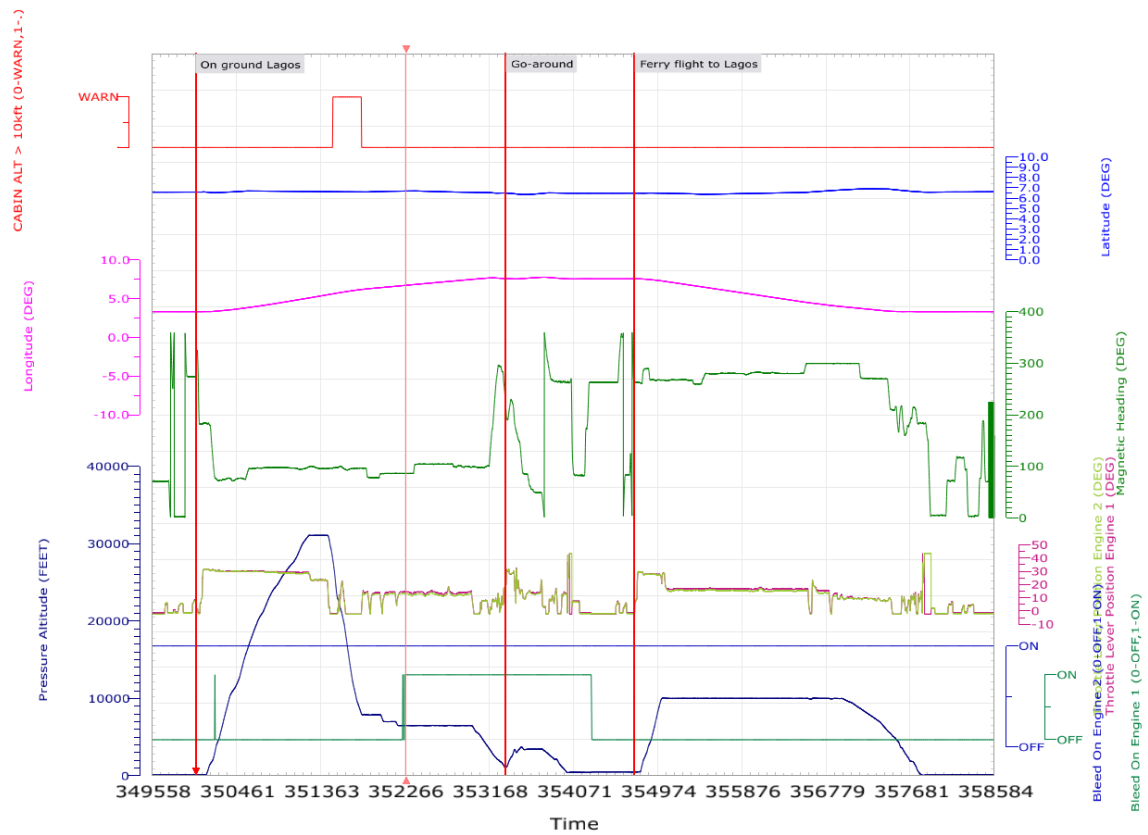
**Figure 1:** FDR plot identifying the incident flight.

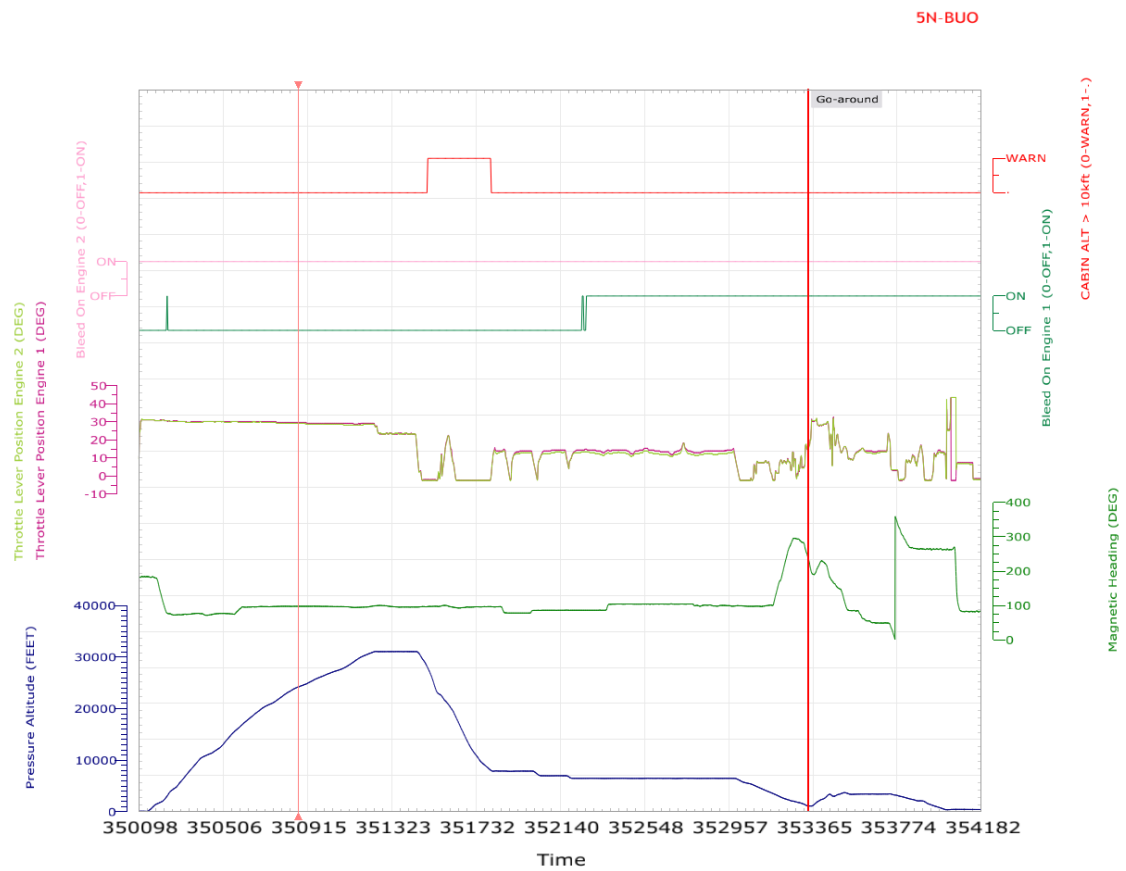
**Figure 2:** FDR plot for the incident flight showing the cabin altitude warning

The cabin altitude warning horn indicates cabin altitude of 10,000 ft, thus showing that cabin altitude on this flight exceeded 8,000 ft limit (Airplane Flight Manual ,Section 08-23-11), which trend was not monitored by the flight crew. The cabin climb rate of 3,500 ft/min observed by the crew on completion of the BLEED TRIP OFF checklist far exceeds normal cabin rate of climb and should have prompted the crew to initiate immediate rapid descent.

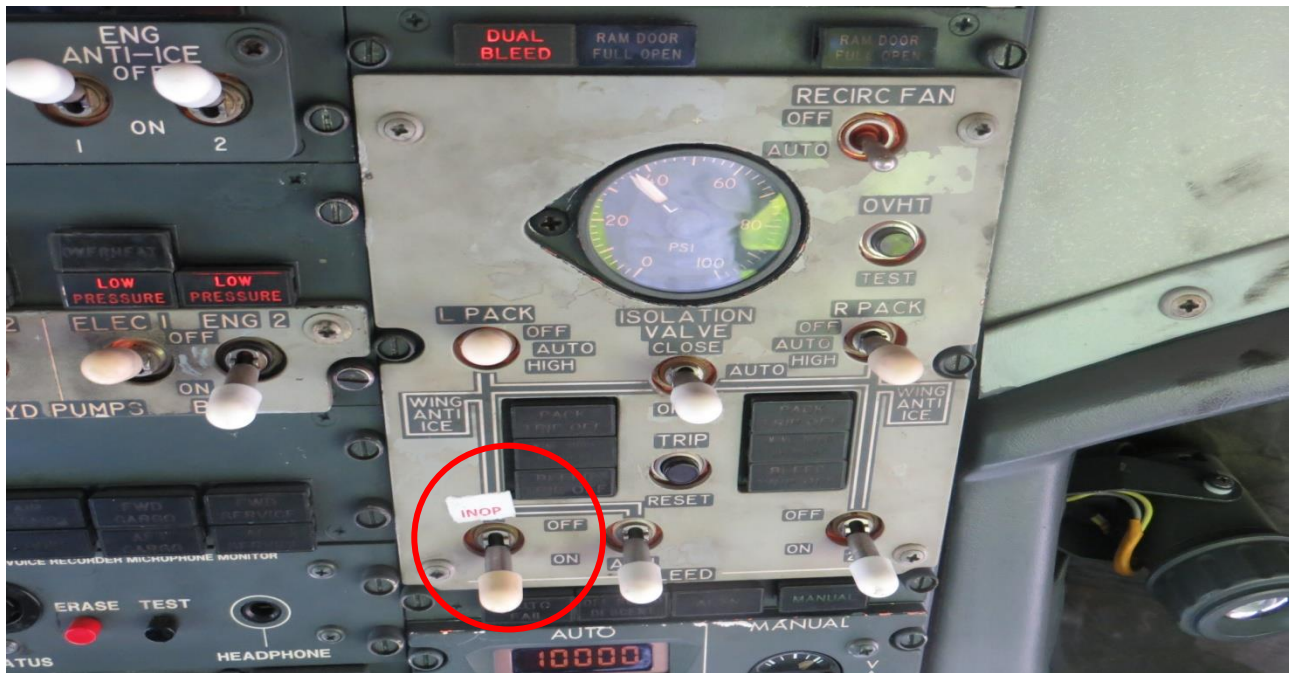
Engine No. 1 bleed switch on the air-conditioning panel was placarded 'INOP'. The left duct pressure was 18 psi and this was entered in the Deferred Defect Log book on 12th December, 2018 with a limit of 22nd December, 2018. Action on the low bleed on engine no. 1 was raised in accordance with MEL (36-05 CAT C).

**Figure 3:** The left engine bleed switch on air-conditioning control panel with 'INOP' placard

The no. 1 bleed switch was placarded inoperative (INOP), hence the crew should have adhered to the limitations for one air conditioning pack inoperative in the MEL, for departure.

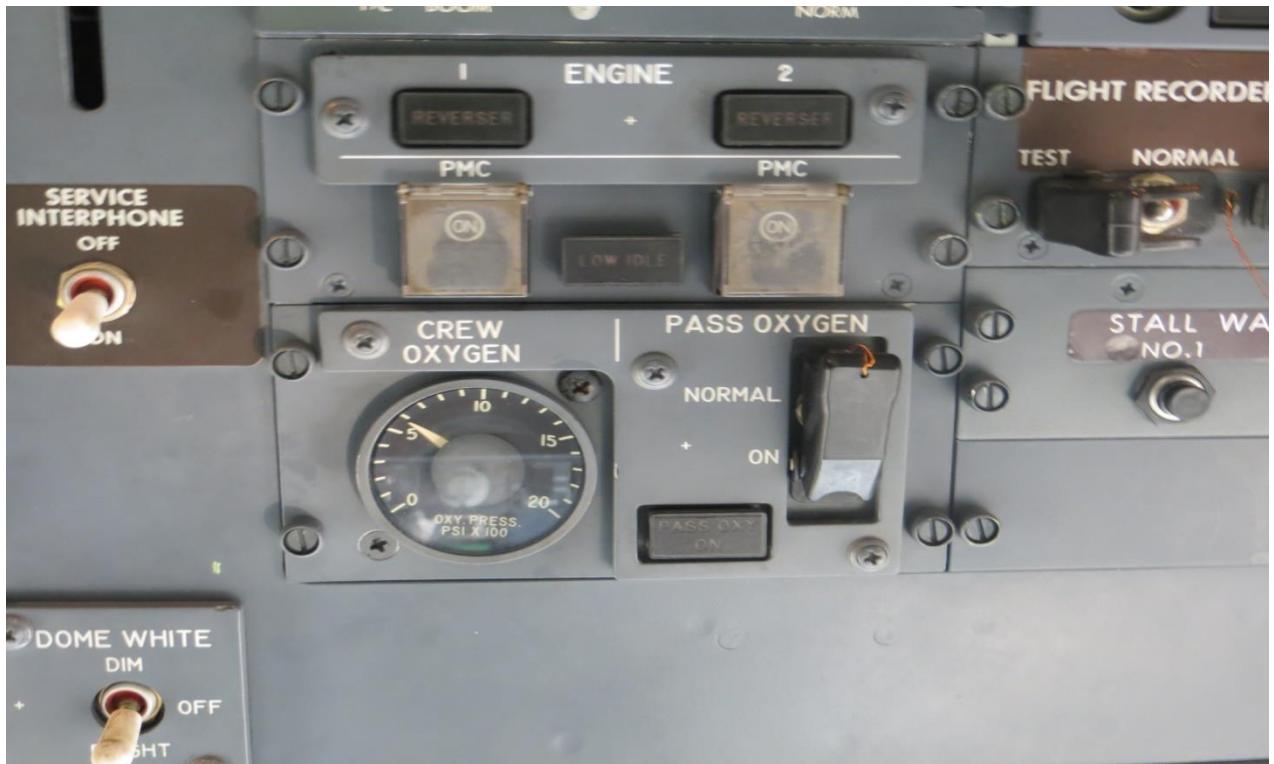
**Figure 4:** The passenger oxygen switch in normal position and wire-locked during post occurrence inspection

15. During post incident inspection, the passenger oxygen switch in the cockpit was found in the NORMAL position and wire-locked.
