PRELIMINARY REPORT ON THE SERIOUS INCIDENT INVOLVING A CHALLENGER 601-3A AIRCRAFT WITH NATIONALITY AND REGISTRATION MARKS N989BC OPERATED BY VMO AERO LIMITED, WHICH OCCURRED NEAR ASABA AIRPORT (DNAS), DELTA STATE, NIGERIA, ON 10 JUNE, 2026

Operator:	VMO Aero Limited
Type and model:	Challenger 601-3A
Manufacturer:	Bombardier Inc., Canada
Year of manufacture:	1988
Nationality and registration marks:	N989BC
Serial number:	5021
Location:	Road under construction in the vicinity of Asaba Airport (DNAS), Asaba, Delta State.
Date and Time:	10 June 2026 at 08:57 h <i>(All times in this report are local times equivalent to UTC+1 unless otherwise stated).</i>

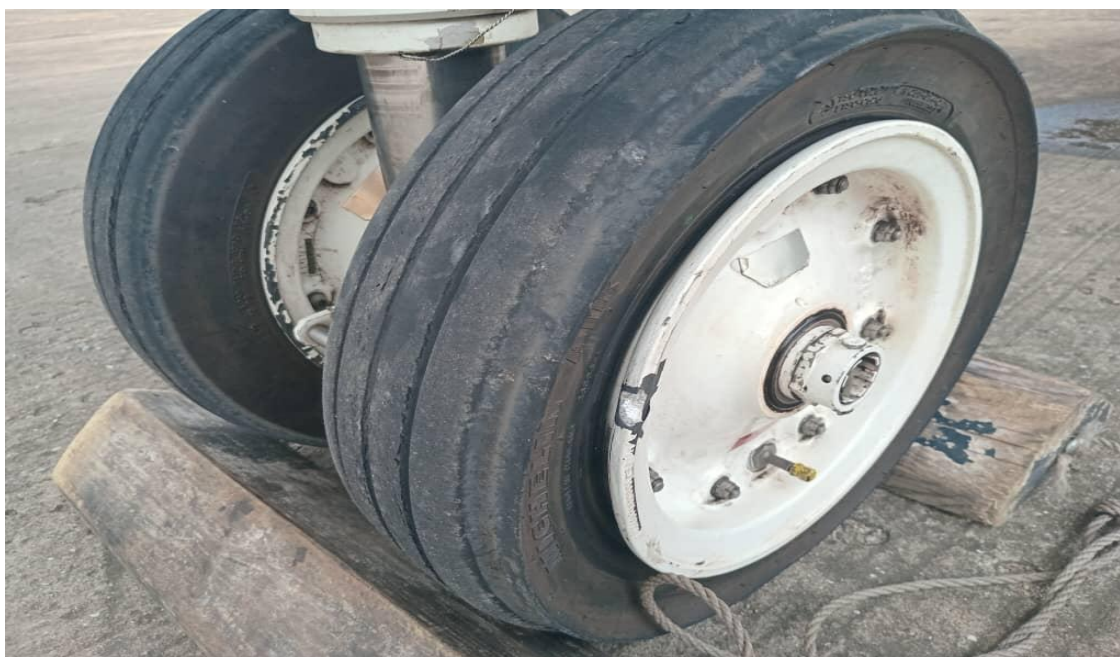
Following arrival in Lagos, the aircraft underwent an external inspection. The PIC stated that damage was subsequently identified to the left nose-wheel assembly.

The aircraft landed on a paved roadway under construction near Asaba Airport, without structural failure or fire. Following an external inspection at the site, the flight crew reported the aircraft serviceable, and it subsequently returned to Lagos. The operator's aircraft engineer also stated that, following the aircraft's return to Lagos, a post-flight inspection was conducted, and the damage to the No. 1 nose-wheel assembly was recorded in the Aircraft Technical Log.

Figure 1: Damage to the left nose-wheel assembly identified during post-flight inspection.
