**PRELIMINARY REPORT ON THE INCIDENT INVOLVING A BOEING 737-300 AIRCRAFT WITH NATIONALITY AND REGISTRATION MARKS 5N-DAB OPERATED BY MAX AIR LIMITED, WHICH OCCURRED DURING CLIMB OUT PASSING THROUGH FL080 EN-ROUTE UMARU MUSA YAR'ADUA AIRPORT (DNKT), KATSINA, KATSINA STATE, ON 11 MAY, 2026.**

| <b>Operator:</b> | Max Air Limited |
| <b>Type and model:</b> | Boeing 737-300 |
| <b>Nationality and registration marks:</b> | 5N-DAB |

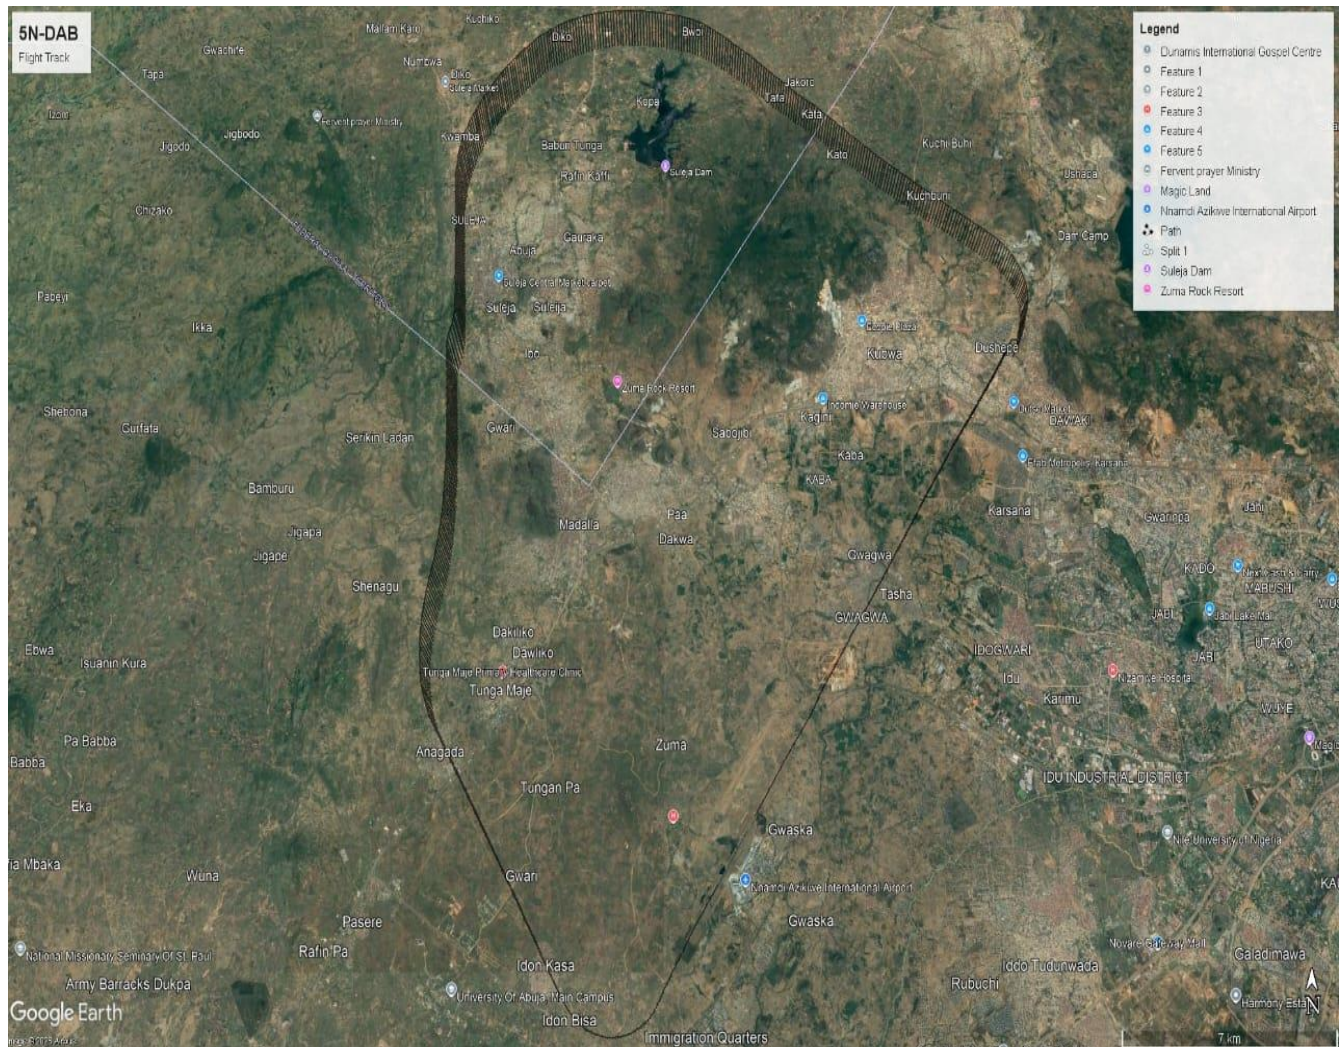
**Figure 1:** Flight track for 5N-DAB showing return to DNAA

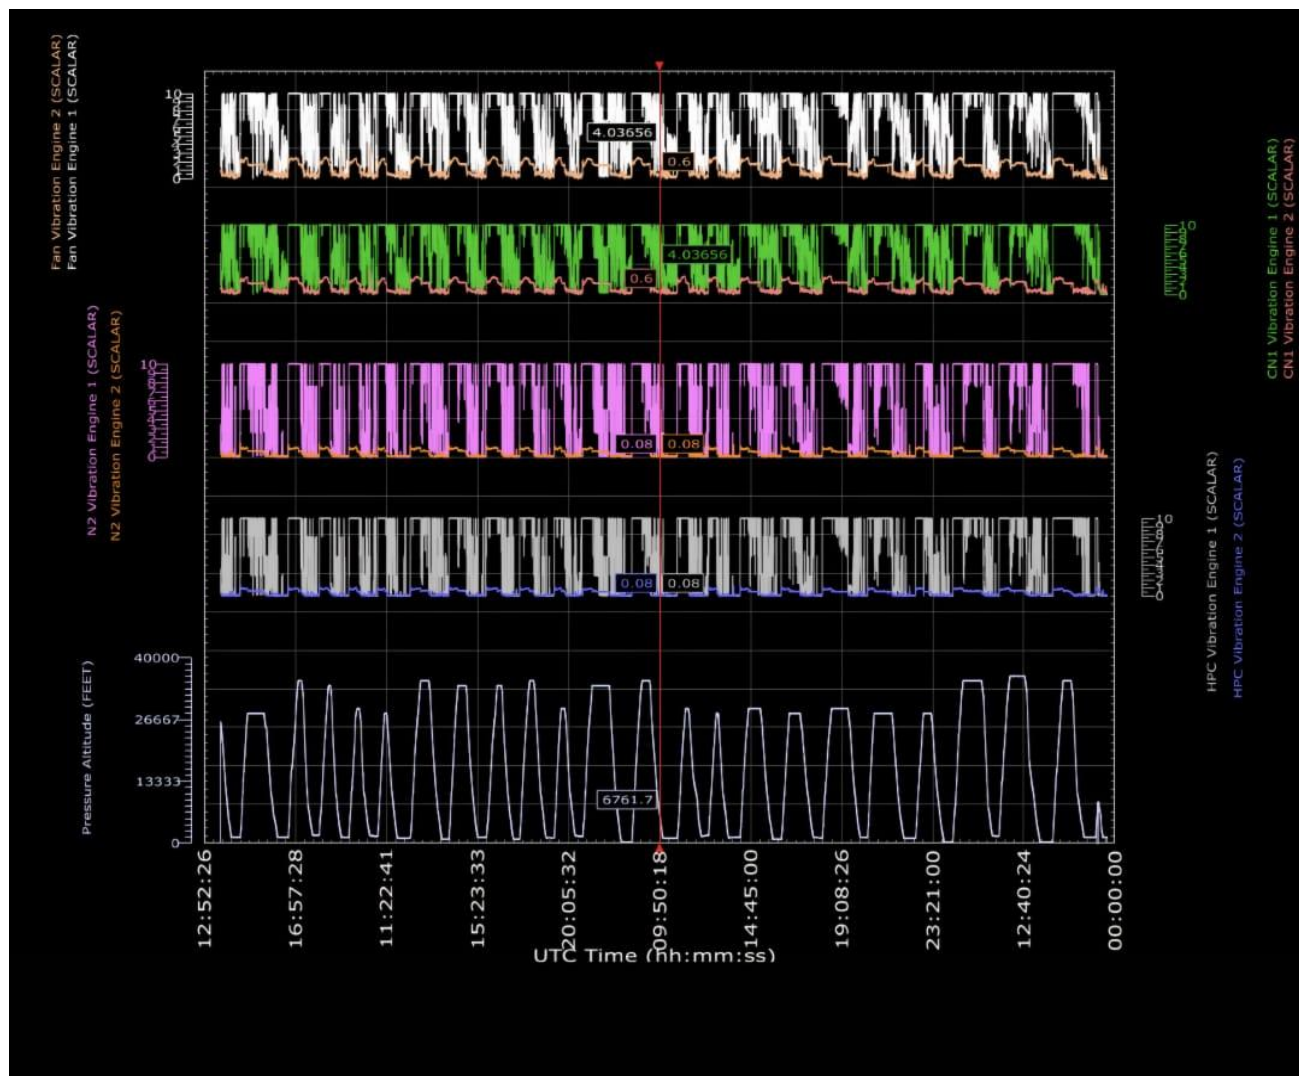
**Figure 2:** Flight and Engine parameters for the flight

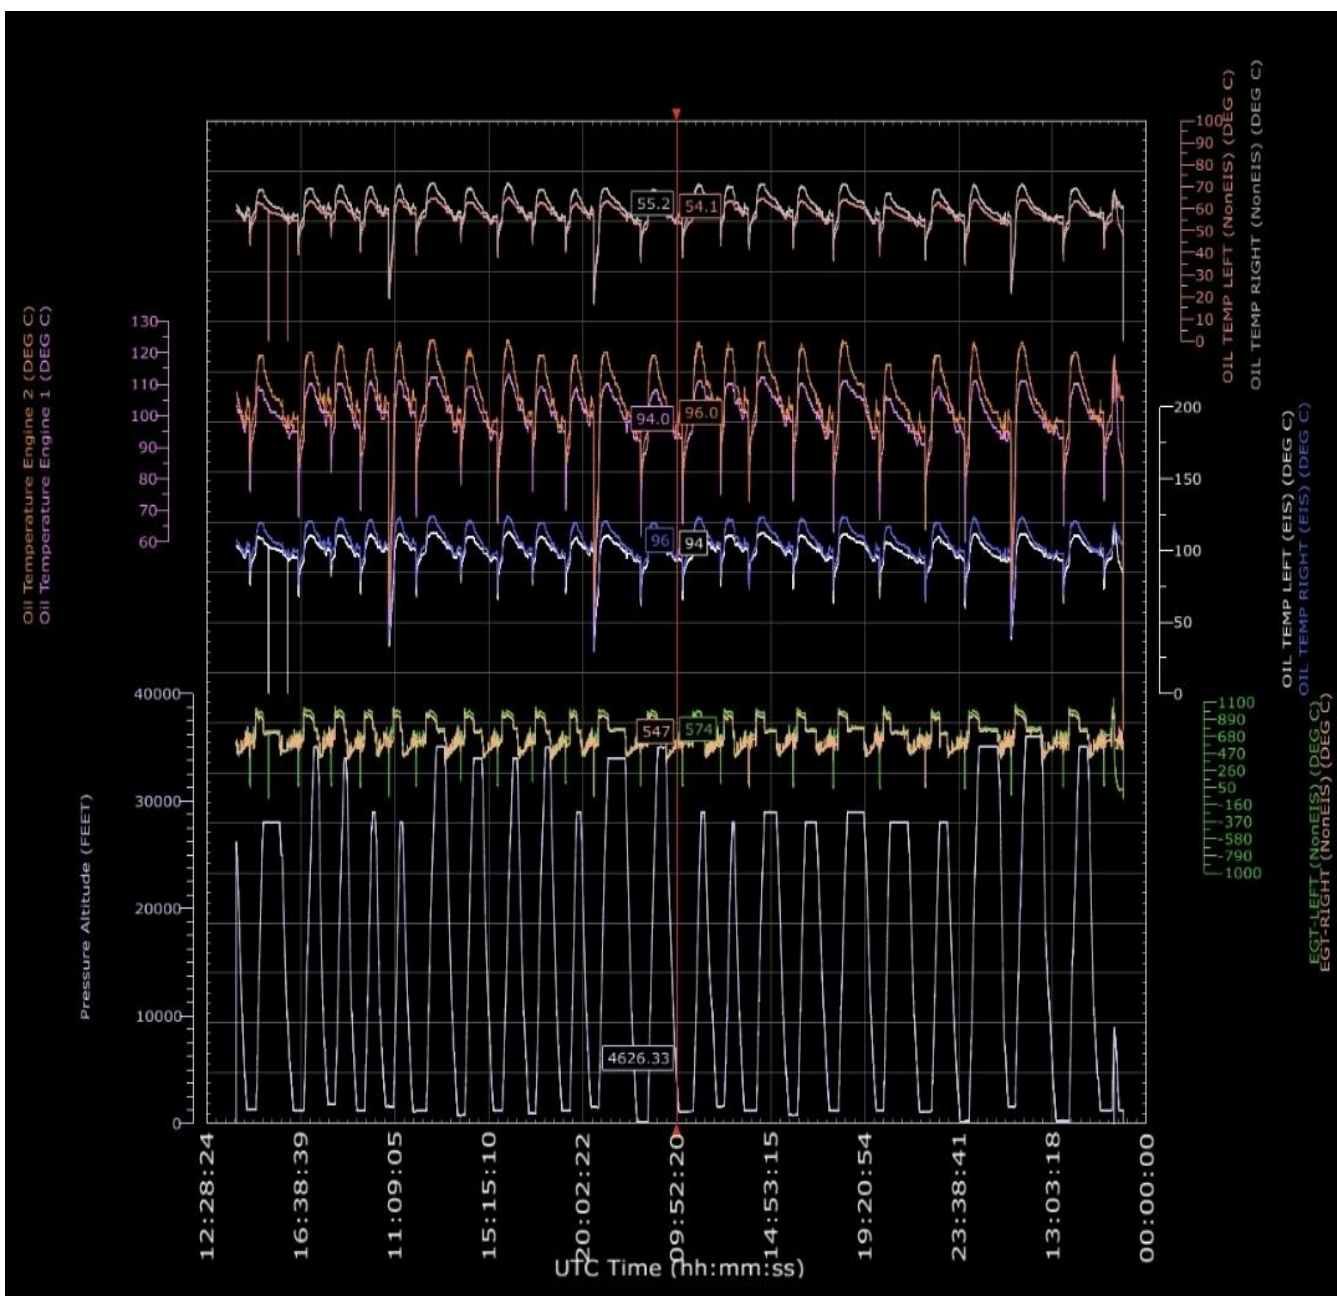
**Figure 3:** Flight and Engine parameters for the flight (cont'd)

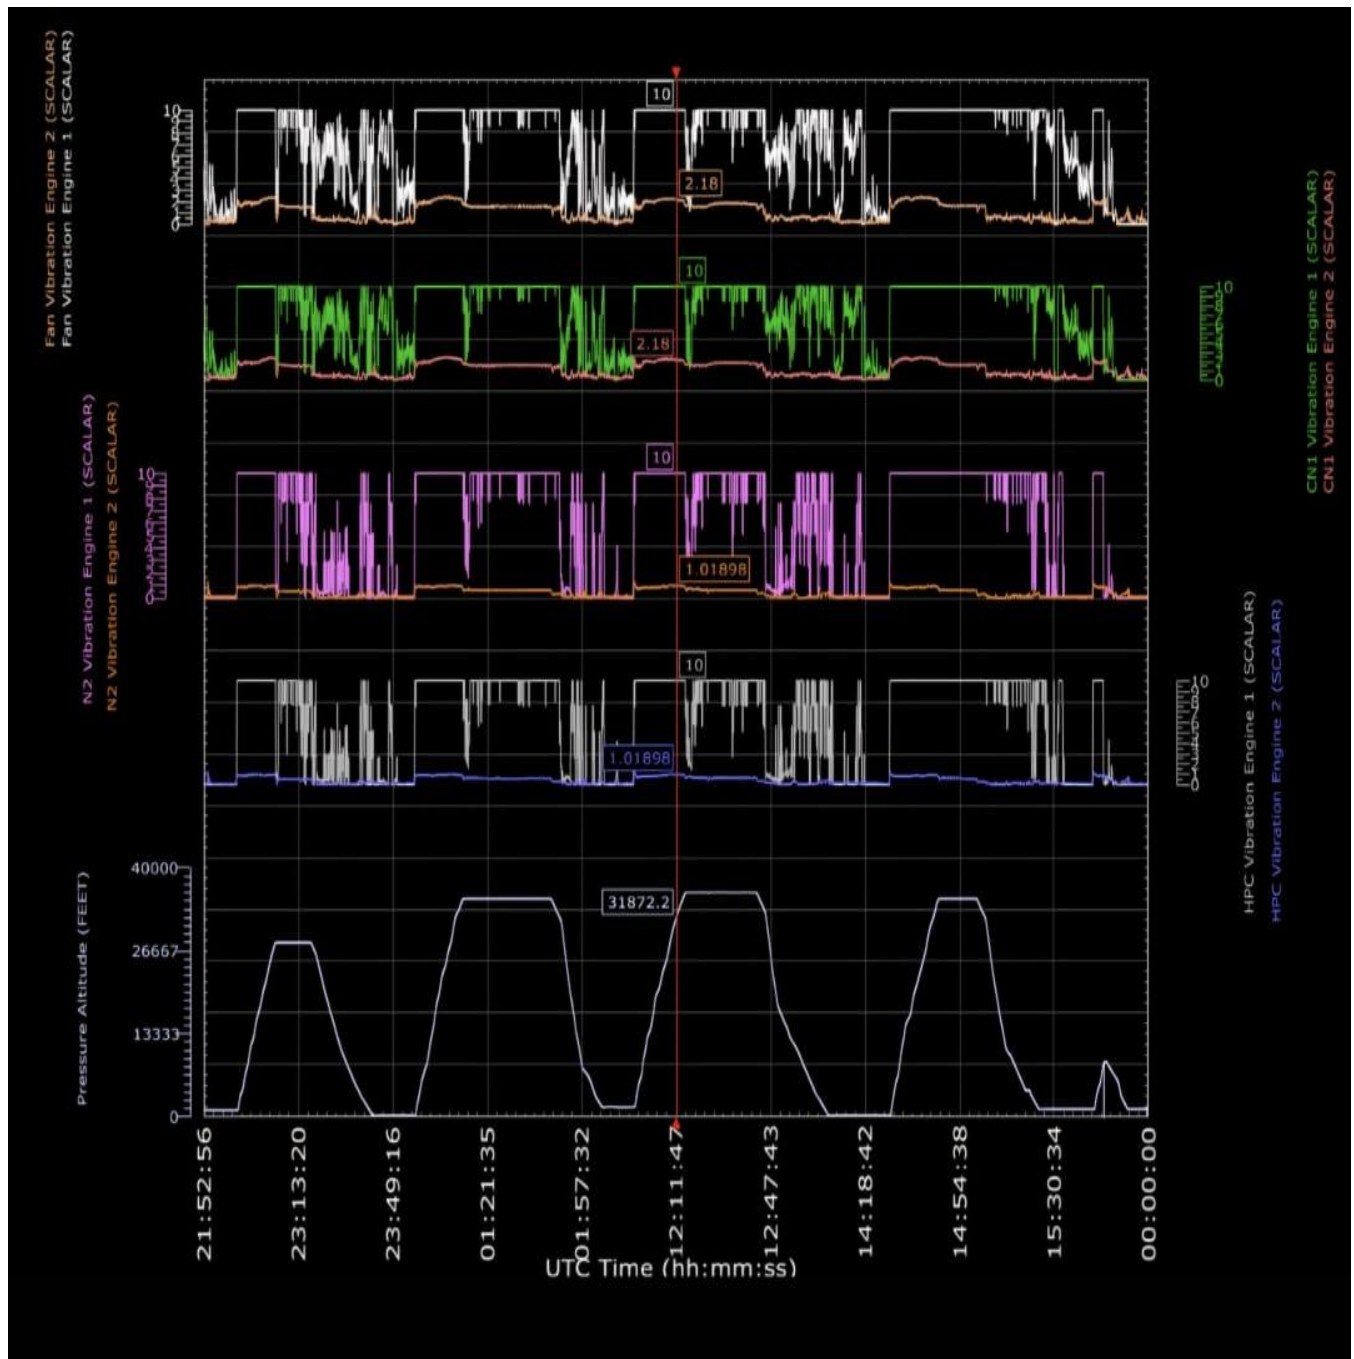
**Figure 4:** Flight and Engine parameters for the flight (cont'd)

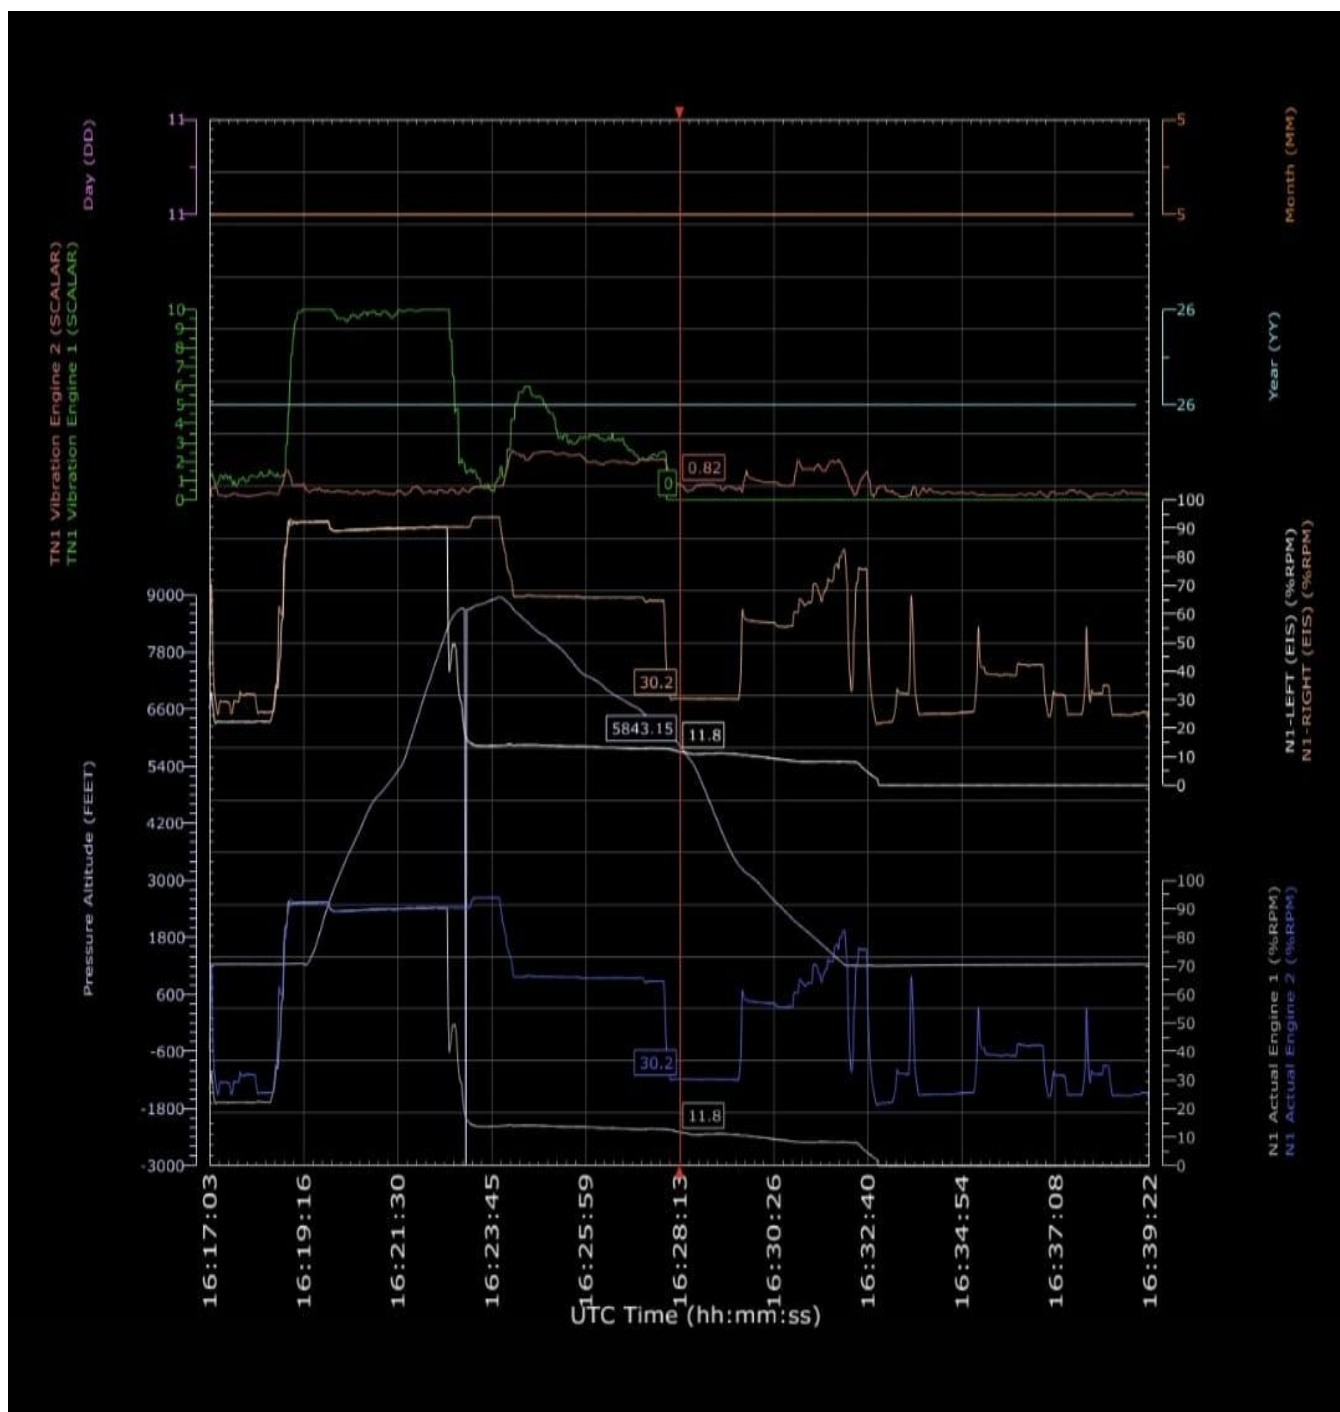
**Figure 5:** Flight and Engine parameters for the flight (cont'd)
