**Preliminary Report on the Accident involving an Embraer ERJ 170-100LR Aircraft with nationality and registration marks 5N-ENR operated by Enugu Air Limited, which occurred at Oba Akenzua II Airport, Benin, Edo State on 23 July 2026**

| <b>Operator:</b> | Enugu Air Limited |
| <b>Type and model:</b> | Embraer ERJ 170-100 LR |
| <b>Nationality and registration marks:</b> | 5N-ENR |

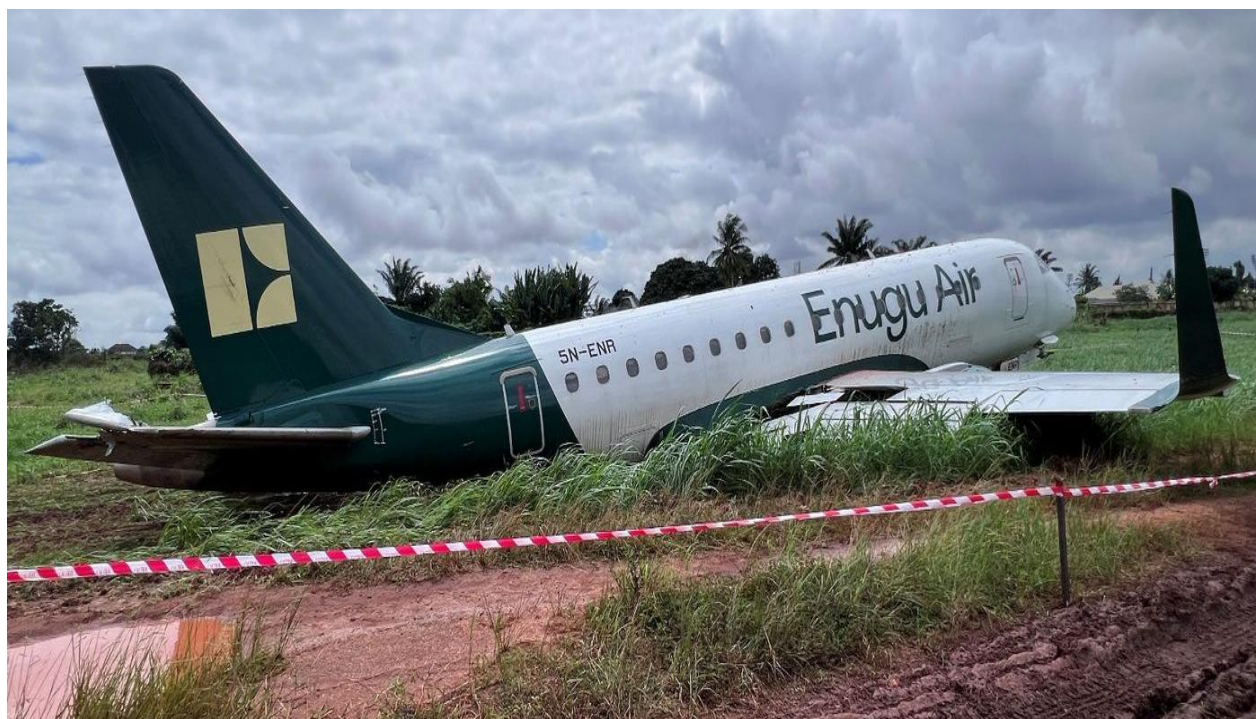
**Figure 2:** Aircraft Final Resting Point

The aircraft came to rest at about 325 m from the end of Runway 05 (Figure 7).

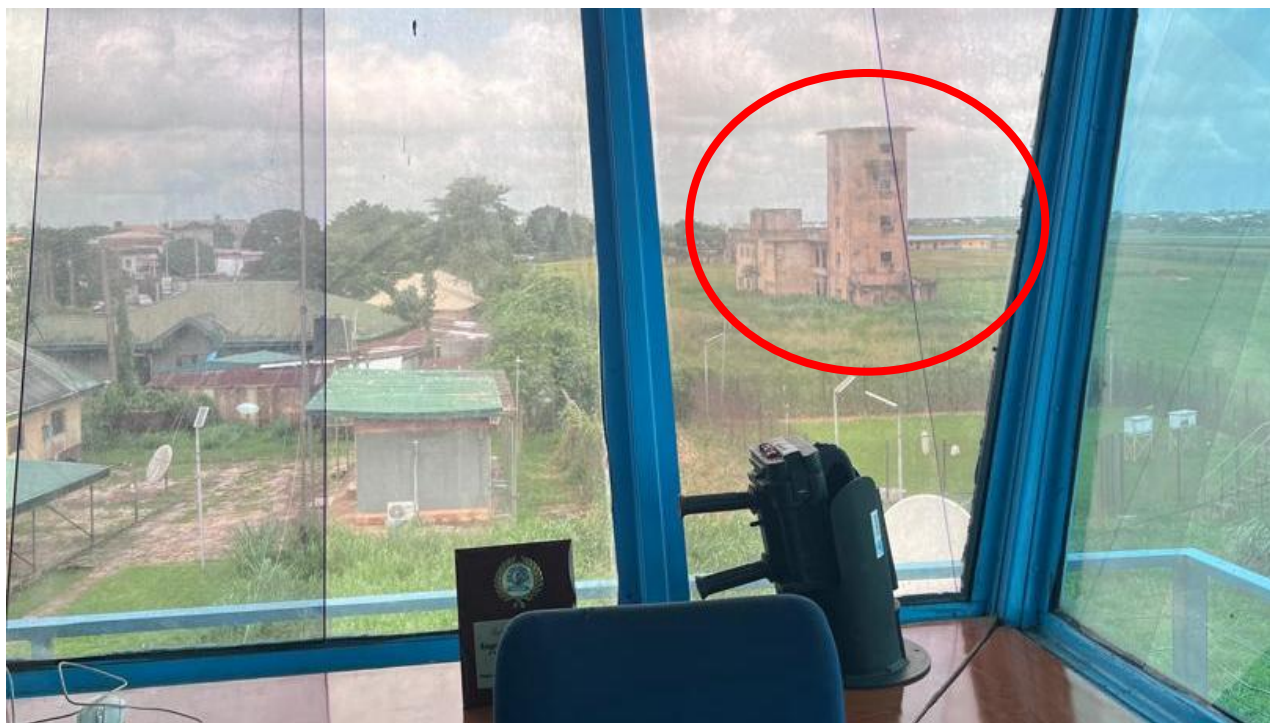
An uncompleted building structure located beyond the end of Runway 05 (Runway 23 threshold end) obstructs the control tower's line of sight to that part of the aerodrome (Figure 3).

**Figure 3:** The incomplete building obstructing the line-of-sight to the end of Runway 05 (Runway 23 threshold end)

19. The weather information display equipment provided for operational use at Benin tower was unserviceable at the time of the occurrence.
20. An uncompleted building structure is obstructing the controller's line of sight towards the end of Runway 05 (Runway 23 threshold end).

The Nigeria Civil Aviation Authority (NCAA) should ensure that the Control Tower is positioned to provide unrestricted view of all the movement areas of the aerodrome.

The Federal Airports Authority of Nigeria (FAAN) should provide a suitable control tower location for the Nigerian Airspace Management Agency (NAMA) to ensure unrestricted view of all the movement areas of the aerodrome.

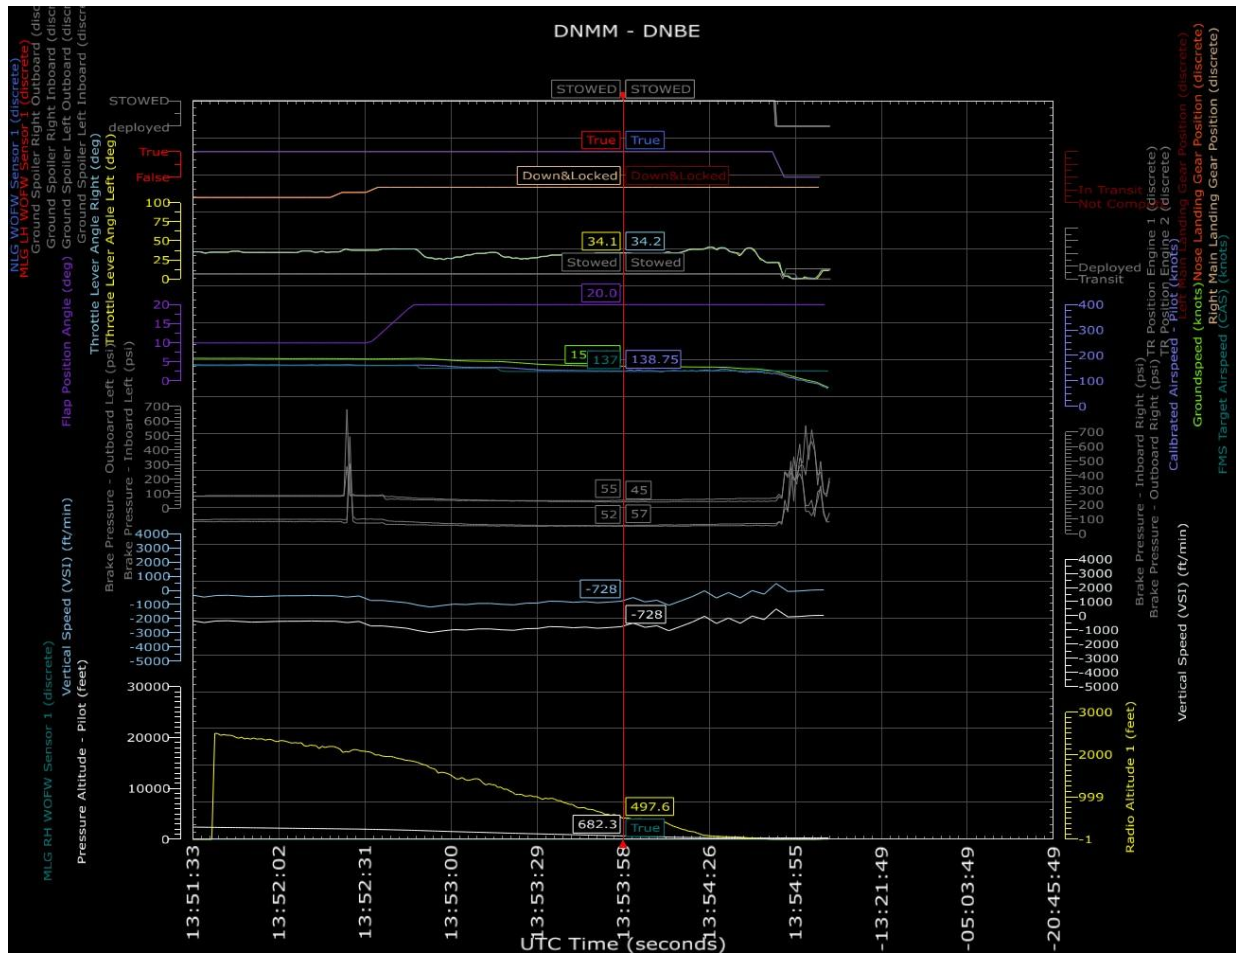
**Figure 4:** FDR-derived flight-data display covering the recorded flight segment

Recorded groundspeed decreased from approximately 138 kt at touchdown to approximately 105 kt after 10 seconds and approximately 79 kt at about 18 seconds. Brake-pressure channels showed an increase after touchdown, with individual recorded pressures reaching several hundred psi. The highest values identified in the analysed portion were approximately 615 psi on the right-hand inboard channel, 568 psi on the left-hand inboard channel and 459 psi on the left-hand outboard channel.

The ground-spoiler channels indicate activation.

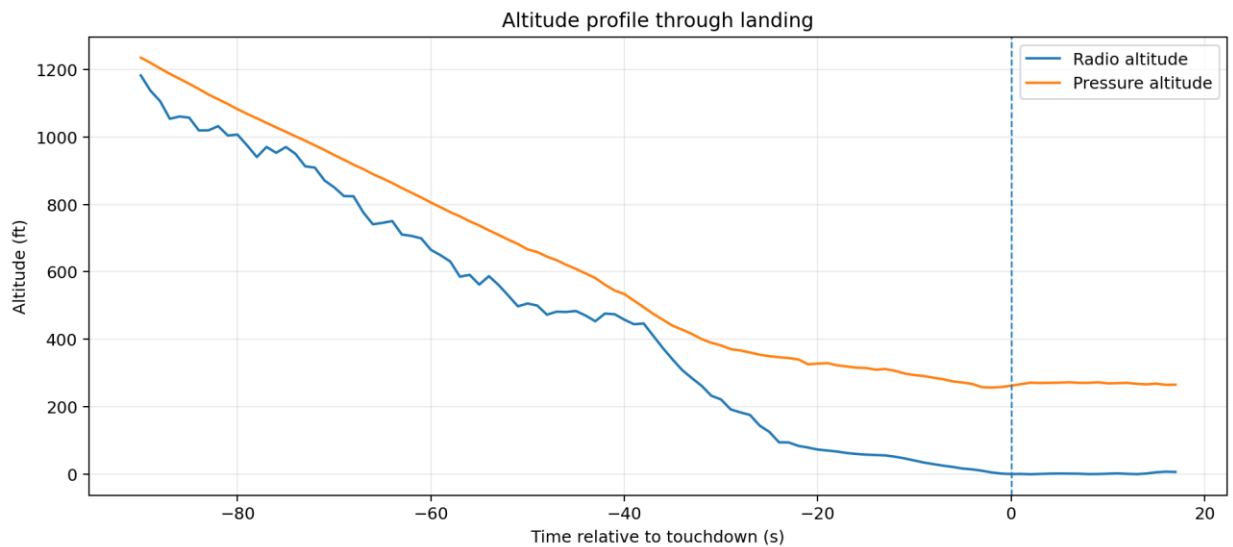
**Figure 5:** Altitude profile through landing

Based on the NSIB flight animation, 5N-ENR appears to have crossed the threshold of Runway 05 at a recorded radio altitude of about 93.5 ft and subsequently touched down at about 1,641.5 m from the runway threshold.

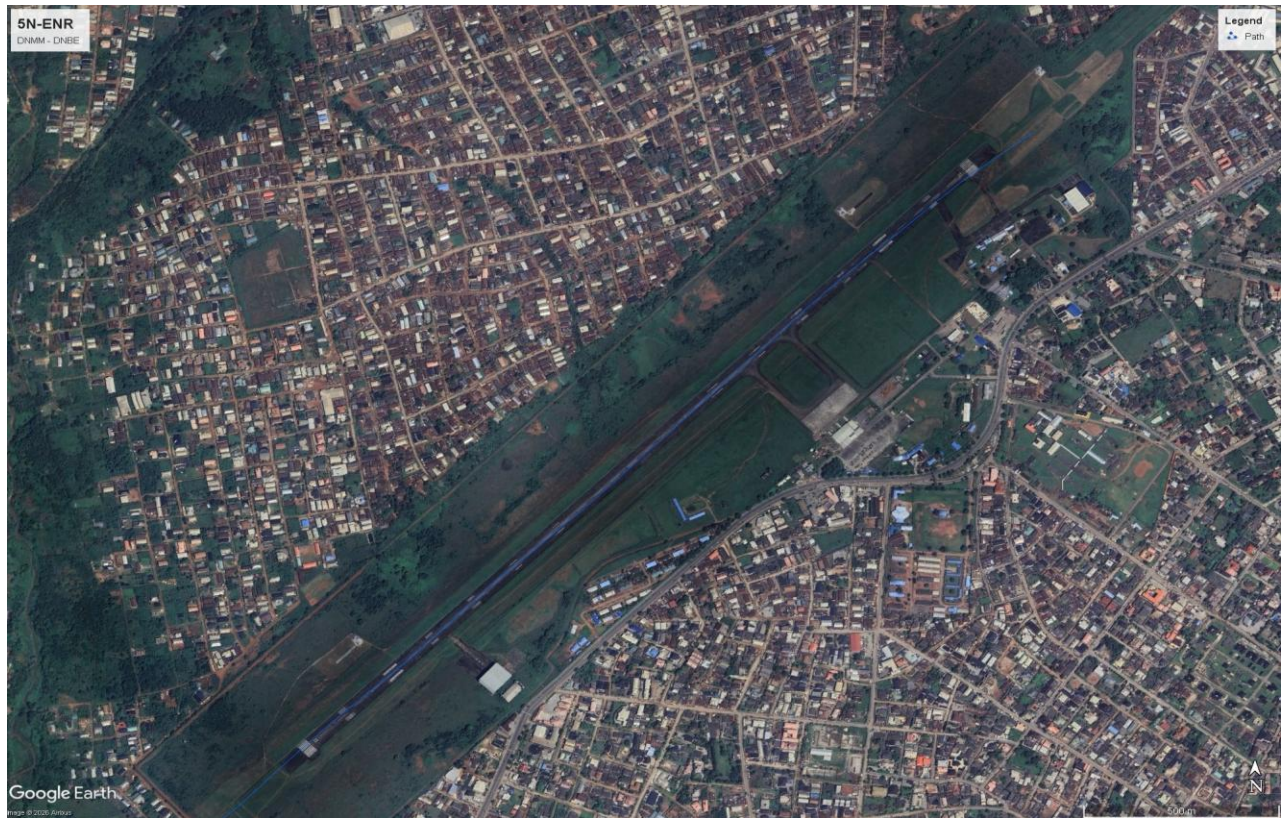
The aircraft landed at about 1,641.5 m from the threshold of Runway 05, traversed the runway-end blast pad and entered the unpaved area beyond the runway. The aircraft then struck the approach-lighting installations and impacted two fixed concrete structures of a decommissioned localizer installation, located beyond the runway end.

**Figure 6:** An overlay of the recorded flight path on Google Earth

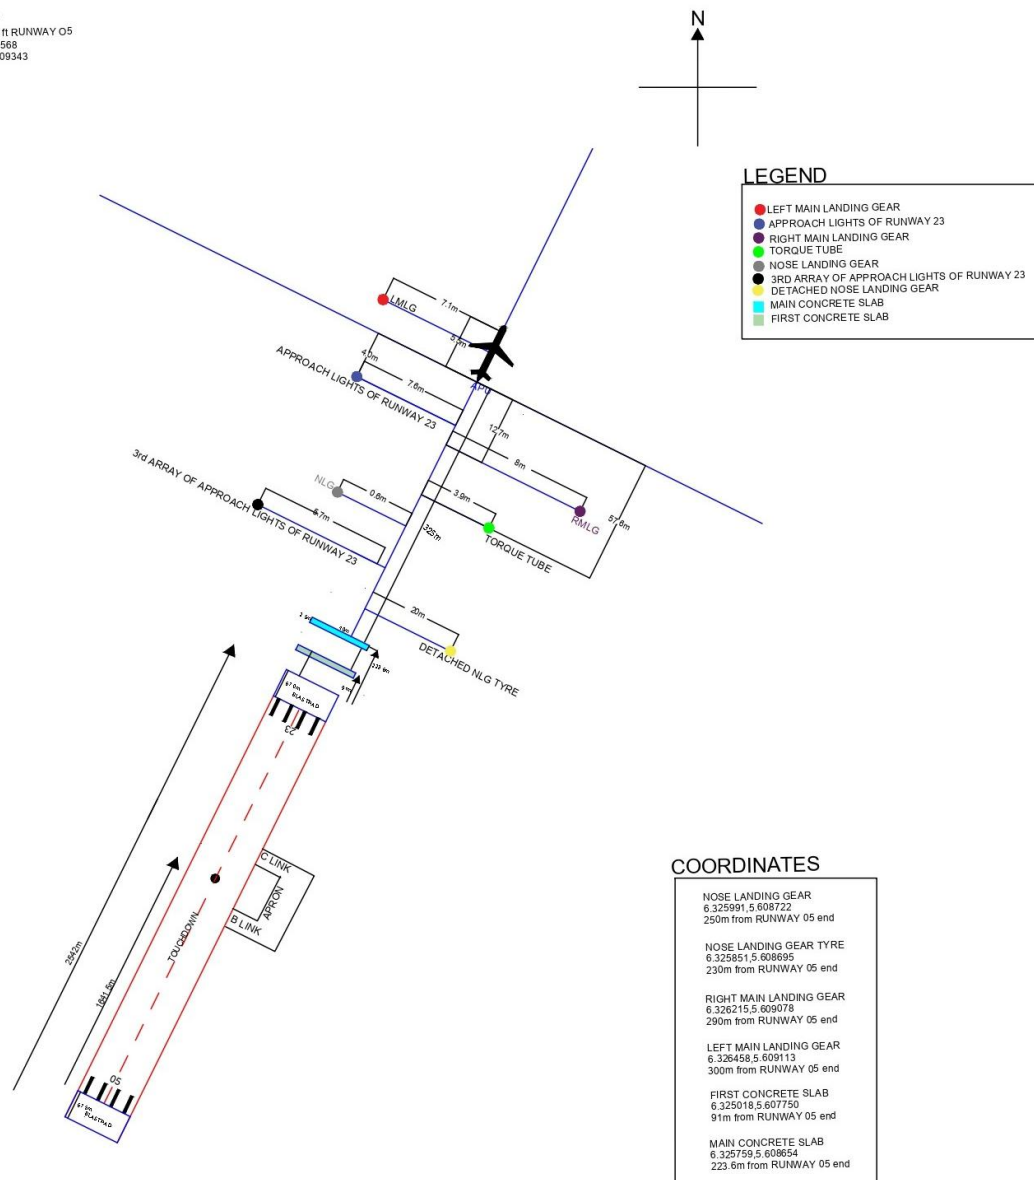
After the aircraft impacted the concrete structure, the landing-gear assemblies broke and separated from the aircraft. Field evidence indicated that the nose landing gear separated first, followed by the right main landing gear and then the left main landing gear.

During the subsequent ground excursion, both engines contacted the ground, leaving about 87.0 m of right-engine and about 82.6 m of left-engine ground-drag marks leading towards the aircraft's final resting position beyond the runway end.

**Figure 7:** Ground track and wreckage distribution diagram

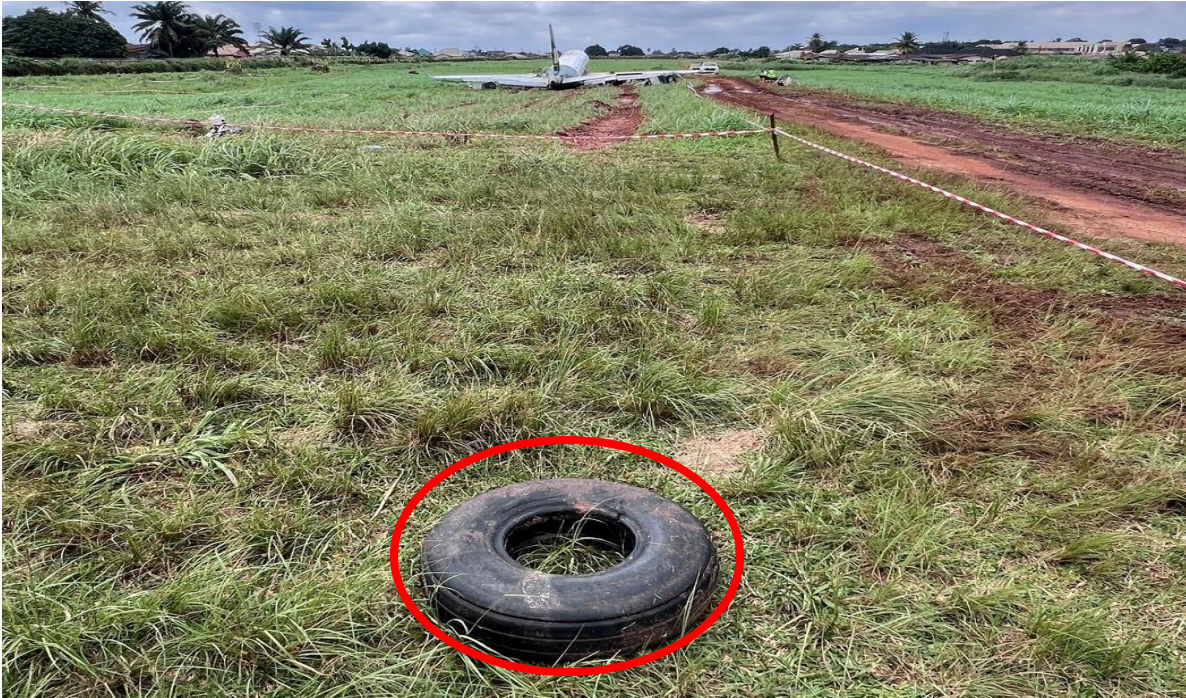
**Figure 8:** Separated nose wheel tyre

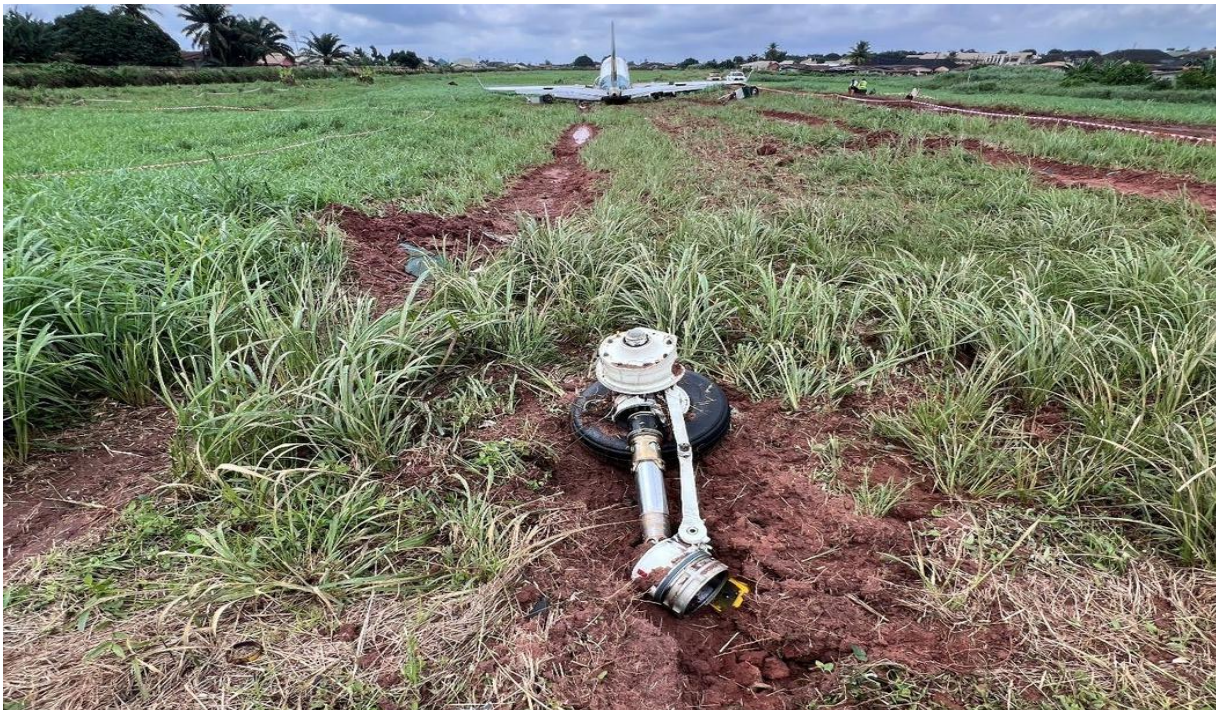
**Figure 9:** Separated nose landing gear assembly

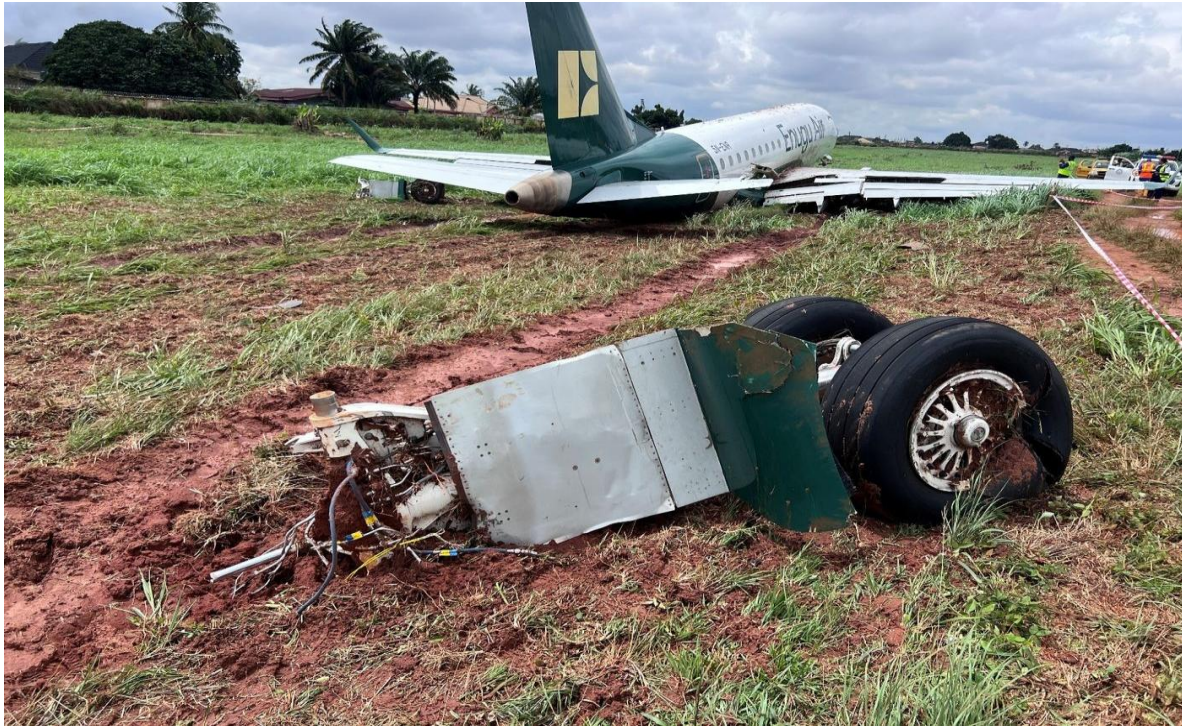
**Figure 10:** Separated right main landing gear assembly

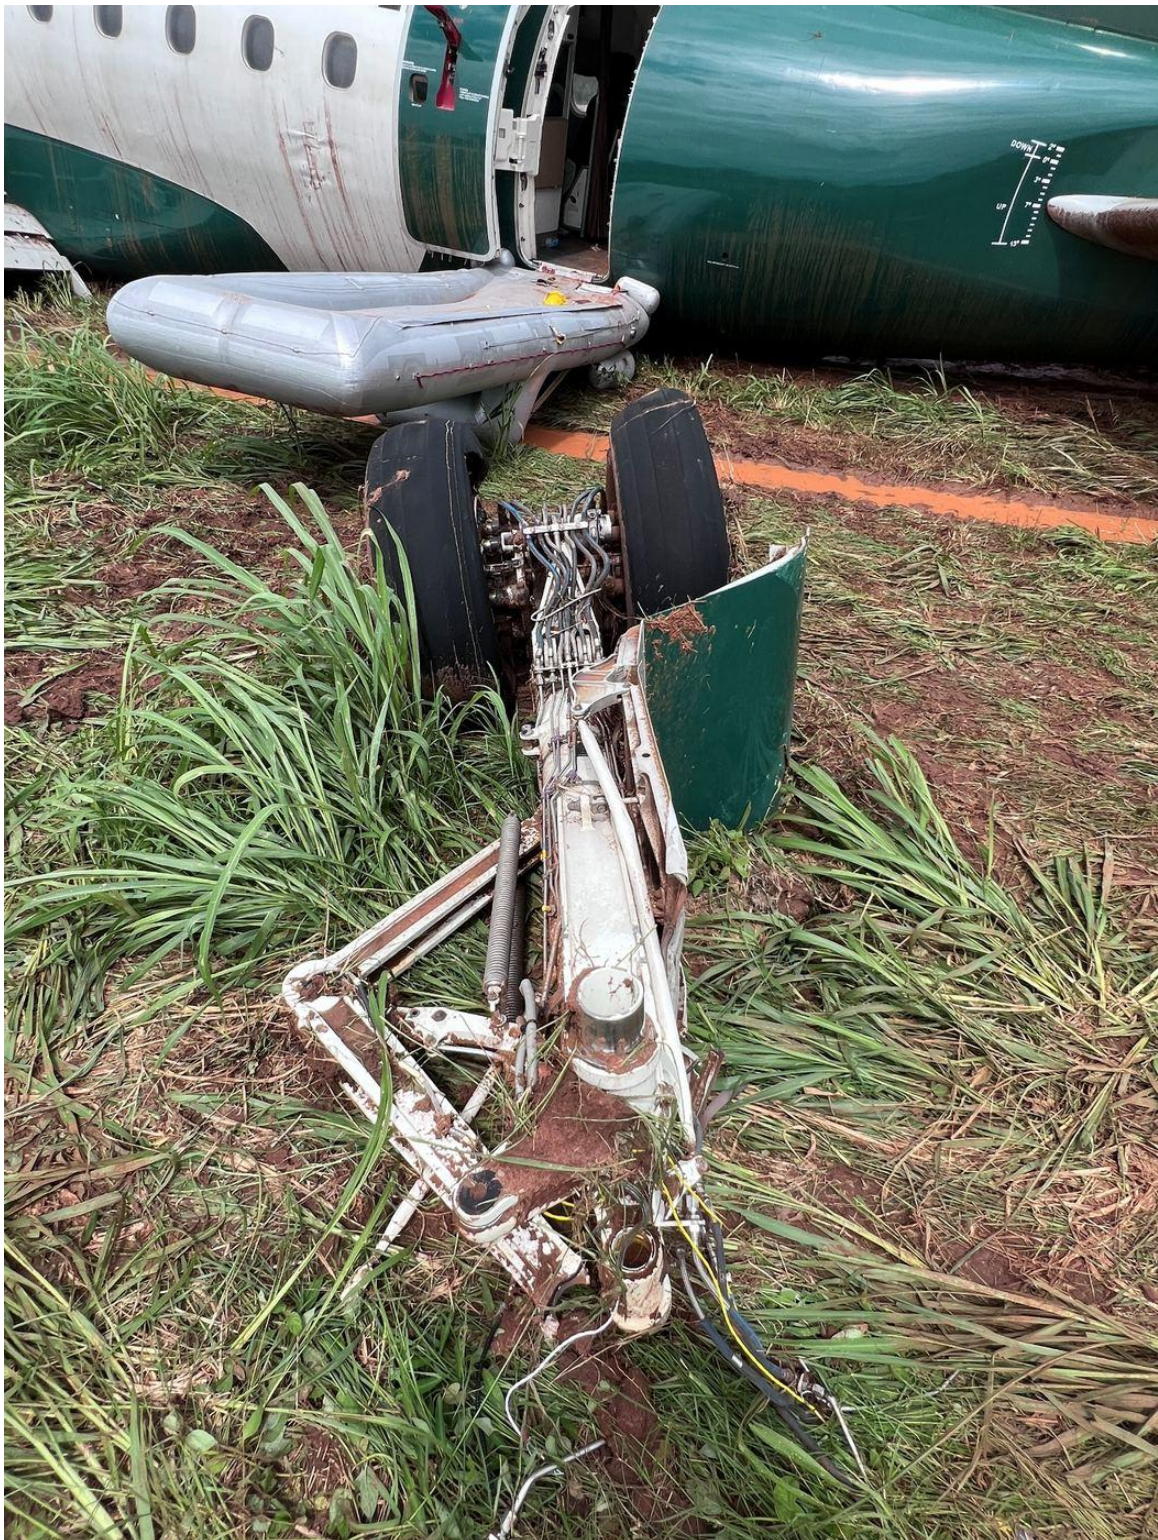
**Figure 11:** Separated left main landing gear assembly

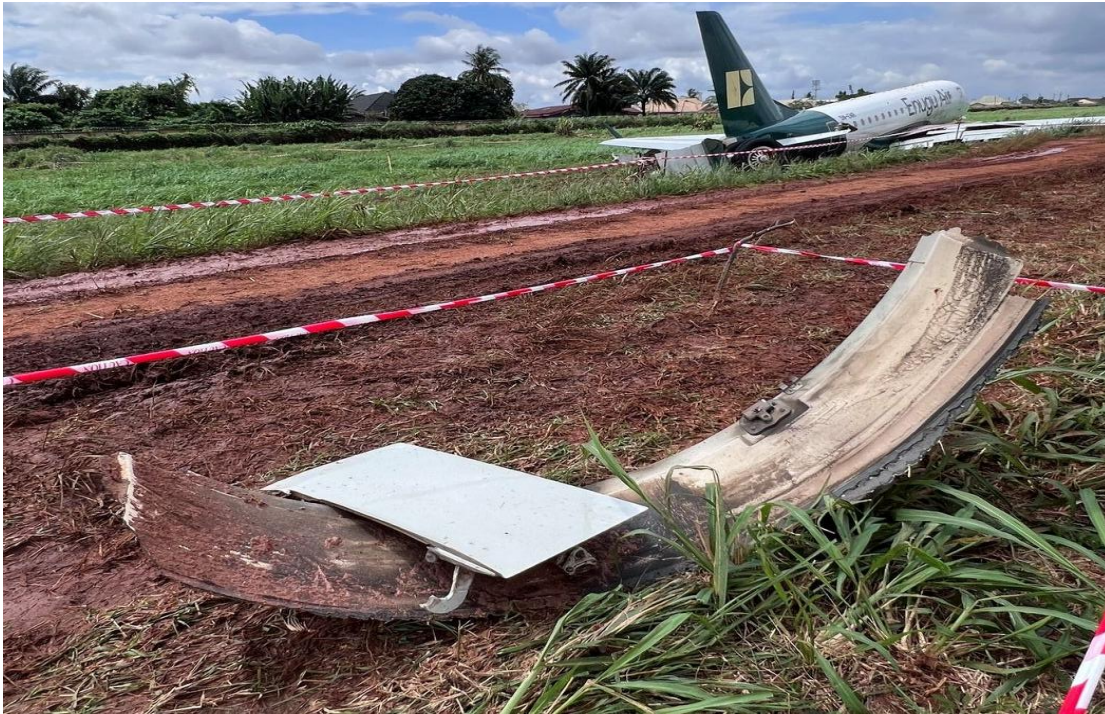
**Figure 123:** Detached fragment of the Right engine cowling

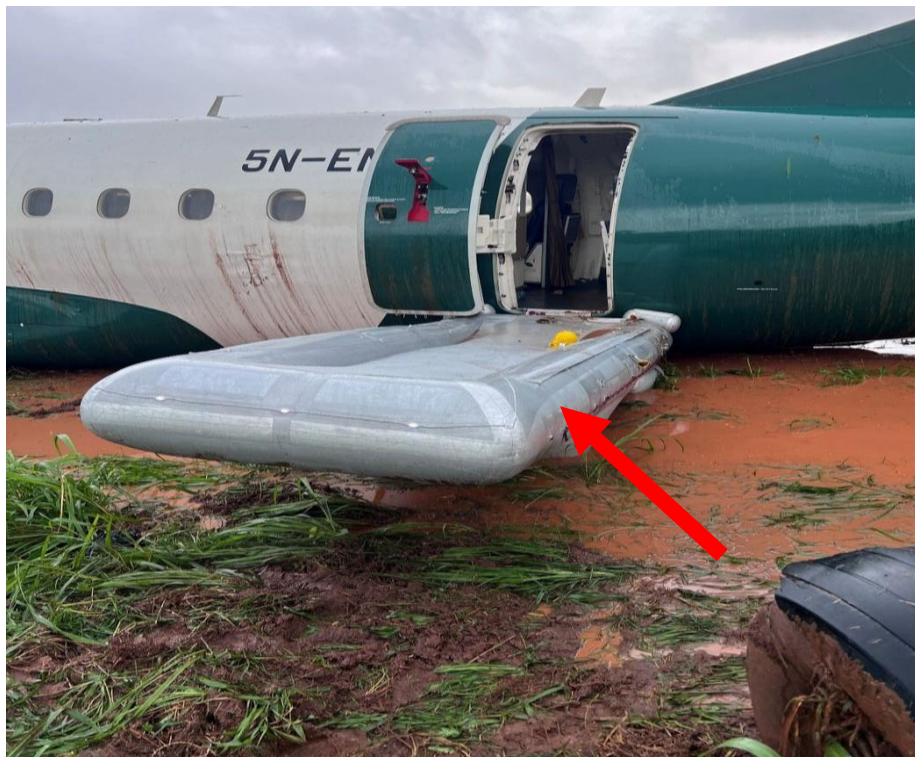
All occupants were evacuated unhurt via the emergency escape slide through the rear left door (L2).

**Figure 13:** Deployed L2 exit slide used for evacuation

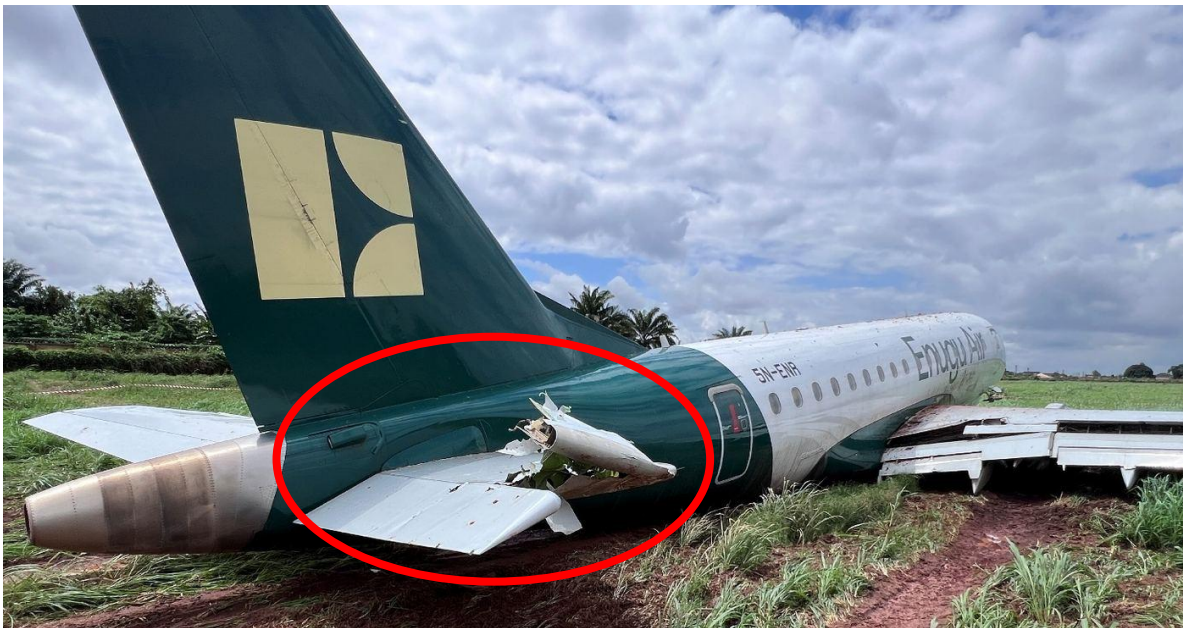
**Figure 14:** Ruptured horizontal stabilizer

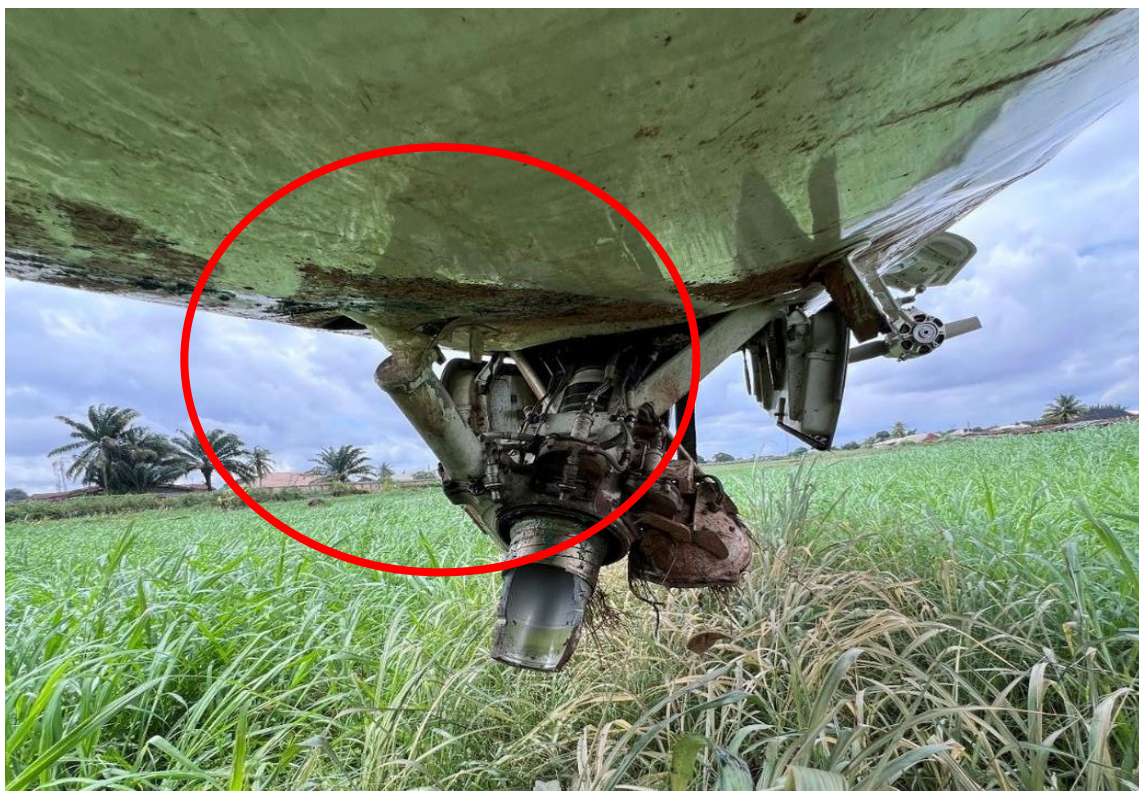
**Figure 15:** Ruptured forward lower fuselage skin

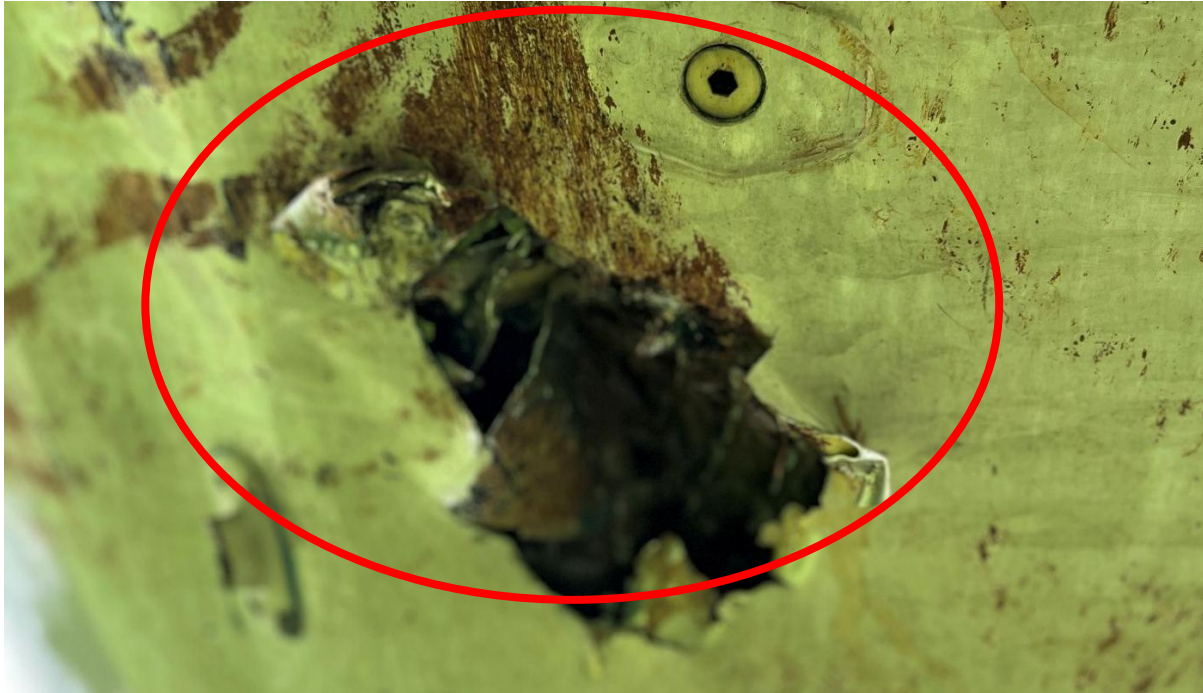
**Figure 16:** Close-up of the ruptured forward lower fuselage skin.

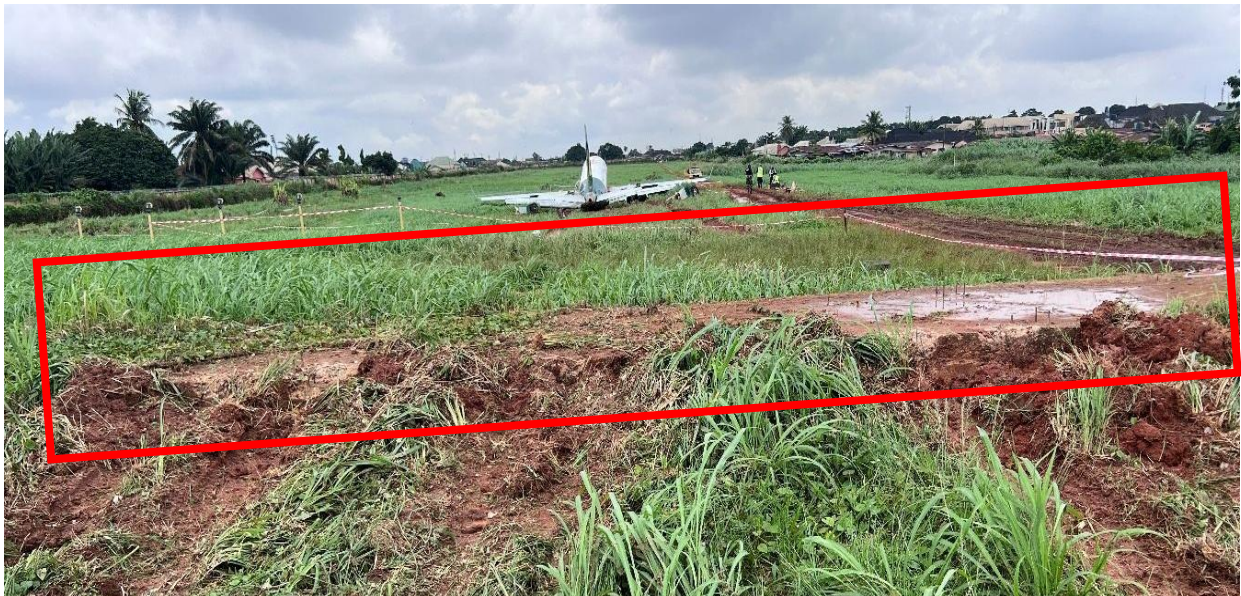
**Figure 17:** A view of the decommissioned localizer installation concrete structure

17. The aircraft struck the approach-lighting installations and impacted two fixed concrete structures of a decommissioned localizer installation, located beyond the runway end.

The Nigeria Civil Aviation Authority (NCAA) should ensure that the Federal Airports Authority of Nigeria (FAAN) remove the fixed structures of the decommissioned localizer installation located at the end of Runway 05 at Oba Akenzua II Airport, Benin.

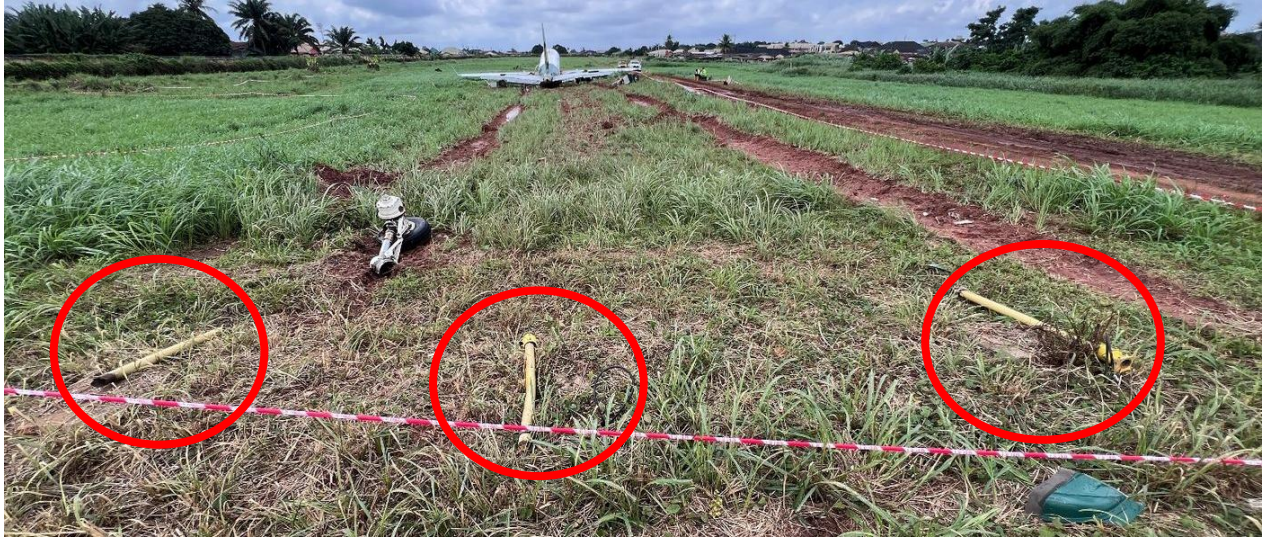
Seven approach lights were damaged during the runway excursion. The investigation is assessing whether damage occurred to other aerodrome or navigational aid infrastructure.

**Figure 18:** Broken approach lights

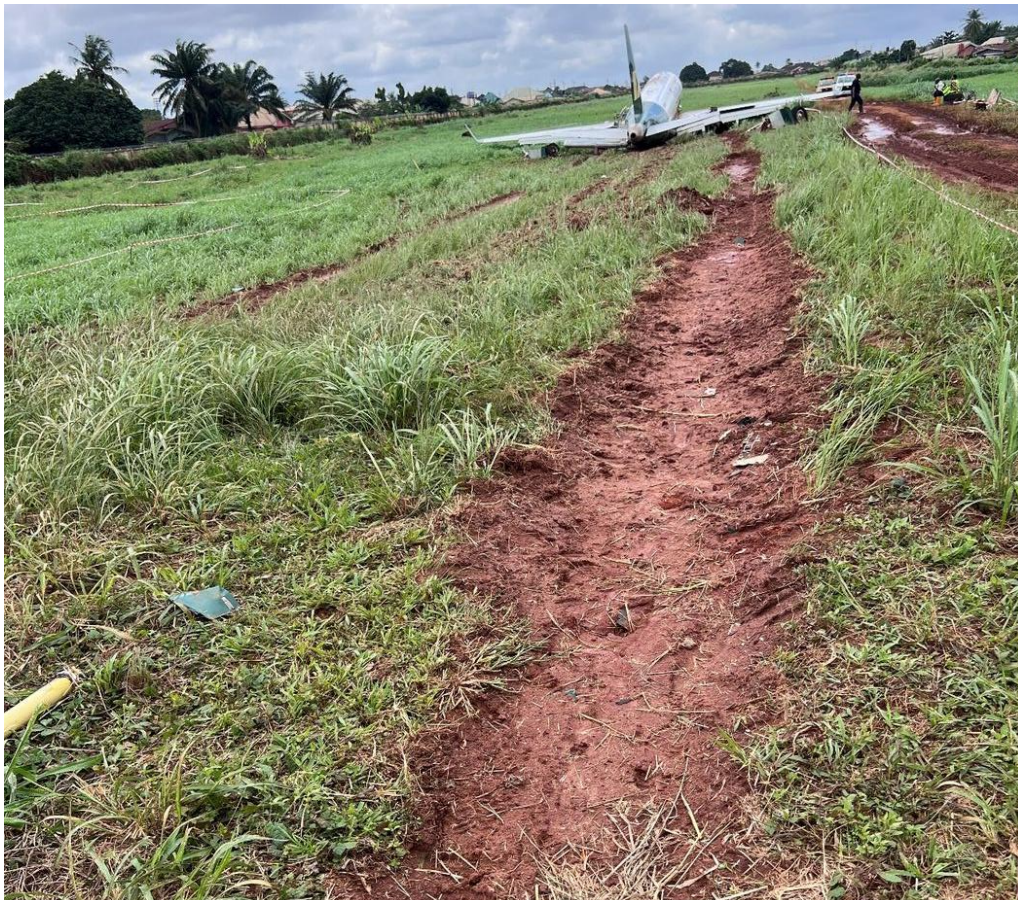
**Figure 19:** Right engine ground drag marks

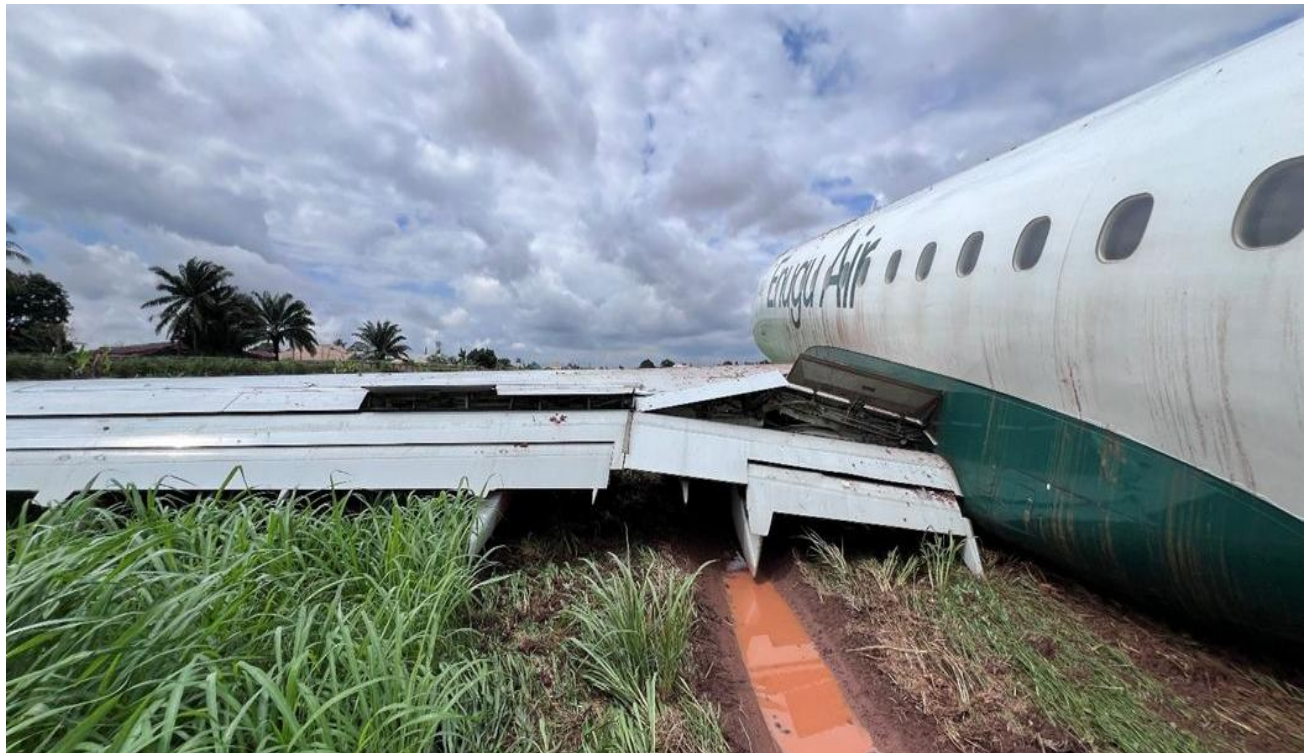
**Figure 20:** The ruptured left wing aileron and flaps

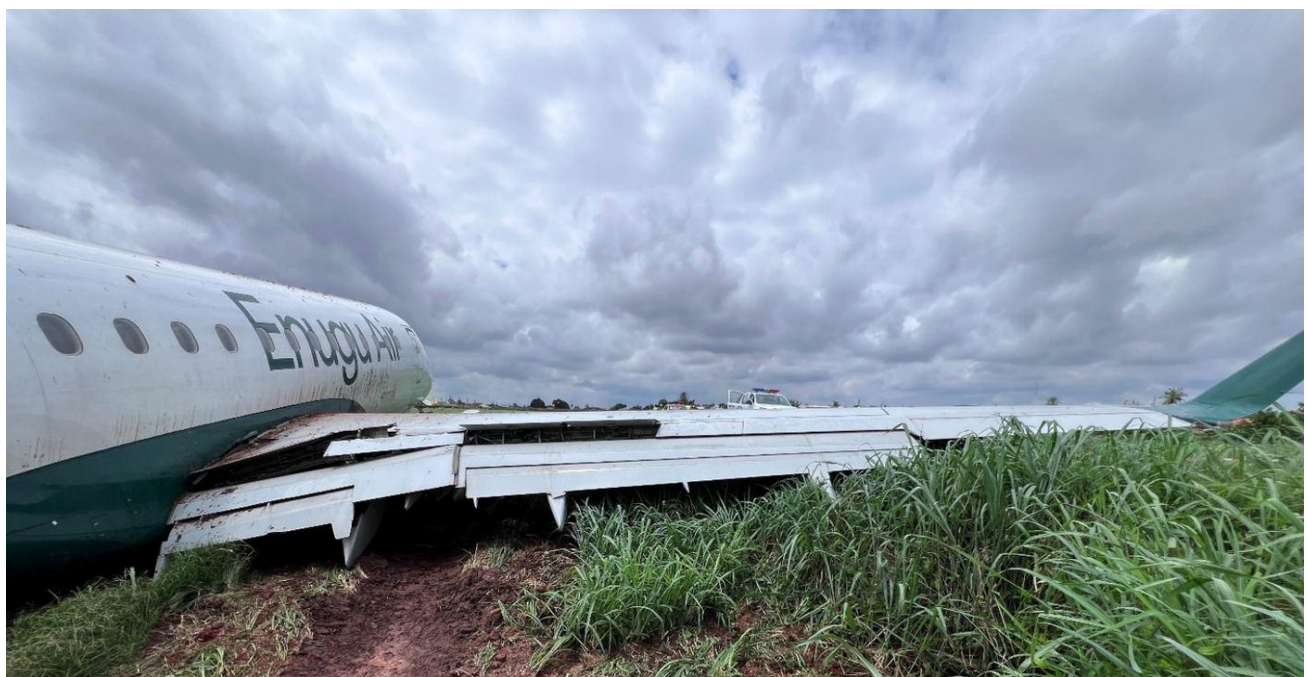
**Figure 21:** The ruptured right wing aileron and flaps

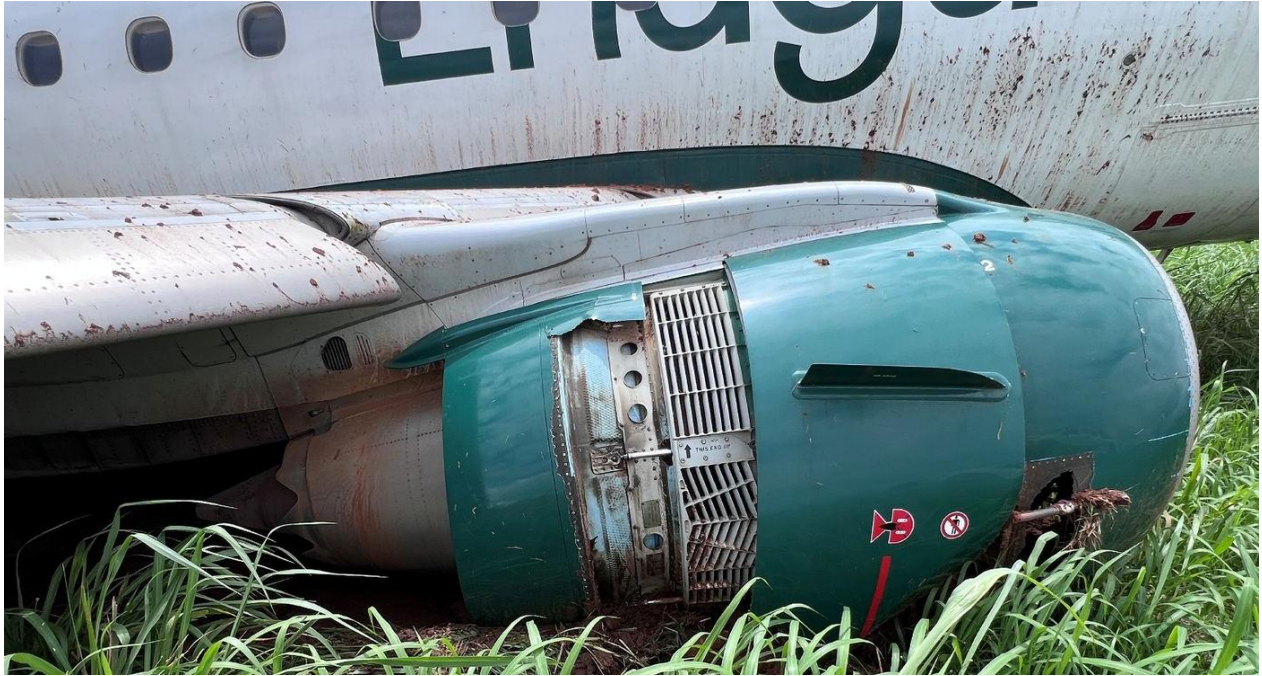
**Figure 22:** Deployed right engine thrust reverser

15. FDR information showed that increased brake pressure and ground-spoiler activation were recorded following touchdown.
16. Post-occurrence examination of the wreckage found the thrust-reverser assemblies in a deployed condition.

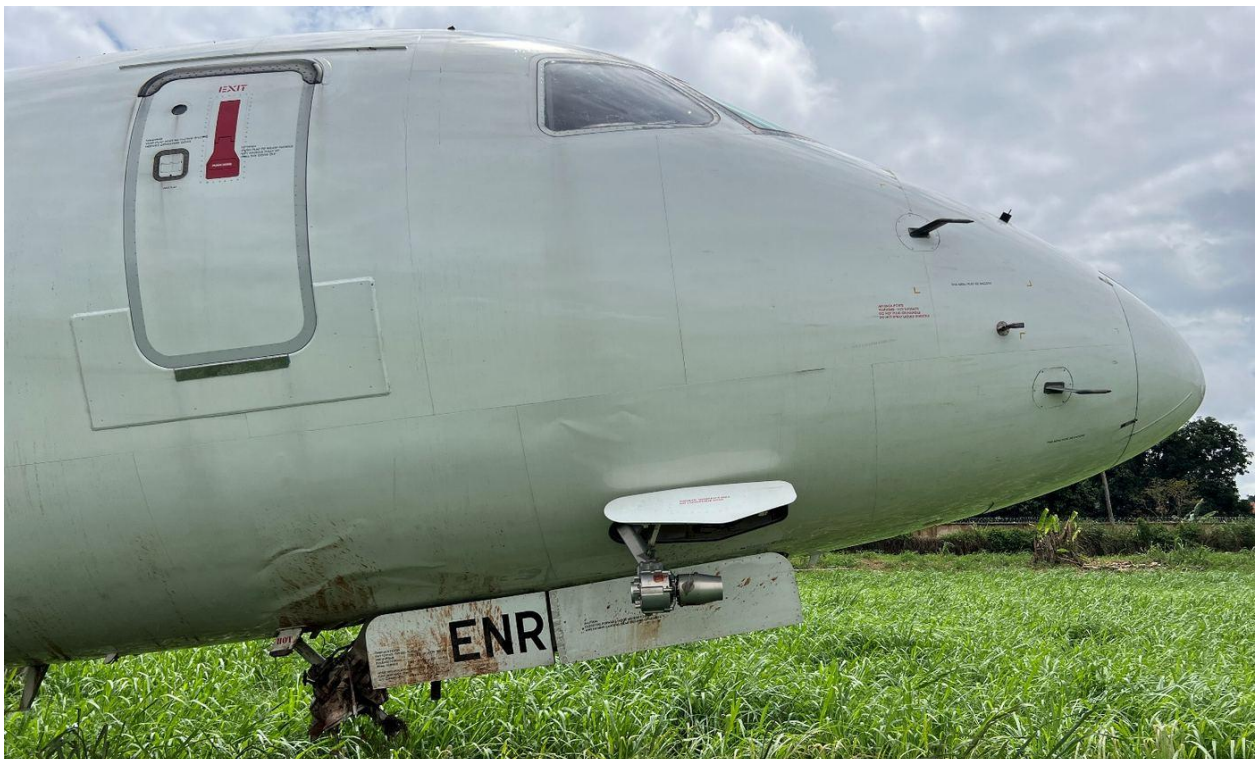
**Figure 23:** Deployed Ram Air Turbine (RAT)
