**Preliminary Report on the Serious Incident involving an Air Tractor AT-502B aircraft with nationality and registration marks 5N-BPV operated by Agro Spray Limited, which occurred on Runway 05, Rukubi airstrip, Doma, Nasarawa State, Nigeria on 29 July 2026**

| <b>Aircraft type and model:</b> | Air Tractor AT-502B |
| <b>Nationality and registration marks:</b> | 5N-BPV |

This Preliminary report details the initial facts, discussions and findings surrounding the occurrence. It includes information gathered from witness statements, inspection of the site and aircraft.

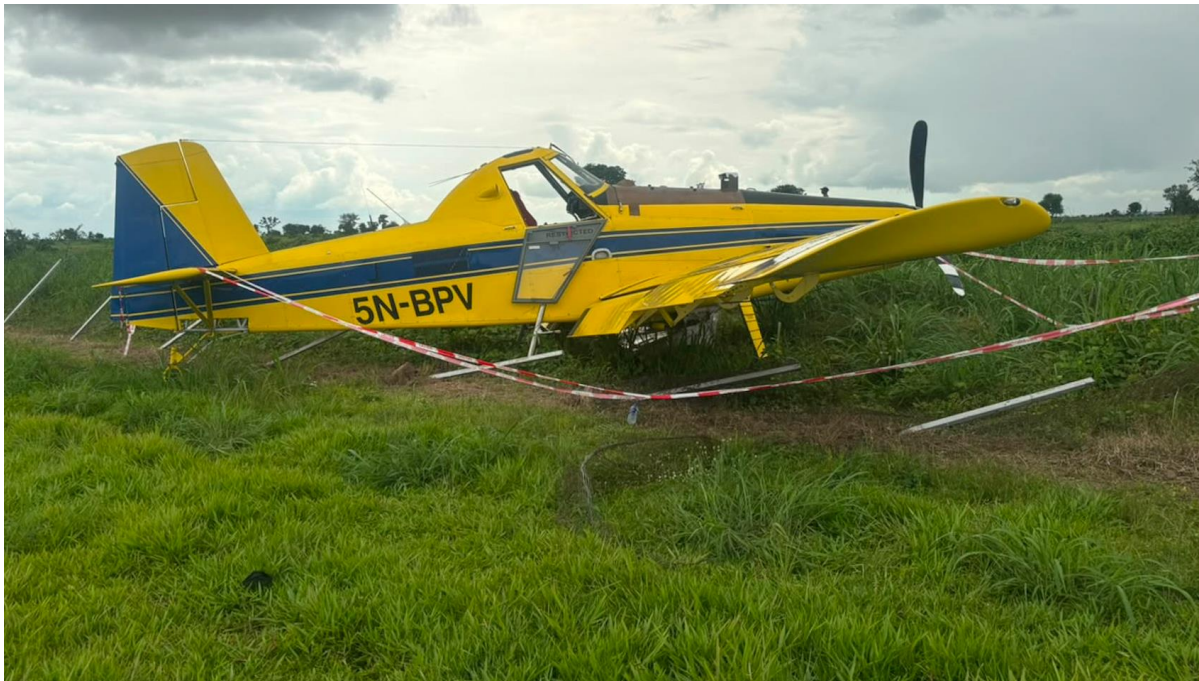
The aircraft touched down about 200 m from the threshold of Runway 05. It then travelled for 550 m before veering off the left side of the runway. The aircraft impacted the wire mesh perimeter fence and stopped at about 50 m from runway center line at a magnetic heading of 015°. The left main wheel tyre got stuck in the mud.

**Figure 4:** Final position of 5N-BPV at the wire mesh perimeter fence

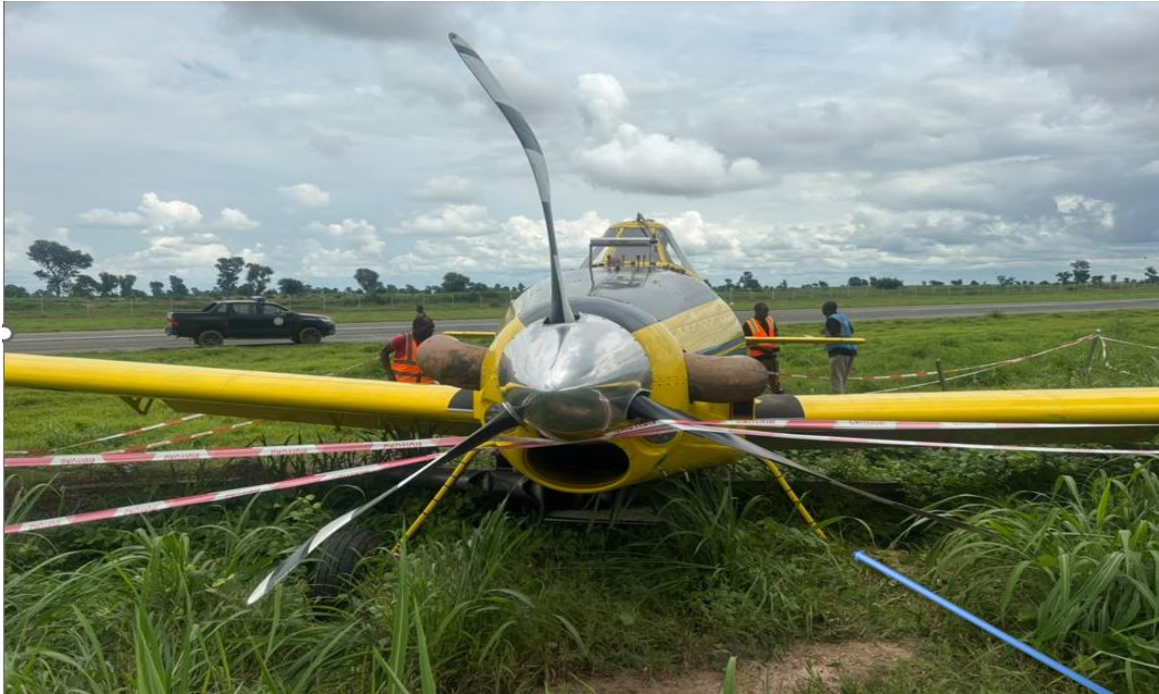
1. The propeller blades were found bent.
2. The right rudder pedal linkage was found work loosen at the attachment.

**Figure 5:** The bent propeller blades and the stuck left main landing gear

14. The propeller blades were found bent.
15. The right rudder pedal linkage was found work loosen at the attachment.

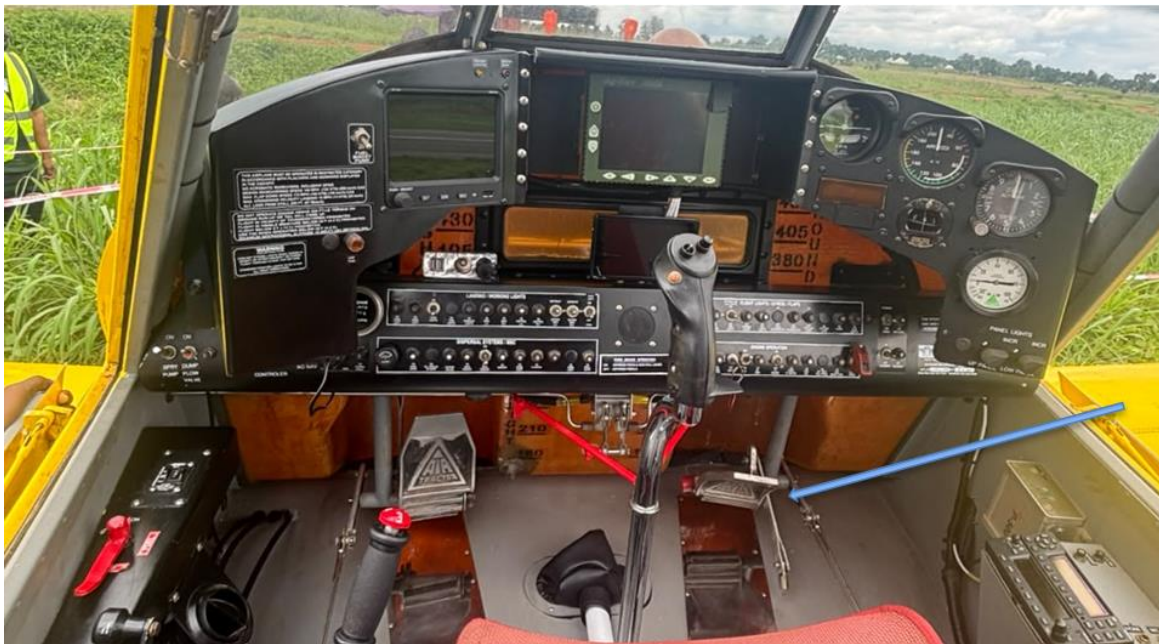
**Figure 6:** Right rudder-pedal linkage found work loosen at the attachment.

1. Detailed examination of the right main wheel brake system.
2. Examination of the right rudder pedal linkage.
3. The maintenance records of the aircraft.

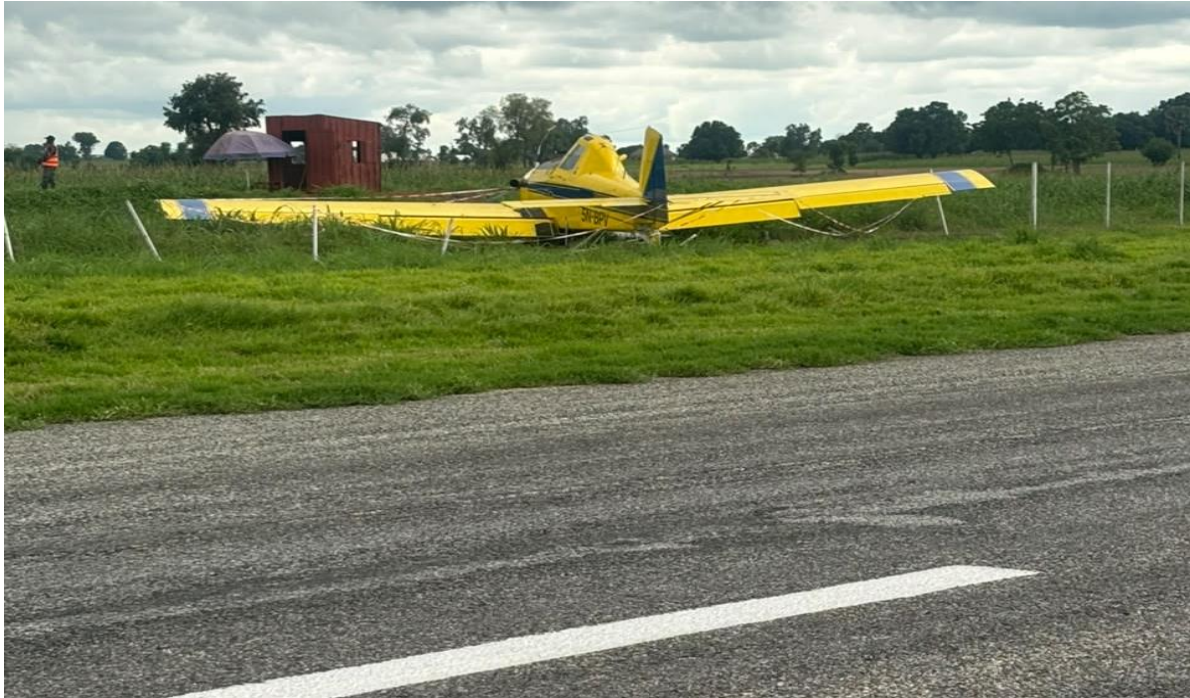
The pilot reported that, after the aircraft had decelerated, the right wheel brake appeared not to respond. The aircraft veered off and came to a stop to the left of the runway, against the wire-mesh perimeter fence.

**Figure 7:** Path showing how aircraft exited the runway
