**AIRCRAFT ACCIDENT REPORT  
01/2008 (BH/2007/08/03/F)**

**Accident Investigation Bureau**

**Report on Bristow Helicopters  
Accident Bell 412 EP Registration 5N - BIQ  
at Qua Iboe Terminal Akwa Ibom State, Nigeria  
on 3rd August 2007**

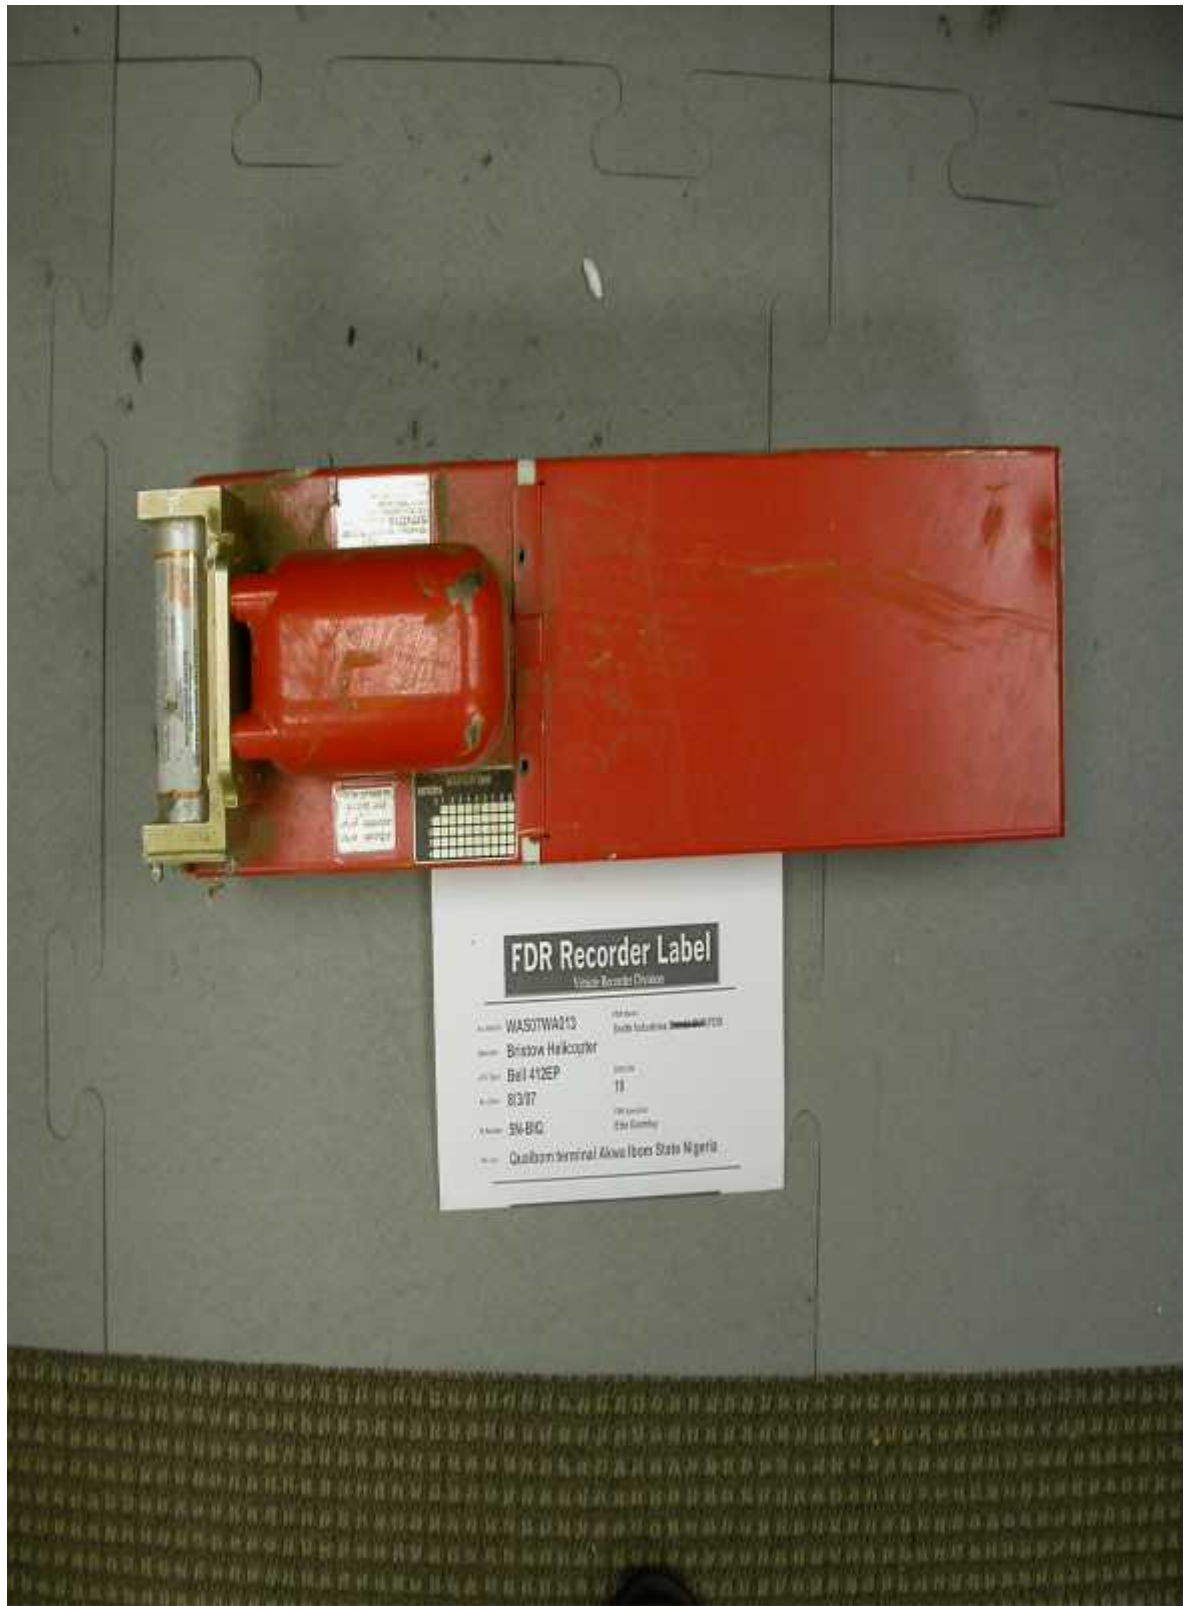
Fig. 1.11 Flight Data Recorder

The recorder(FDR) exhibited impact damage and the data could not be extracted from the unit in the normal manner. The crash protected memory was removed from the damaged accident box and transferred to a surrogate unit in order to download the data.

The FDR recording contained over 600 hours of recorded data. The event flight was the last data and the recording duration was 5 minutes. The four (4) plots in this report contain data which illustrated the event flight.

Analysis of the flight recorders parameters revealed that flight control inputs, gearbox, transmission and engines were functioning normally up till the moment the aircraft impacted the ground. The CVR never revealed any distress call, except for a significant statement, "*all right*" at 0733:59hrs by the captain.

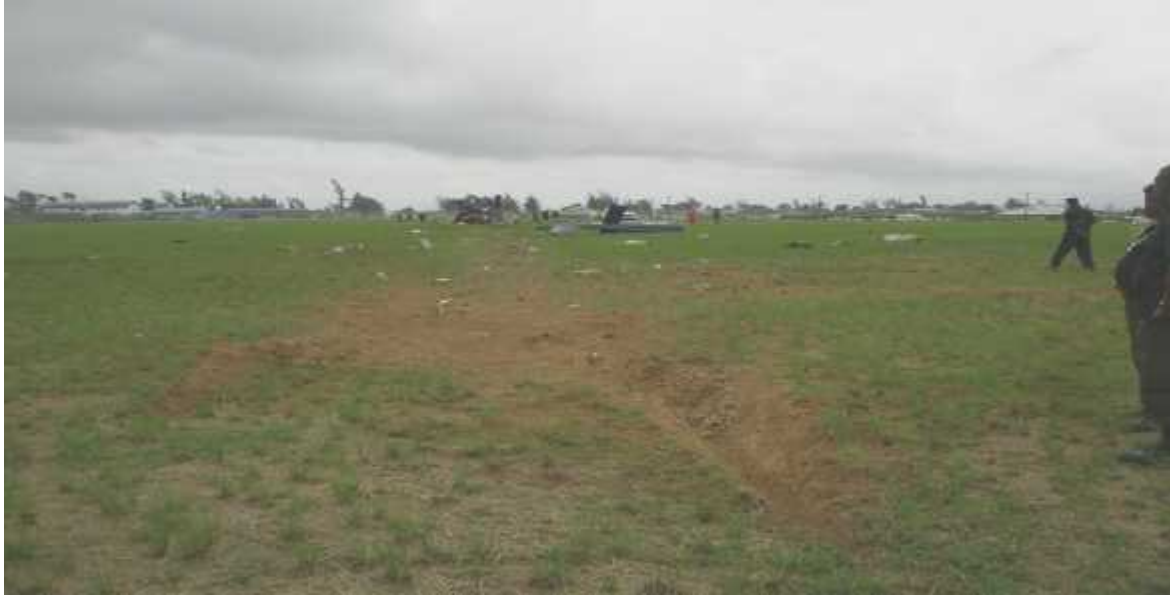
Photograph showing point of impact

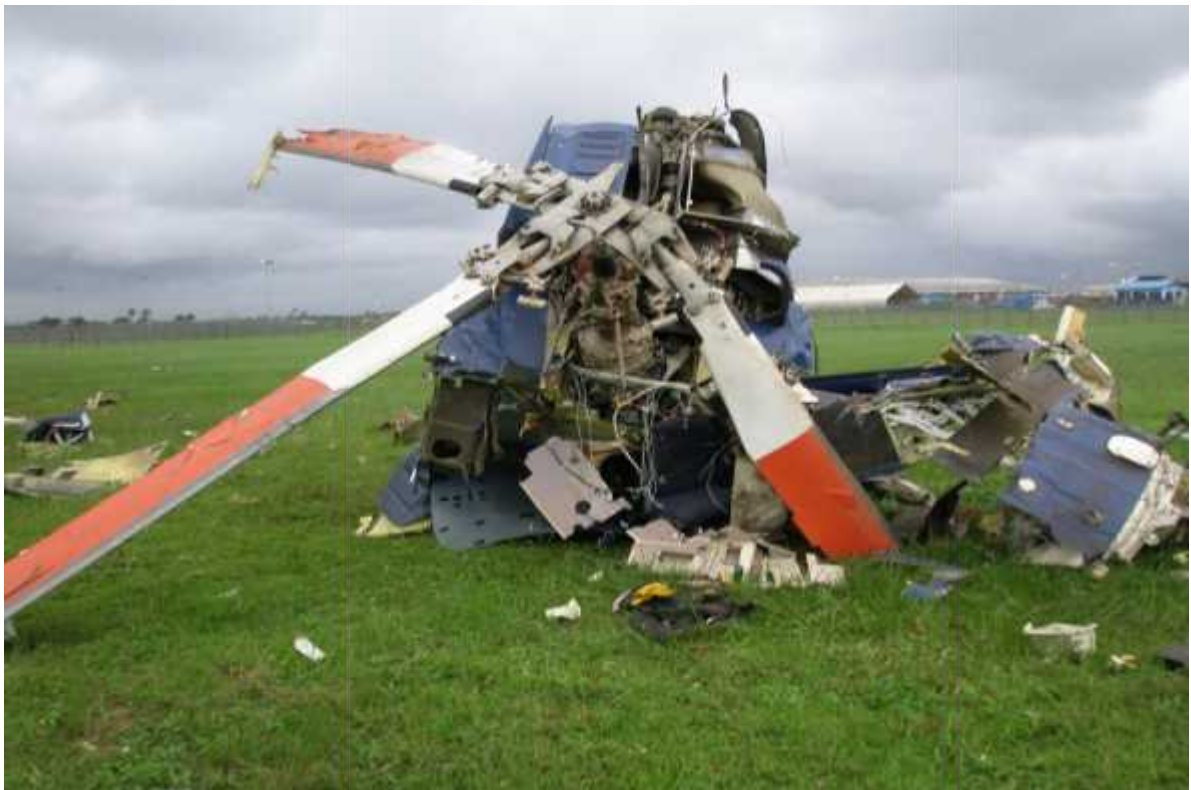
All damages occurred as aircraft impacted the ground.

Photograph showing main wreckage

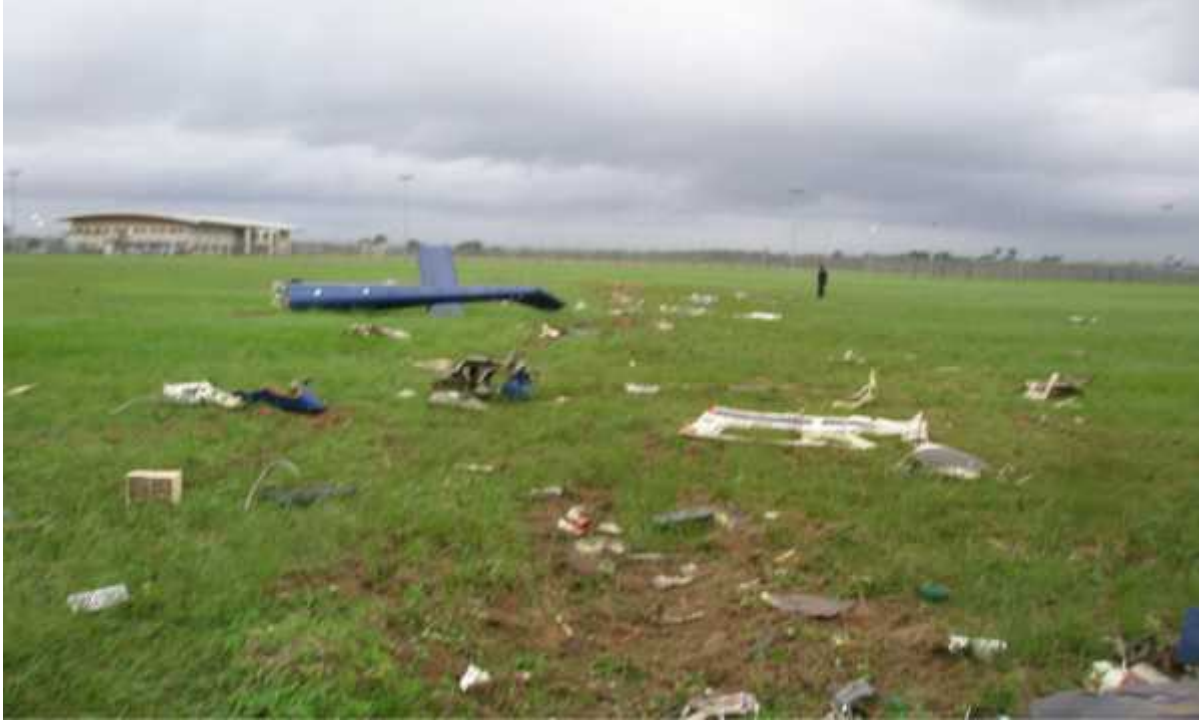
Photograph showing Debris trail

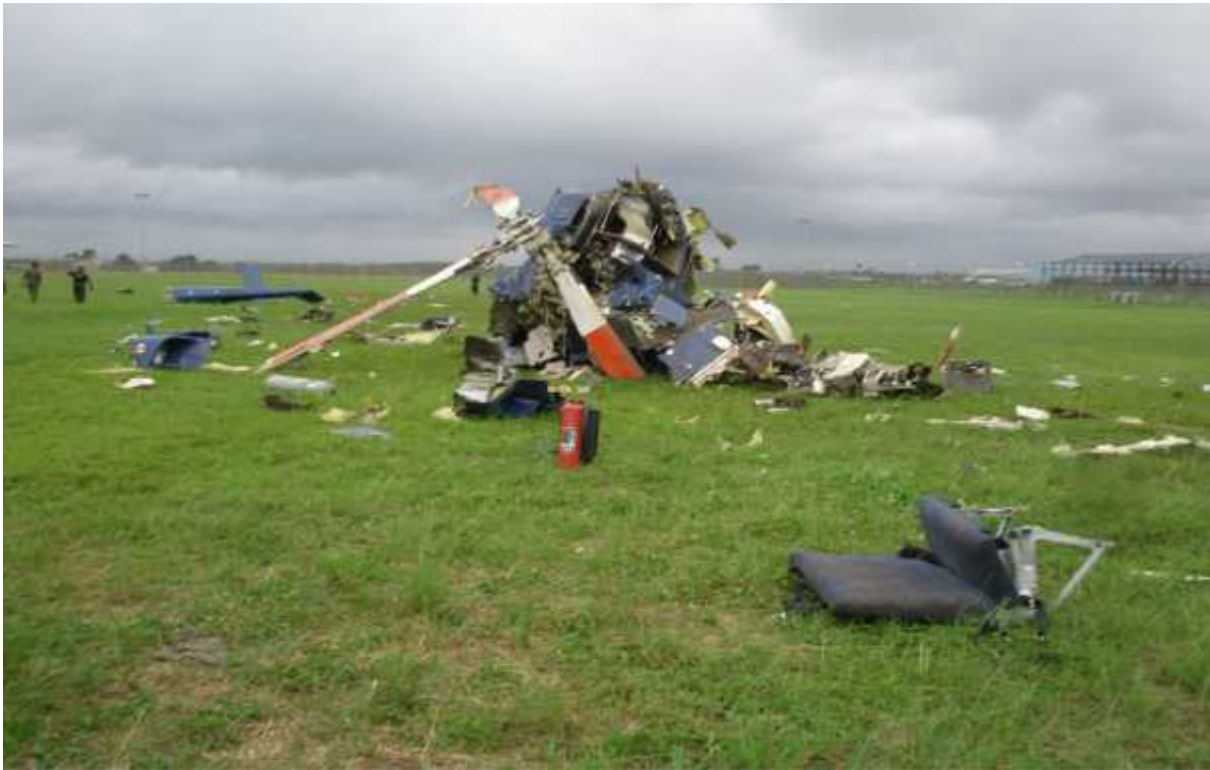
Photograph showing final resting place after impact

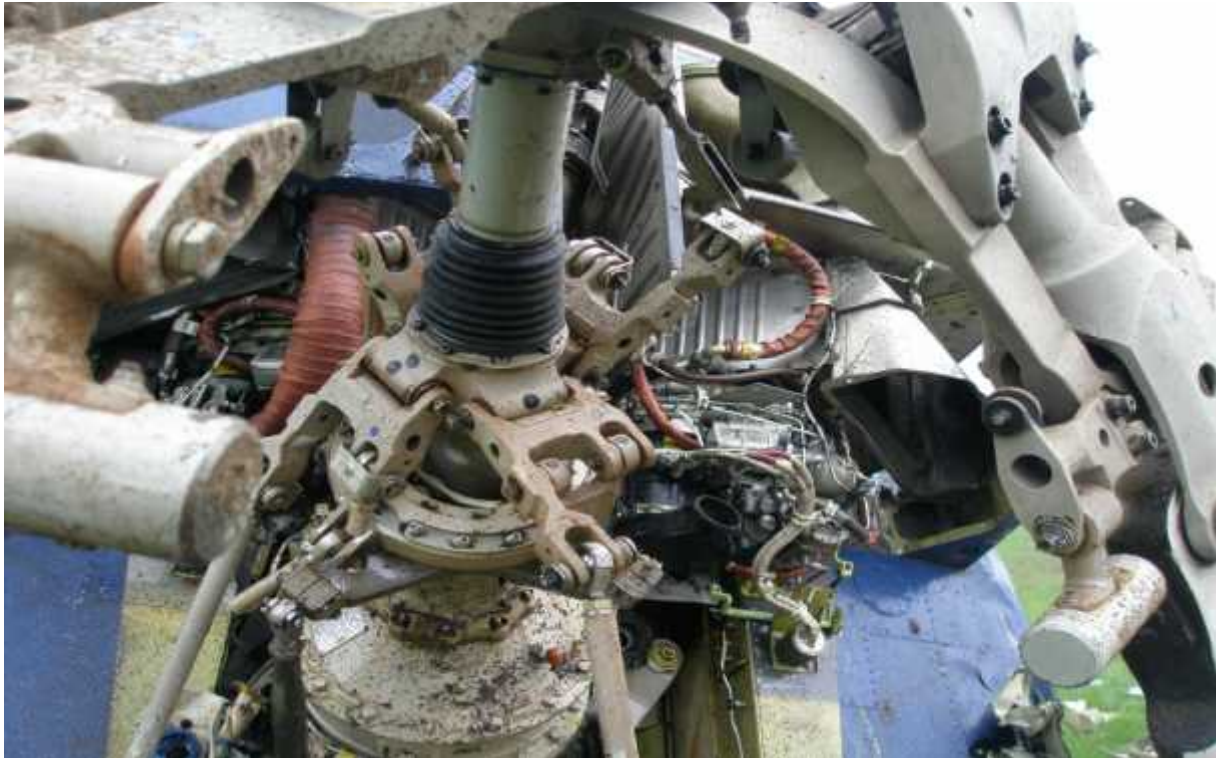
The main transmission was free to rotate and the chip detectors and oil filters were checked, no debris found.

Photograph showing rotor assembly and transmission damage

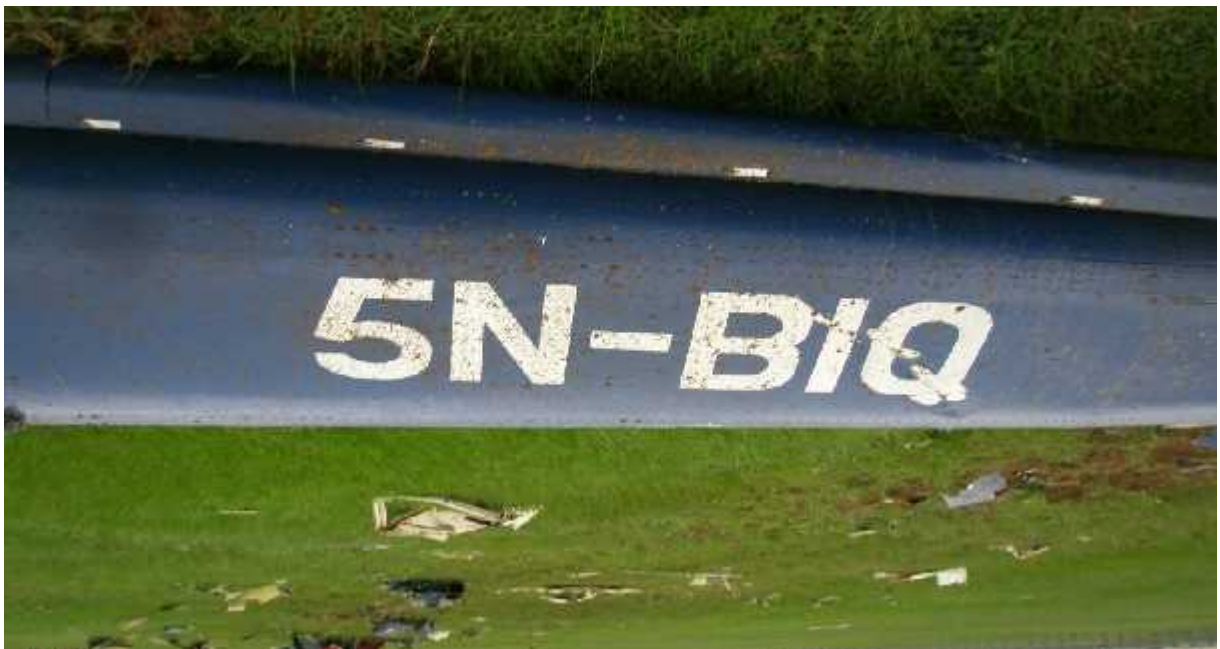
Photograph showing separation of tail boom
