AIRCRAFT ACCIDENT REPORT

AERO/2015/07/21/F

**Report on the Serious Incident involving Aero
Contractors Nig. Ltd Boeing 737-42C aircraft with
Registration 5N-BOB, which occurred on Runway 18L,
Murtala Muhammed Airport, Lagos, Nigeria
on 21st July, 2015**

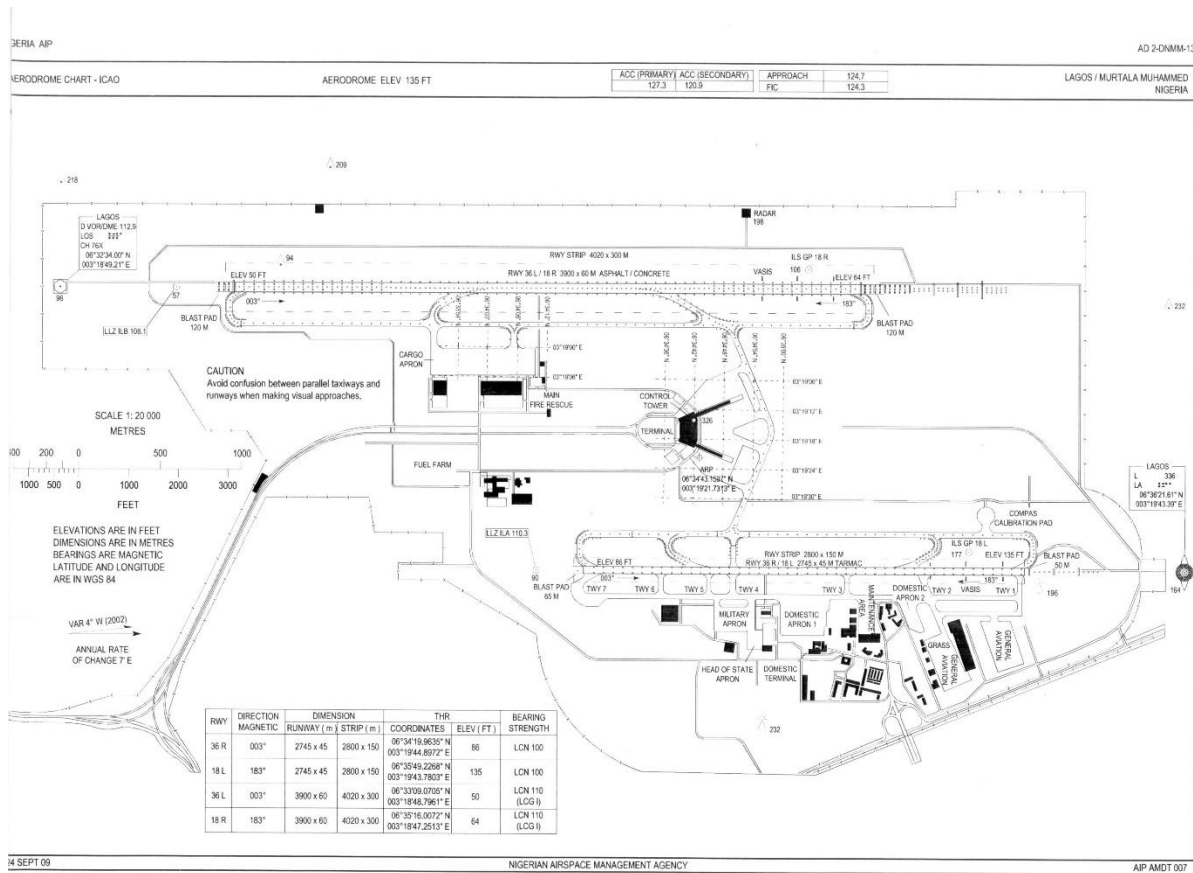
Link 4 is located at the southern end of Runway 18L/36R, along the take-off path. Runway inspection was carried out by ATC inspection team at 08:20hrs on the day of the occurrence. The second inspection was carried out by the ATOM and his team to inspect the reported crack abeam link 4 on runway 18L at 14:07hrs after which the runway was subsequently closed between 14:07hrs and 14:55hrs.

Figure 1: Layout of the runway (Aeronautical Information Publication)

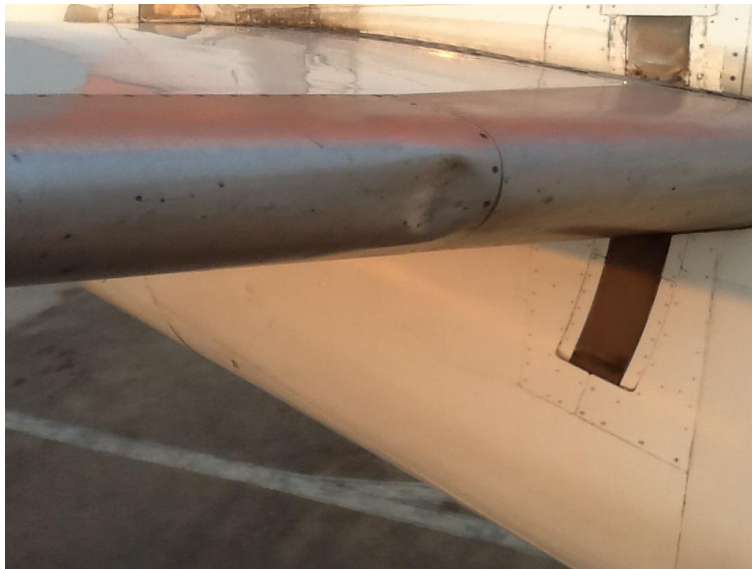
- RH Inboard Ground Spoiler which severed into two pieces (with a piece that flew off in flight),
- No 4 Main Wheel Tyre,
- Wheel well doors,
- A deep dent on the Right Horizontal Stabilizer leading edge, and,
- Multiple dents on the skin of the Right Vertical Stabilizer.

Figure 2: Damage to the leading edge of horizontal stabilizer

The No. 4 main wheel tyre was found damaged upon inspection, after the aircraft landed. The damage to the ground spoiler and other parts of the aircraft may have been caused by impact from fragments of rubber from the blown tyre.

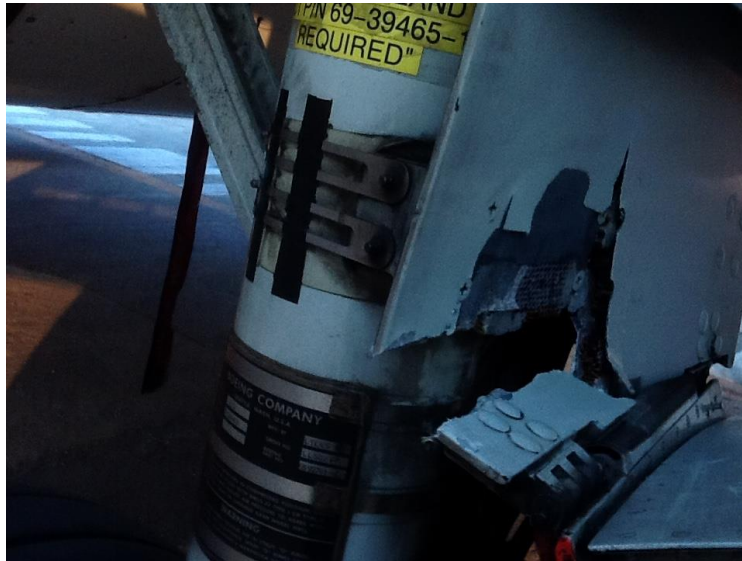
Figure 3: Damage to No. 4 Main landing gear strut and doors

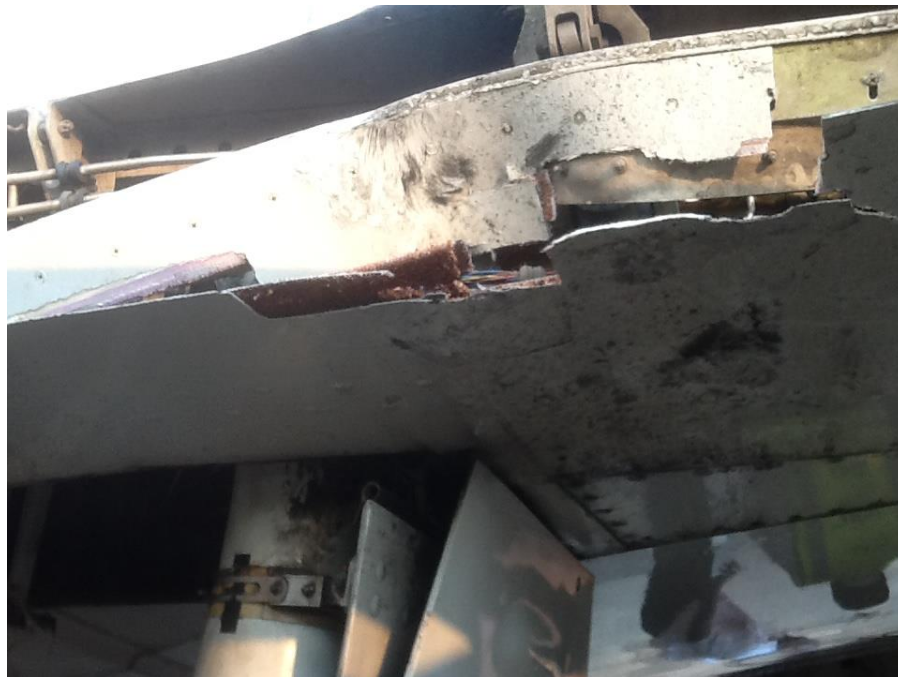
Figure 4: Damage to No. 4 Main landing gear struts and doors

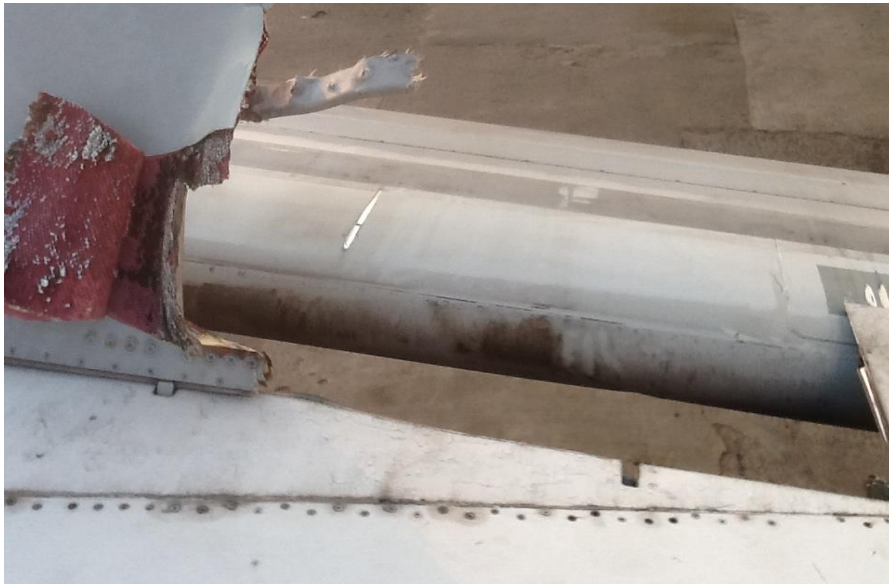
Figure 5: Damage to the edges of the Vertical/Horizontal Stabilizers

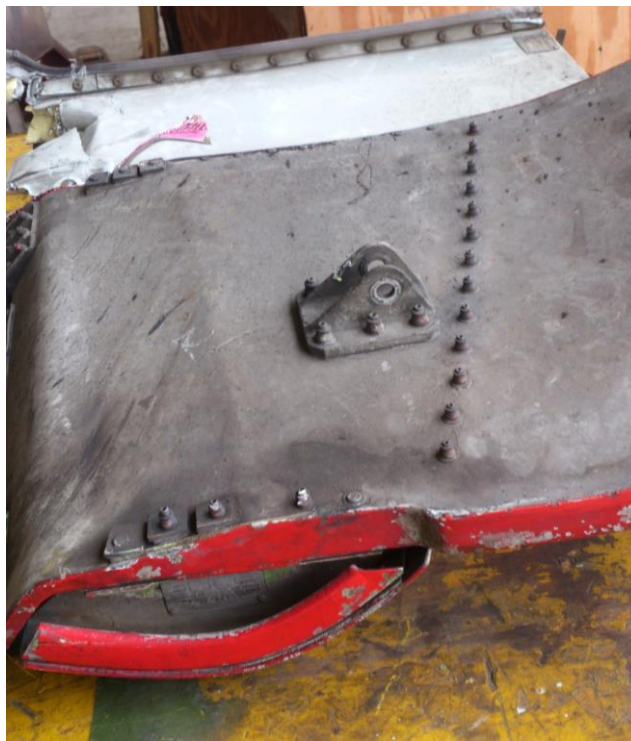
Figure 6: Damage to the wheel well doors

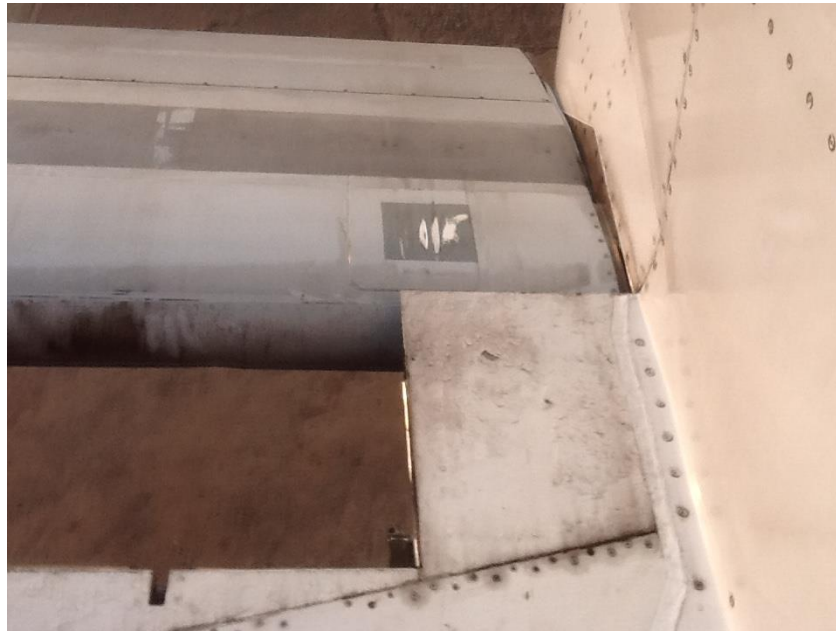
Figure 7: The missing section of the right wing

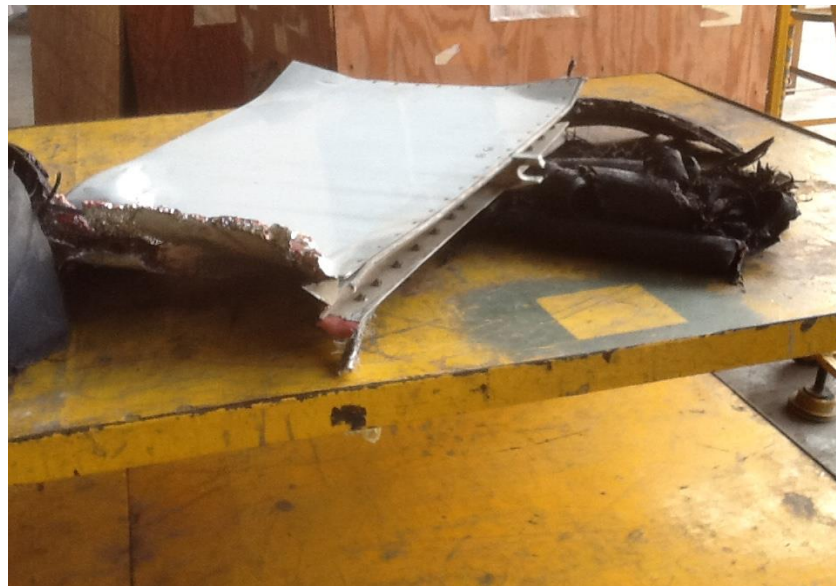
Figure 8: A portion of the ground spoiler

The damage to the ground spoiler could have occurred at some point during the take-off roll or just after lift-off; while the faulty wheel was still in the extended position, suggesting that the abnormal condition of the No. 4 tyre had not been noticed during the taxi or take-off roll.

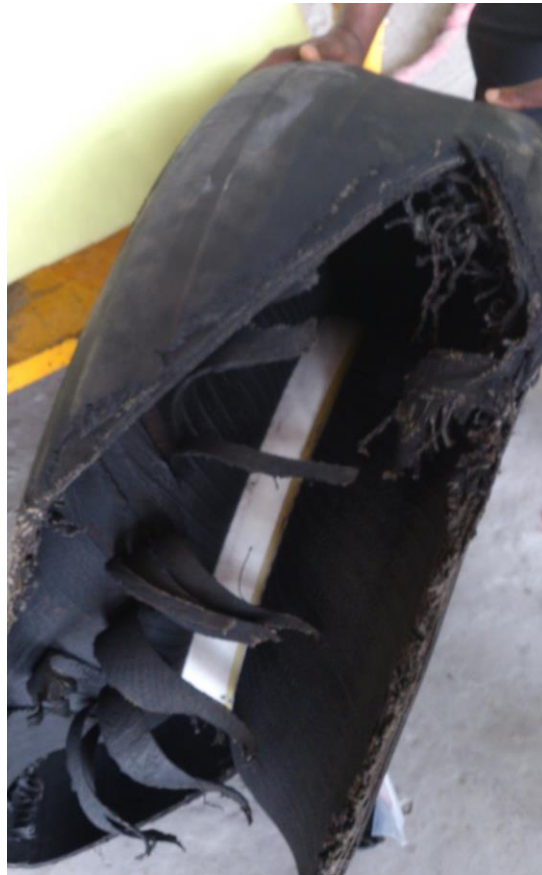
Figure 9: Damage to tyre of No. 4 Main landing Gear

5N-BOB was the first aircraft cleared to use runway 18L after the inspection of the reported crack at Link 4. It can be reasonably deduced that the tyre debris found on the runway afterwards came from the aircraft, and hence the No. 4 main wheel had sustained damage during the taxi or take-off roll.
