AIRCRAFT ACCIDENT REPORT

AIB/NCAT 2006/10/10/F

**Report on the Accident involving
TAMPICO Club 9 Aircraft, Reg. 5N-CBF
at Zaria, Kaduna State, Nigeria
On 10 October 2006**

Aircraft Accident Report No: (NCAT/2006 /10 /10/F)

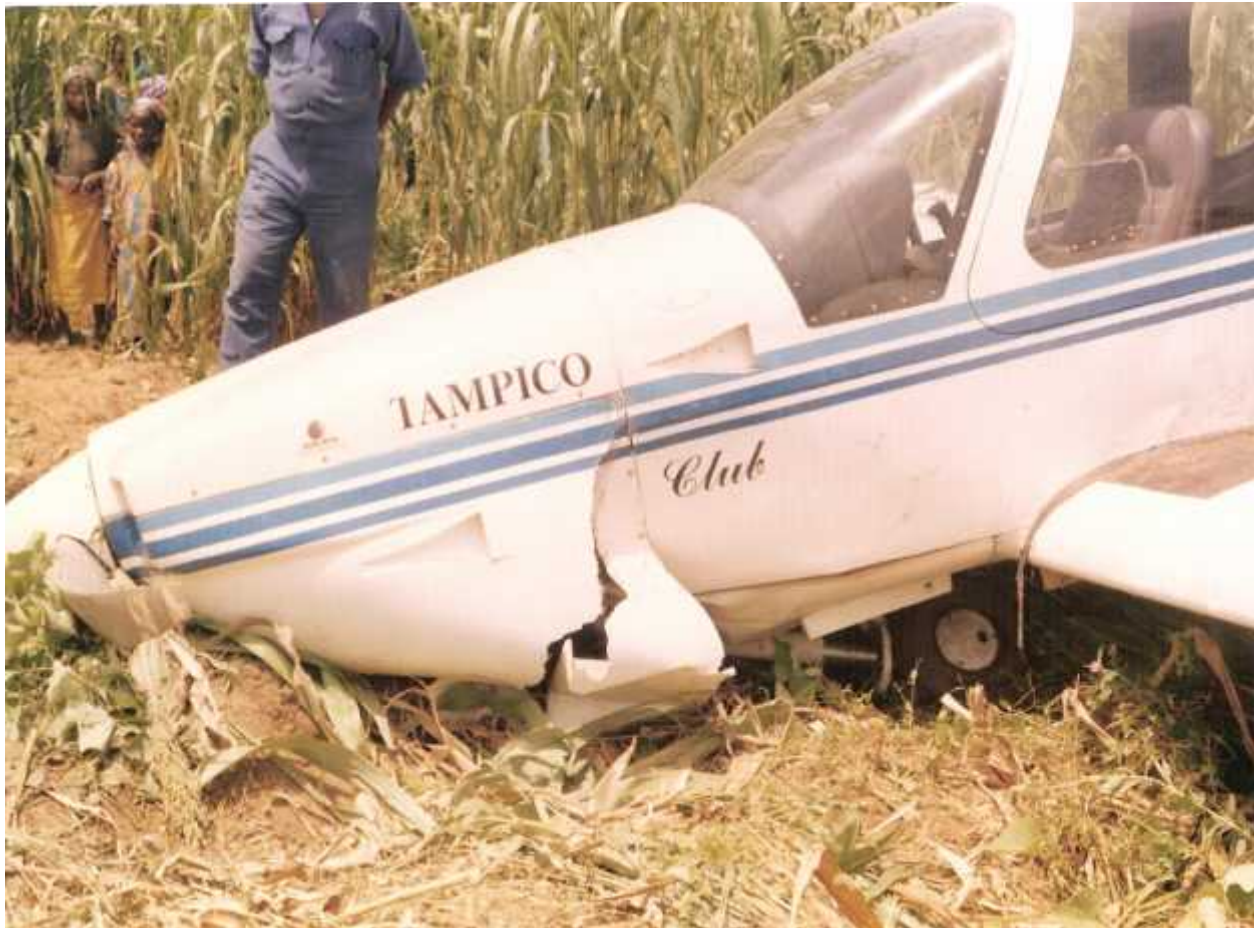
The aircraft was substantially damaged as a result of ground impact. (See fig 1.3).

Fig 1.3 Photograph showing damaged aircraft

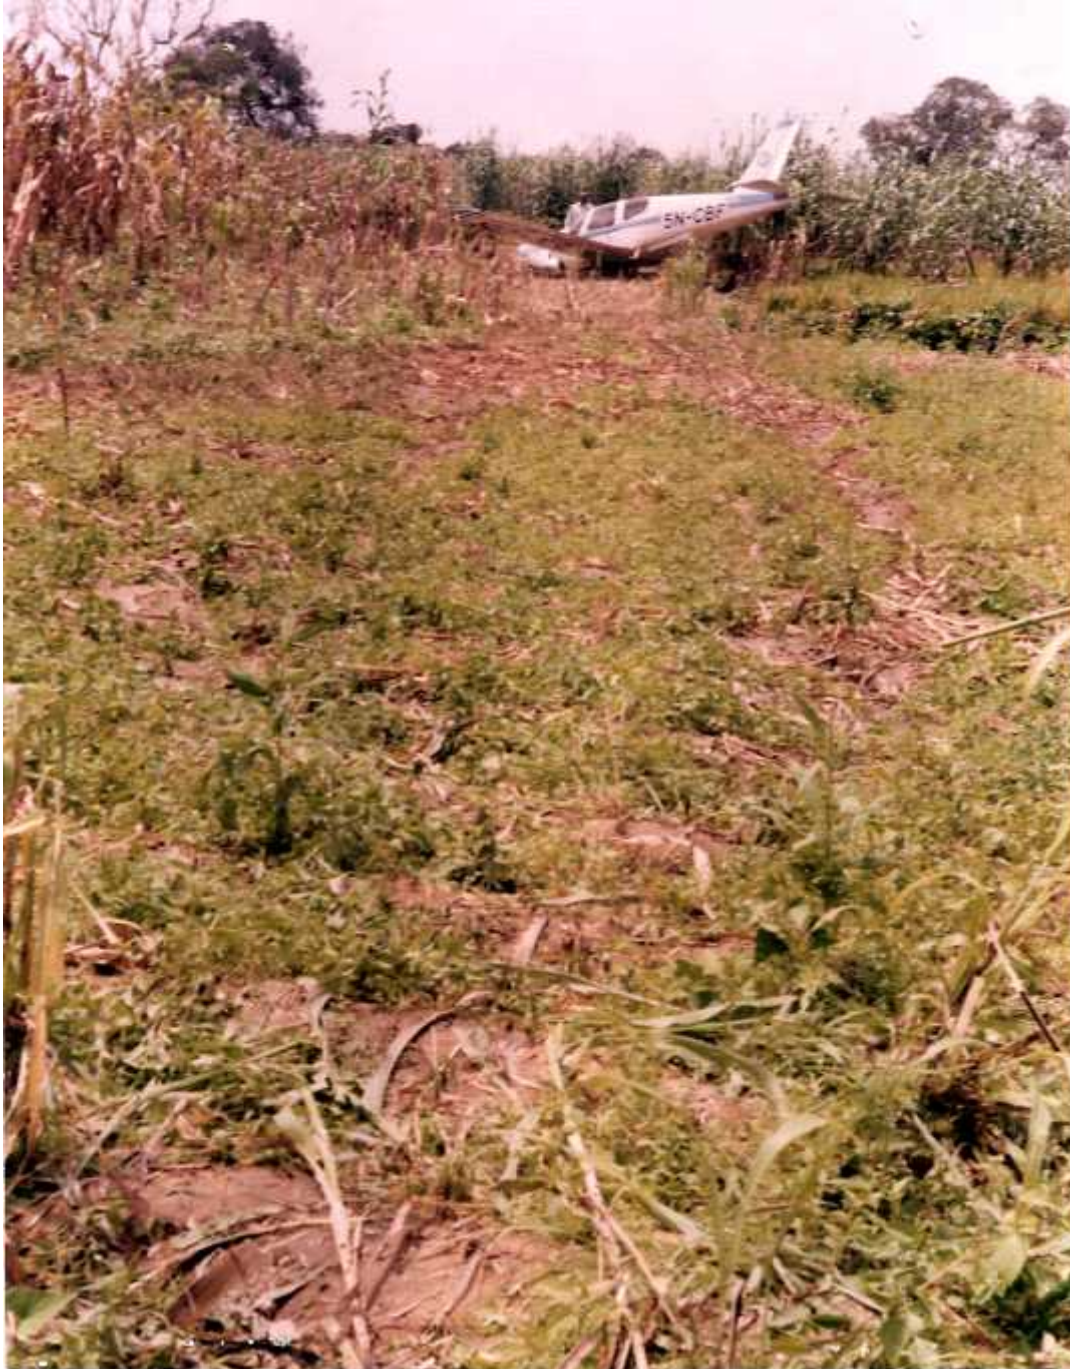
Damage was done to crops and farm land (See fig 1.4).

Fig 1.4 Photograph showing damage to farm land

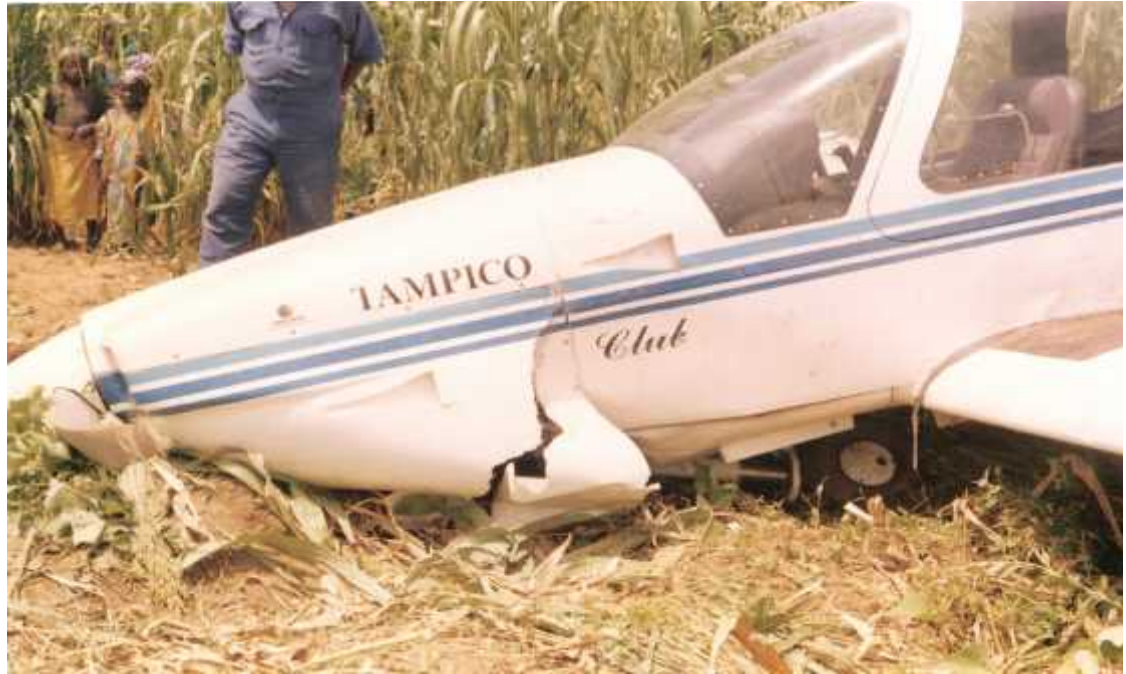
The aircraft first point of contact was with millet crops at a farm land in Fanfulani village, 2NM southwest of Zaria aerodrome. The aircraft was largely in one piece except for the landing and taxi lamps which were recovered 50 meters from the aircraft. The propeller blades were bent rearwards and the right main landing gear was buried in the ground (See fig.1.12a & 1.12b).

Fig. 1.12a Photograph showing nose landing gear sheared off from its attachment point

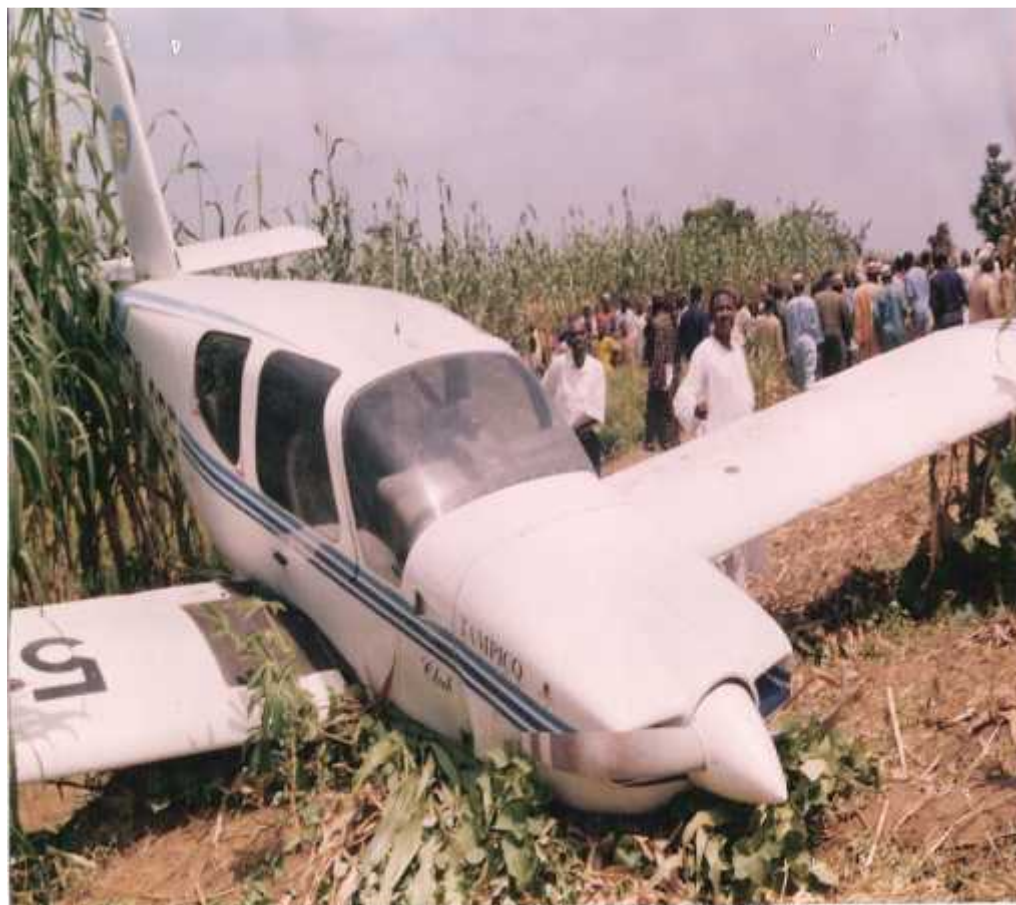
Fig. 1.12b Photograph showing the Main Wreckage

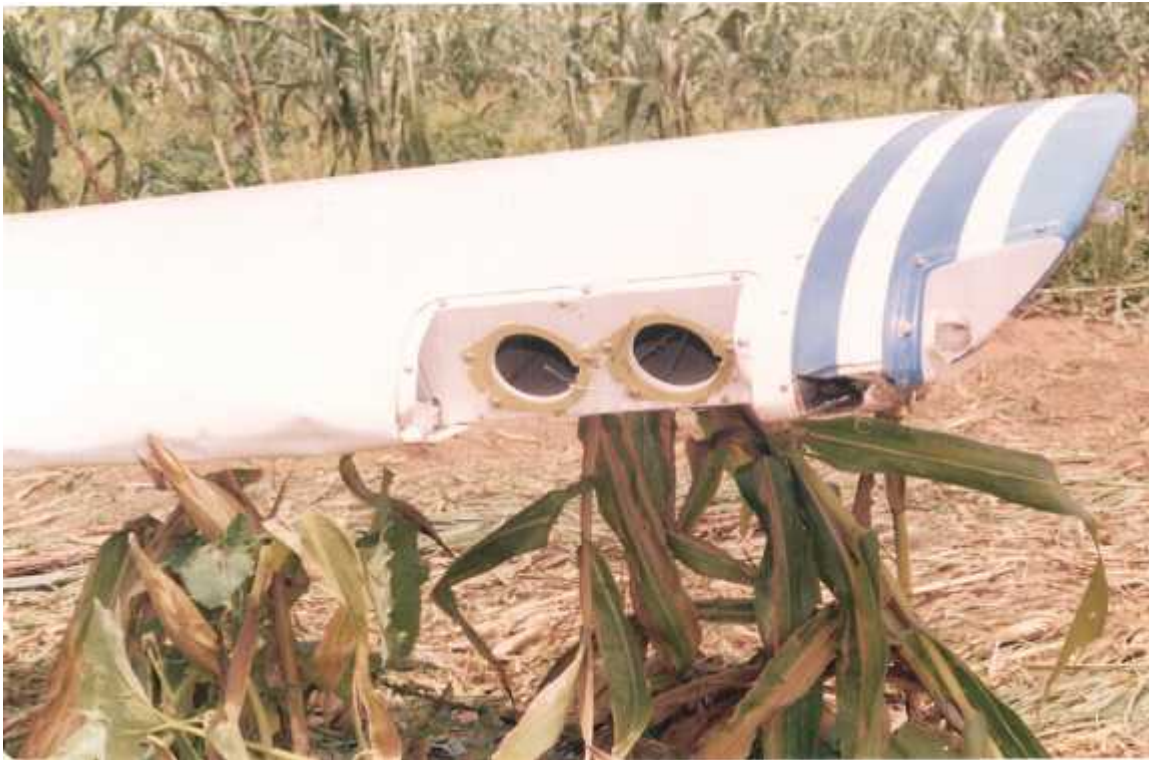
All circuit breakers were in off position. Physical check of fuel for the right and left wings shows there was fuel in both tanks; landing and taxiing lamps were missing (See fig 1.12.1a-b).

Fig. 1.12.1 Photograph showing right wing taxi and landing light destroyed

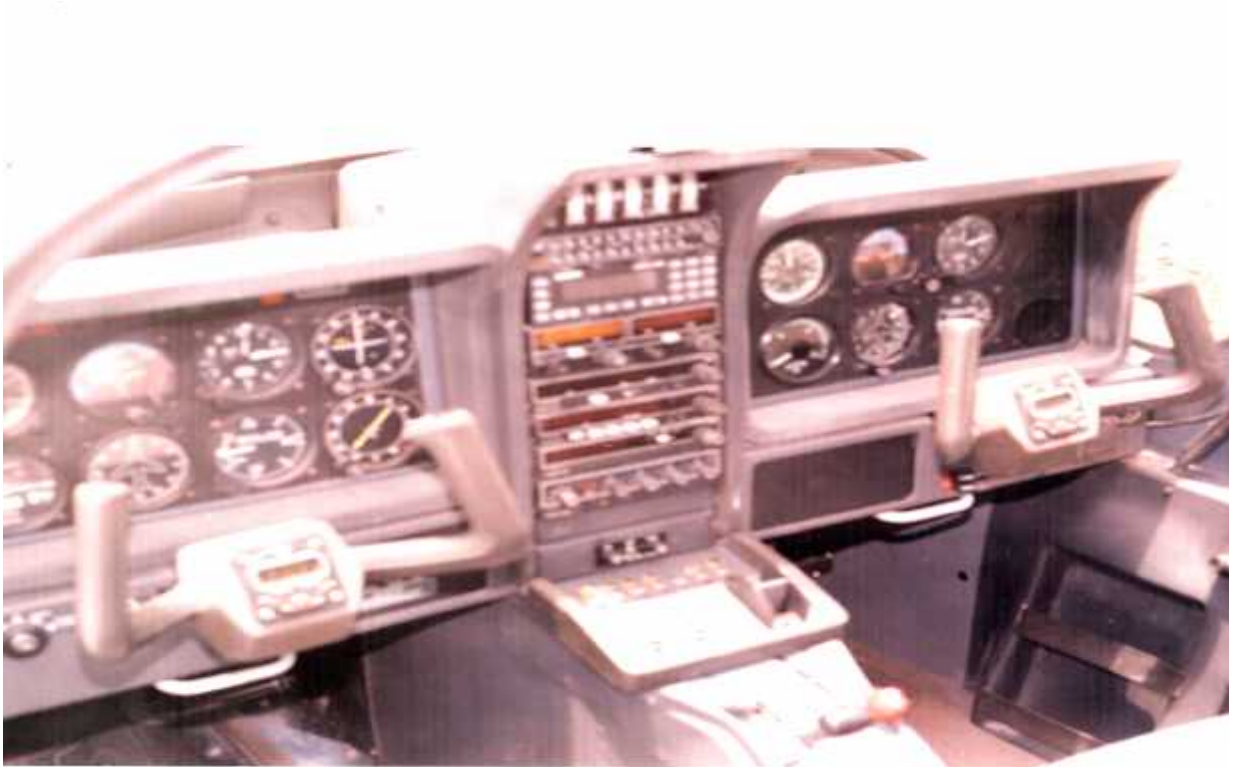
Fig. 1.12.1b Photograph showing carburetor heat control knob in mid hot position

The operation of the carburetor heat in mid position in a non-carburetor icing condition, causes a drop in engine power and can also increase the vibration level of the engine. The use of carburetor heat is essentially to prevent ice from forming in the carburetor. Carburetor icing leads to a power rating /manifold pressure drop and slight vibration.

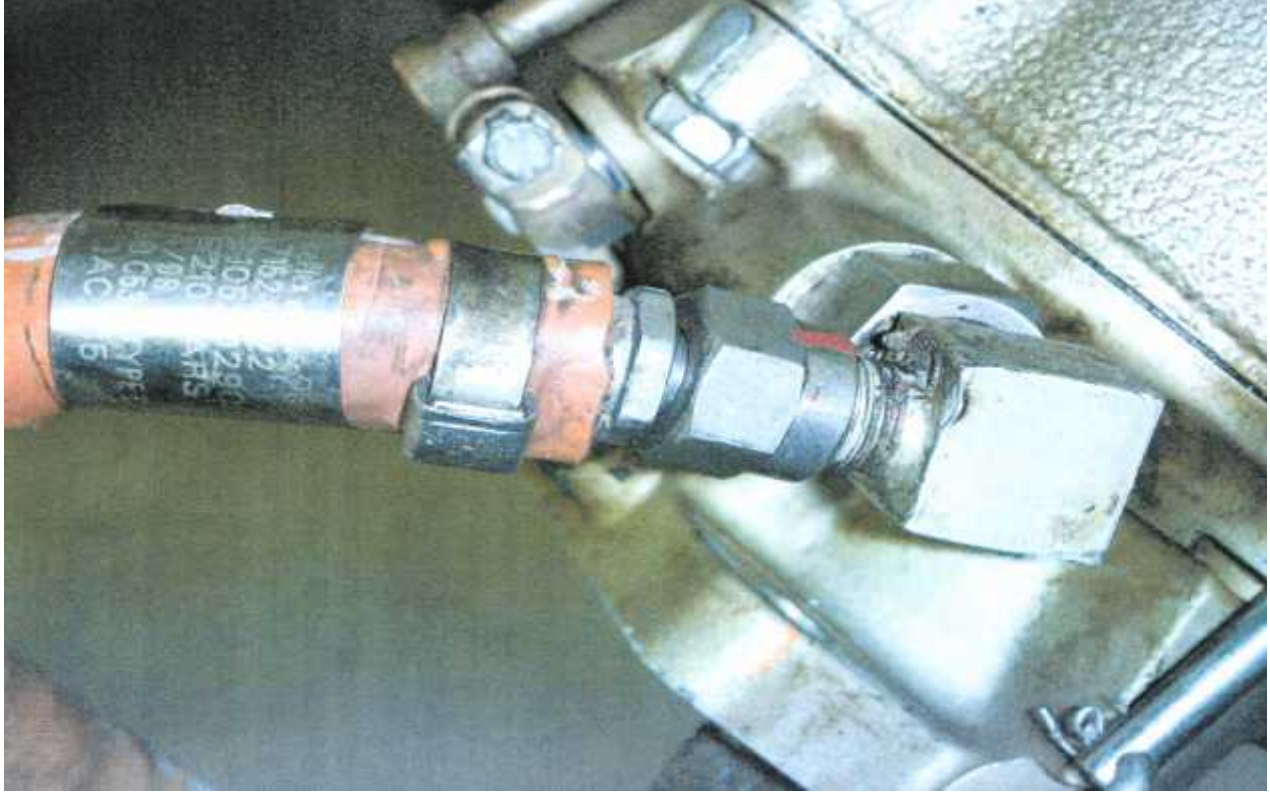
The cross-threading of 90^o fitting at the carburetor end of the fuel hose that runs from the engine fuel pump to the carburetor fuel inlet filter, resulted to fuel leakage, loss of fuel pressure to the engine and consequent engine fuel starvation.

Fig. 1-9 Photograph showing cross threaded end of the fuel hose

The report showed that during the last VP 2A inspection, the 90⁰ fitting at the carburetor end of the fuel hose that runs from the engine fuel pump to the carburetor was cross threaded into the hose and was not properly seated. As a result, fuel leaked under pressure and the carburetor got less fuel than required to run the engine smoothly. The spark plugs were found to be in good working condition.

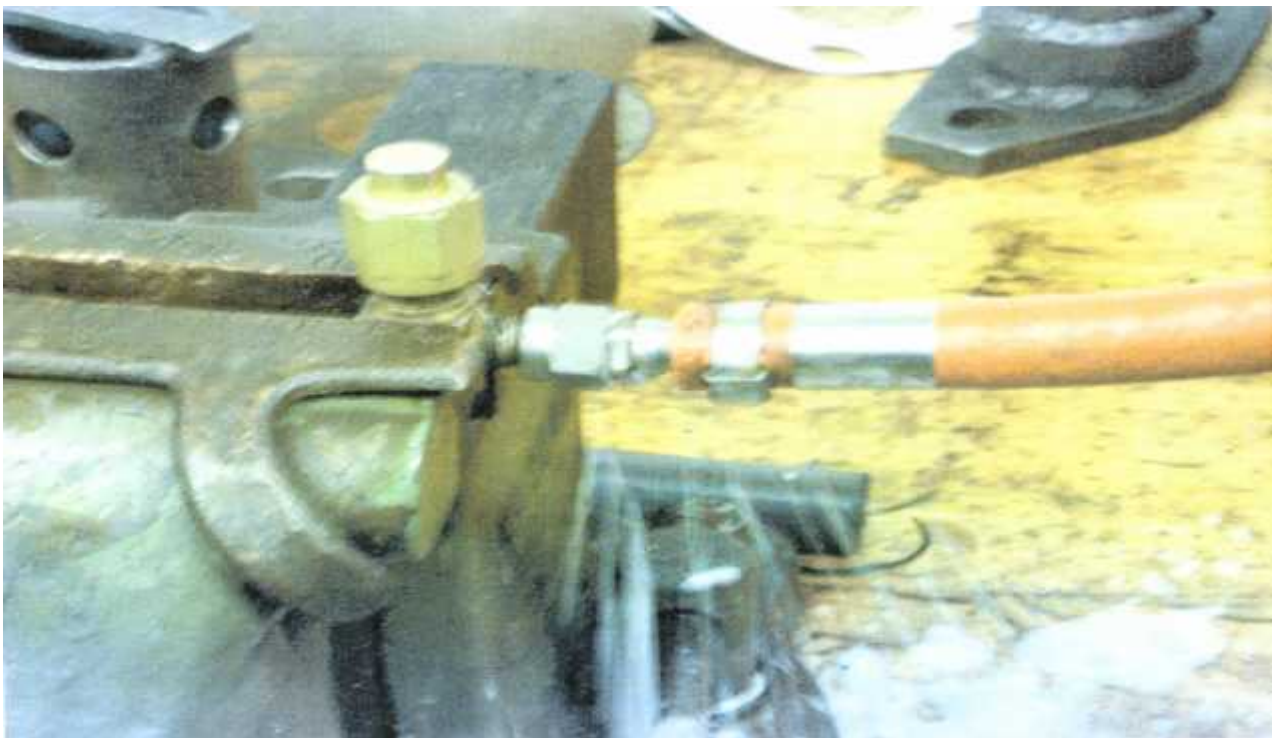
Fig.1-10 Photograph showing the hose leaking fuel under pressure

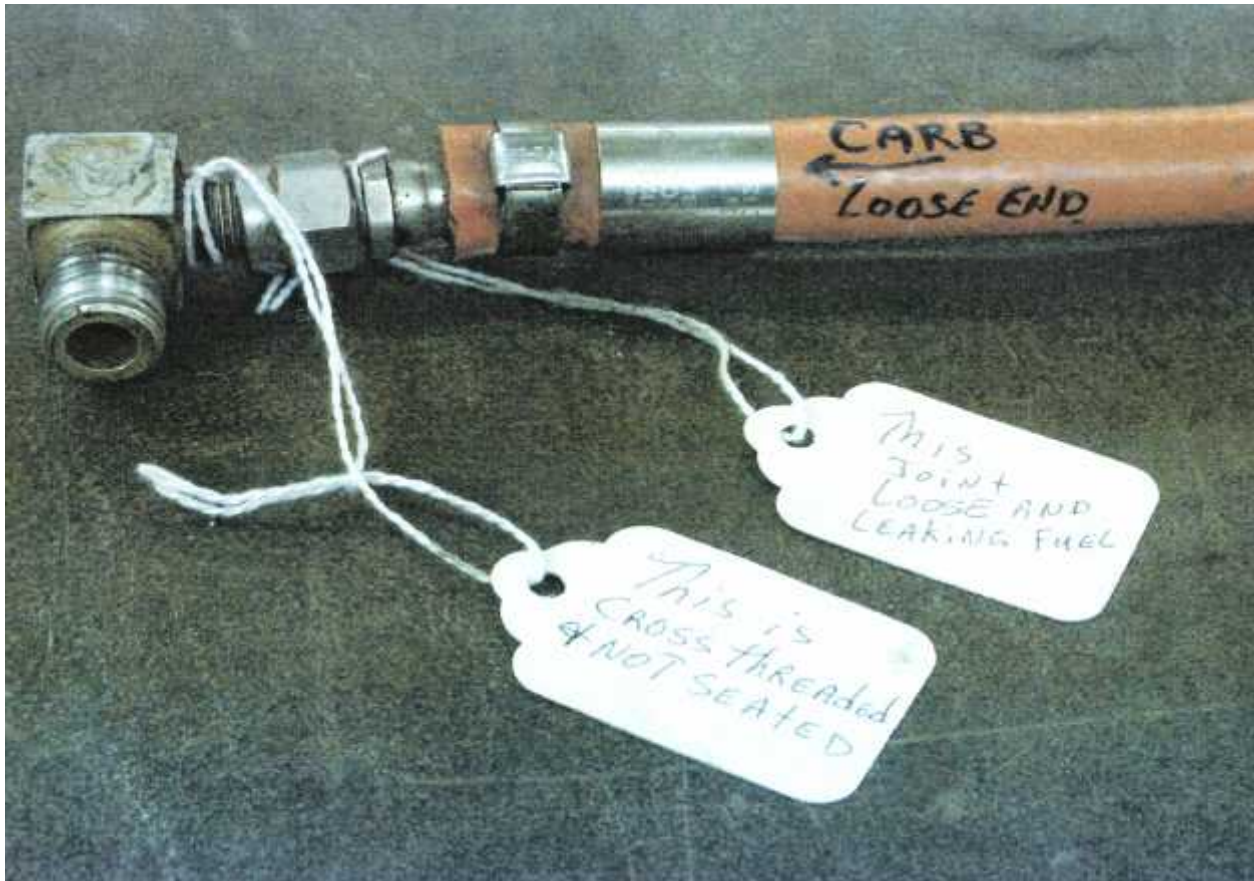
Fig. 1-11 Photograph showing fuel hose and 90° fittings

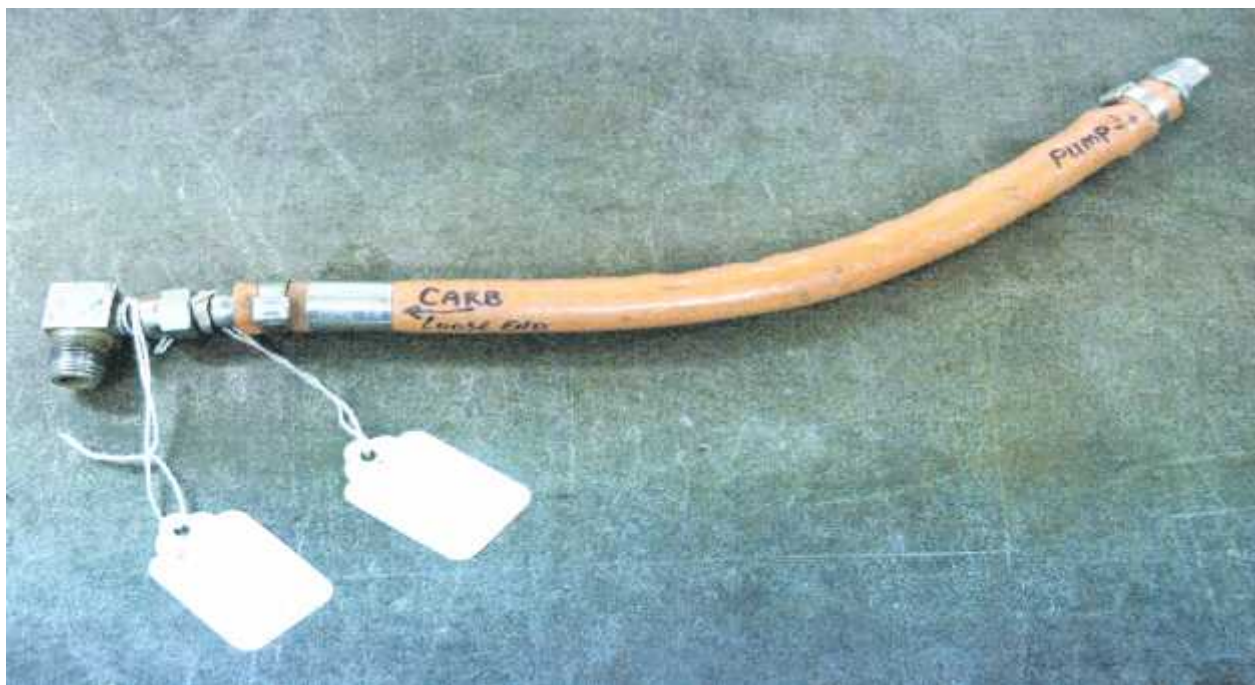
Fig. 1-12 showing loose and cross threaded 90° ends of the fuel hose.

The cross-threading of 90⁰ fitting at the carburetor end of the fuel hose that runs from the engine fuel pump to the carburetor fuel inlet filter, resulted to fuel leakage, loss of fuel pressure to the engine and consequent engine fuel starvation.

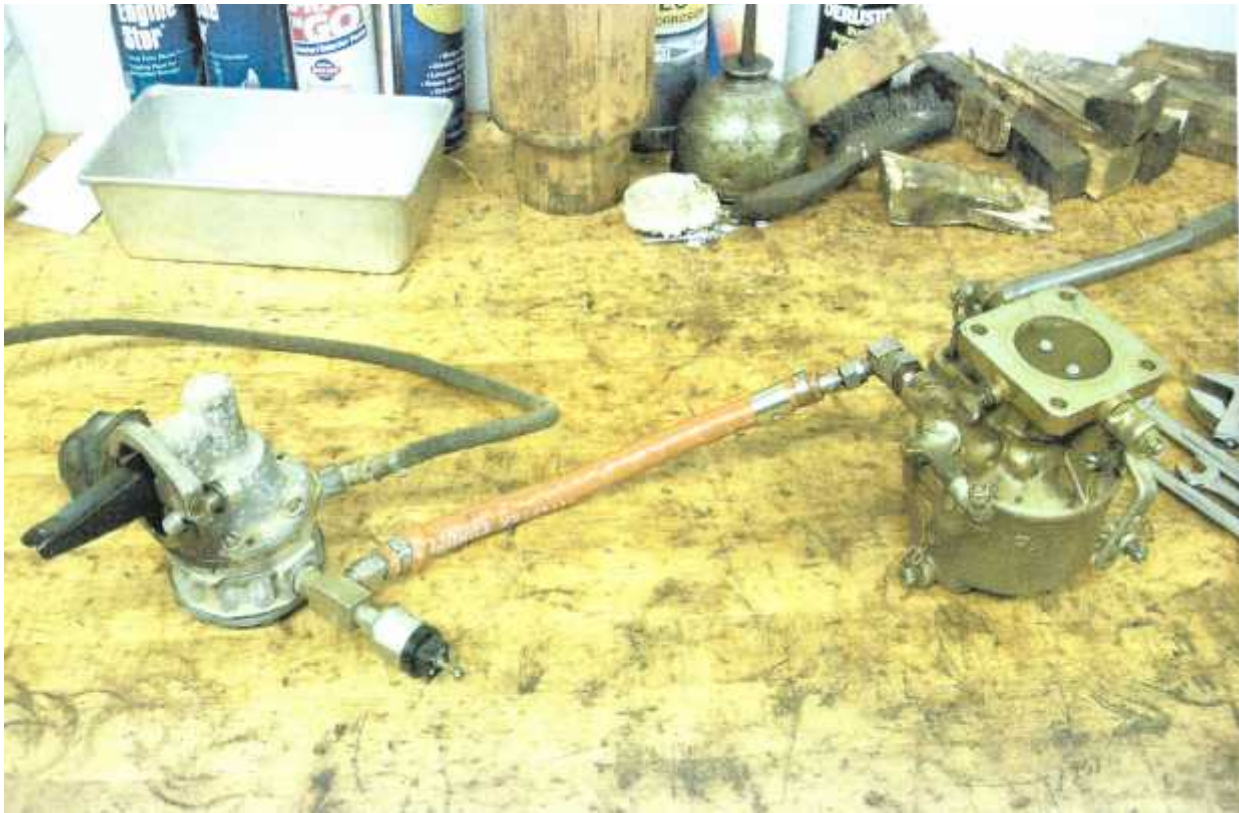
Fig. 1-13 showing hose connecting the fuel pump that supplies fuel to the Carburetor
