CIVIL AVIATION ACCIDENT
REPORT NO 04/368

Accident Investigation and Prevention Bureau

CIVIL AVIATION ACCIDENT REPORT

ACCIDENT TO THE PAN AFRICAN AIRLINES CESSNA 208 CARAVAN I
AMPHIBIAN AIRCRAFT REGISTRATION 5N-PAN AT WARRI AIRSTRIP
ON THE 25TH NOVEMBER 1998.

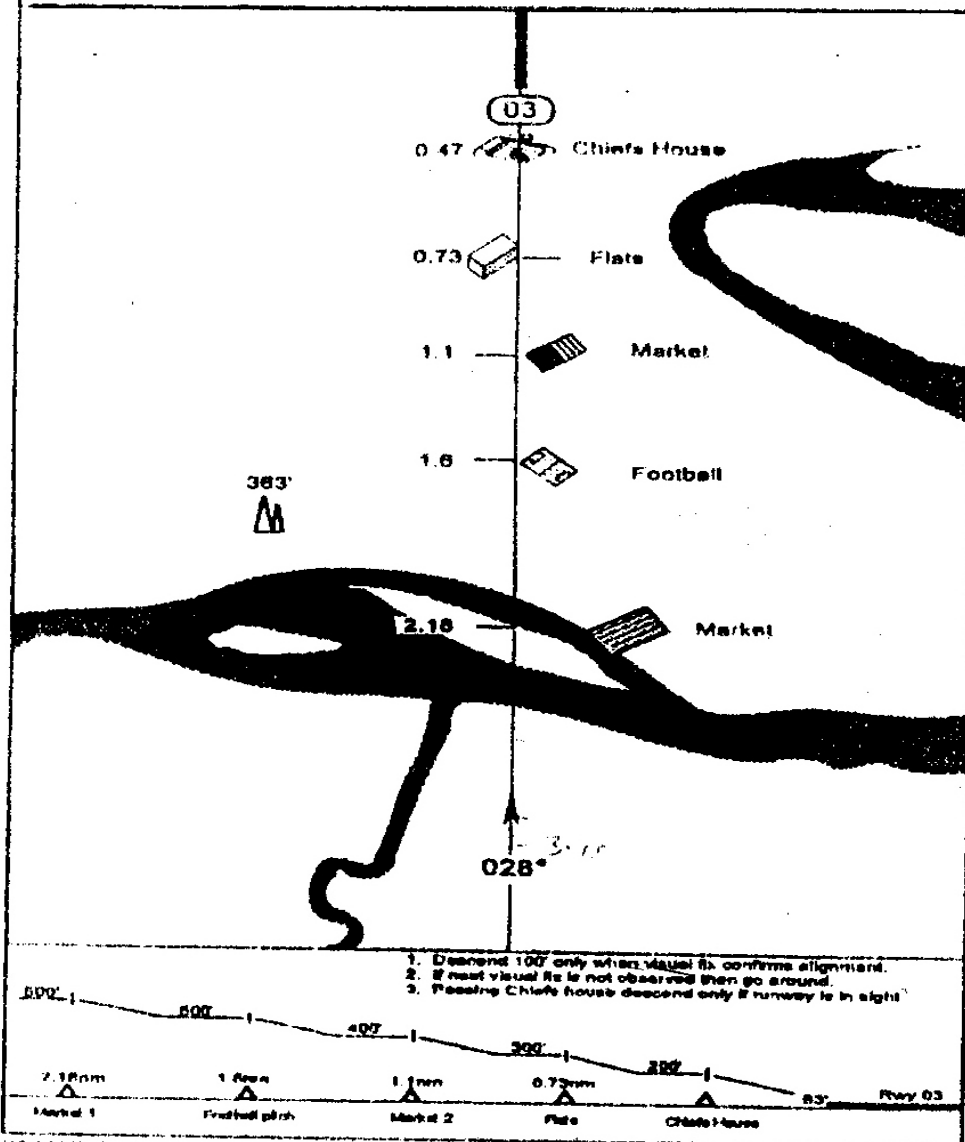
VISUAL CONTACT APPROACH for WARRI RUNWAY 03

threshold. A graphical interpolation of the flight pattern on the glide performance chart shows that, at the 5N-PAN's height above the terrain and its approach profile when the engine failed, the aeroplane could not have made it to the threshold of runway 0 3 if the pilot had insisted on pressing on. Instead, the aircraft could have, probably, dropped right into the chief's large compound, which might have endangered lives and property. (Please see appendix 2).

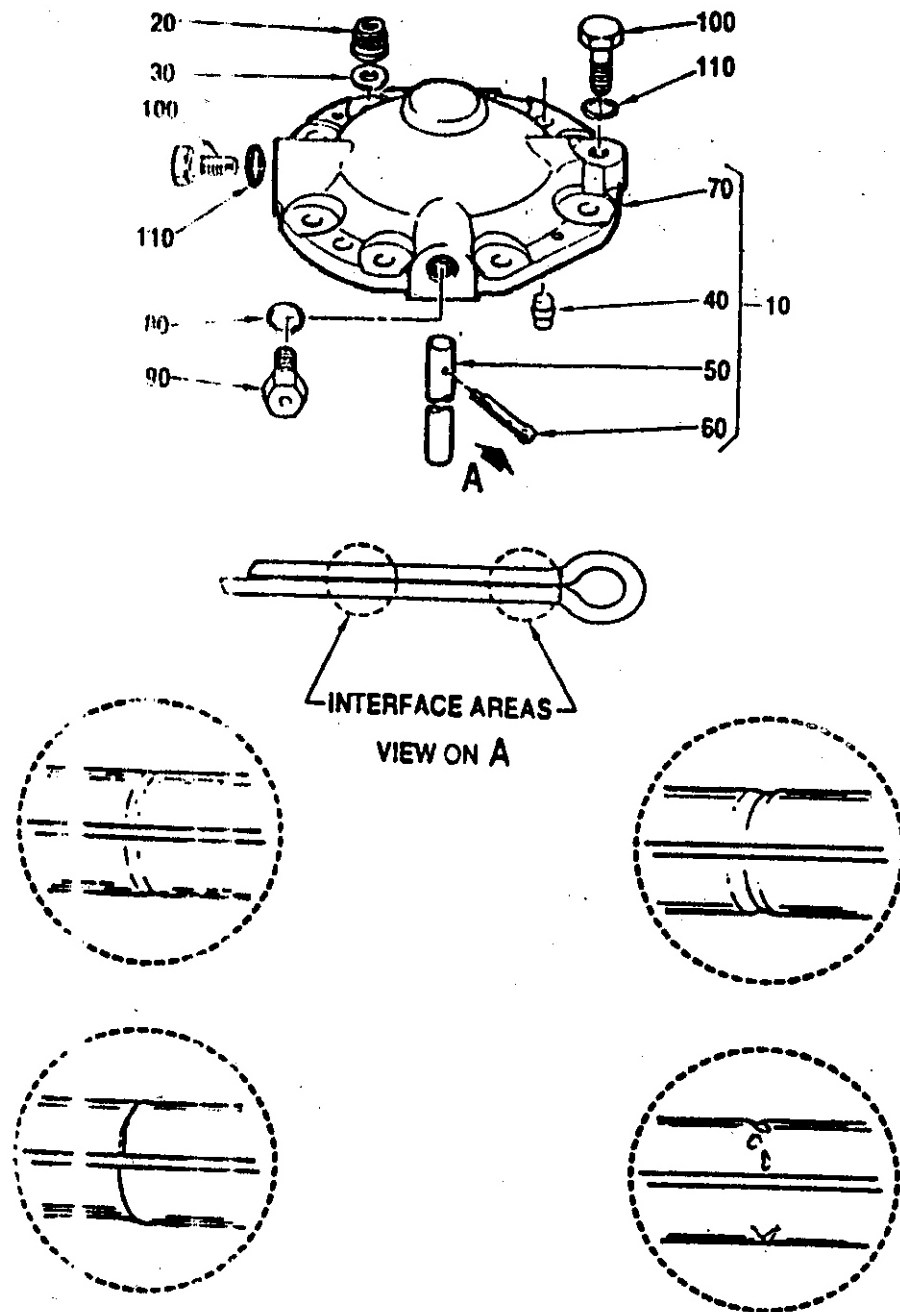
Compressor Bleed Valve Cover Inspection and Replacement Area
Figure 1

The SB No. 153883 was issued sequel to the malfunction of BOV (Ref. Supplier Code No. 8070) due to the possible movements of guide shaft pin which can result in wear indications or fracture of the cotter pin. The Service Bulletin specifies that during the inspection, any defect such as marks, dents, grooves, or any evidence of pitting, pinching or any wear at

the middle section on the cotter pin is a true indication of movement of the guide shaft pin in the bore while the valve is in operation. If any of these conditions is found, a new compressor bleed valve cover assembly must be installed.

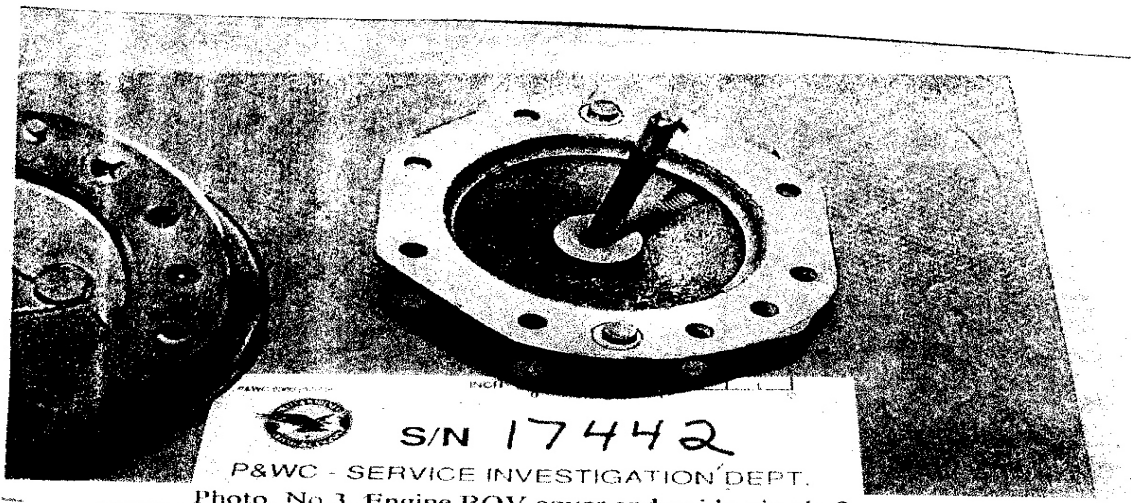
The inspection of the BOV cover plate revealed the remaining portion of the fractured cotter pin as depicted in appendix 6.

By visual observation, half of the fractured surface of the cotter pin has been oxidized. Under close examination however, the fracture of the cotter pin occurred as a result of low cycle fatigue. The deformation of the cotter pin was observed at the interface of the guide shaft pin and the BOV cover's cotter pin hole (See Appendix 5). No metallurgical abnormalities were observed on the fractured cotter pin.

S/N 17442
P&WC - SERVICE INVESTIGATION DEPT.
Photo. No.3, Engine BOV cover and guide pin shaft.
