*Civil Aircraft Accident Report
No. CIA 119*

REPORT ON THE ACCIDENT

ALOUETTE III HELICOPTER REGISTERED 5N-ALD AT MEREN 24 OFF-SHORE
LANDING PAD (JACKET) ON FRIDAY THE 6TH OF DECEMBER, 1985.

**Aircraft Accident Investigation Civil
Accident Bulletin No. CIA 119**

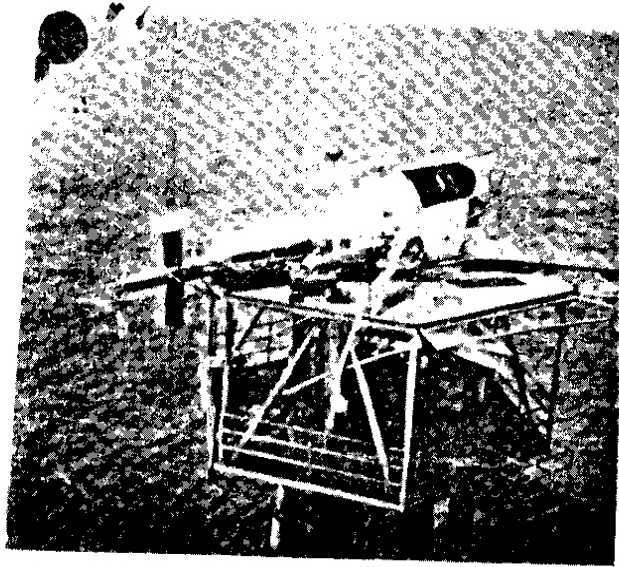
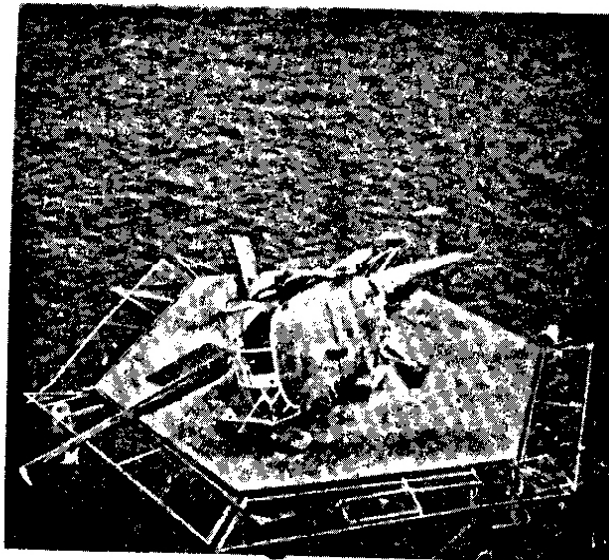
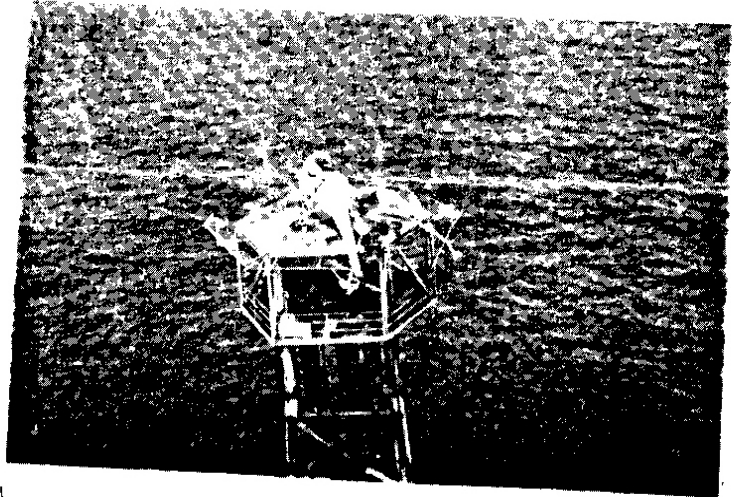
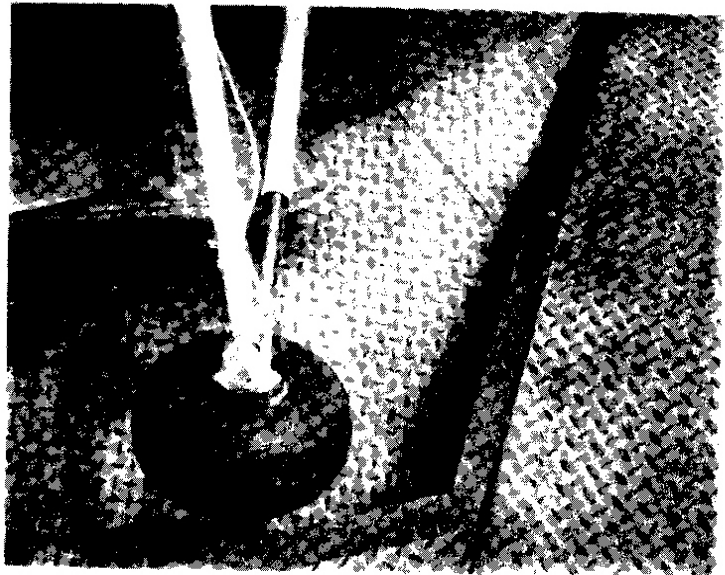
APPENDIX I

1.12 Wreckage and Impact Information: The helicopter had its main rotors shattered and remained intact lying on its right side.

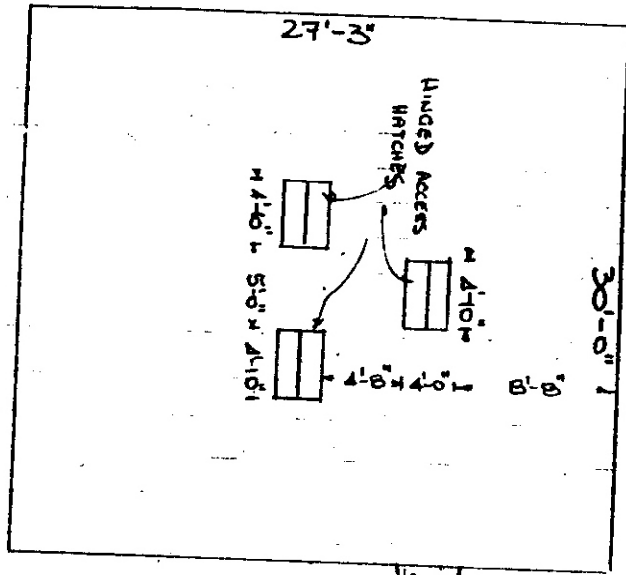
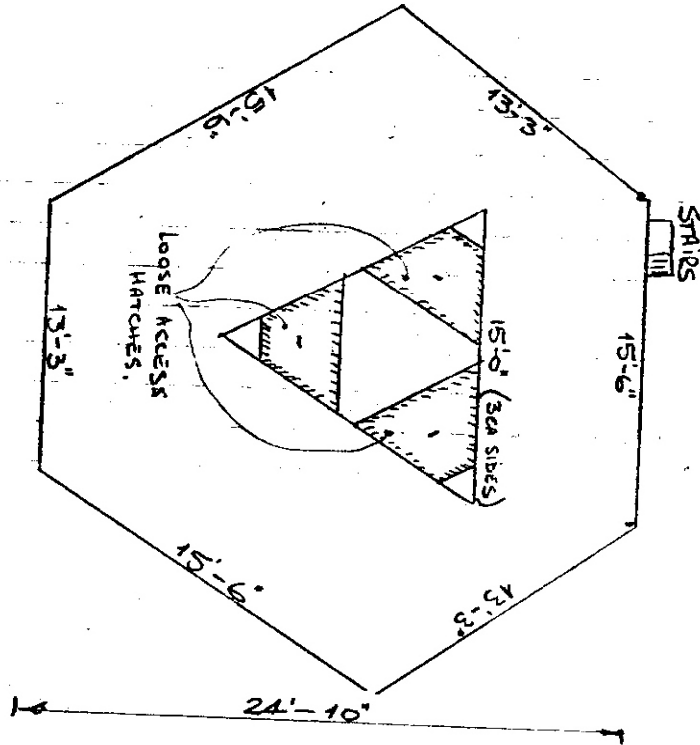
APPENDIX II

The rectangular jackets are provided with hinged rectangular access hatches but the hexagonal jackets are provided with loose access hatches (see appendix II). The resistance to side forces on the later access hatches results from the weight of these hatches resting on 3 inch lip sustaining edges. A high proportion of side movement restraint would also result from the 1/4 inch plate placement countersink.

Given the combination of side forces which are normally transmitted to the landing surface by the construction of the Alouette III landing gear, and the loose access hatches of the hexagonal jackets it is obvious that the displacement of the loose hatches is one day bound to happen. It was also gathered during the interviews that the pilots were very much aware and had experienced the hatches giving way under them.

The probable cause of the accident was due to the displacement of a loose access hatch due to the side forces transmitted to it by the compression of a the right rear wheel oleo strut as the helicopter was landing.

The security of the access hatches must be achieved with immediate effect. It was observed that if the opening and closure of the hatches were carried out on hinges which are firmly welded on the hatches and the adjacent retaining edges, the hinges themselves would then act as restraints against any side movement of the hatches.

2. Security of all access hatches on all heliports must be designed either with the use of hinges or retaining locks.
3. In the case of landing the helicopter away from the access hatches, a training area must be marked out on dry land in order that pilots may practise the proportion of scanning required between the relative position of the helicopter and the helipad, and viewing of the helicopter wheels through the mirror arrangement.
