AIRCRAFT ACCIDENT REPORT

EMIRATES-HAK/2015/07/06/F

Report on the Serious Incident involving an Emirates Boeing 777-200 aircraft with registration mark A6-EWD and a parked Boeing 737-400 aircraft belonging to HAK Air with registration mark 5N-BOU which occurred at Murtala Muhammed Airport, Ikeja, Lagos on 6th July, 2015

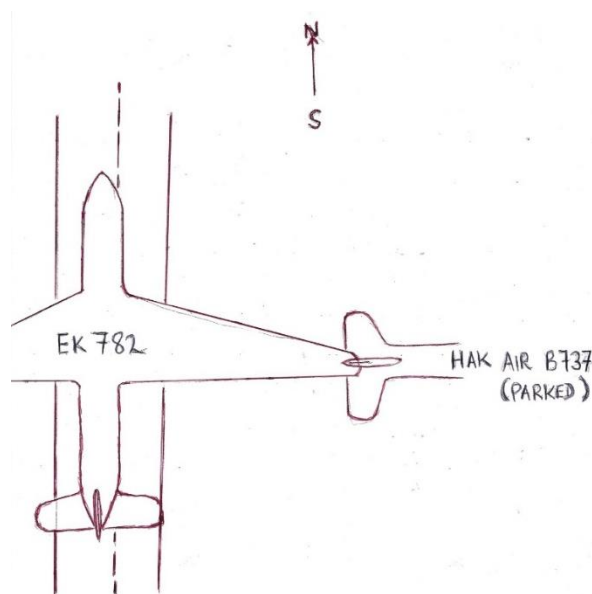
Figure 2: A sketch of the layout of the colliding aircraft

At the point of impact, the nose wheel position of the Boeing 777-200 aircraft was about 8ft left of the taxiway centerline. The left main wheel outboard tyres of the aircraft were on the left edge of the taxiway and the right main wheel inboard tyres were close to the taxiway centerline.

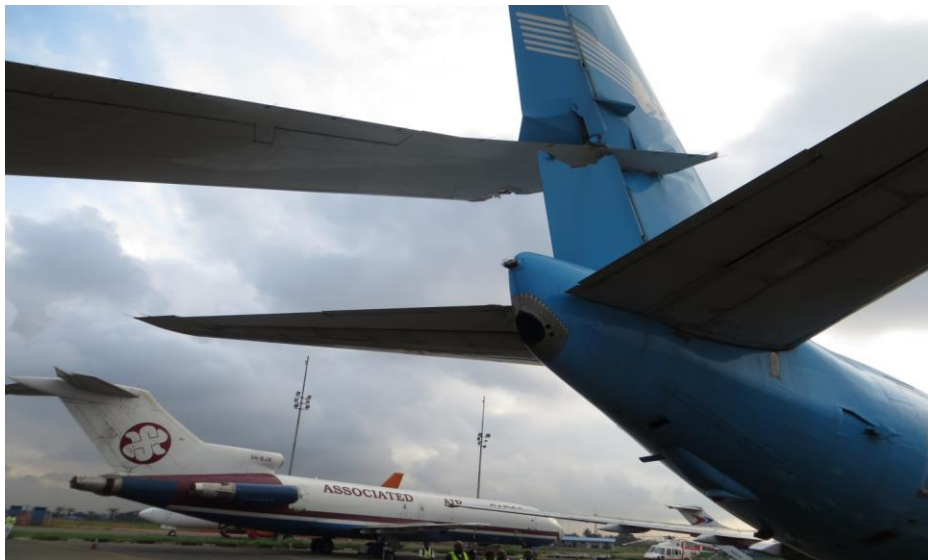
Figure 4: A close-up view of the damage to the Rudder and the tail section of 5N-BOU

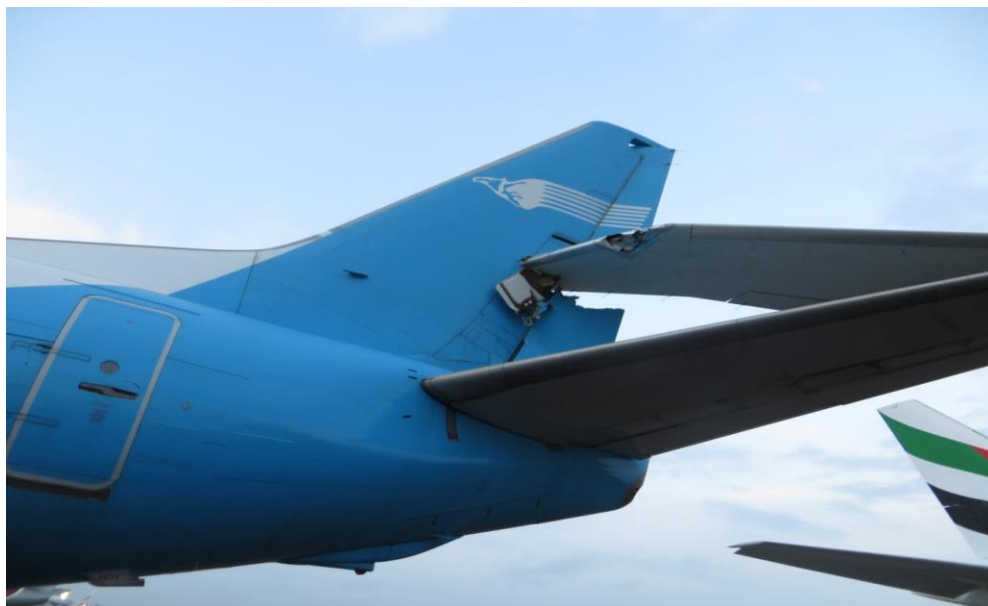
Figure 5: Another close-up view of the damage to the rudder and the tail section of 5N-BOU

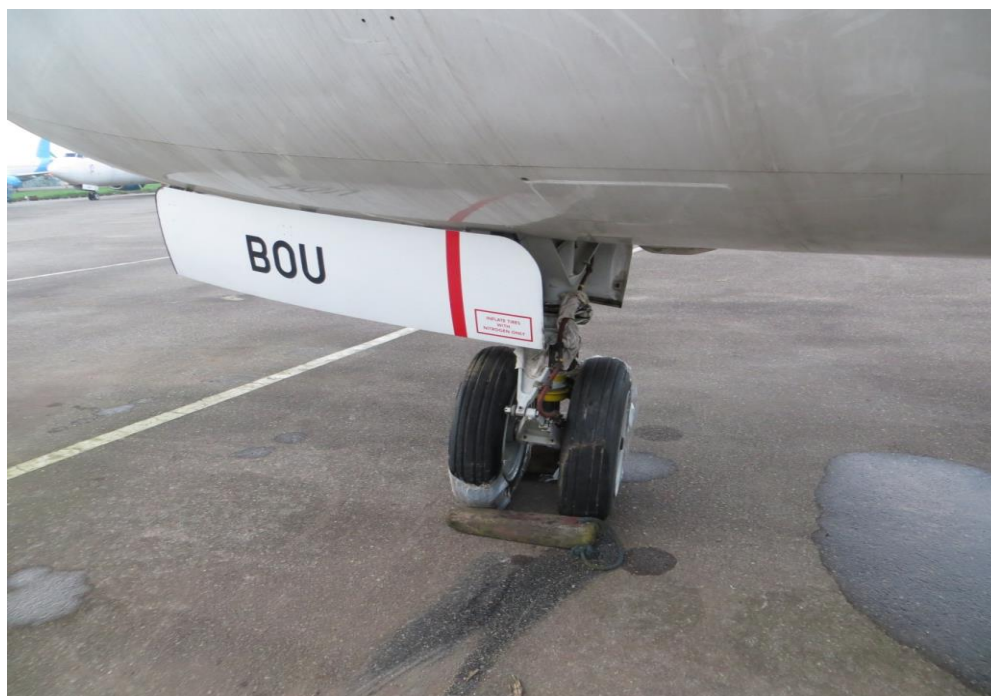
Figure 6: HAK Air Aircraft moved 5ft sideways and nose wheel turned 90°

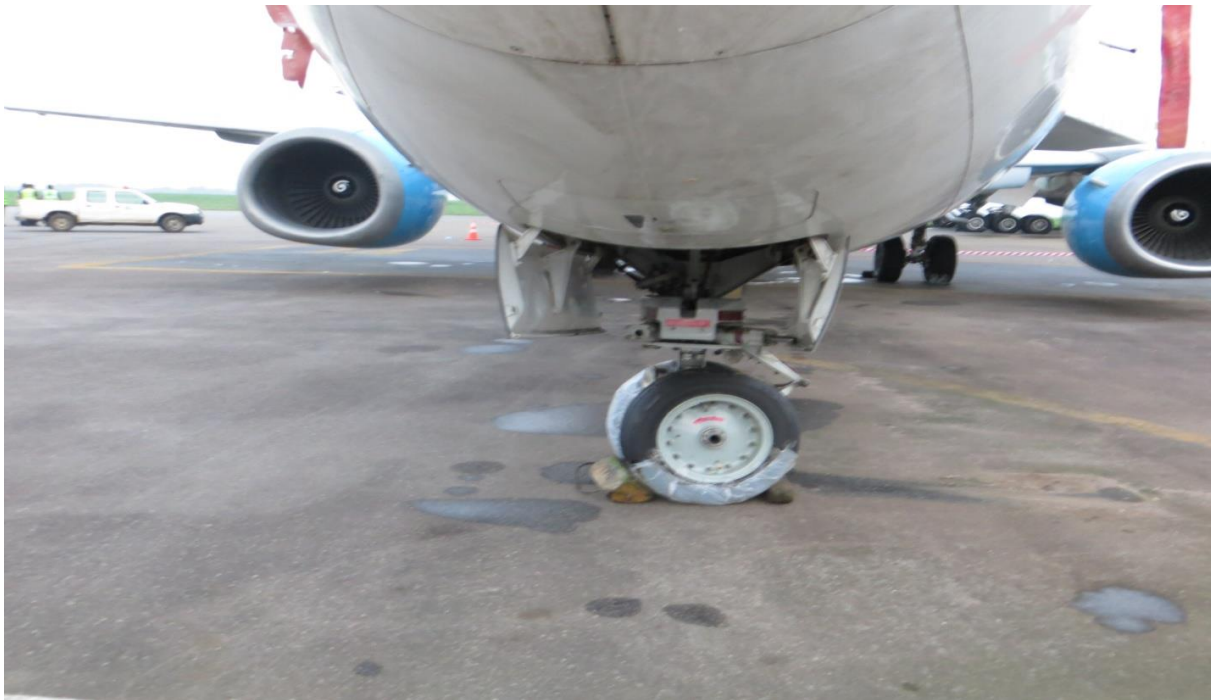
Figure 7: HAK Air Nose wheel at 90° due to the impact with Emirates aircraft

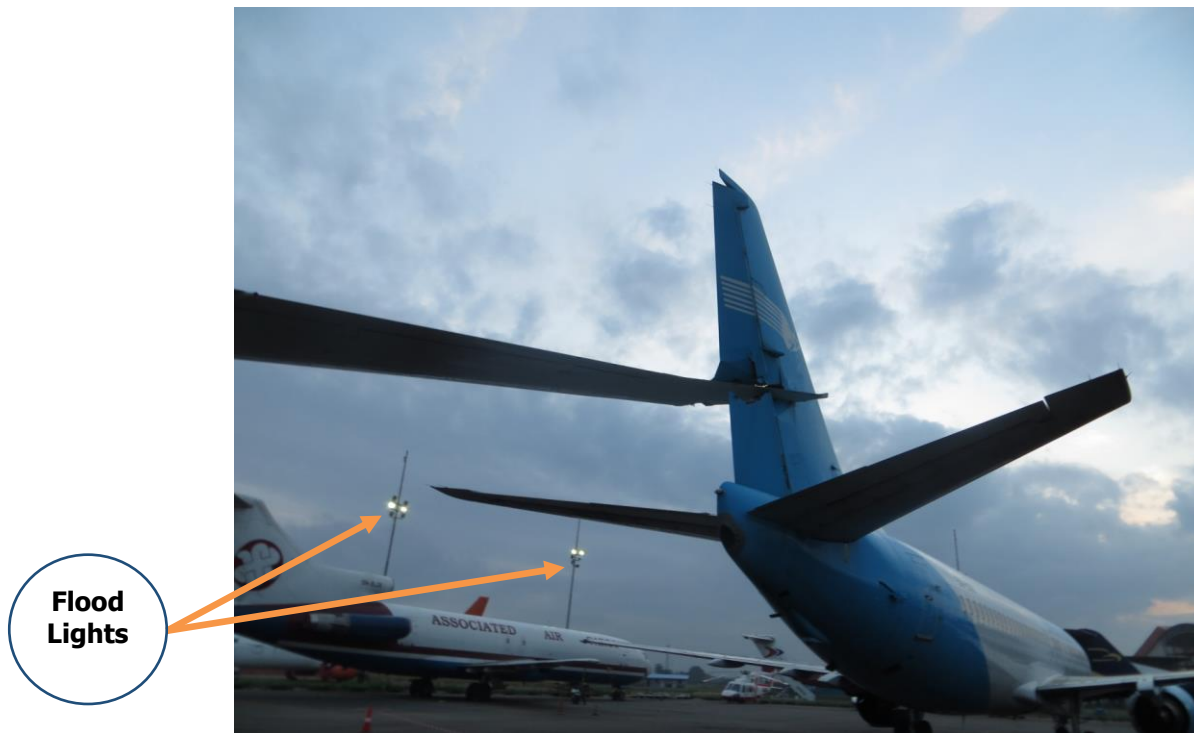
Figure 8: Photograph showing the amount of light available to the General Aviation parking area taken at 06:30hrs

The lighting available at the General Aviation Terminal (GAT) parking area was inadequate at the time of the occurrence. The intensity of the flood lighting at the GAT apron was reduced to about one-third due to failure of some light bulbs.

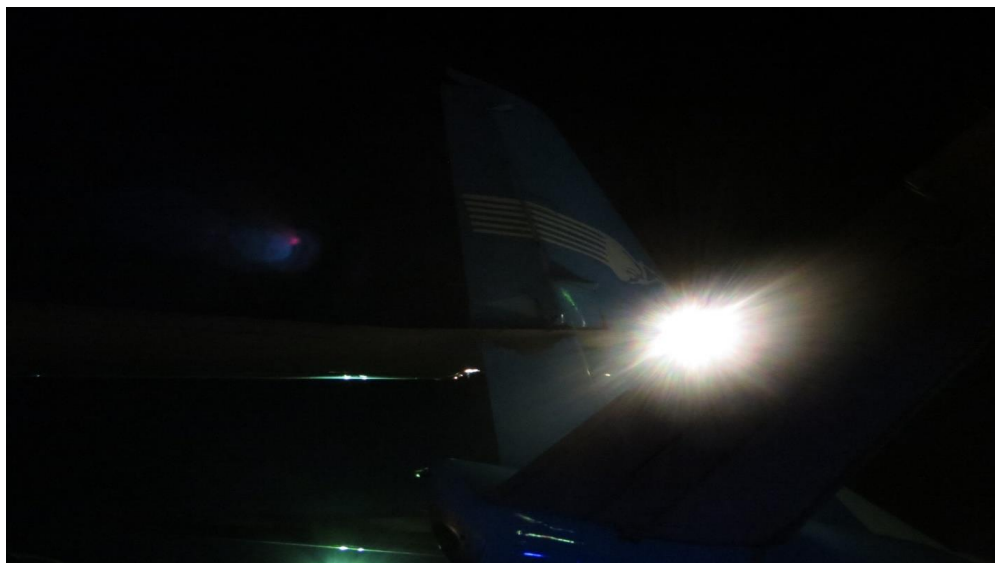
The incident happened in the General Aviation area of the airport. Most of the flood lights provided at the Apron of the General Aviation Terminal were unserviceable at the time of the occurrence.

Figure 9: Photograph taken at night showing the lighting available at night

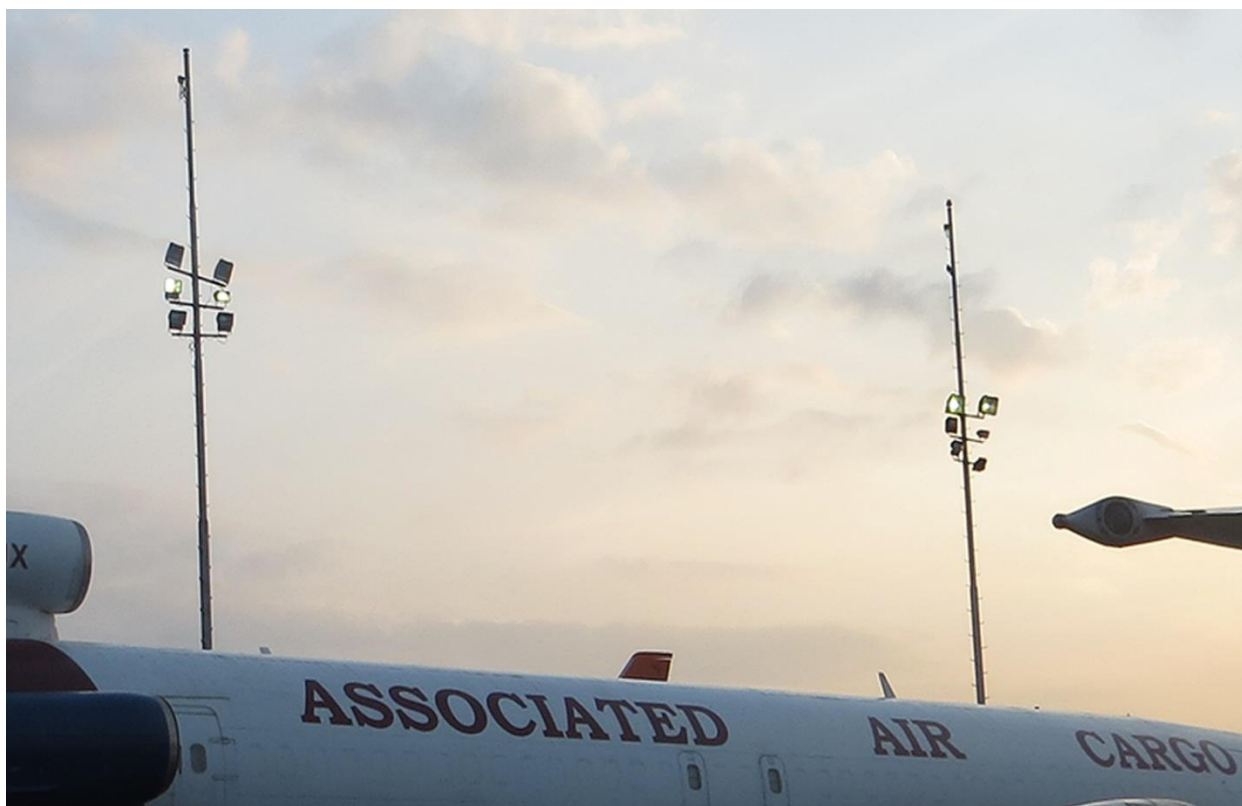
Figure 10: An enlarged view of the Lighting available at the General Aviation area taken at 06:30hrs

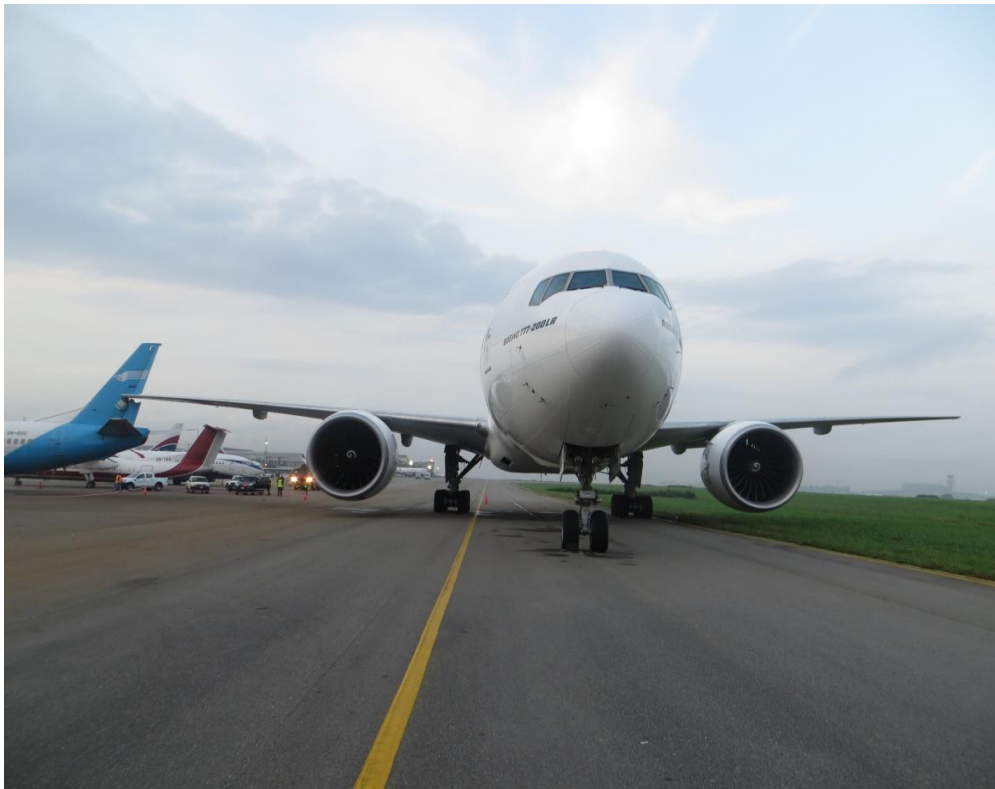
The picture above shows the final position of the Emirates aircraft at impact, indicating that the cockpit crew had deviated from the statutory yellow taxiway centreline. It is thus obvious that the cockpit crew had foreseen the obstruction ahead and turned sideways of the centreline to avoid it, rather than discontinuing the taxi and reporting to ATC.

- 3.1.9 The UAE 782 nose wheels position was found at about 8ft left of the taxiway centerline after the occurrence.
- 3.1.10 The right wing tip of the Emirates Airline Boeing 777-200 aircraft impacted the rudder and vertical stabilizer of the parked HAK Air Boeing 737-400.
