PRELIMINARY REPORT ON THE ACCIDENT INVOLVING A BOEING 737-300 AIRCRAFT WITH NATIONALITY AND REGISTRATION MARKS 5N-BQO OWNED AND OPERATED BY AIR PEACE LIMITED WHICH OCCURED ON RUNWAY 18R MURTALA MUHAMMED INTERNATIONAL AIRPORT ON 23RD JULY, 2019

Registered Owner and Operator:	Air Peace Limited
Aircraft Type and Model:	Boeing 737-300
Manufacturer:	Boeing Aircraft Company, USA
Date of Manufacture:	28th April, 1998
Nationality and Registration Marks:	5N-BQO
Serial Number:	28571
Location:	Runway 18R
Date and Time:	23rd of July, 2019 at about 11:28 h

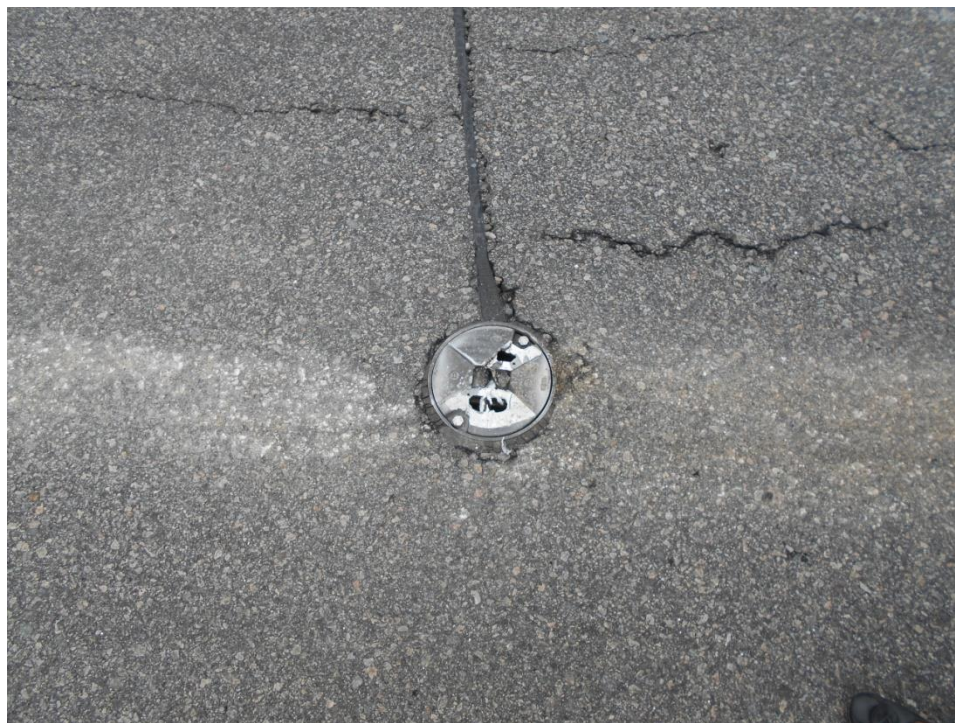
The asphalt and concrete runway was damaged due to impact forces, with deep holes made by the nose wheel shock strut. Also, electrical lines and light on runway were damaged. See the figure below:

Figure 1: Photo showing witness mark and damage to runway lighting

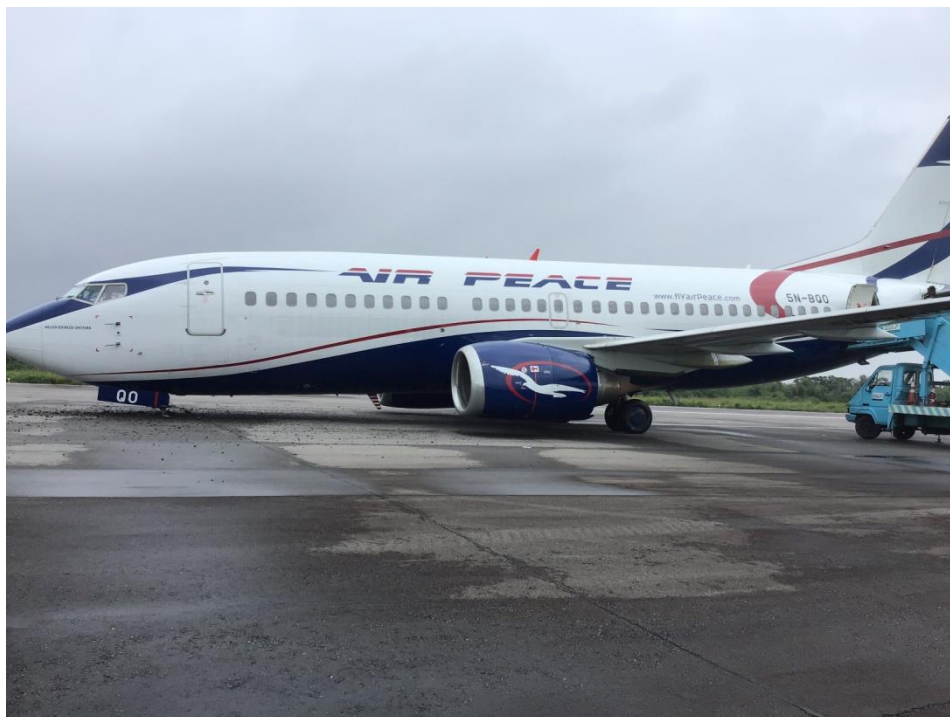
Figure 2: Photo showing the aircraft where it stopped on the runway

The aircraft was found at a distance of 2,491 m from the runway threshold, at a point 18 m left of the runway centreline.

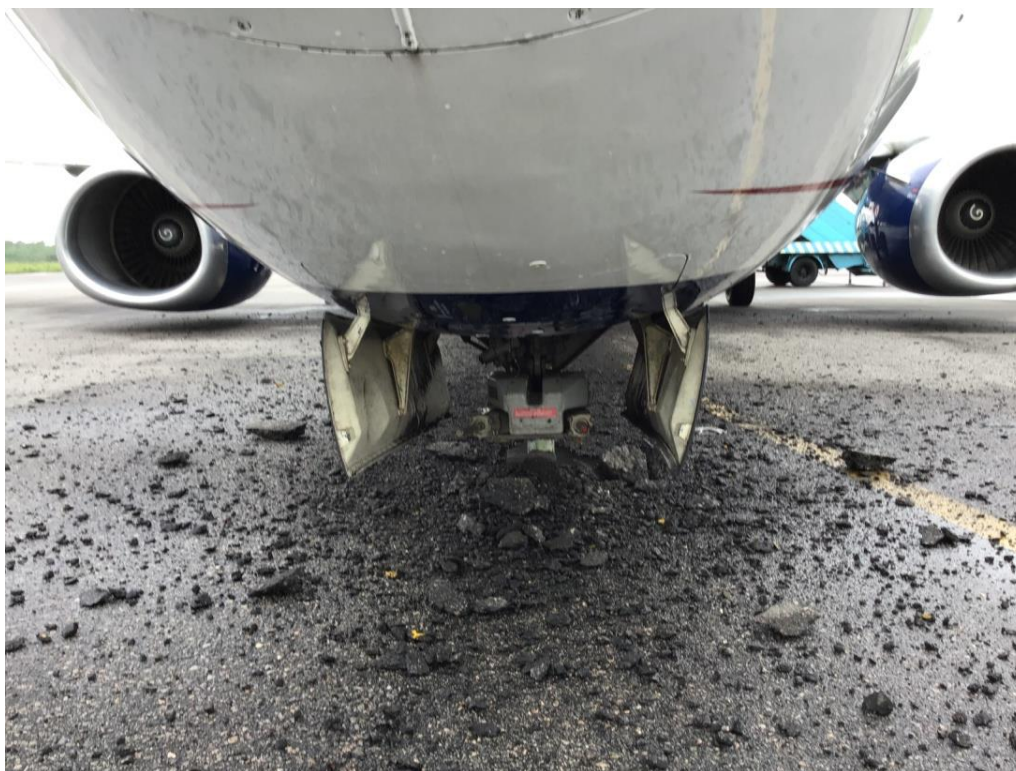
The marks made by the nose landing gear (NLG) shock strut on the runway were seen from point 971 m from touchdown point up until 2,491 m where the shock strut made deep cuts on the runway.

Figure 5: Photo showing nose landing gear strut stuck in the runway

7. The runway surface was damaged by the nose landing gear shock strut abeam link A3 of runway 18R.
8. The lower fan cowl of the RH Engine was damaged.
9. The LH nose wheel assembly was found intact outside the runway on the grass verge, 1,058 m from the threshold.

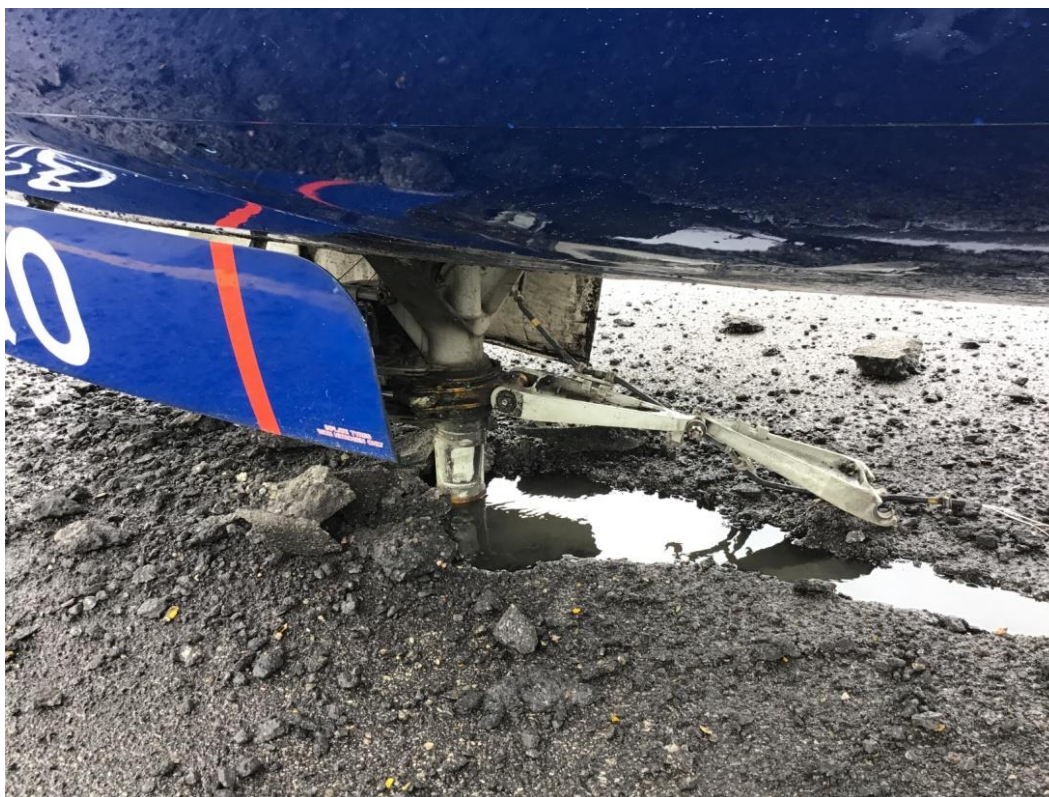
Figure 6: Photo showing nose landing gear strut with torsion link sheared off from lower end of the cylinder

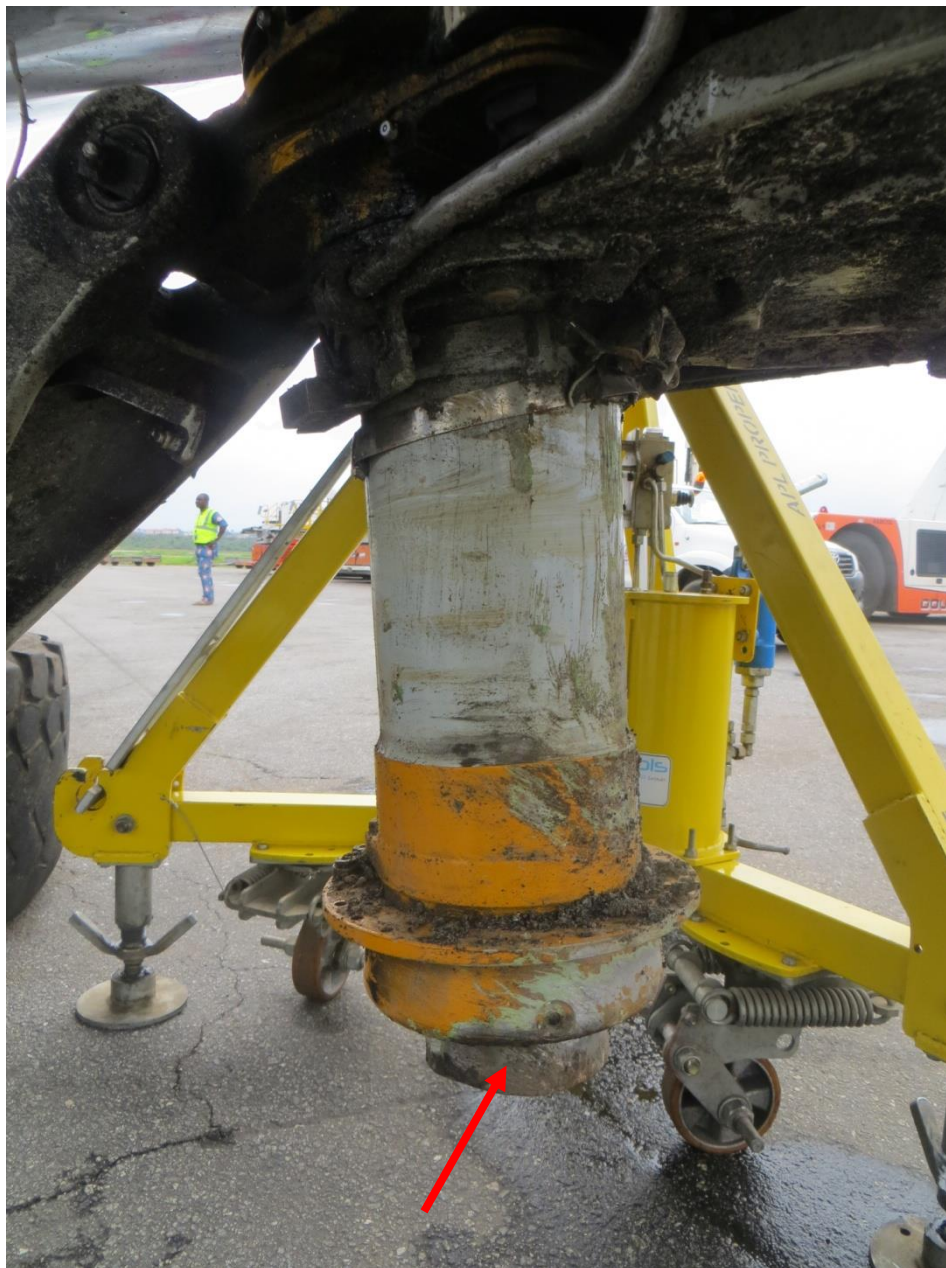
Figure 7: Photo indicating 0.984 inches of the remains of the nose landing gear shock strut

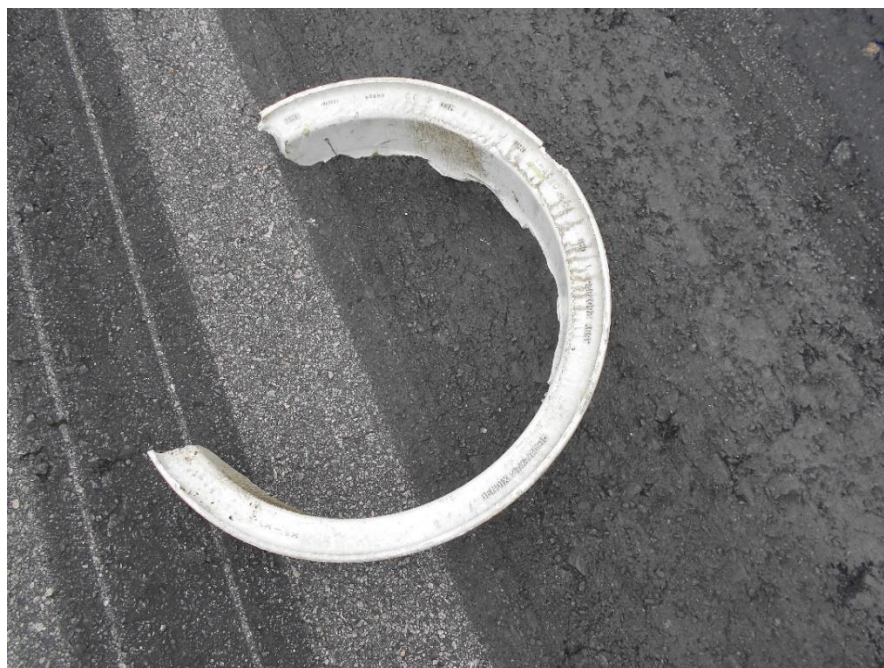
The two wheel assemblies of the nose landing gear were found detached from the axle; the flange of one-half of the right nose wheel assembly was found on the runway, 971 m from the threshold. The left nose wheel assembly was found intact on the grass verge at 1,058 m from the threshold, while the larger half of the right nose wheel assembly was found on the runway, 1,129 m from the threshold.

Figure 8: Photo showing flange of the RH nose wheel assembly found at 971 m from runway threshold

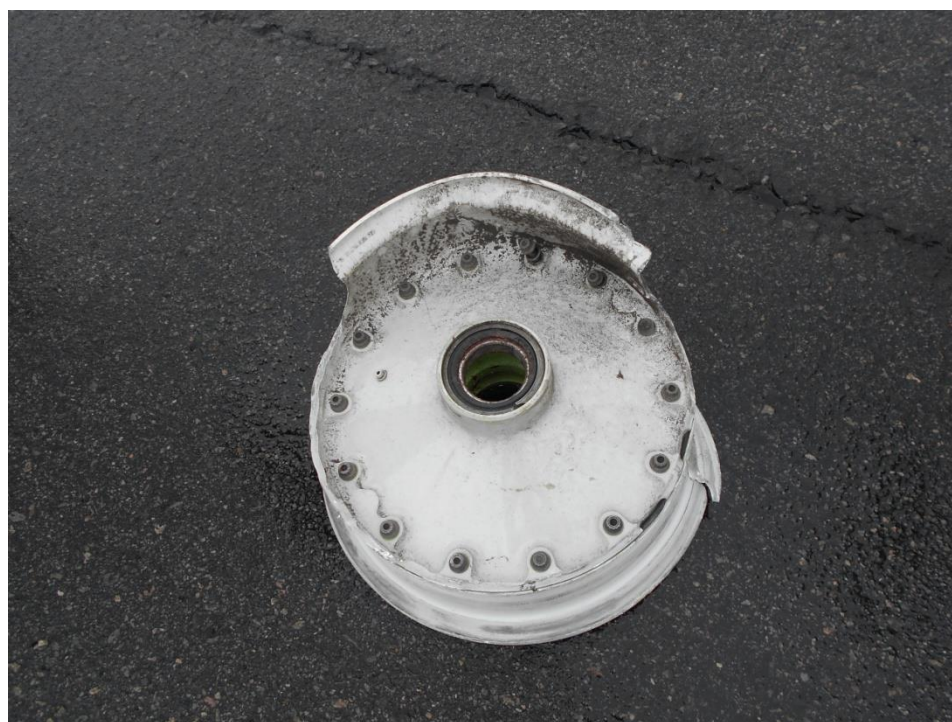
Figure 9: Photo showing the main half of the RH nose wheel assembly found 1,129 m from the threshold

10. The flange of the RH nose wheel assembly was found at 971 m from the runway threshold and the main half of the RH nose wheel at 1,129 m from the threshold.

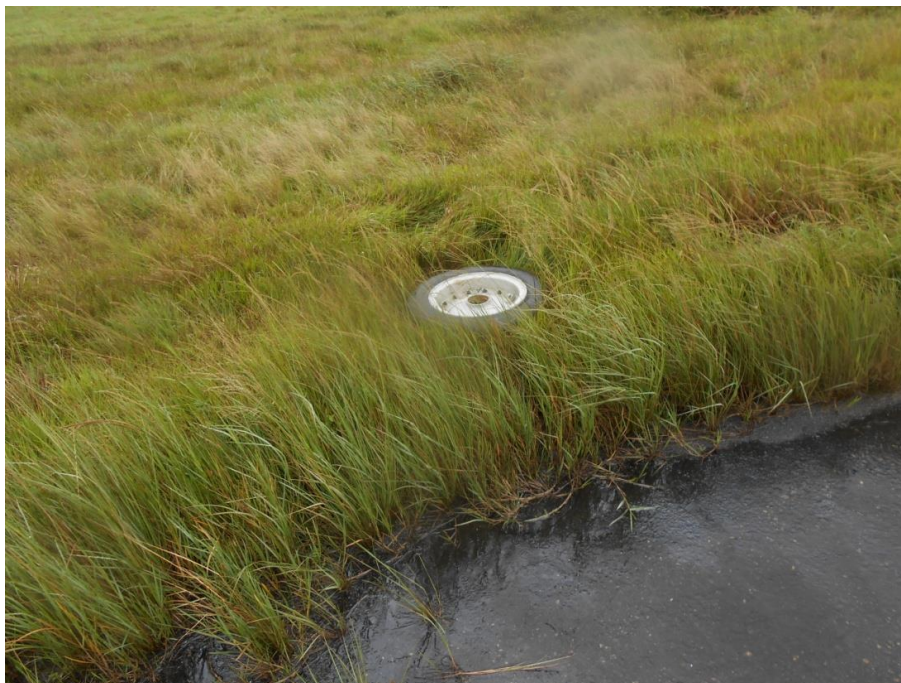
Figure 10: Photo showing LH nose wheel assembly found outside the runway on the grass verge, 1,058 m from the threshold

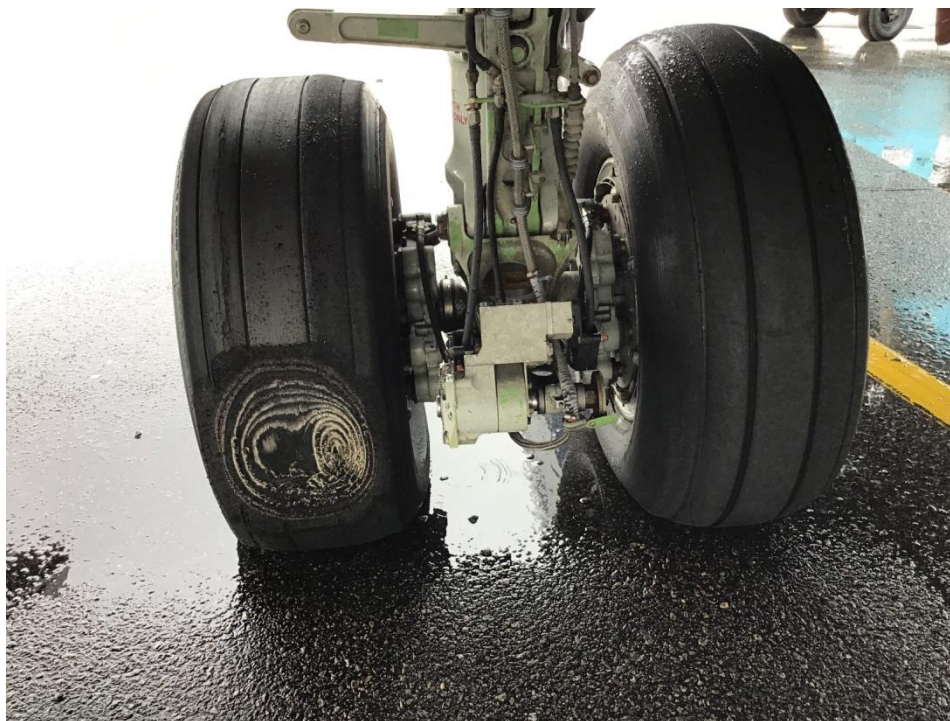
The lower fan cowl area of engine No. 2 impacted the runway and scratches were found there. Also, the RH main wheel outboard tyre was found deflated with severe flat spot.

Figure 11: Photo showing severe flat spot on the deflated RH main wheel outboard tyre

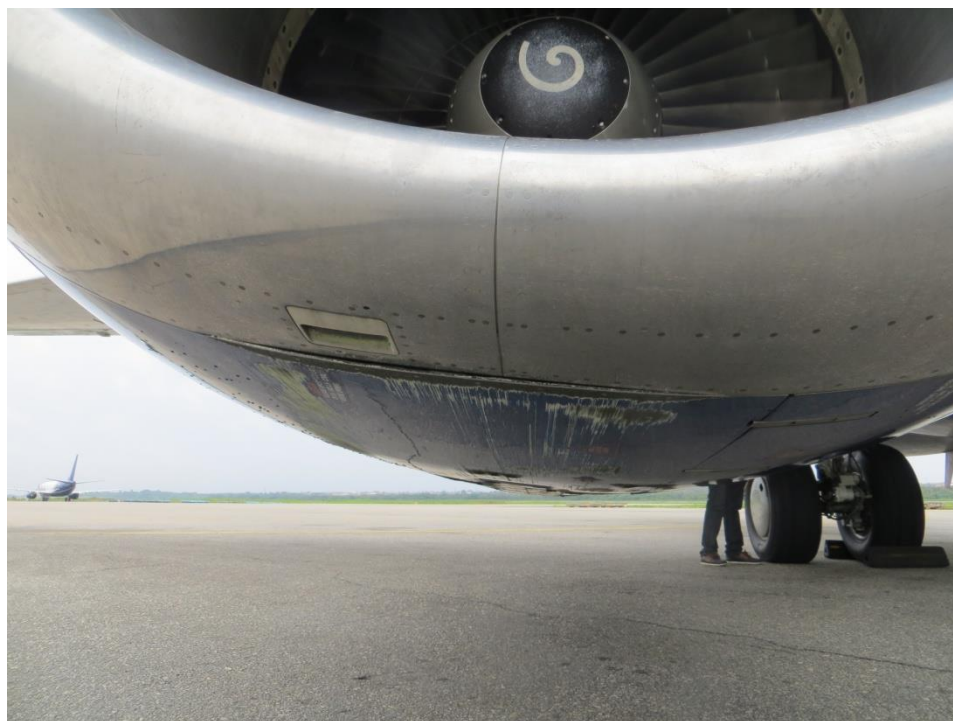
Figure 12: Photo showing the damage to lower fan cowl of RH Engine
