AIRCRAFT ACCIDENT REPORT

CHL/2019/02/02/F

**Report on the accident involving AgustaWestland
AW139 helicopter operated by Caverton Helicopters
Limited with nationality and registration marks 5N-
CML, which occurred at Kabba, Kogi State on 2nd
February, 2019.**

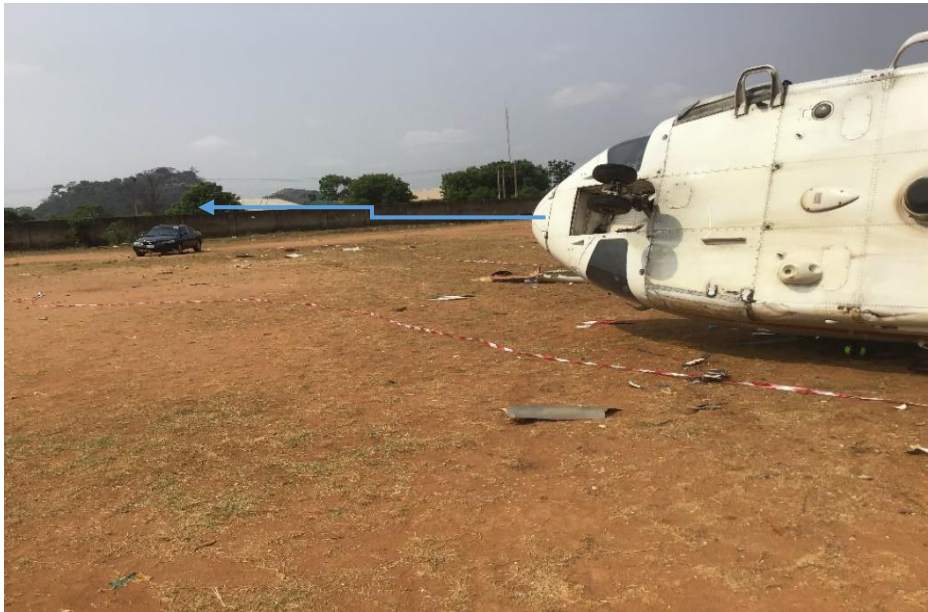
A parked car had slight damage from flying debris.

Figure 1: Damaged parked car relative to the helicopter

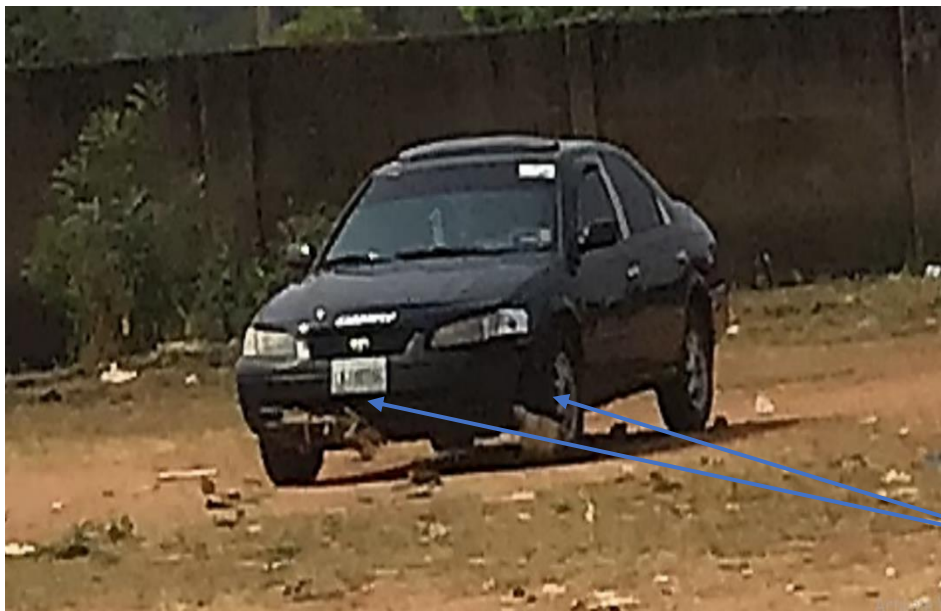
Figure 2: Damage to a parked car from flying debris

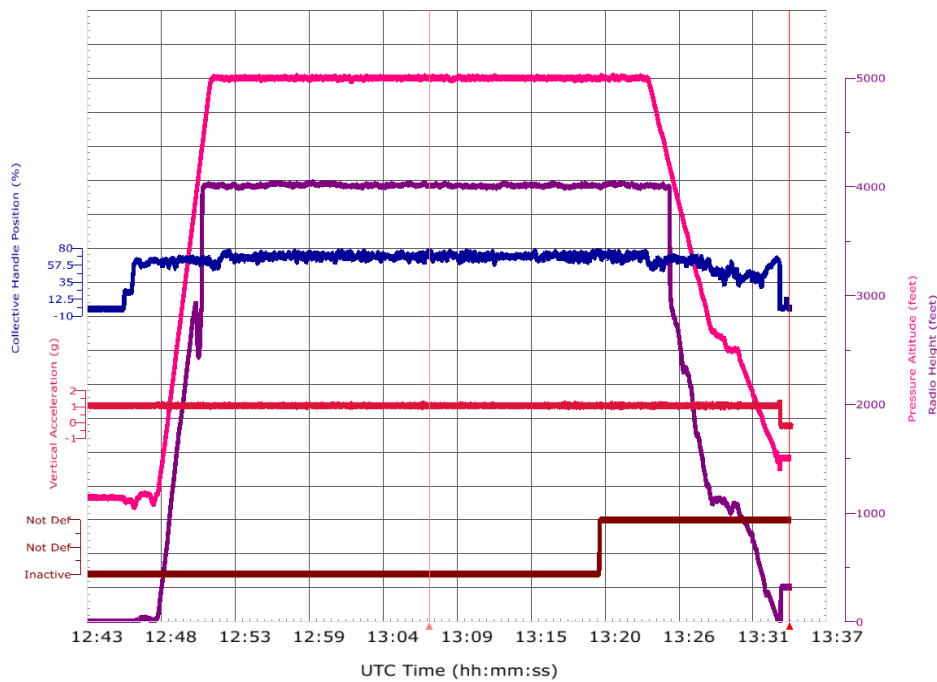
The QAR recorded a vertical acceleration of 1.4 g at the moment of landing. The tri-axial accelerometers, located near the centre of gravity of the helicopter, were the primary source of acceleration data recorded. However, smoothing of the data before recording caused the data to reflect the underlying acceleration trend and not the dynamic accelerations. Hence, it was likely that the landing was significantly “harder” than the 1.4 g recorded.

Figure 3: Profile of the flight

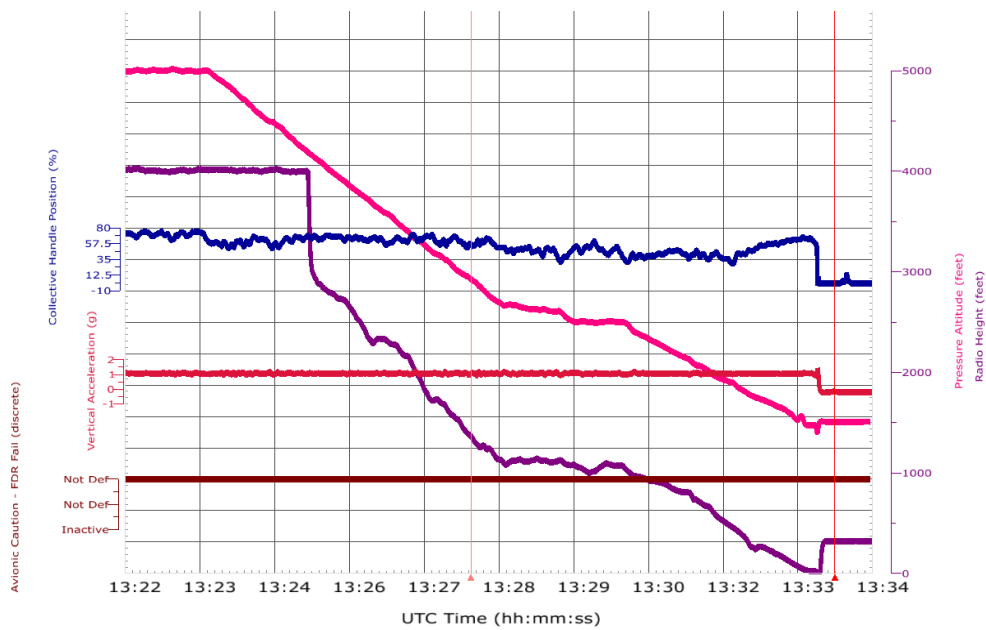
Figure 4: Approach and landing phase

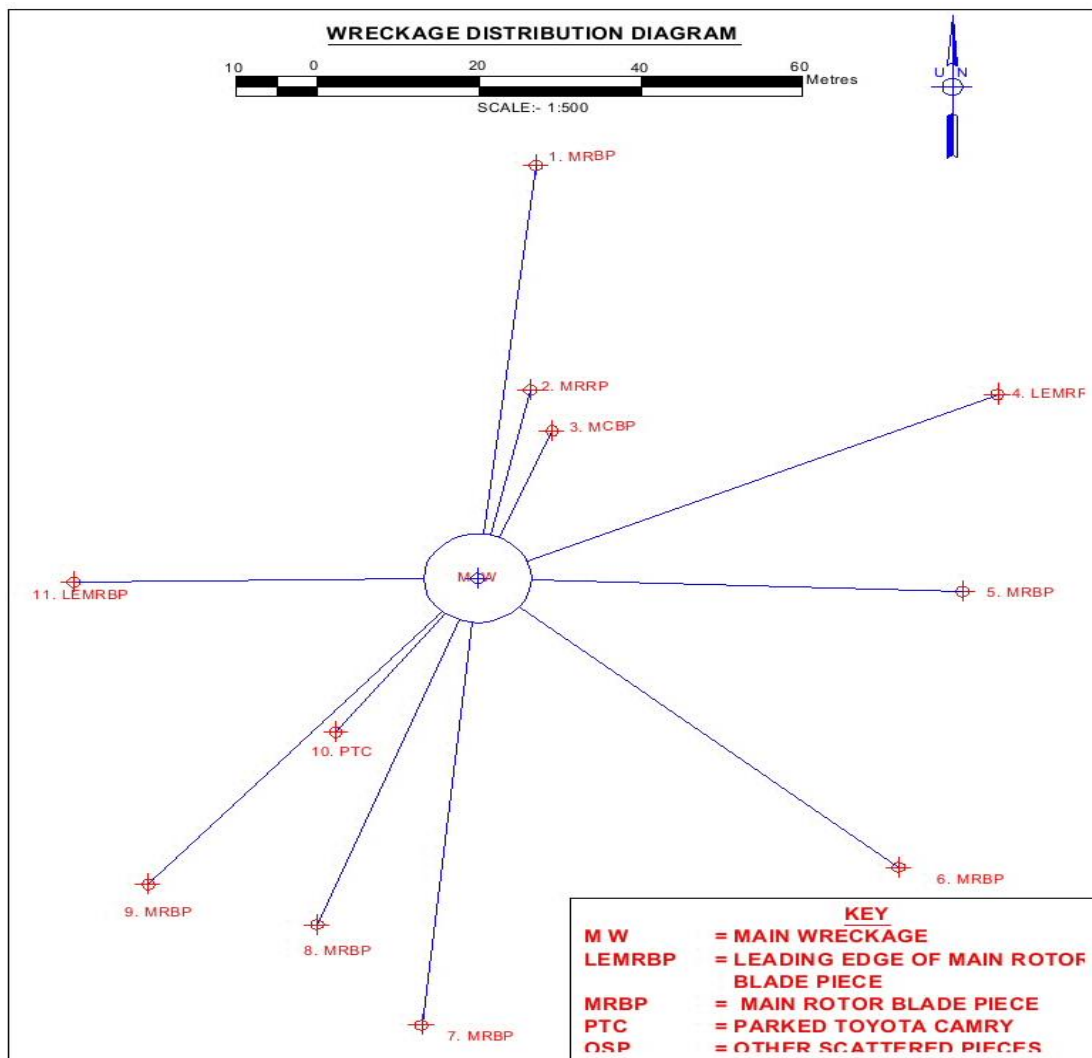
Figure 5: Wreckage distribution diagram

The right main landing gear broke and the right horizontal stabilizer was damaged. The tail rotor blades suffered damage, but the tail rotor assembly remained intact. The life raft deployed, and the left and the right floatation devices did not deploy.

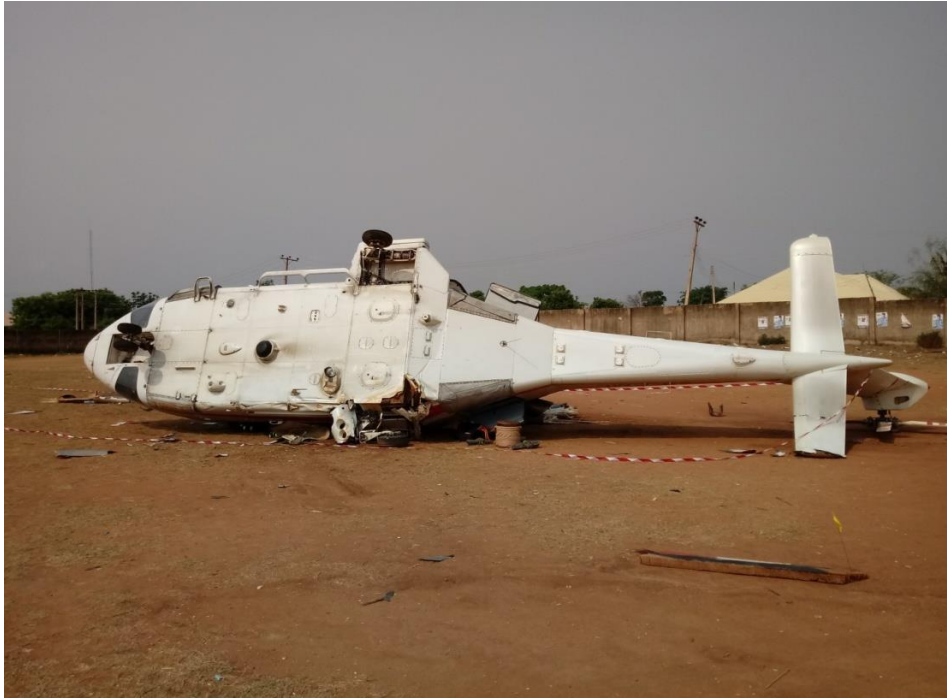
Figure 6: The underside of the helicopter

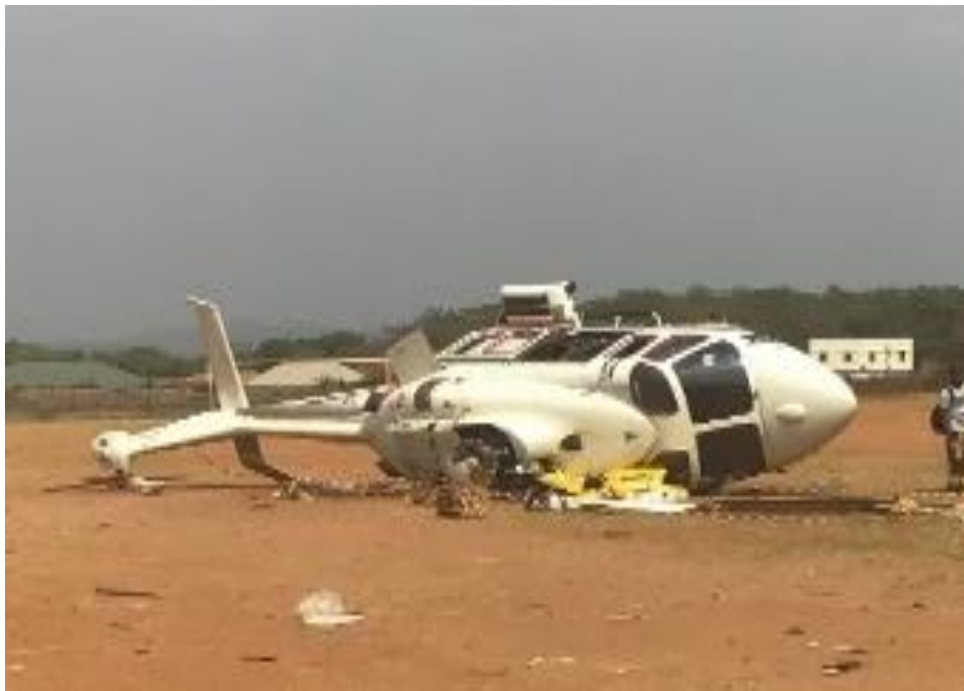
Figure 7: The helicopter

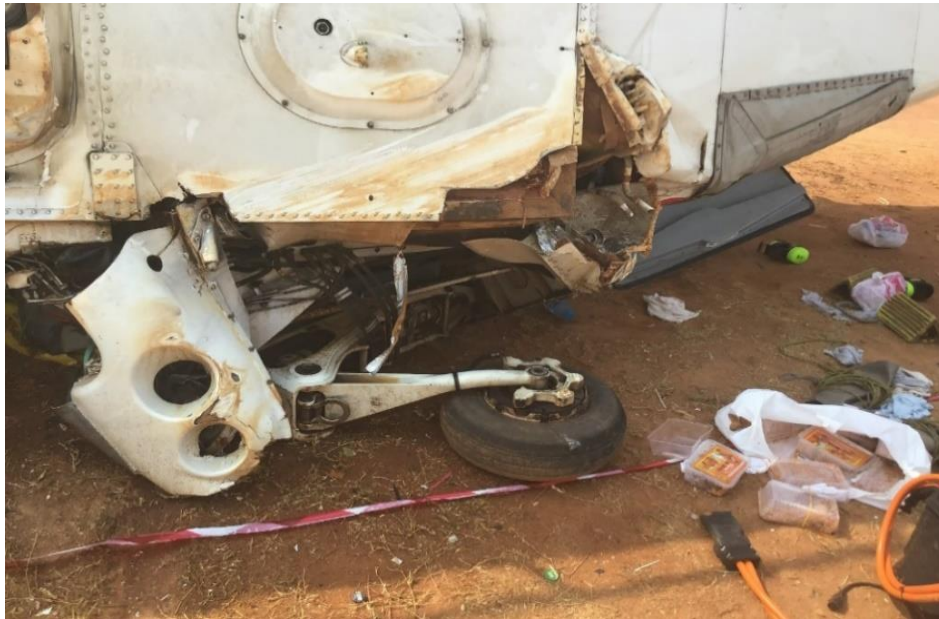
Figure 8: Damaged right main landing gear

brownout and the loss of visual references caused flight crew spatial disorientation and loss of situational awareness. As a result, the helicopter attitude may not have been level and a lateral movement may have taken place, which may have contributed to the hard landing and the breakage of the right landing gear.

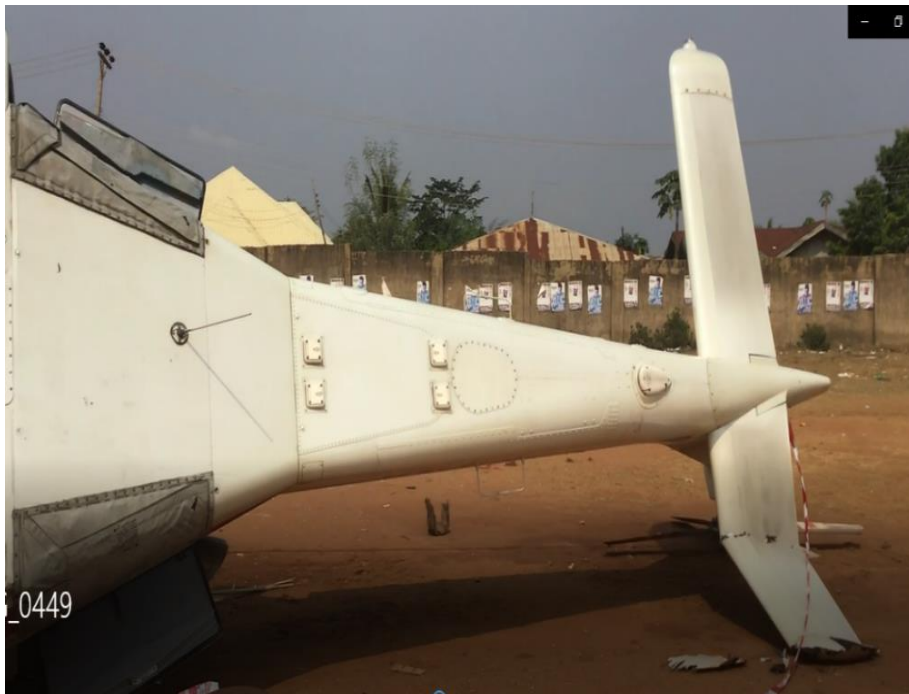
Figure 9: Damaged right horizontal stabilizer

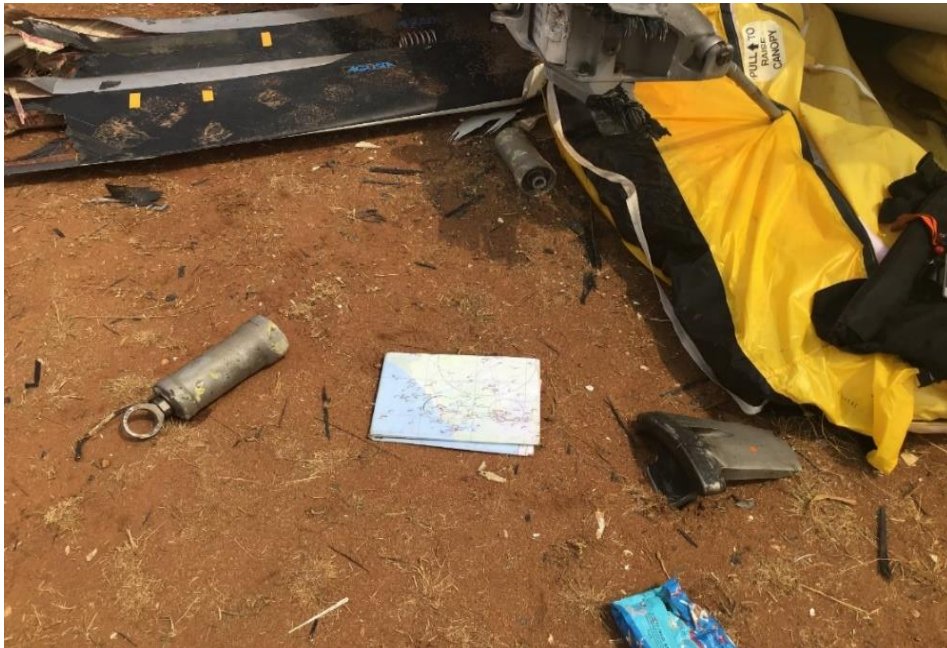
Figure 10: Deployed life raft

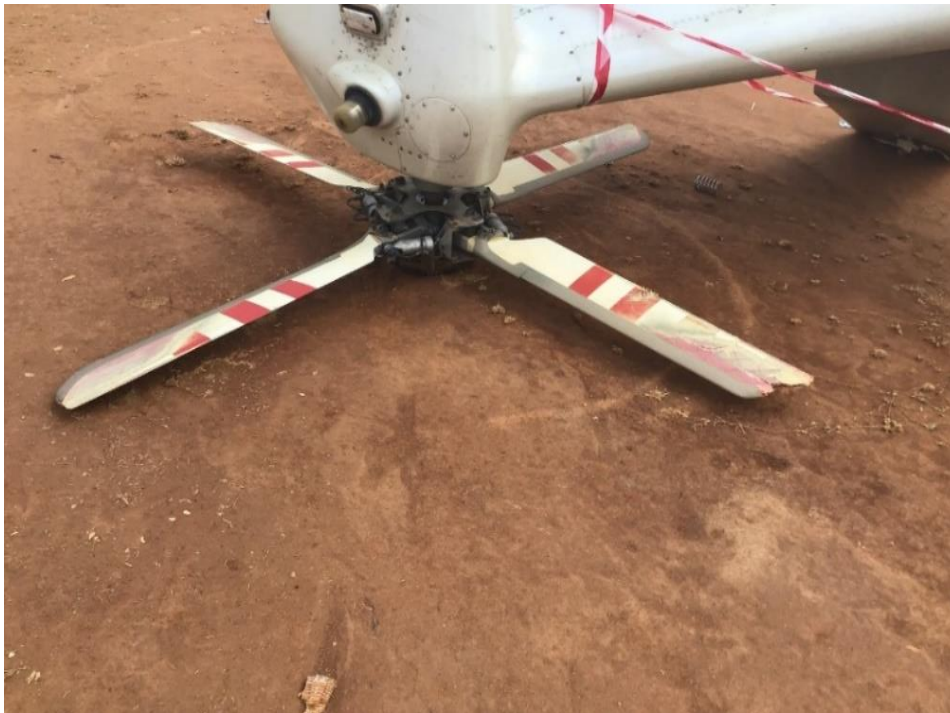
Figure 11: Damaged tail rotor blades
