# AIRCRAFT ACCIDENT REPORT

IAC/2019/05/01/F

**Report on the Serious Incident involving a Diamond  
DA-42 aircraft with Nationality and Registration Marks  
5N-BNH owned and operated by the International  
Aviation College which occurred on Runway 23 Ilorin  
International Airport on 1st of May, 2019**

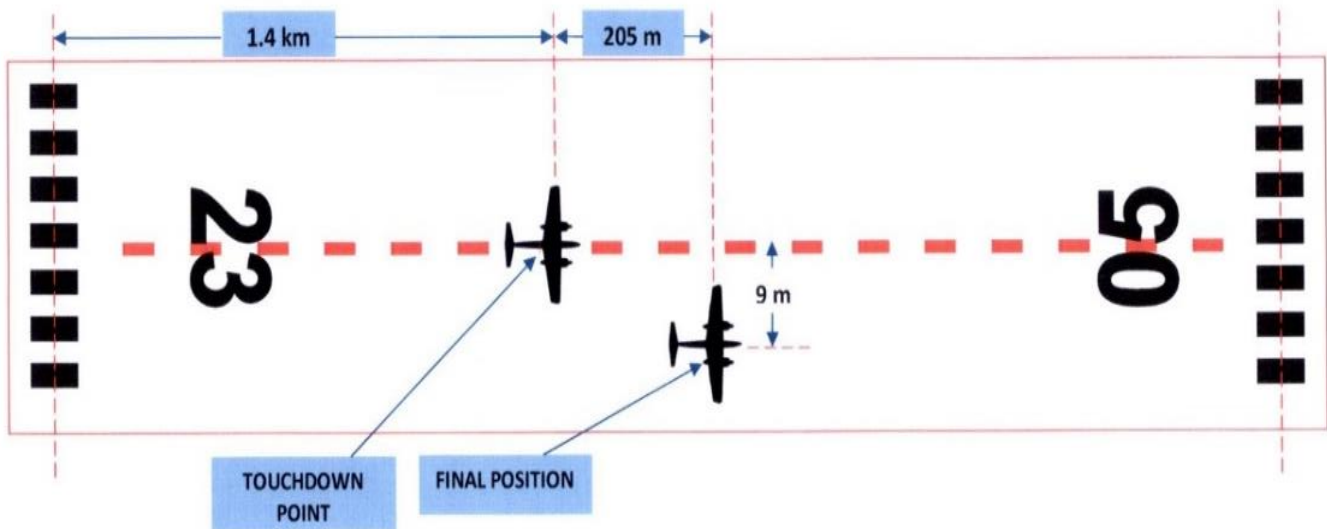
5N-BNH touched down on its engine cowlings at a distance of 1,387 m from the threshold of Runway 23 with the nose in the direction of the runway heading and

stopped at a distance of 205 m from the touchdown point. Although the aircraft structure was relatively in one piece, the left and right steps were found chopped off, the base of the engine cowling and exhaust as well as the tail skid were abraded, and all the propeller blade tips of both engines were broken.

**Figure 1:** A diagram of the position of aircraft on the runway

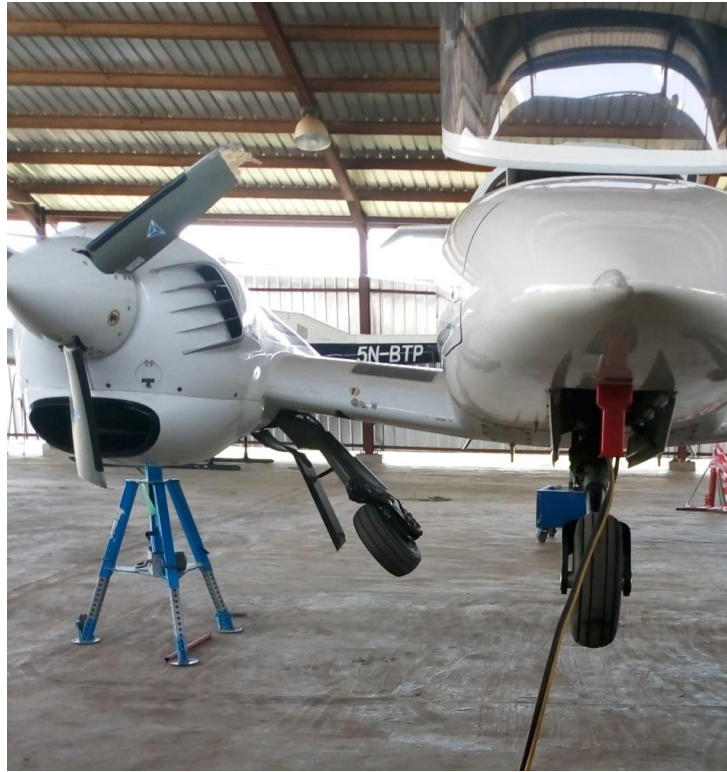
**Figure 2:** Photo of aircraft landing gear being retracted and extended under test

Landing Gear Extension and Retraction test was conducted after the incident in accordance with Aircraft Maintenance Manual 32-30-00 Rev 4 and was found satisfactory.

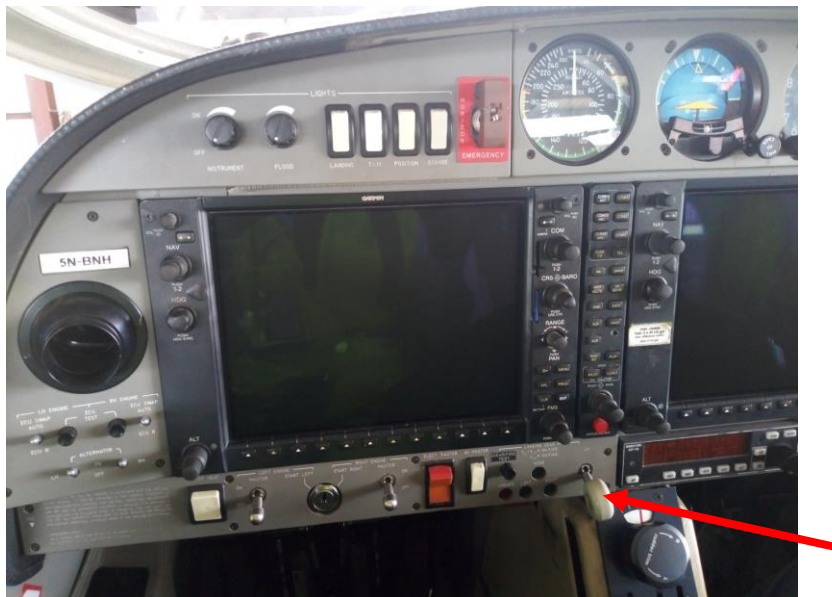
The Flight Instructor reported that on reaching final, he selected the landing gear switch to extend the landing gear. The FI stated that the switch knob came off in his hand while he did this. He put back the knob and continued the approach. He further stated, "I forgot to verify the 3 greens on the final approach till landing gear warning came up...". The Student Pilot reported that she selected the landing gear switch but the aircraft was too close to the runway surface.

**Figure 3:** Photo of the knob on the landing gear switch

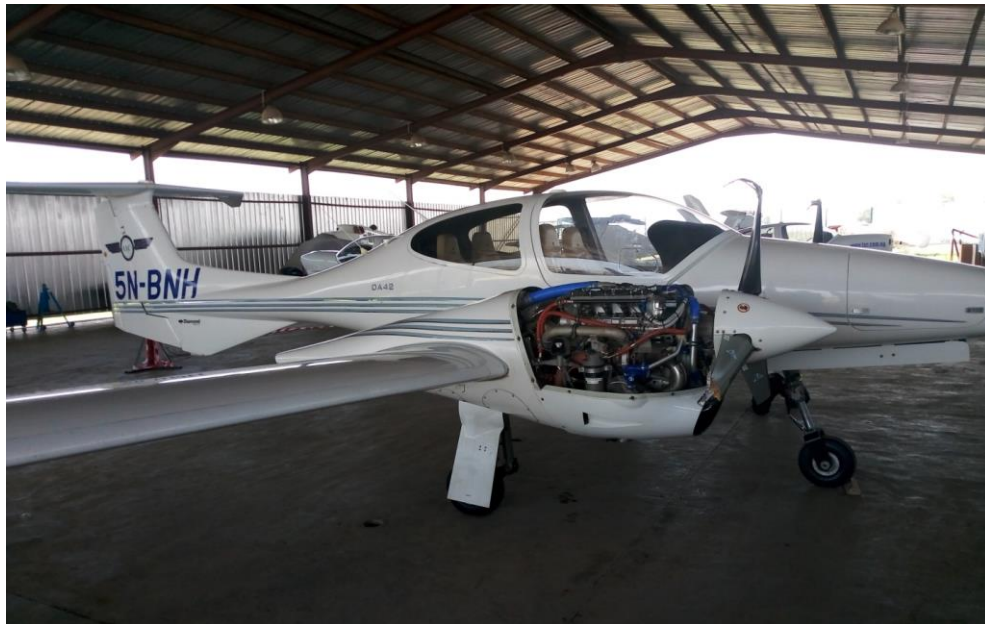
**Figure 4:** Photo of 5N-BNH standing on its landing gears without support

As stated on my previous reports; when the aircraft was being jacked up from the runway, the three landing gears were gradually extending until they fully extended and locked by gravity.

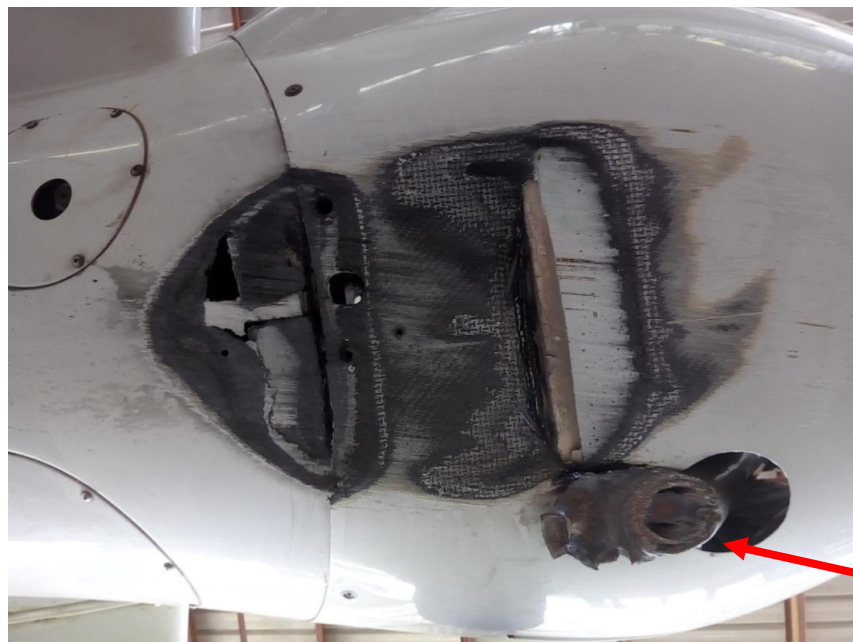
**Figure 5:** Photo of the base of engine cowling and exhaust abraded after the incident

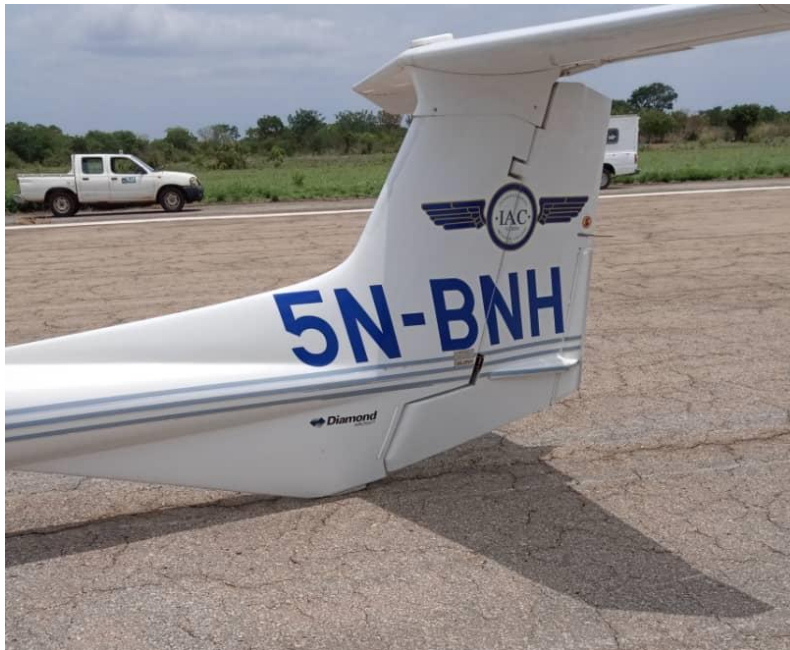
**Figure 6:** Photo of the tail skid of aircraft resting on the runway

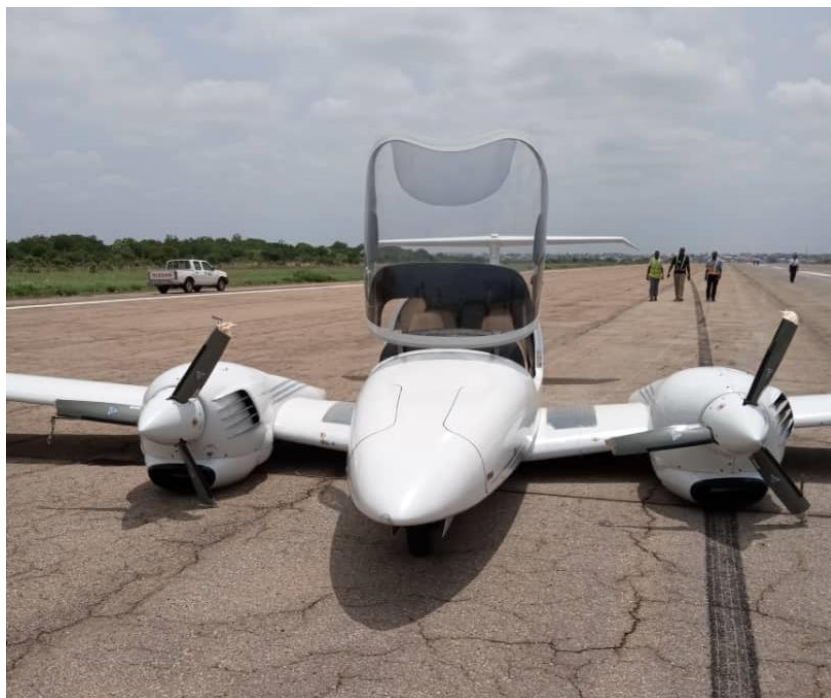
**Figure 7:** Photo of the final position of 5N-BNH on runway 23

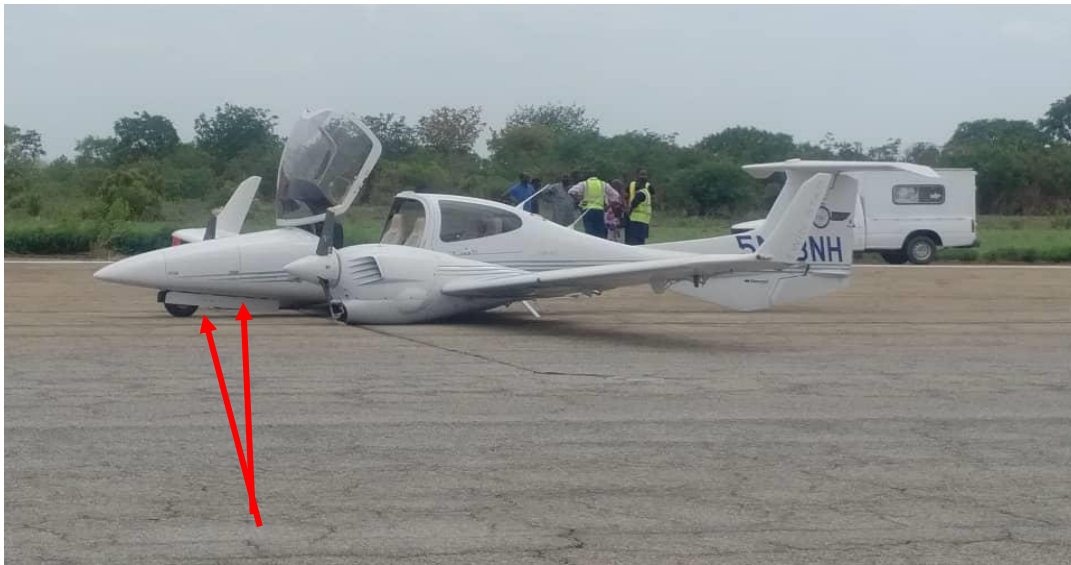
**Figure 8:** Photo of the nose-wheel door opened and landing gear partially extended

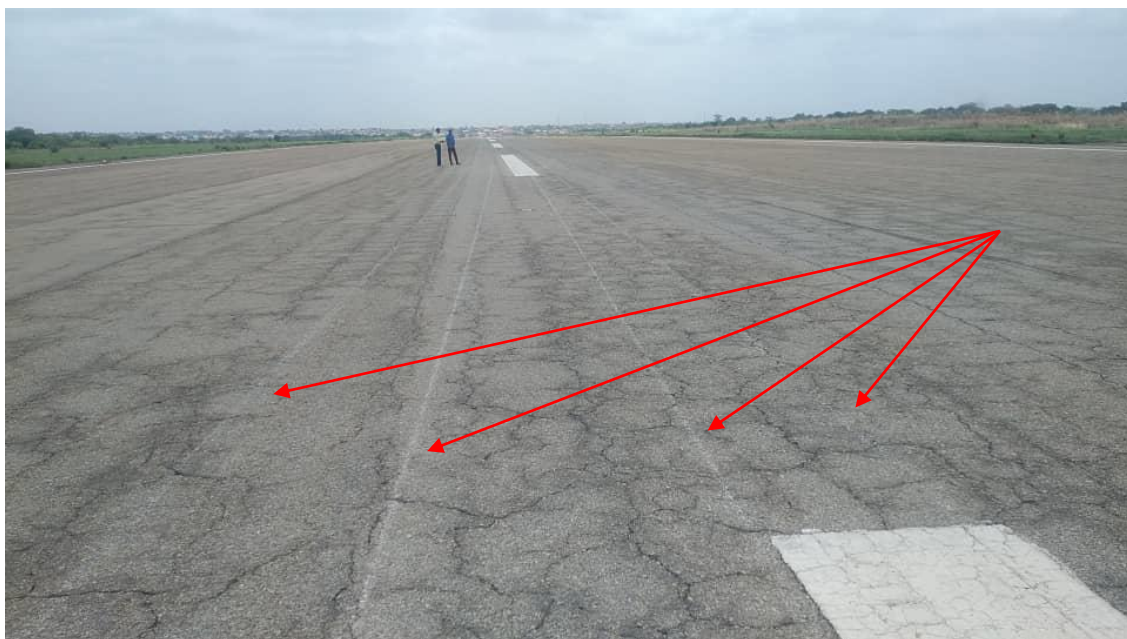
**Figure 9:** Photo of skid marks made by 5N-BNH on runway 23

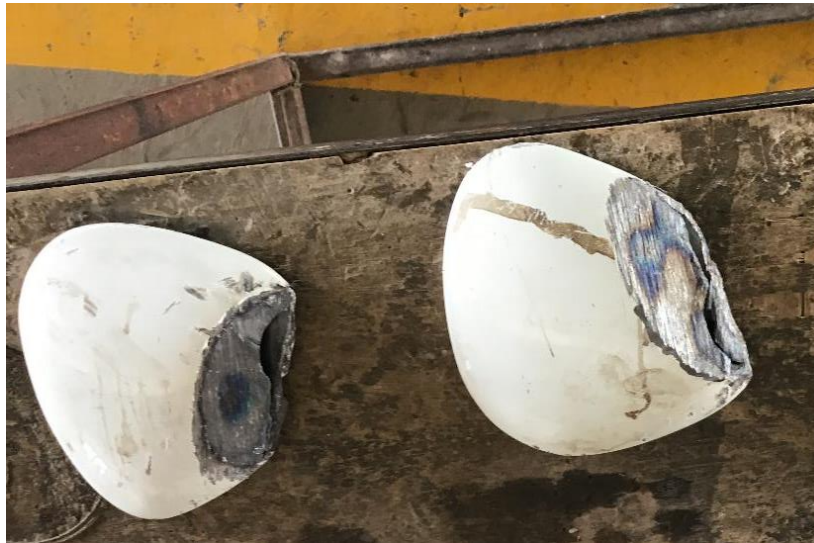
**Figure 10:** Photo of the broken left and right steps

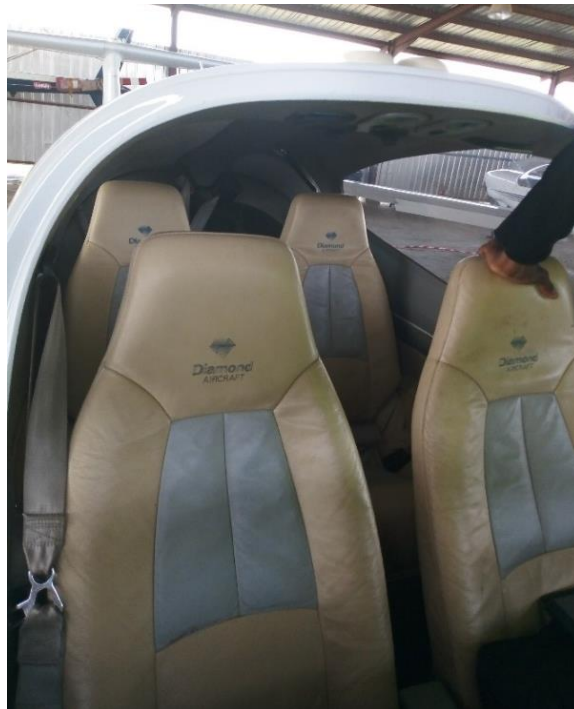
The cabin section of the aircraft remained intact after the occurrence and there was a liveable volume for survival. The harnesses were intact; the seats were in the normal positions after the incident.

**Figure 11:** Photo of the cabin after the incident
