# AIRCRAFT ACCIDENT REPORT

AIRPEACE/2019/05/15/F

**Report on the Serious Incident involving Boeing 737-300 aircraft owned and operated by Air Peace Limited with nationality and registration marks 5N-BUK which occurred at Murtala Muhammed Airport, Lagos  
On 15th May, 2019**

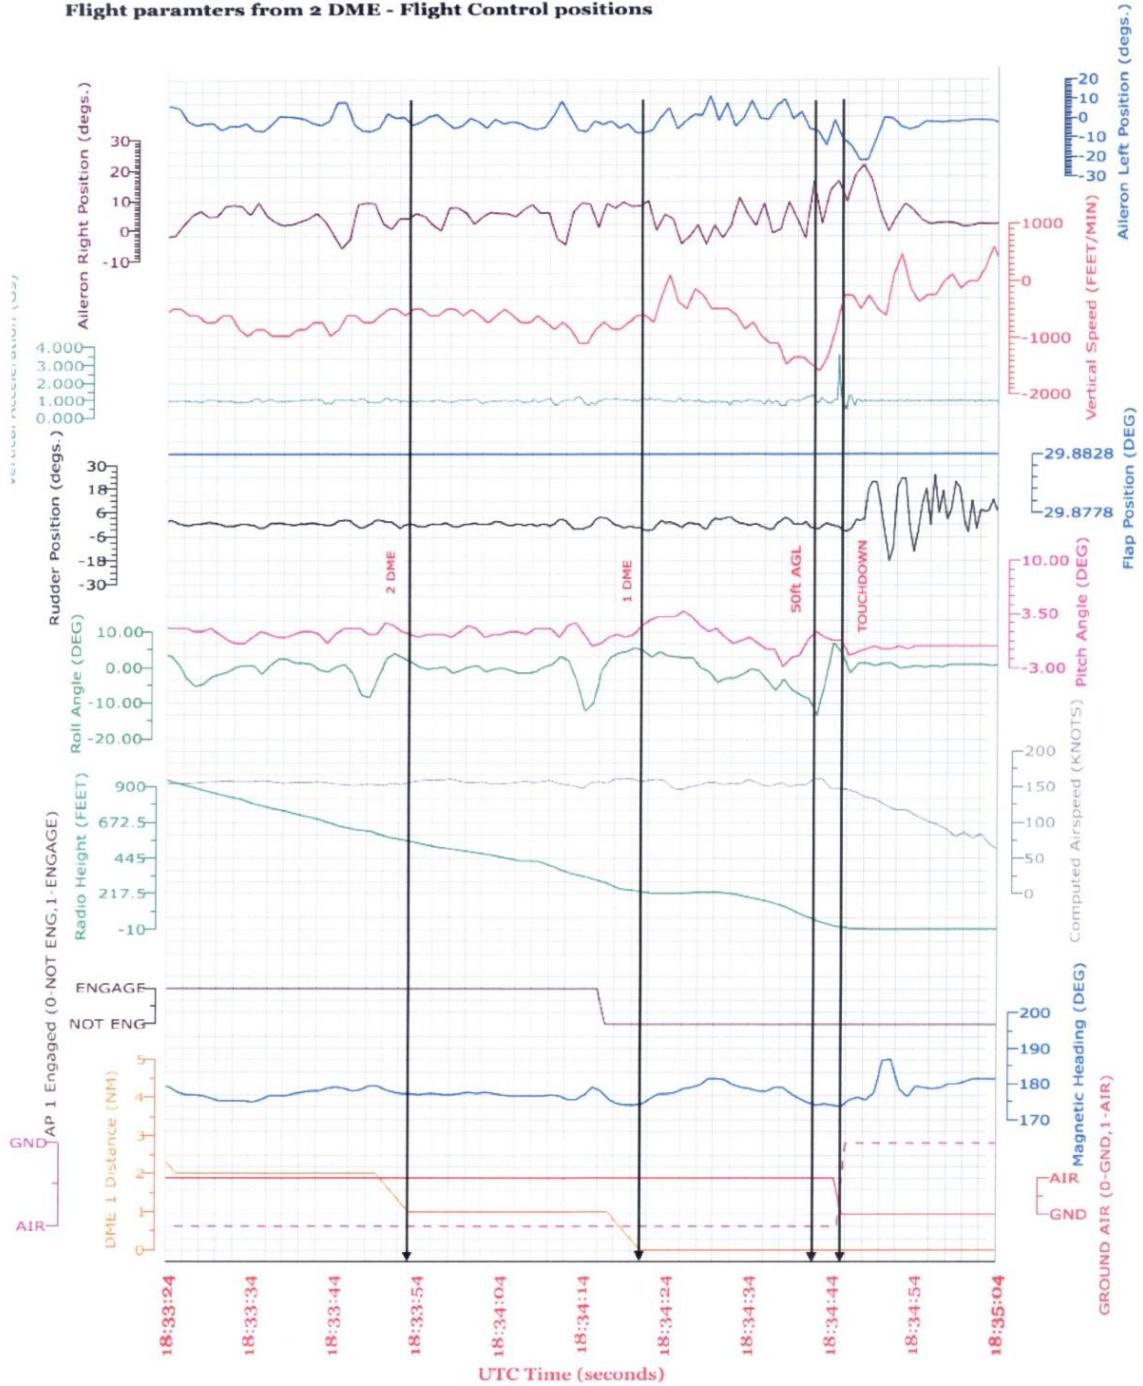
Figure 1: Flight control parameters from 2 NM

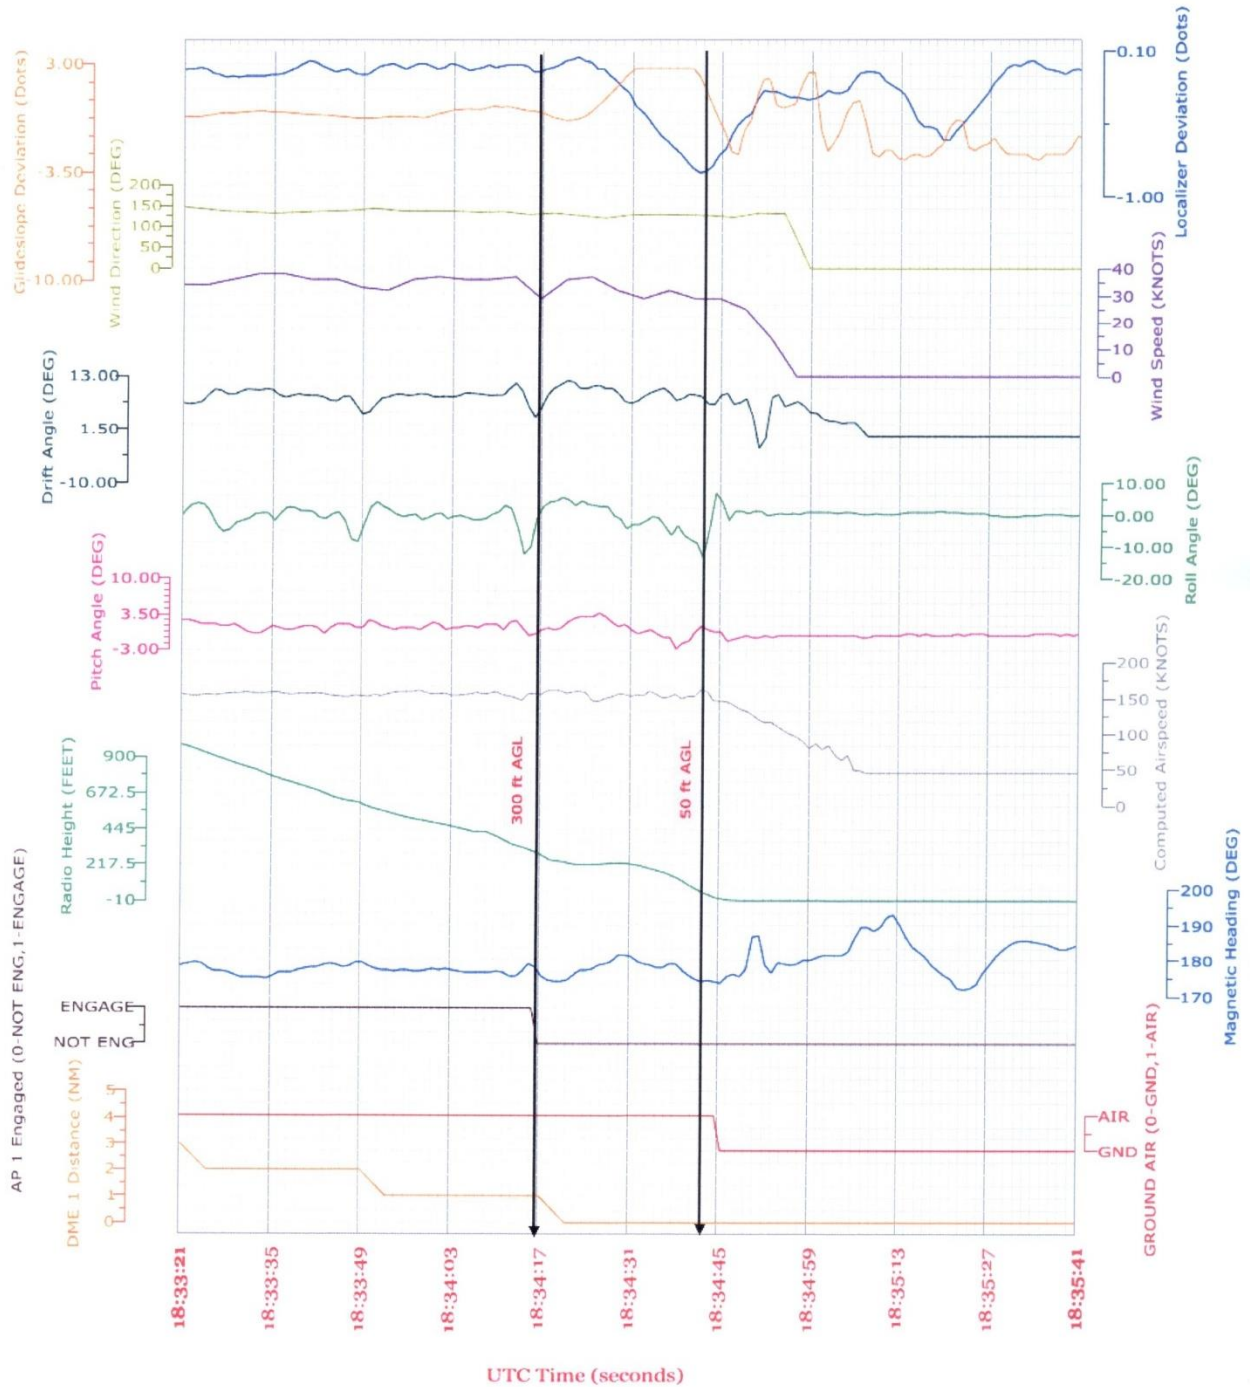
**Figure 2:** Weather related parameters from 2 NM

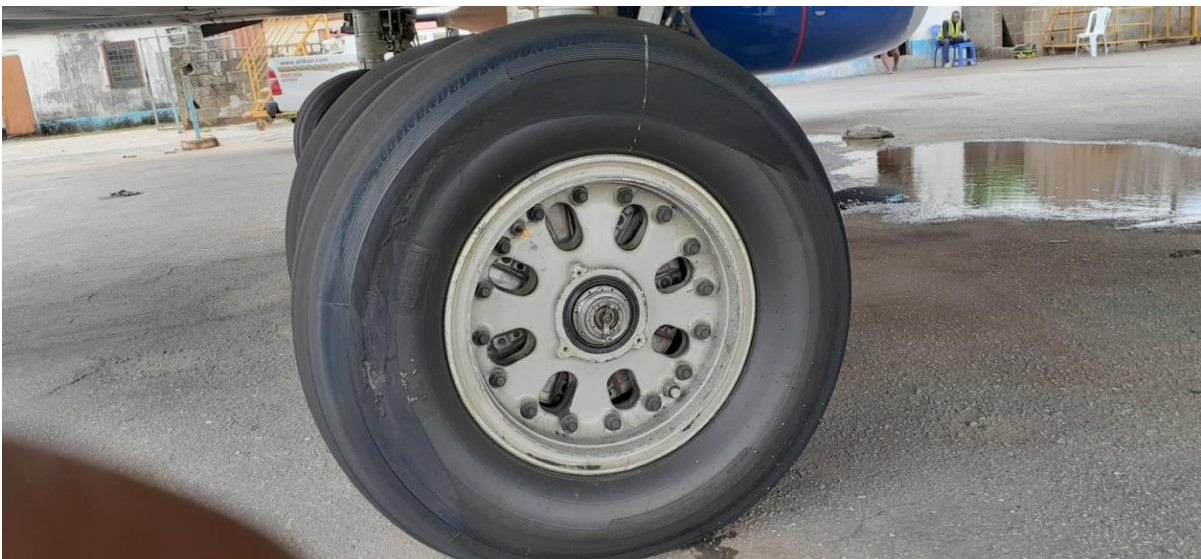
The aircraft touched down in a right bank, impacting the runway with the right (No. 2) engine cowling. The following damage were observed:

**Figure 3:** Photo of scuff marks on the No. 4 main wheel tyre

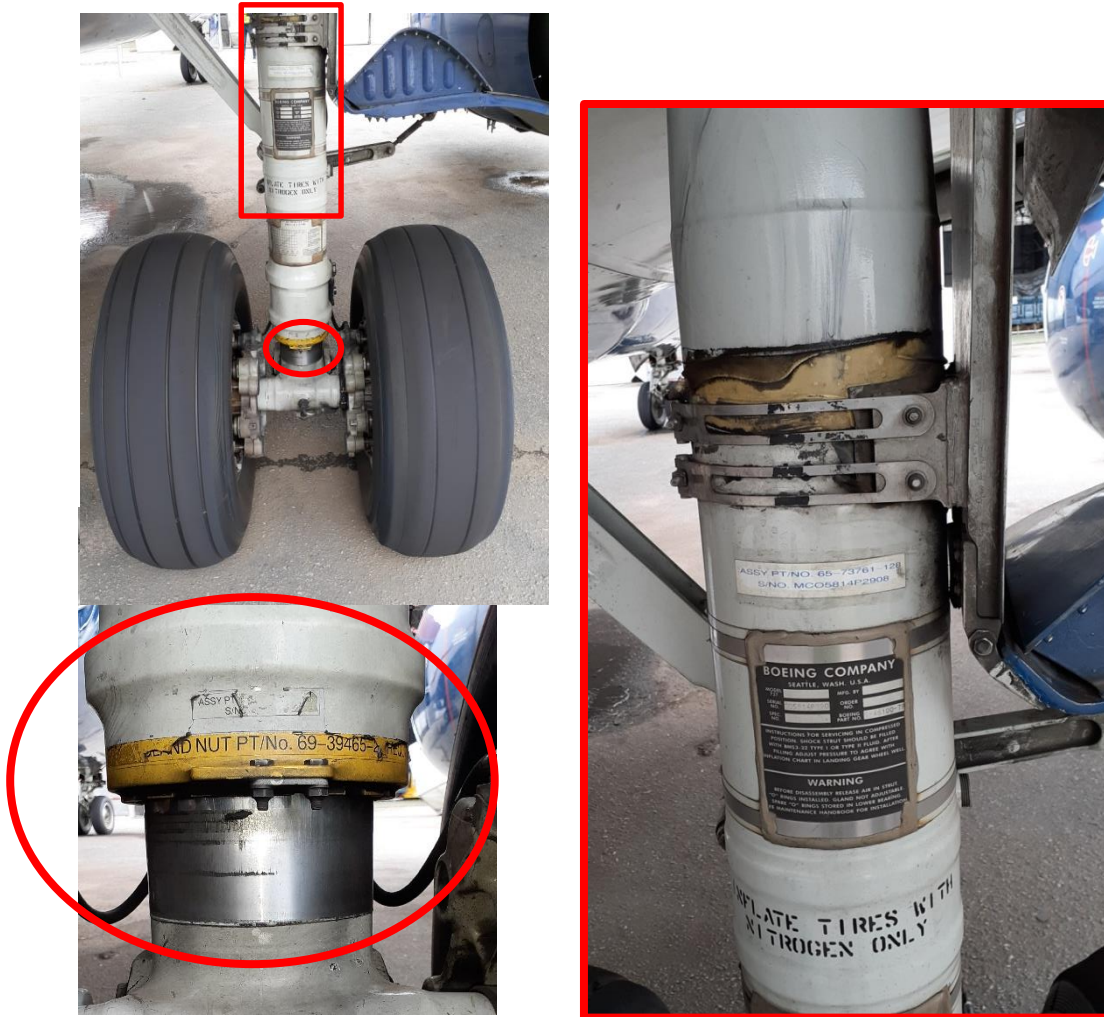
**Figure 4:** Photo of the displacement of the right main landing gear door clamps and oleo struts

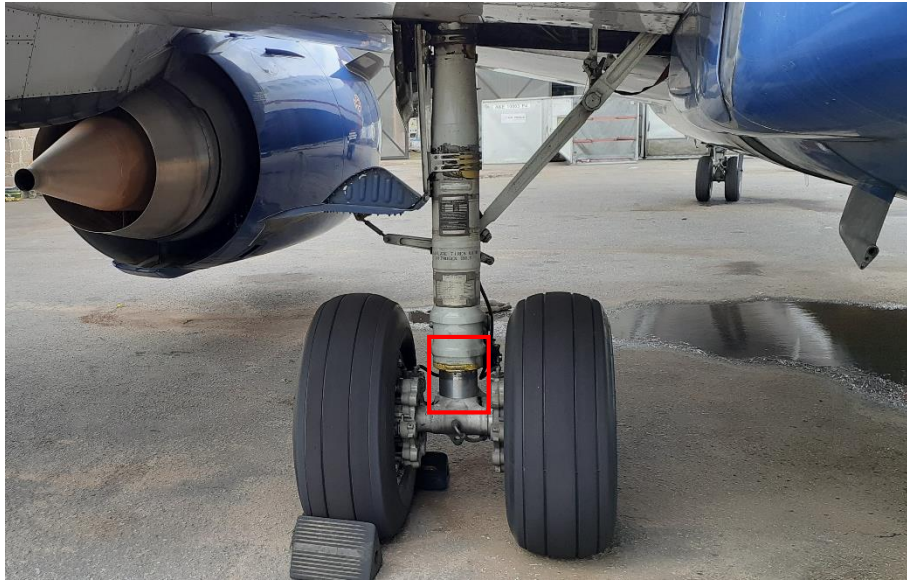
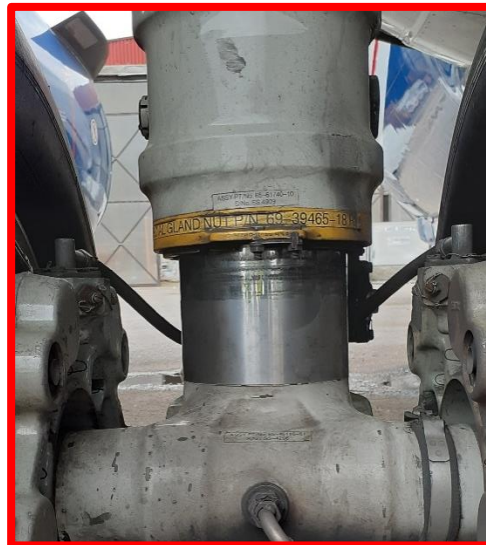
**Figure 5:** Photo and close up of the left main landing gear oleo strut

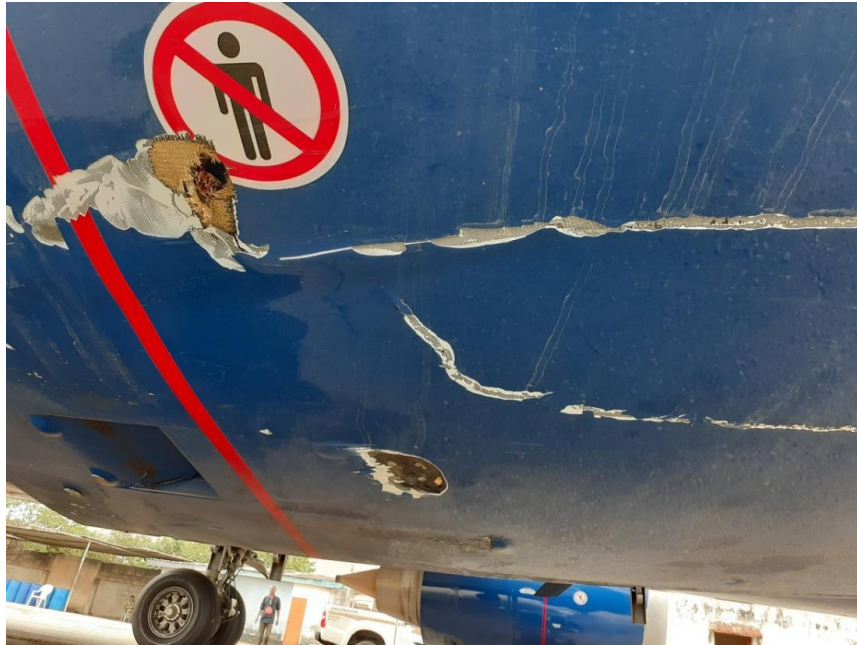
**Figure 6:** Photo of abrasions and dents on the No. 2 engine cowling

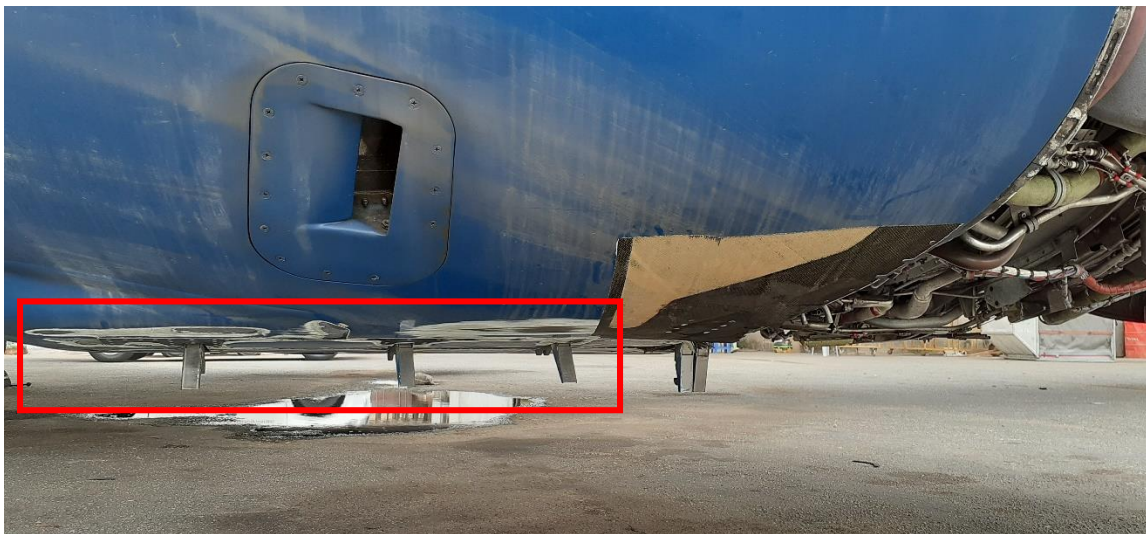
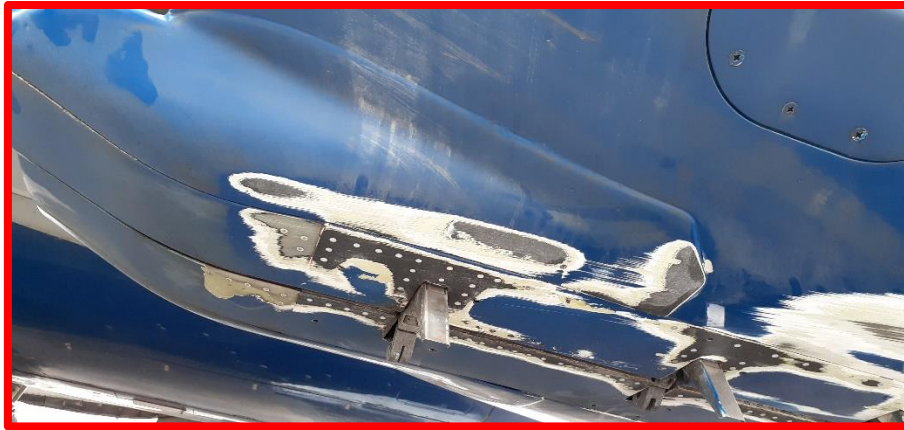
**Figure 7:** Close-up photo of the abraded surface of the No. 2 engine cowling

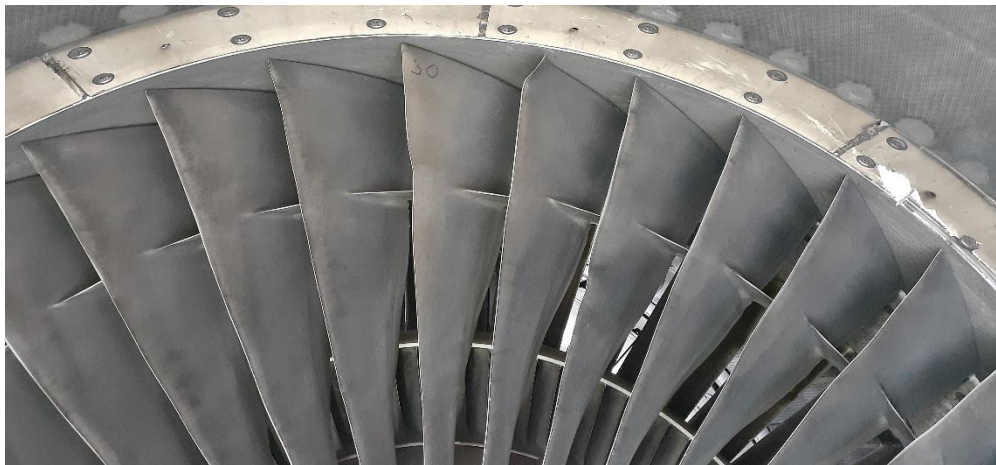
**Figure 8:** Close-up photo of Engine No. 2 fan blades
