# AIRCRAFT ACCIDENT REPORT

CAL/2010/08/20/F

**Report on the Serious Incident involving a B737-200  
aircraft with nationality and registration marks  
5N-BIF owned and operated by Chanchangi Airlines  
which occurred at Kaduna Airport, Runway 05,  
Kaduna State, Nigeria  
On 20th of August, 2010**

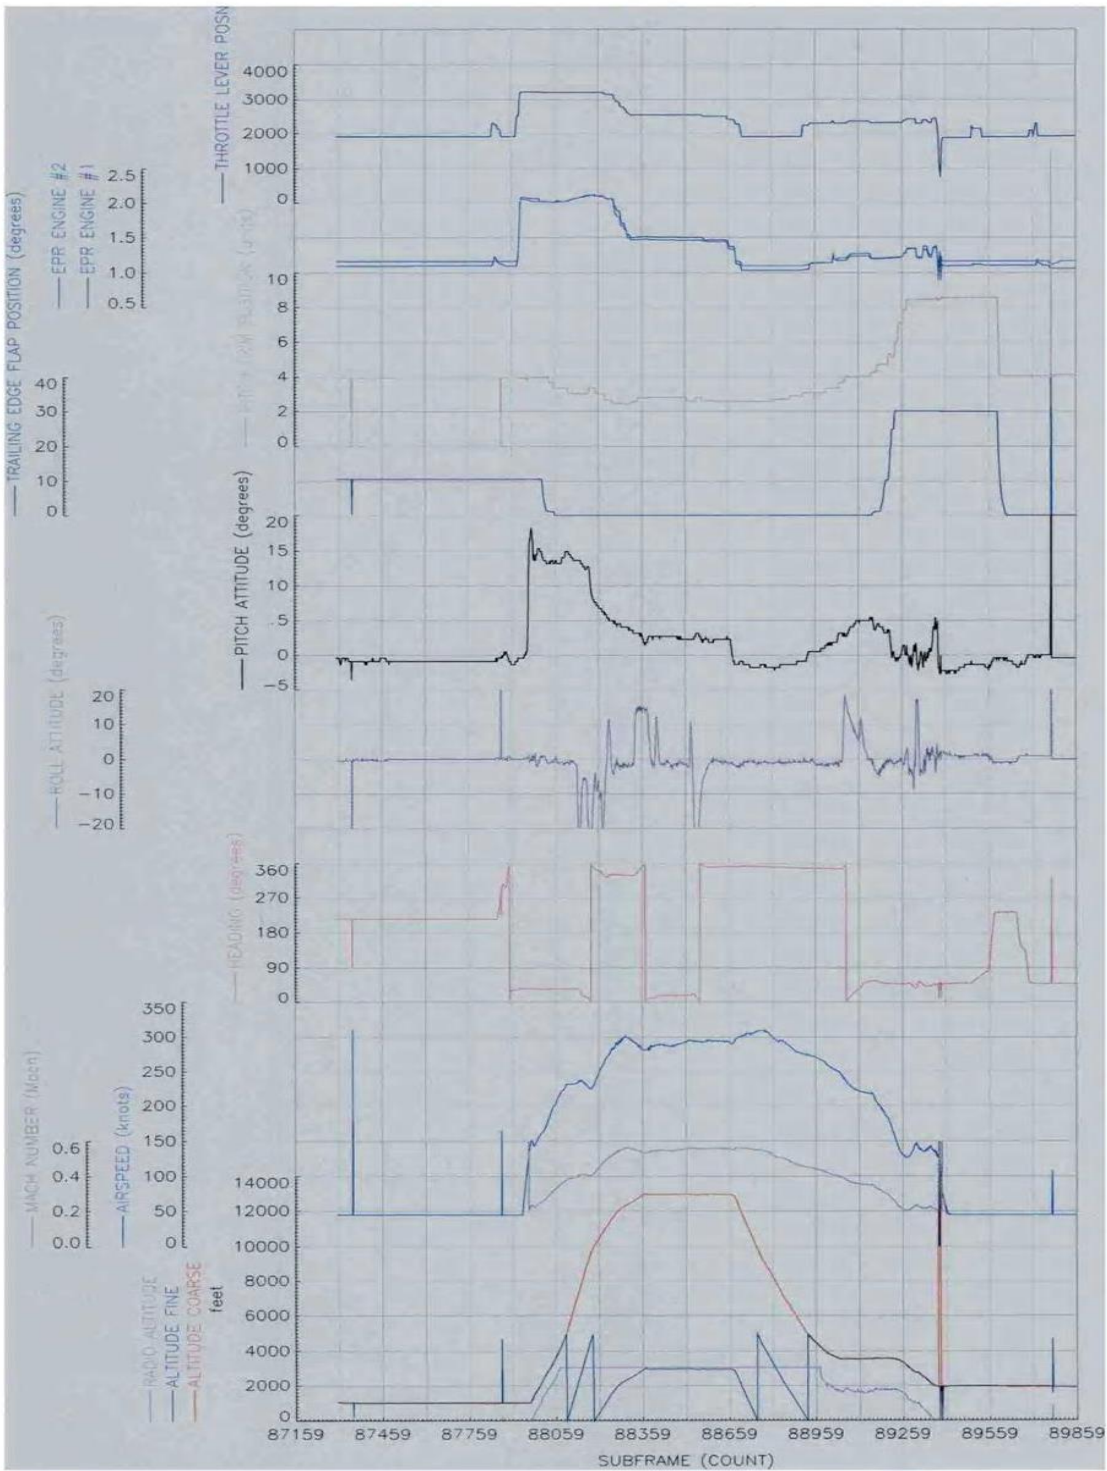
Figure 1: Flight Data Recorder plot of the whole journey

The FDR was successfully downloaded and analyzed. The FDR contained 42.5 minutes (42 minutes 30 seconds) of recorded data of the event flight. Twelve parameters of the event flight were recorded. The aircraft maintained an average speed of 134 knots with a corresponding Engine Pressure Ratio (EPR) in the last three minutes of its landing, confirming adequate power from the engines according to the FDR plots.

The pitch, the roll attitudes and the heading were found to be unstable during the last segment of the flight. The Radio altitude was at zero (0) ft at 89,375 secs, that is, 34.4 minutes (34 minutes 24 seconds) of the total flight duration. (See FDR plot on the next page)

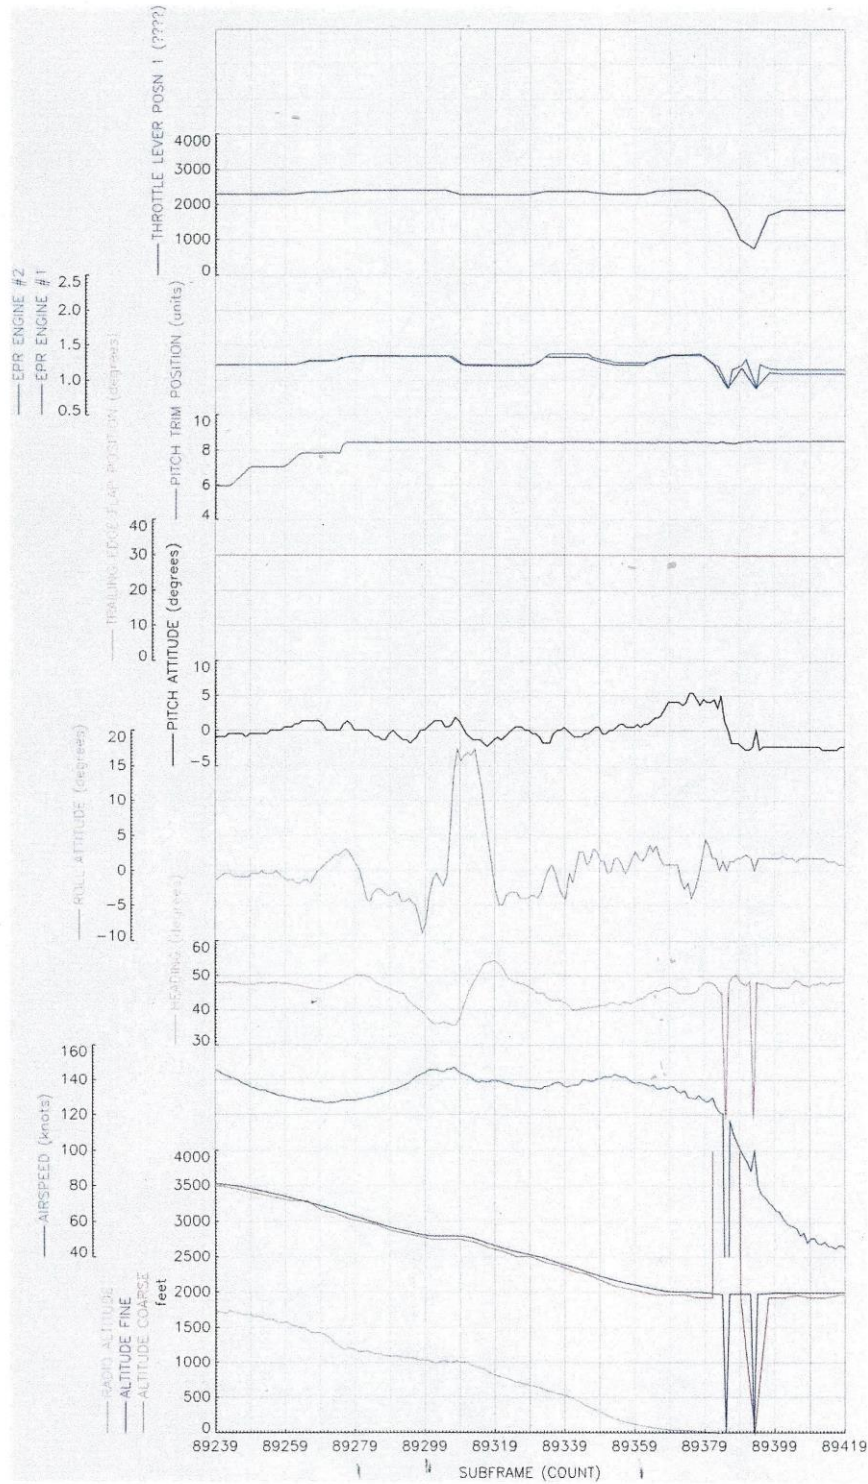
Figure 2: FDR plot of the last 3 minutes of the flight

The analysis of the FDR revealed that at 2,300 ft, there was sudden change in speed, pitch attitude and airspeed coupled with loss of altitude which led to the aircraft impacting the NDB equipment along the runway landing path. At this point, the aircraft showed a descent rate of 825 ft per minute at 225 ft above the aerodrome elevation. This situation may have been caused by poor instruments’ scanning from the pilot flying and lack of situation awareness.

Chanchangi Stabilized Approach). The heading was found to fluctuate between 36 and 55 degrees while the Pitch attitude fluctuated between -02 and +05 degrees.

From the FDR plot, no evidence was found to show any sudden/excessive sink rate of the aircraft to corroborate "the sudden loss in height and speed" due to wind shear.

The investigation revealed that the sink rate was found to be 825 fpm (between 750 fpm and 900 fpm) on the average and this value was found to be normal and in accordance with Chanchangi SOPs.

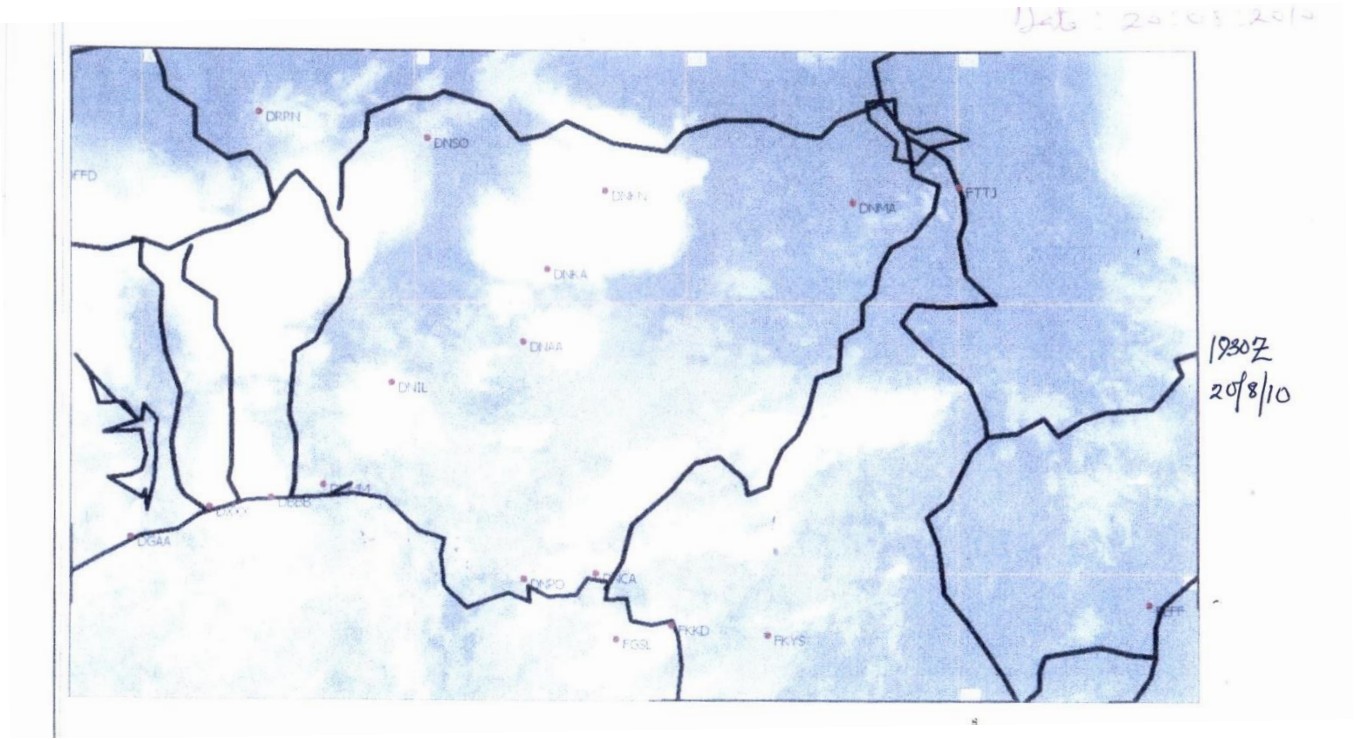
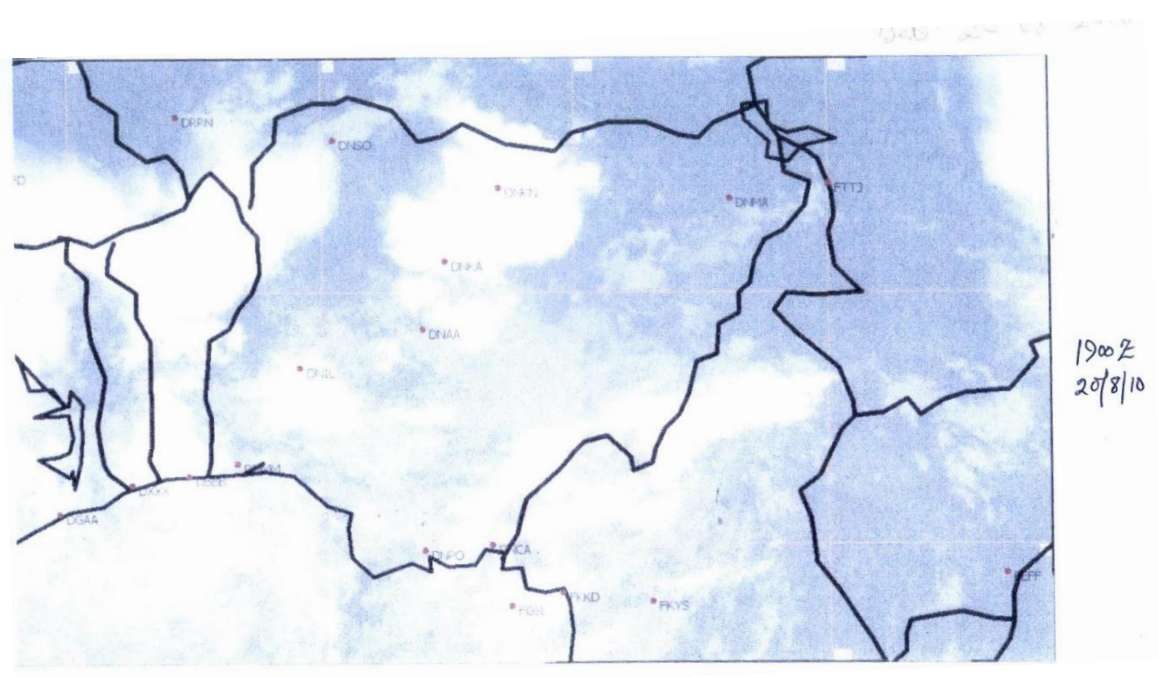
**Appendix B: Satellite weather imagery**

The satellite weather imagery received from Nigerian Meteorological Agency (NIMET), showed clouds development at hourly intervals beginning from 1800 h to 2000 h when the serious incident occurred. It was apparent that the isolated convective cell developed sometime around 1800 h and grew rapidly with an estimated base of 2,500 ft. Given the intensity, vertical development and the movement of the cell over Kaduna, it produced rain, lightning activities, wind shear, downburst wind, and other adverse meteorological conditions which are the associated characteristics features of a typical thunderstorm Cumulonimbus (CB) cloud.
