AIRCRAFT ACCIDENT REPORT

NPF/2019/08/03/F

Accident Investigation Bureau

Report on the serious incident involving a Bell 429 helicopter with nationality and registration marks 5N-MDA, operated by the Nigeria Police Airwing, which occurred at Nnamdi Azikiwe International Airport, Abuja On 3rd August, 2019

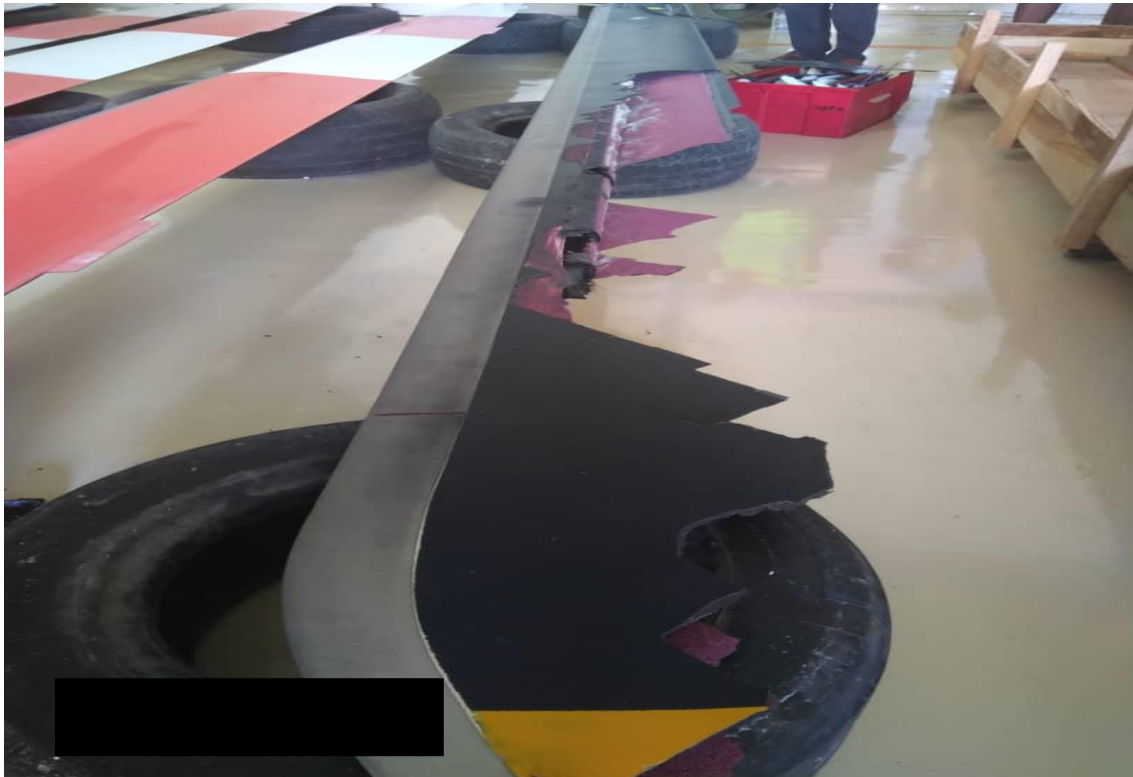
Figure 3: Damaged Main Rotor Blade

The helicopter was intact with one of its main rotor blades shattered.

The crew adjudged the clearance between 5N-MDA and the parked 5N-LEH to be enough for safe parking without any means of guidance. However, while powering down, the downwash⁵ generated by the main rotor blades of 5N-MDA blew off a tie-down sock of the parked 5N-LEH. As a result, the tie-down sock flew into one of the main rotor blades of 5N-MDA and shattered its trailing edge.

13. The downwash generated by the main rotor blades of 5N-MDA blew off a tie-down sock of the parked 5N-LEH.
14. The tie-down sock flew into one of the main rotor blades of 5N-MDA and shattered its trailing edge.

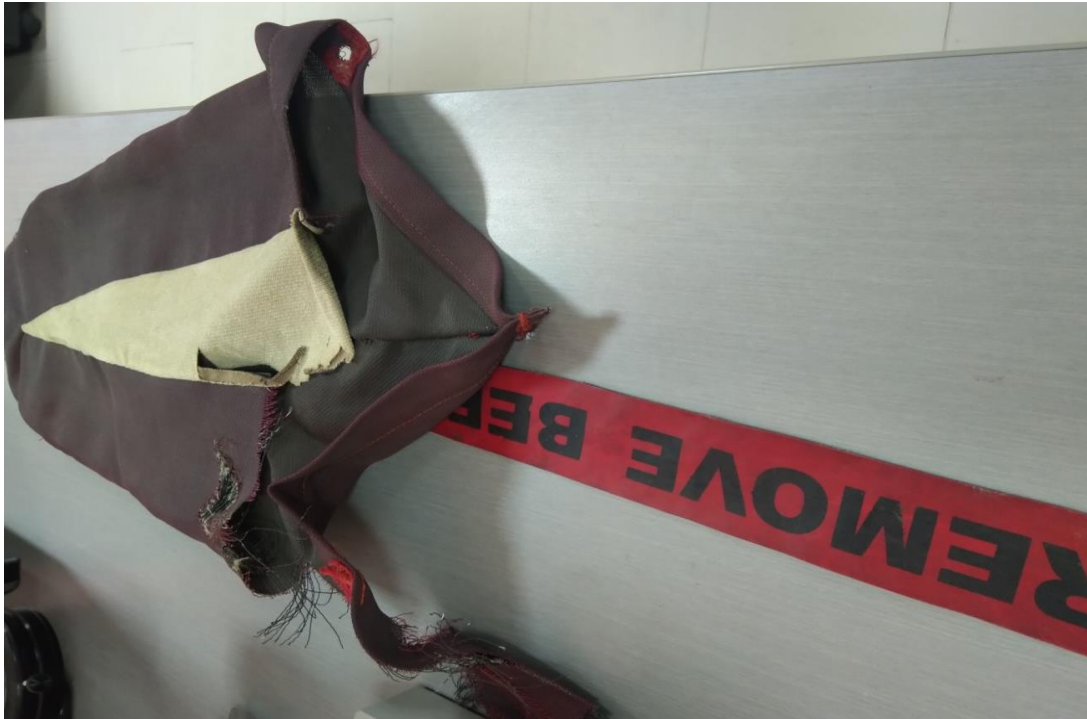
Figure 4: The severed tie-down sock from the parked Bell 412 (5N-LEH)

A tie-down sock of the parked Bell 412 (5N-LEH) was severed.
