AIRCRAFT ACCIDENT REPORT

NPF/2018/10/03/F

Accident Investigation Bureau

**Final Report on serious incident involving
Cessna Citation 560 XLS+ aircraft with nationality
and registration marks 5N-HAR operated by the
Nigeria Police Airwing which occurred at Sir
Abubakar Tafawa Balewa Airport Bauchi, Nigeria
On 3rd October, 2018**

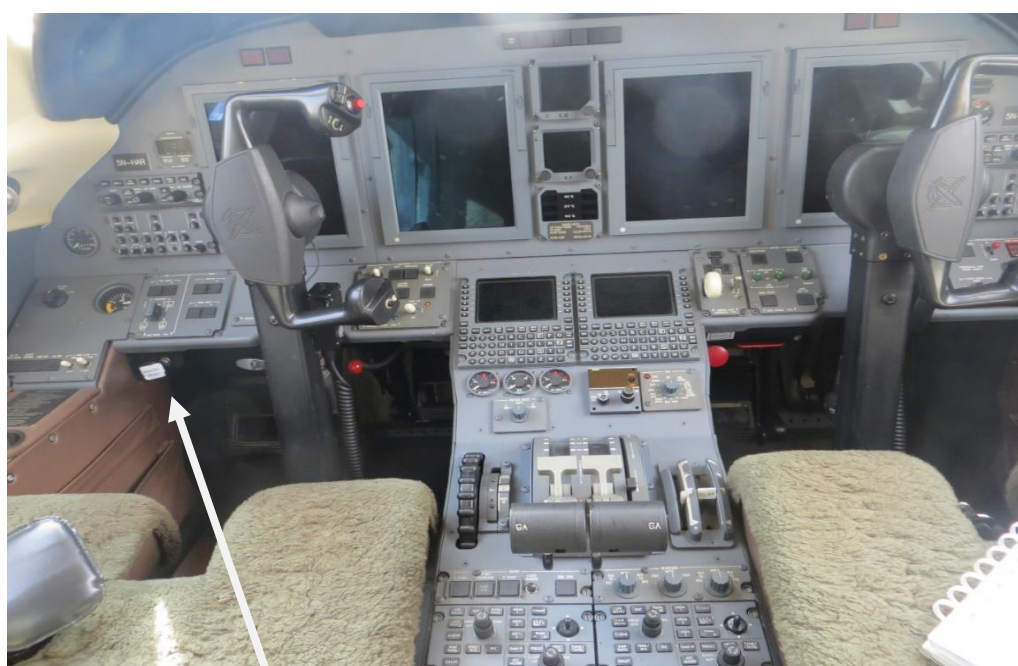
Figure 2: Parking brake position in the cockpit

It is possible for the parking brake to operate partially even when the parking brake knob is pushed forward if the pilot fails to fully depress the brake pedal when setting the parking brake. The PF stated that he maintained his toes on the brakes up to the

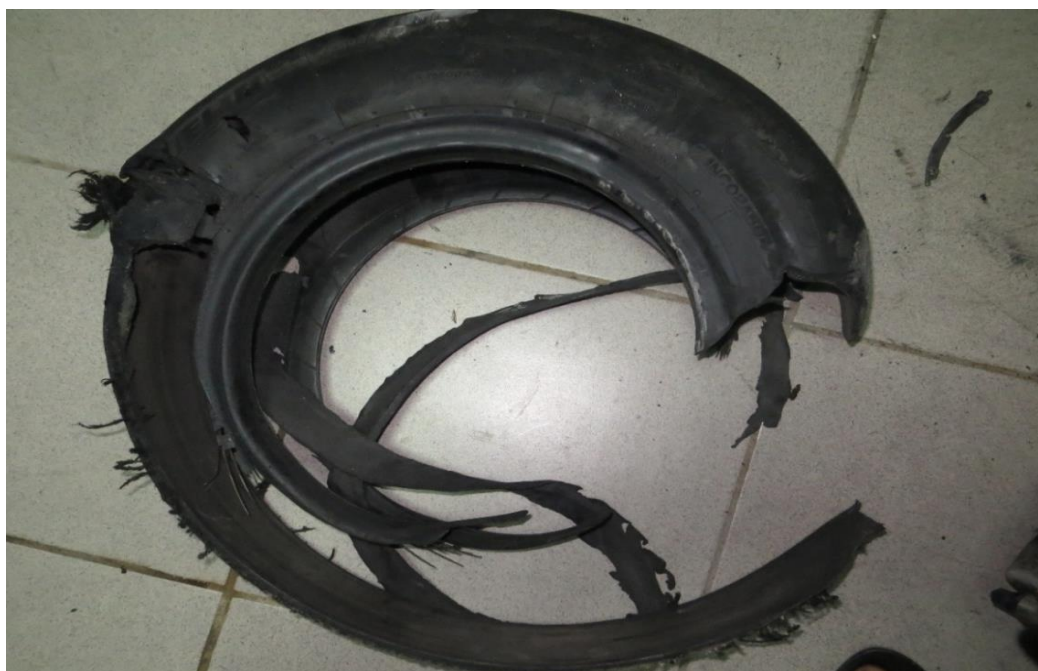
Figure 4: Burnt main landing gear tyre

The two main landing gear wheel assemblies were completely burnt.

When this occurs, the brake disks rub against the brake pads and causes heat to build-up which can be enough to start a wheel fire. This condition of partial operation of the parking brake during the taxi and take-off roll led to brake binding which resulted in wheel fire.

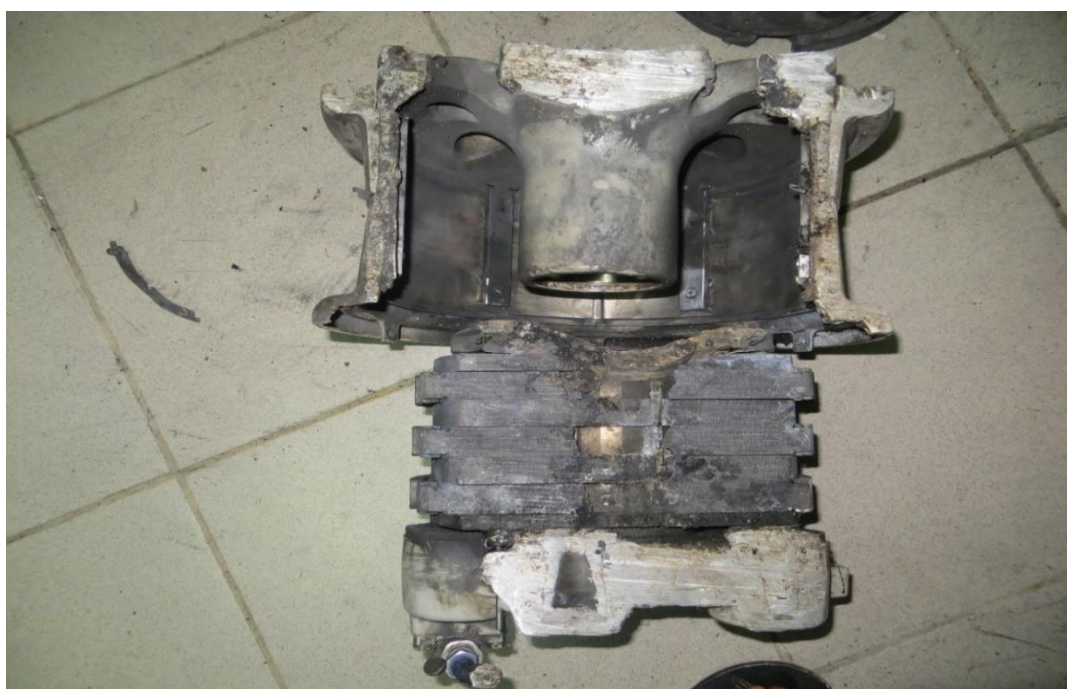
The aircraft came to a stop at about 45° to the right of centre line, 603 m (1,977 ft) before the end of RWY 17. The brake assembly of the two main landing gears were damaged including the hub cap, nut and screw from the main landing gear wheel. The main landing gear tyres were burnt and the left main landing gear up-lock bolt was also broken.

Figure 5: Damaged main landing gear brake assembly

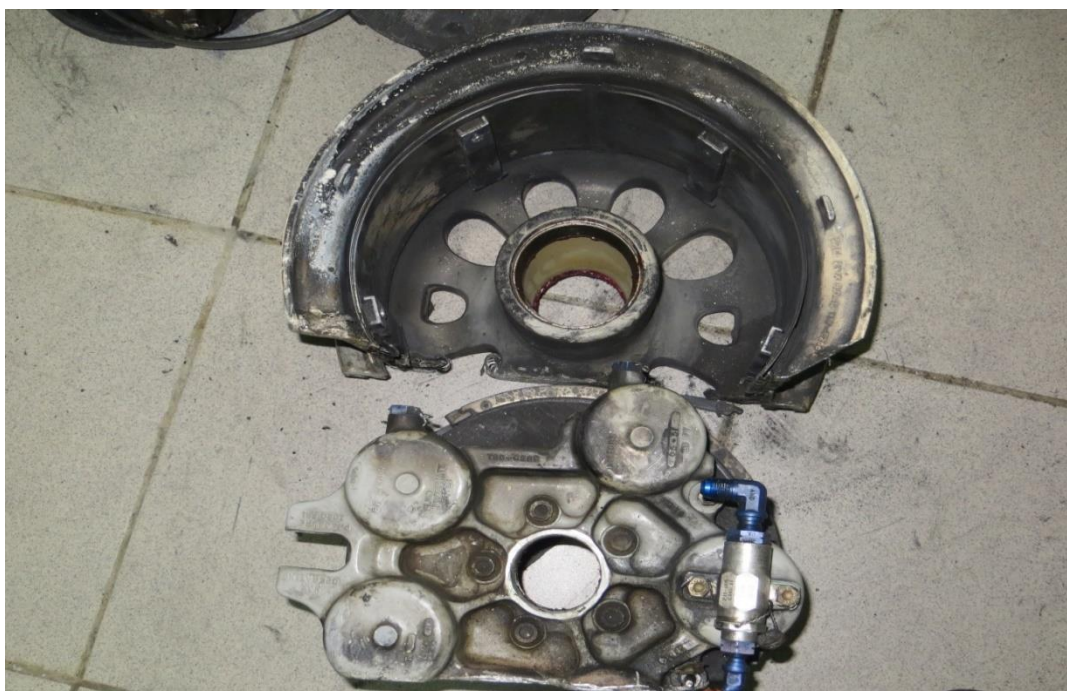
Figure 6: Damaged left main landing gear up-lock bolt

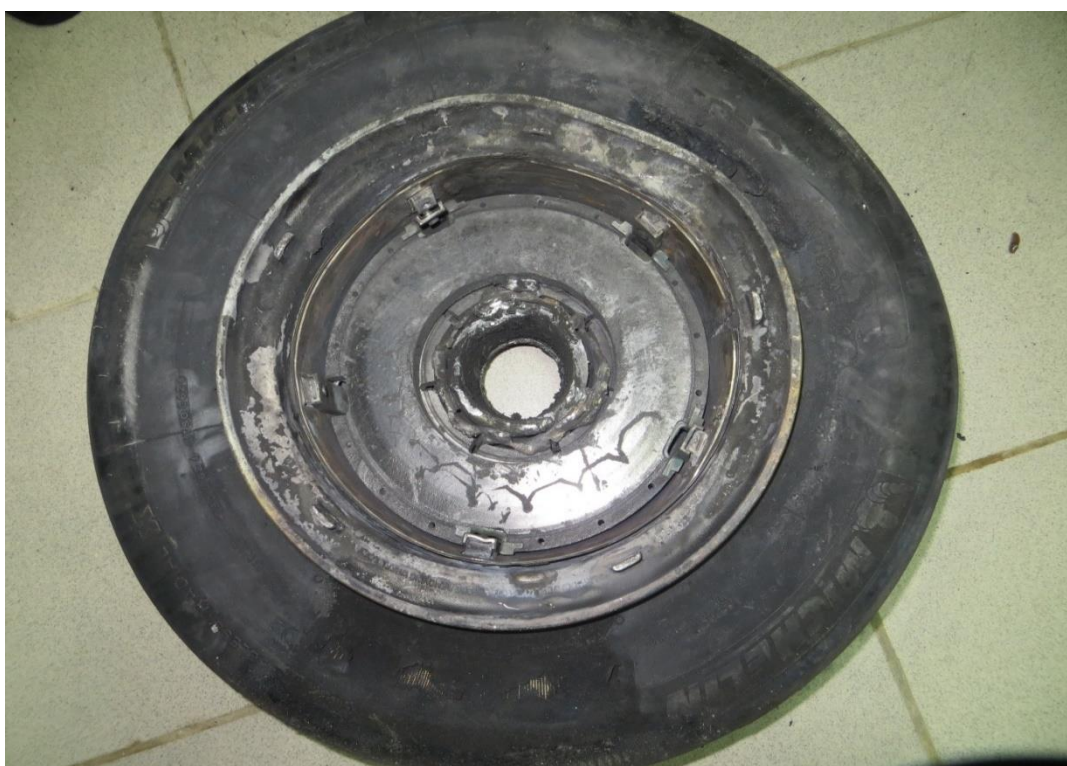
Figure 7: Damaged main landing gear wheel assembly
