AIRCRAFT ACCIDENT REPORT

MEA-TURKISH/2020/07/29/F

Accident Investigation Bureau

**Final Report on the serious incident involving Airbus 330-243 aircraft operated by Middle East Airlines with nationality and registration marks OD-MEA and a parked Boeing 777 aircraft operated by Turkish Airlines with nationality and registration marks TC-LJC which occurred at Murtala Muhammed International Airport, Lagos
On 29th July, 2020**

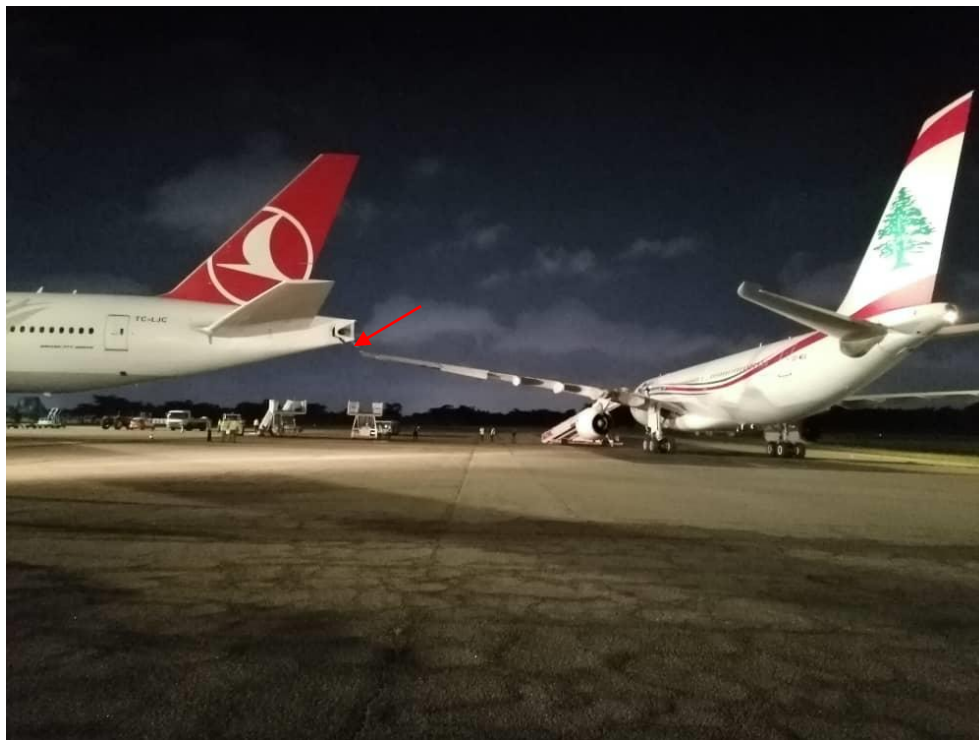
The left winglet of MEA572 impacted, cut into the APU exhaust area and damaged the right horizontal stabilizer of the parked Turkish Airlines Boeing 777-300 at bay E55 while taxiing on the Apron. The left winglet of the MEA572 Airbus 330-243 was also damaged.

Figure 3: MEA572 aircraft winglet clipped the APU exhaust of the Turkish aircraft

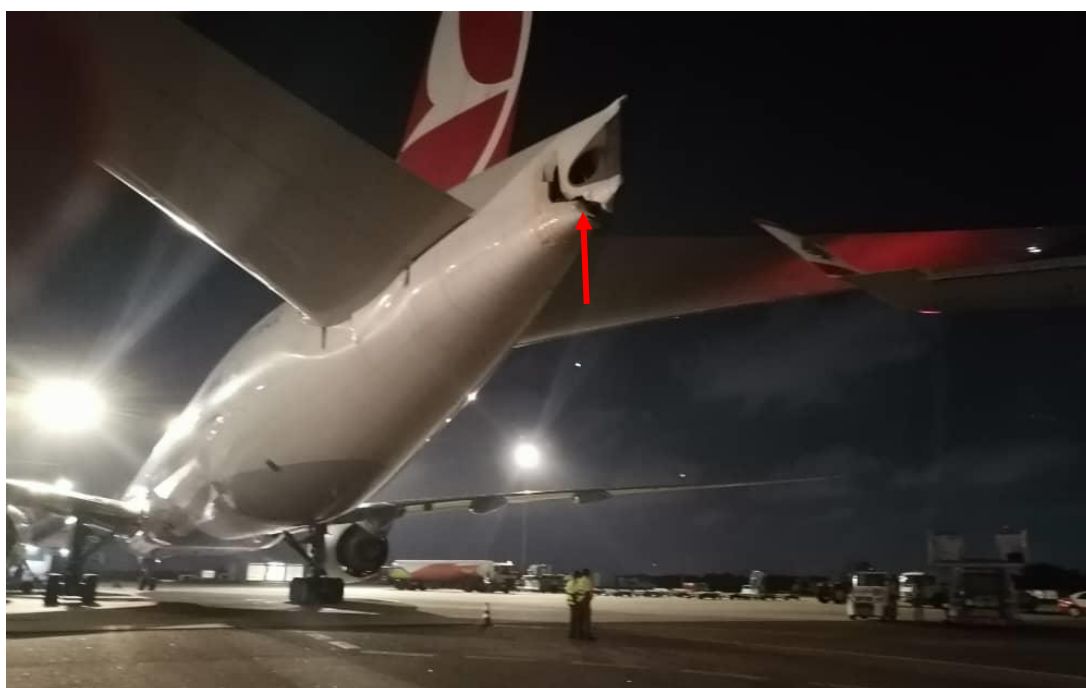
Figure 4: Damaged APU exhaust area of the Turkish Airlines aircraft

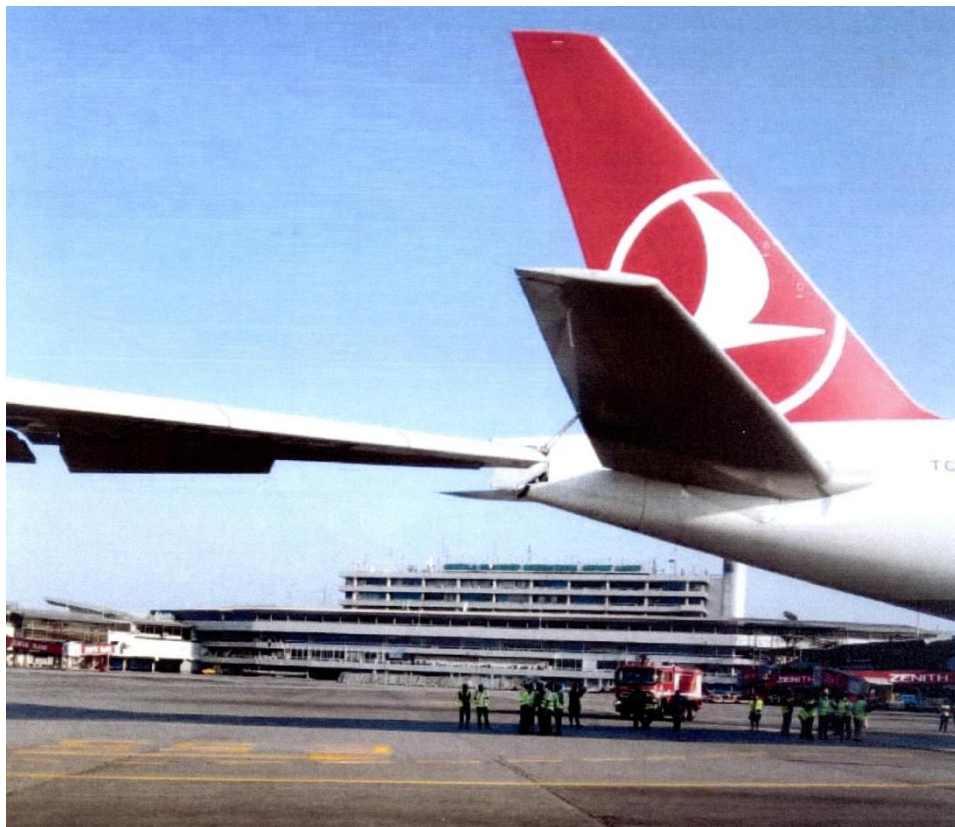
Figure 5: A close-up of the impact

However, in the process of taxiing further, the left winglet of OD-MEA impacted, cut into the APU exhaust area of TC-LJC and also damaged its horizontal stabilizer. The crew of OD-MEA should not have deviated from the leading yellow line when in doubt of safe taxiing behind the parked TC-LJC. They should have instead stopped the aircraft and requested the ATC for a wing walker or a tow truck.

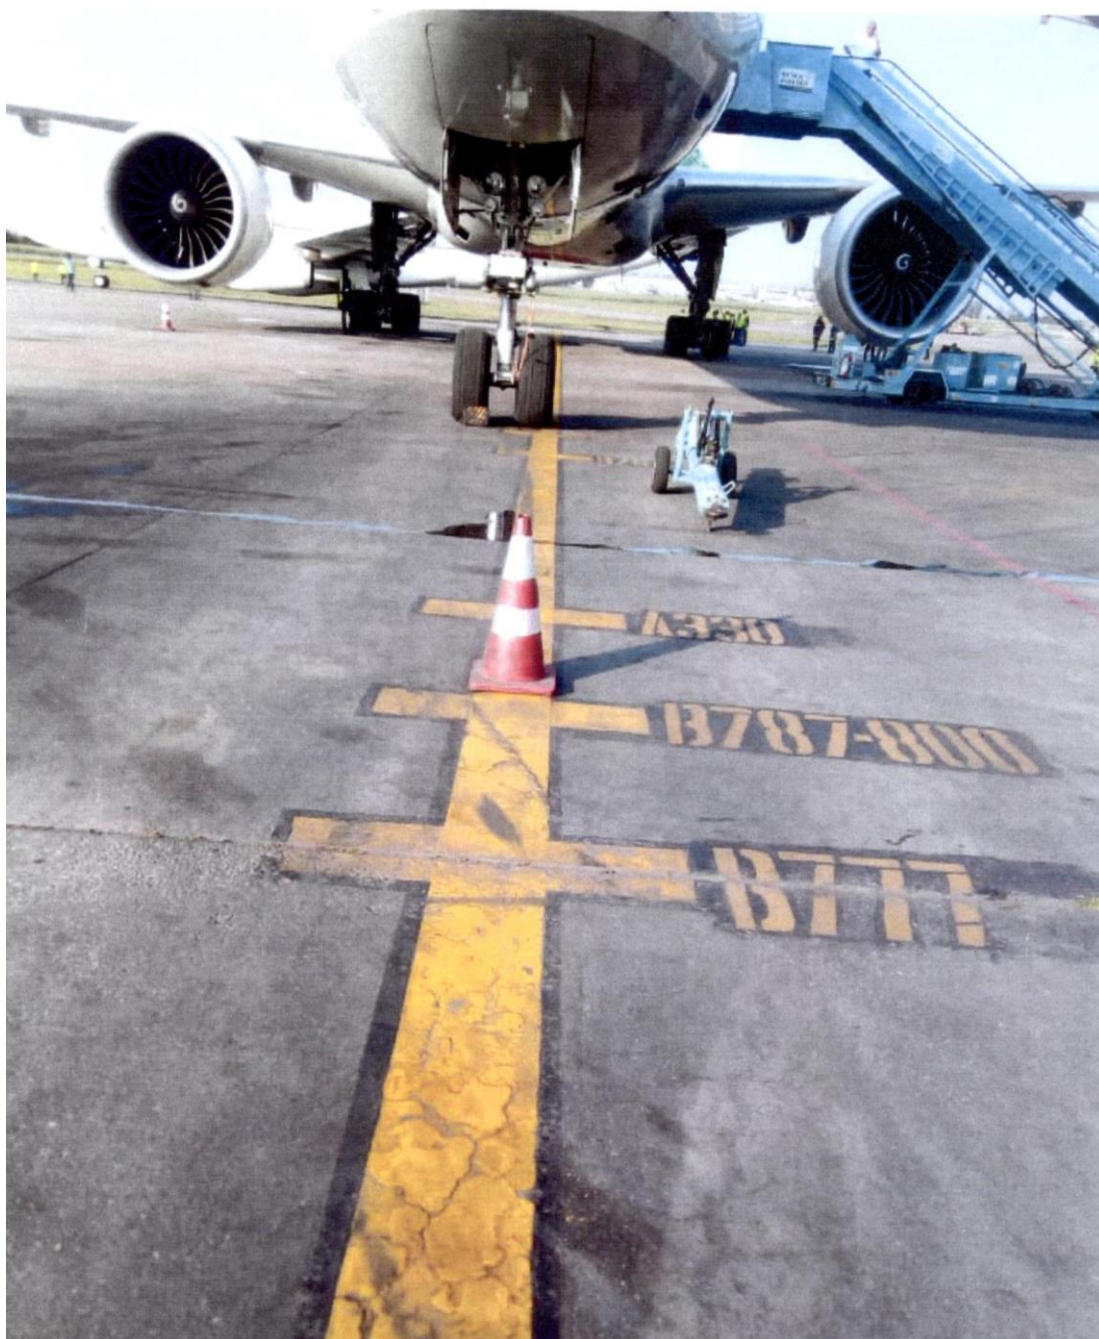
The Marshaller parked the aircraft at Bay E55 of the international Apron but stopped it before it got to the designated stop-line marking for B777 aircraft on the Apron by about 13.5 m.

Post-occurrence site inspection revealed that the aircraft tail section protruded into the taxi-way F3.

Figure 5: Turkish Airline B777-3F2ER aircraft parked at E51

However, in this case, this was not done as post incident inspection showed that TC-LJC was parked 13.5m short of the designated marking point, thereby constituting an obstacle to OD-MEA taxiing behind it.

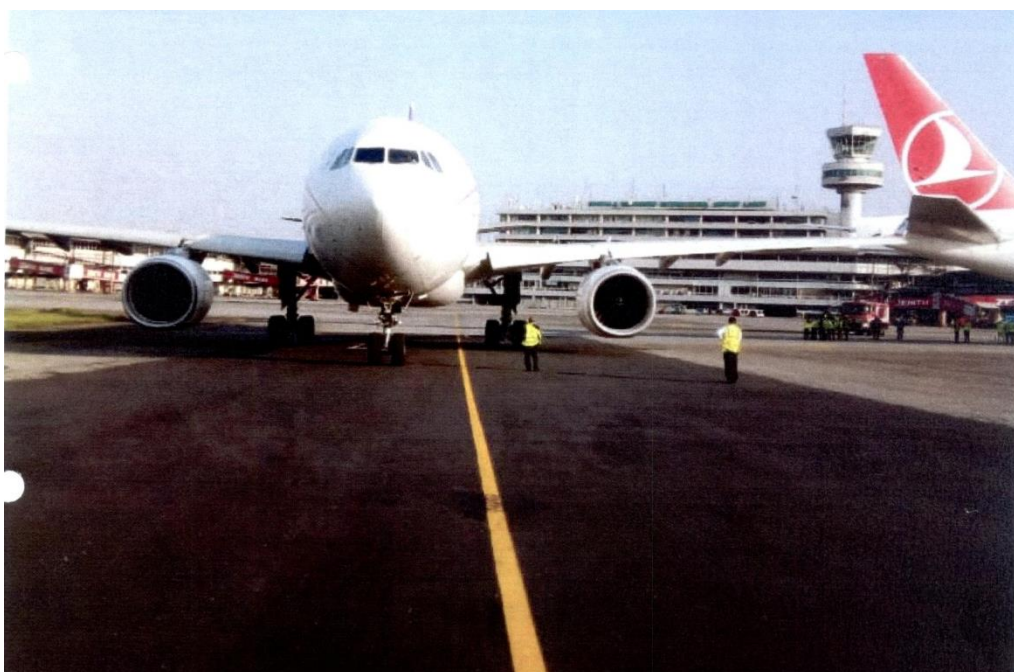
Middle East Airline aircraft, OD-MEA requested push back and start-up clearance from ATC and were granted. Afterwards, the crew requested for taxi clearance and was also granted. While taxiing out on the Apron via taxiway F3 to the holding point runway 18R, the crew noticed the parked Turkish Airline aircraft, TC-LJC with the tail section protruding into the taxiway and decided to deviate from the yellow leading line to the right by about 6.5 m in order to avoid impact.

Figure 6: The deviation of MEA572 airlines aircraft from the taxi line

11. OD-MEA maneuvered about 6.5 m right of the yellow track on the apron in an attempt to avoid collision with the stationary TC-LJC.
12. At 17:25 h, OD-MEA reported the occurrence to ATC.
13. NAHCO is the ground handling company for Turkish Airline.
