PRELIMINARY REPORT ON THE SERIOUS INCIDENT INVOLVING AN ATR 42 -320 AIRCRAFT WITH NATIONALITY AND REGISTRATION MARKS 5N-BRQ OPERATED BY OVERLAND AIRWAYS LIMITED WHICH OCCURRED AT SHORT FINAL, RUNWAY 18R, MURTALA MUHAMMED AIRPORT, LAGOS ON 15TH JUNE, 2022

Registered owner and operator:	Overland Airways Limited
Aircraft type and model:	ATR 42 - 320
Manufacturer:	Avions De Transport Regional, Toulouse, France
Year of manufacture:	1994
Nationality and registration marks:	5N-BRQ
Serial number:	351
Location:	Short Final, Runway 18R, Murtala Muhammed Airport
Date and time:	15 th June, 2022 at about 19:43 h

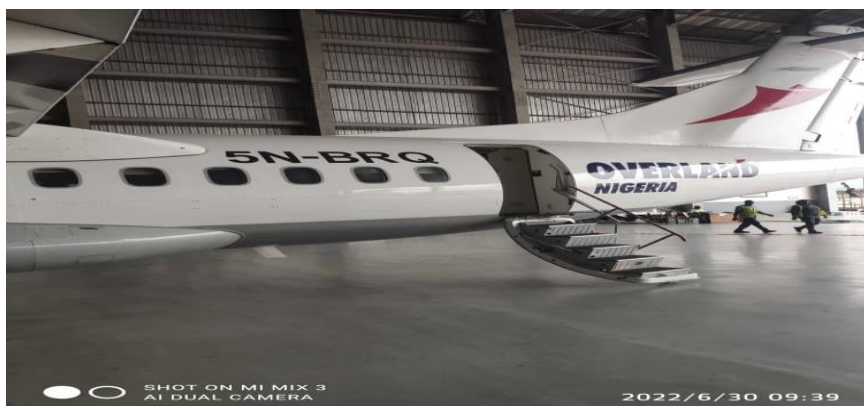
5N-BRQ parked at the Overland Airways Limited Hangar after the occurrence

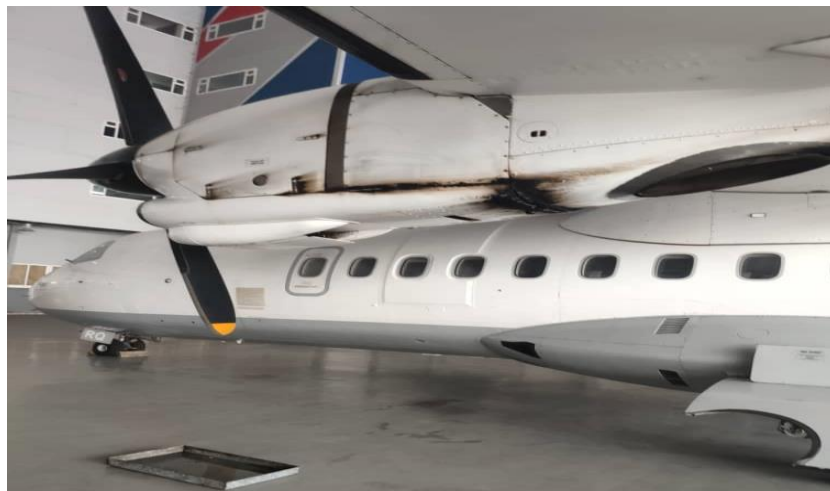
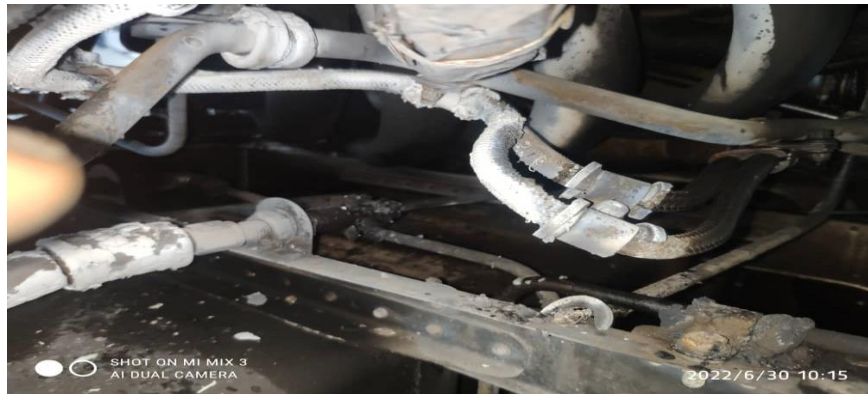
1.12 Wreckage and impact information

Photos showing severe fire damage to the left engine

There was fire on engine number 1 prior to landing.
