5N-MJQ

Preliminary Report on ground collision between a conveyor belt TUG660 truck with fleet number 49/9 operated by Skyway Aviation Handling Company (SAHCO) Plc and a parked Boeing 737-700 aircraft with nationality and registration marks 5N-MJQ owned and operated by Arik Air Limited which occurred at Nnamdi Azikiwe International Airport Abuja on 3rd February, 2022.

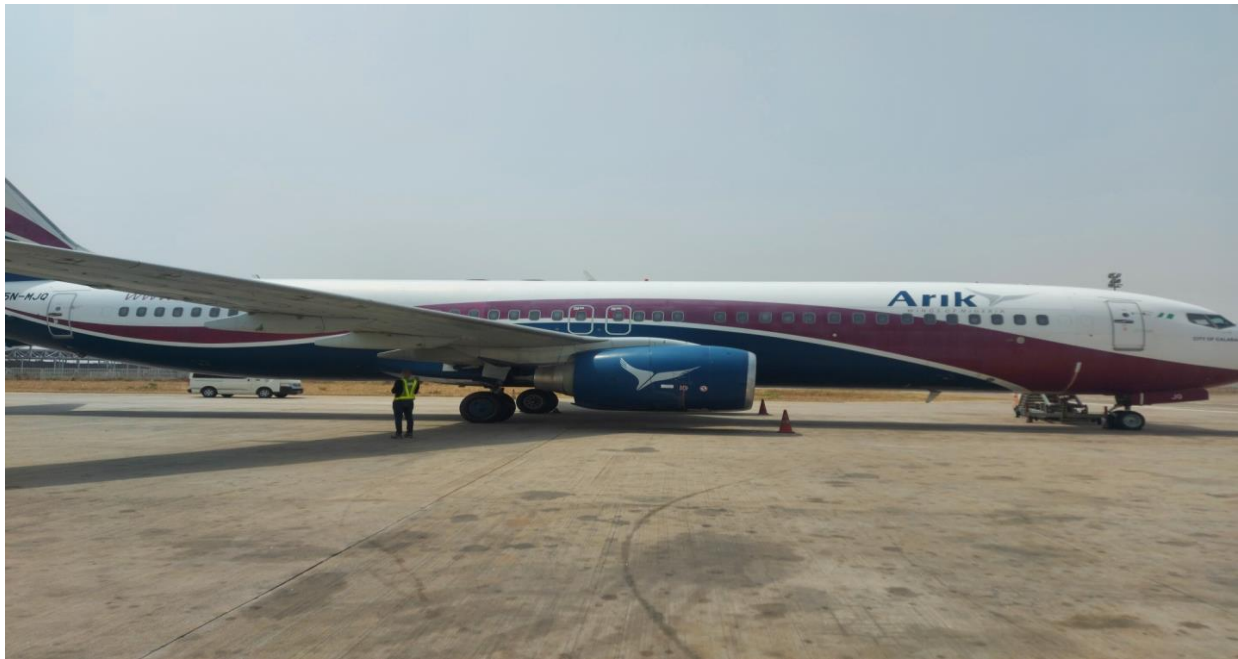
Figure 1: Parked Arik Air Boeing 737-700 after the occurrence

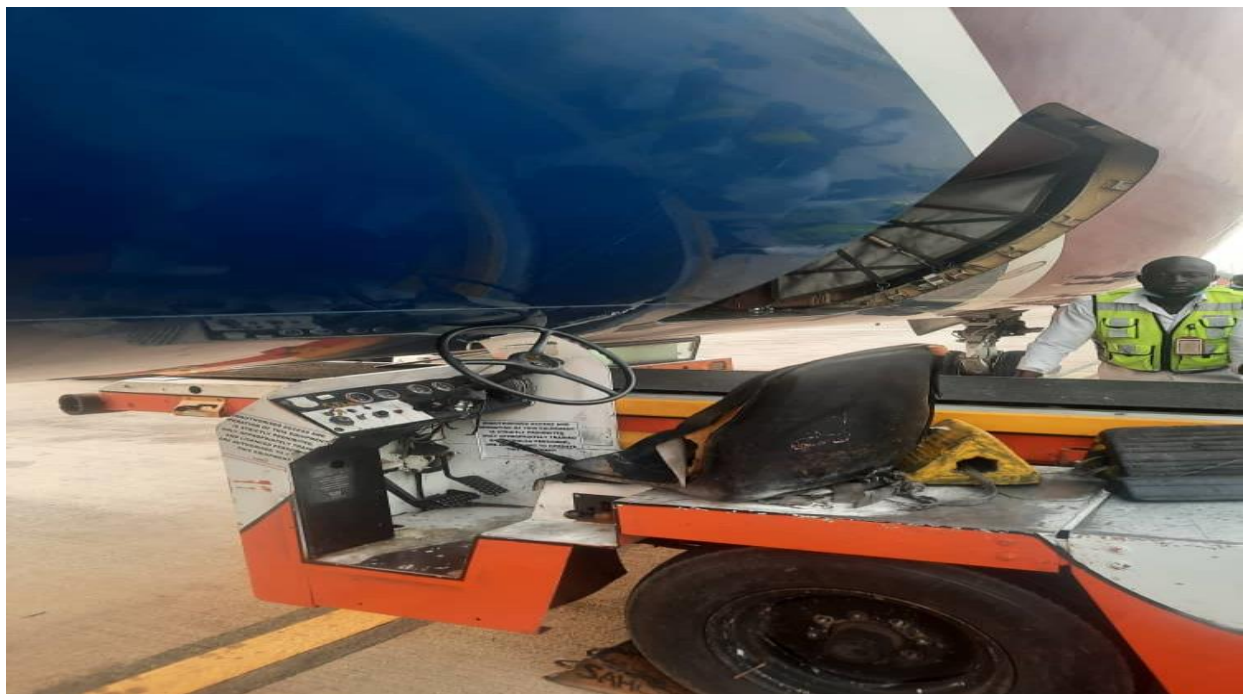
**Figure 2: The conveyor belt truck still under the aircraft after the occurrence
(Picture taken by the crew)**

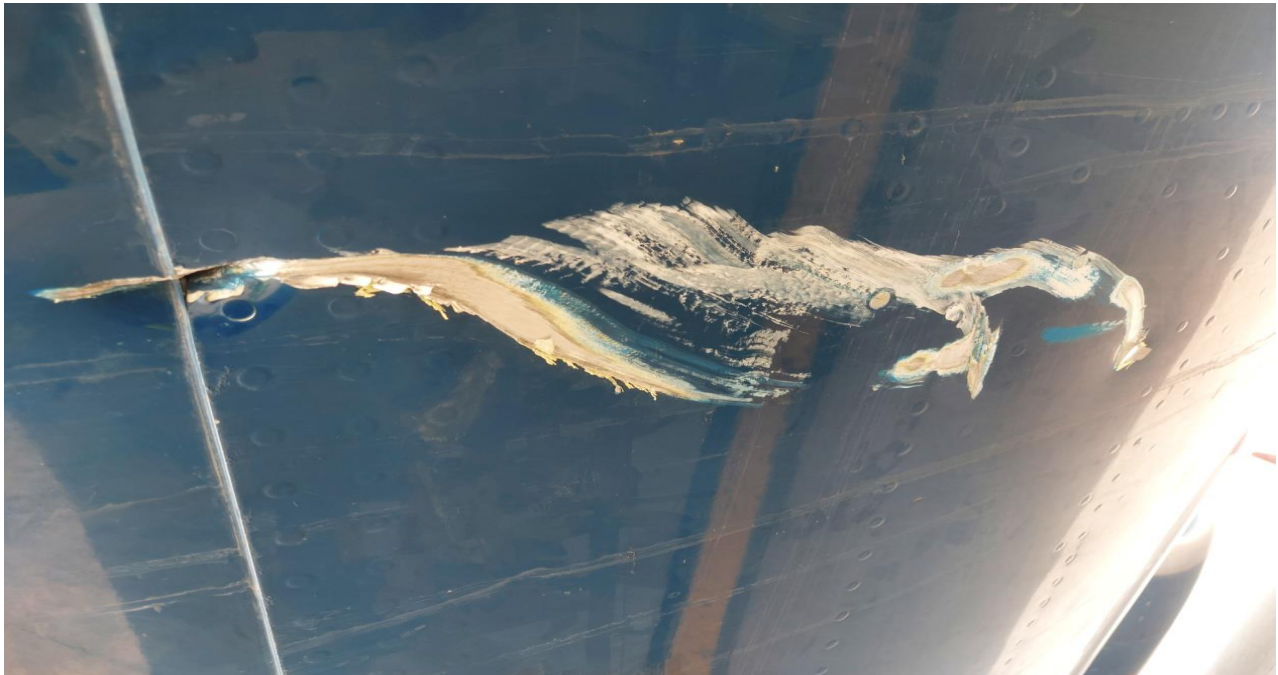
The aircraft was mainly in one piece, the right hand VHF antennae was broken and the fuselage of the aircraft was punctured.

- i. Right hand VHF antennae
- ii. Punctured fuselage underneath the aircraft towards the forward cargo hold

Figure 3: Puncture to the fuselage of the Arik air aircraft (a pressurised section of the aircraft)

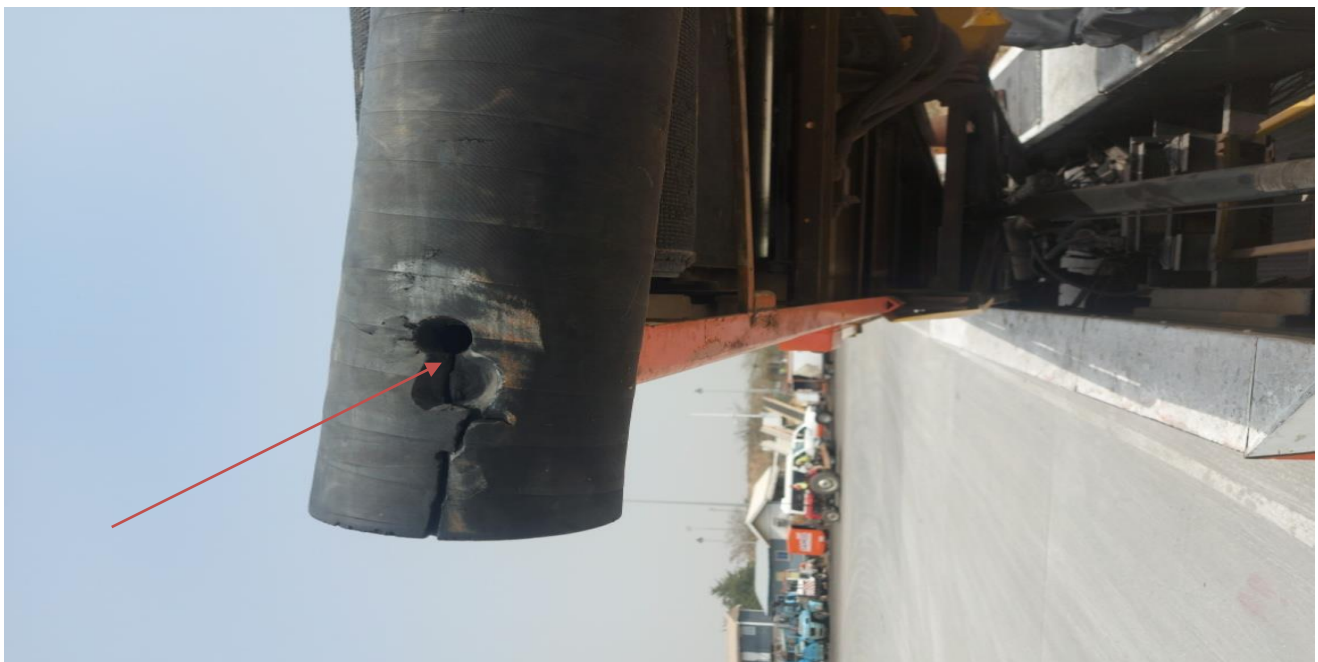
Figure 4: point of the conveyor belt that hit the aircraft

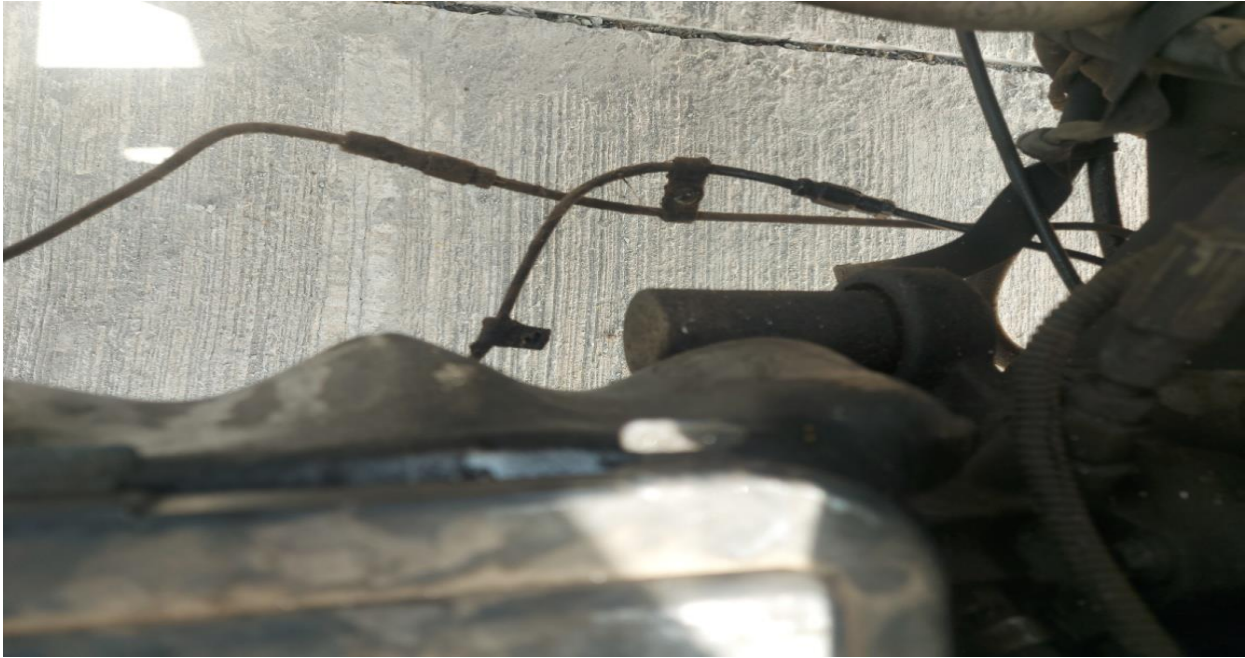
During post occurrence inspection, it was discovered that the brake was not effective (flat). On further inspection, it was discovered that one of the dual reservoir of the brake master cylinder was empty the fluid had leaked out.

Figure 5: Brake assembly of the conveyor belt truck

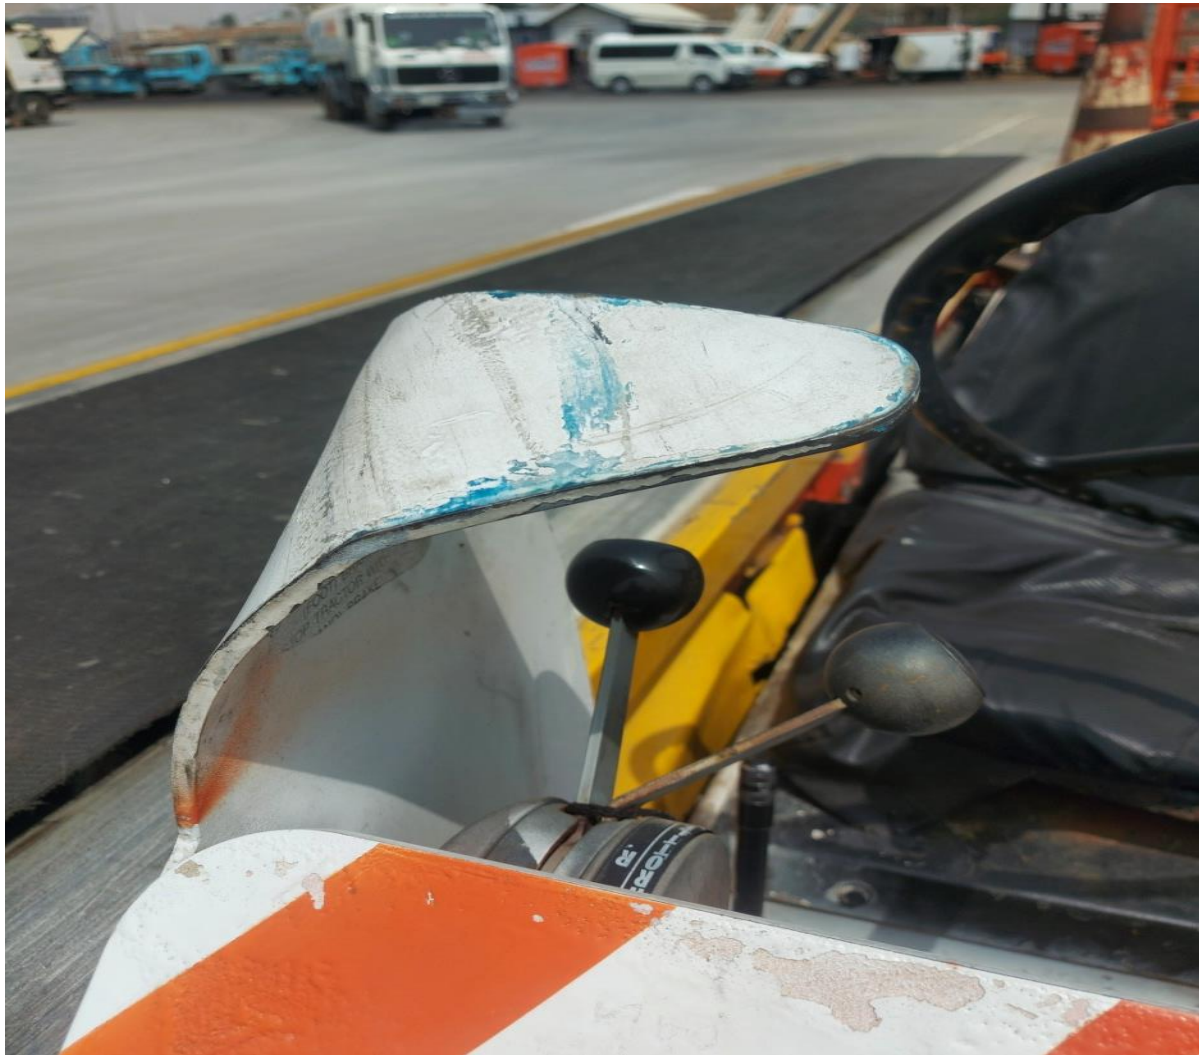
Figure 6: Head protector of the conveyor belt that punctured the fuselage of the aircraft

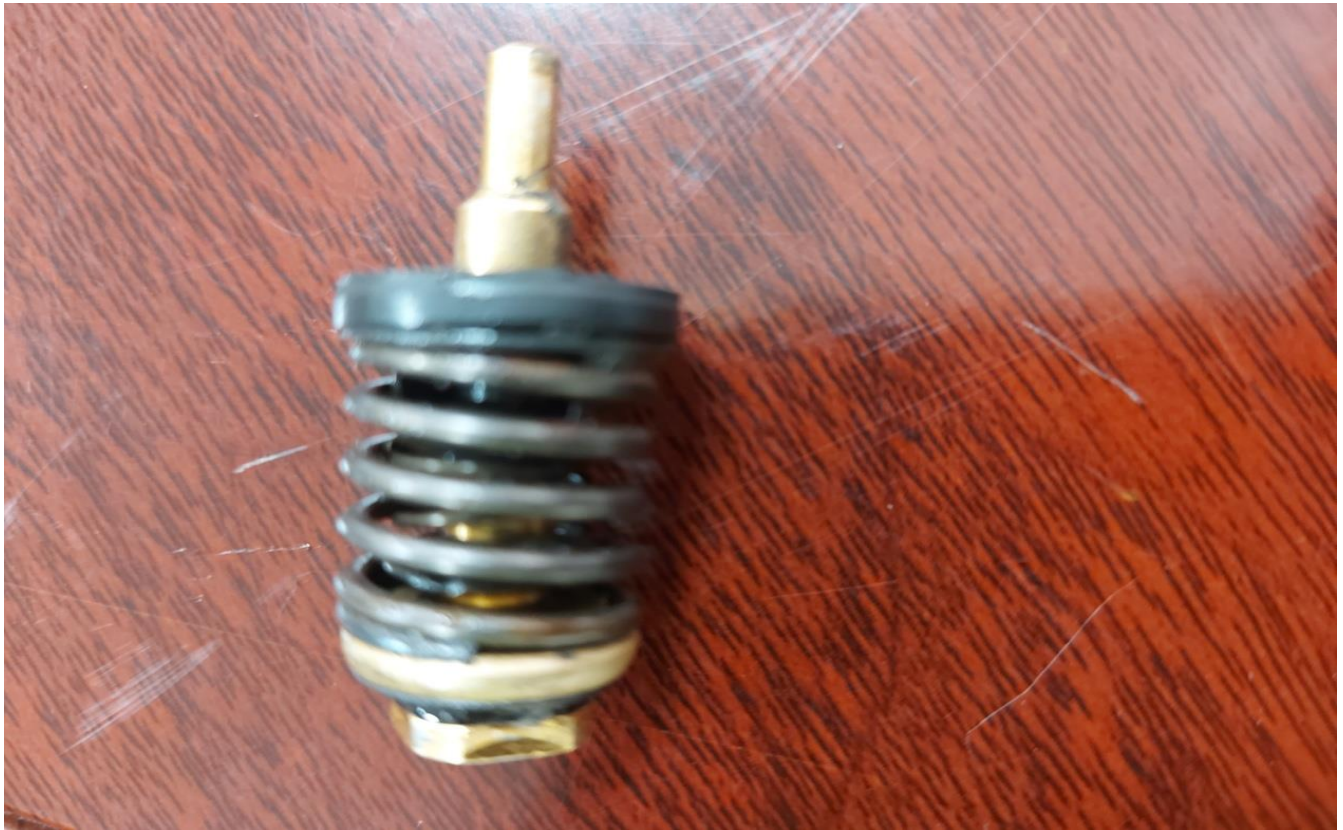
To further ascertain the source of the leakage, the brake components were screened and the leakage was traced to the brake proportioning valve. The brake component of the TUG 660 belt loader comprises of brake master, hydro booster, brake pipes, brake proportioning valve, brake callipers, brake pads, brake discs, brake drum, brake linings and wheel cylinders. The brake system is set up with brake discs in the front and brake drum in the rear.

Figure 7: Brake proportioning valve of the truck where the leakage was traced to
