**PRELIMINARY REPORT ON ACCIDENT INVOLVING A BOMBARDIER CRJ900 AIRCRAFT WITH NATIONALITY AND REGISTRATION MARKS 5N-BXR OWNED AND OPERATED BY FLYFORVALUE AVIATION LIMITED AT PORT HARCOURT INTL. AIRPORT, RIVERS STATE ON 14TH NOVEMBER 2023**

<b>Registered owner and operator:</b>	Flyforvalue Aviation Limited (Value Jet)
<b>Aircraft type and model:</b>	Bombardier CRJ900
<b>Manufacturer:</b>	Mitsubishi Heavy Industries Ltd.
<b>Date of manufacture:</b>	2006
<b>Nationality and registration marks:</b>	5N-BXR
<b>Serial number:</b>	15065
<b>Location:</b>	Grass verge adjacent Link A5, Runway 21, Port Harcourt Airport, Rivers state
<b>Date and time:</b>	14th November 2023 at about 15:18 h

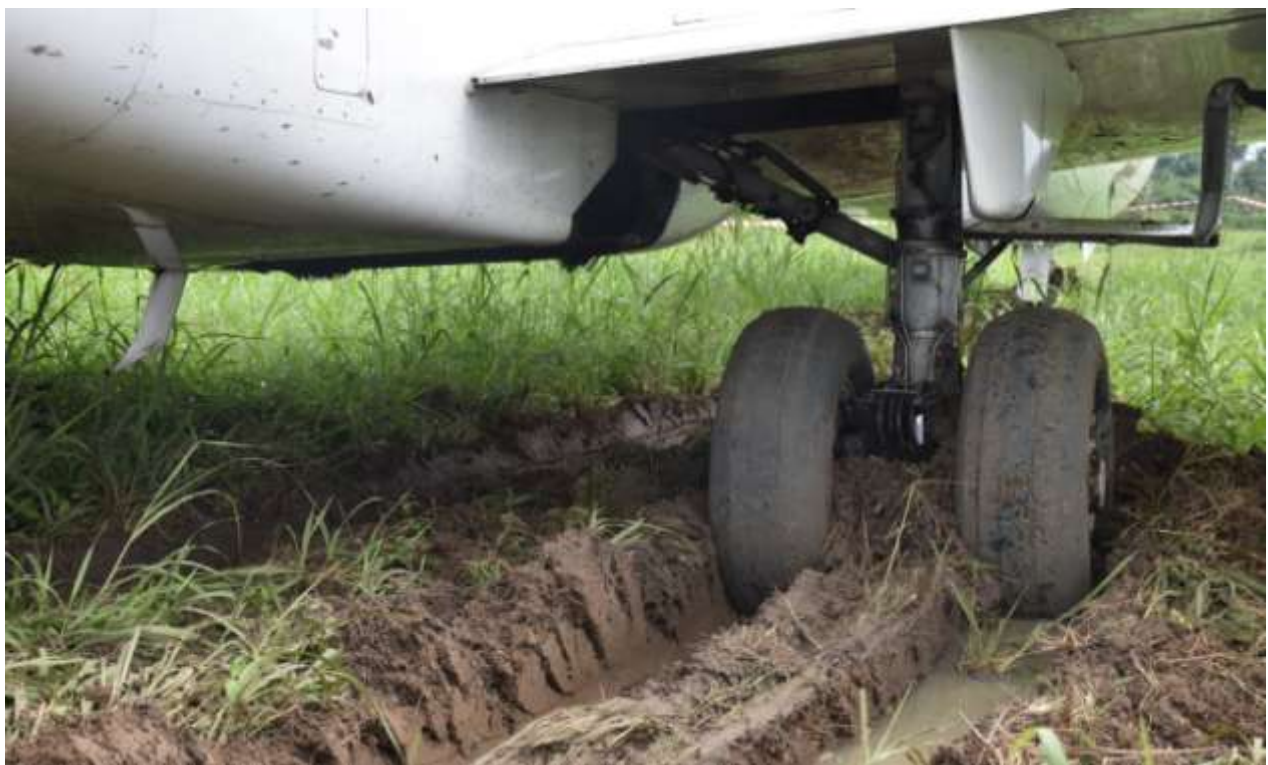
The extent of damage is yet to be determined. However, all landing gear particularly the nose wheel were embedded in mud.

**Figure 1: Some views of the aircraft landing gear where it stopped**

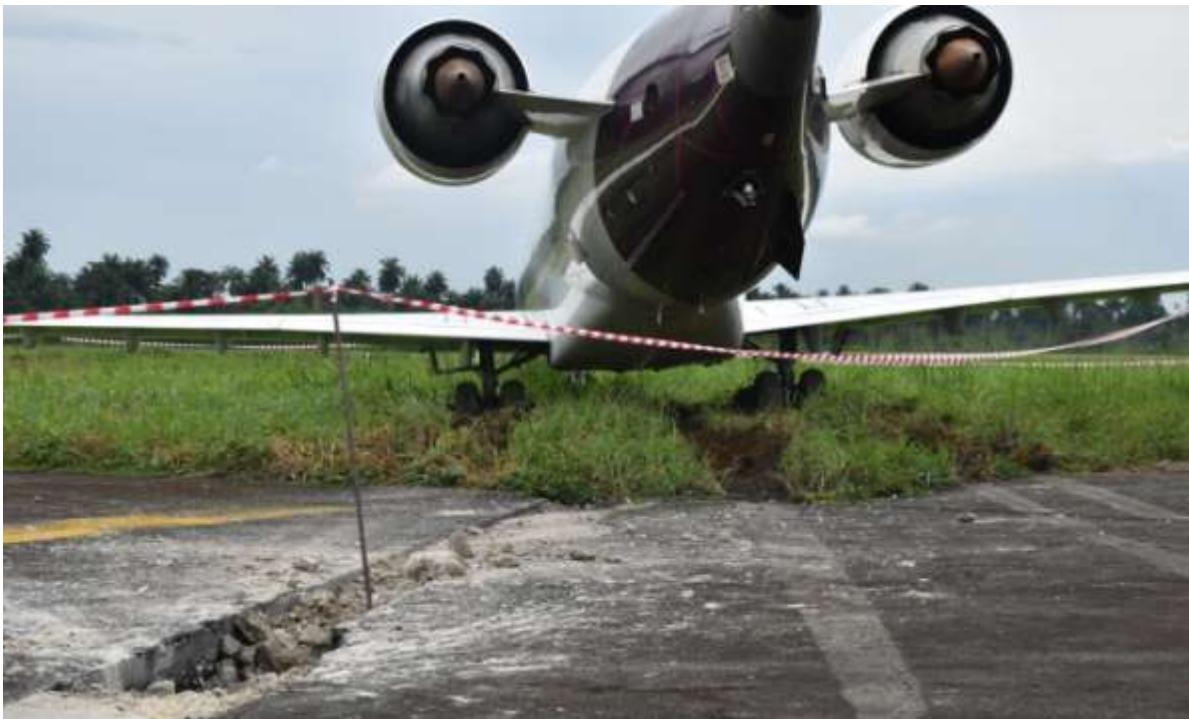
A drainage channel at the end of runway 21 was damaged where the aircraft crossed it en route the grass verge adjacent Link A5.

Tyre marks on the runway leading to the final position of the aircraft showed that the aircraft impacted and damaged a drainage duct and uprooted some embedded power cables.

**Figure 2: The damaged drainage duct (In the foreground)**
