## **PRELIMINARY REPORT ON A SERIOUS INCIDENT INVOLVING A LEONARDO S.p.A AW139 AIRCRAFT WITH NATIONALITY AND REGISTRATION MARKS 5N-BSG OPERATED BY CAVERTON HELICOPTERS LIMITED, ENROUTE BONGA FPSO ON 20TH JANUARY 2024**

<b>Registered owner:</b>	TVPX Aircraft Solutions Inc.
<b>Registered operator:</b>	Caverton Helicopters Limited
<b>Aircraft type and model:</b>	AW139
<b>Manufacturer:</b>	Leonardo S.p.A, Italy
<b>Year of manufacture:</b>	2014
<b>Nationality and registration marks:</b>	5N-BSG
<b>Serial number:</b>	41360
<b>Location:</b>	Enroute Bonga FPSO, Radial 152°, 80 NM (Coordinates 5°17.87' N, 4°8.43' E, 11.95 NM WSW ERHA <sup>1</sup> )
<b>Date and time:</b>	20 January 2024 at about 08:40 h All times in this report are local time (UTC +1) unless otherwise stated

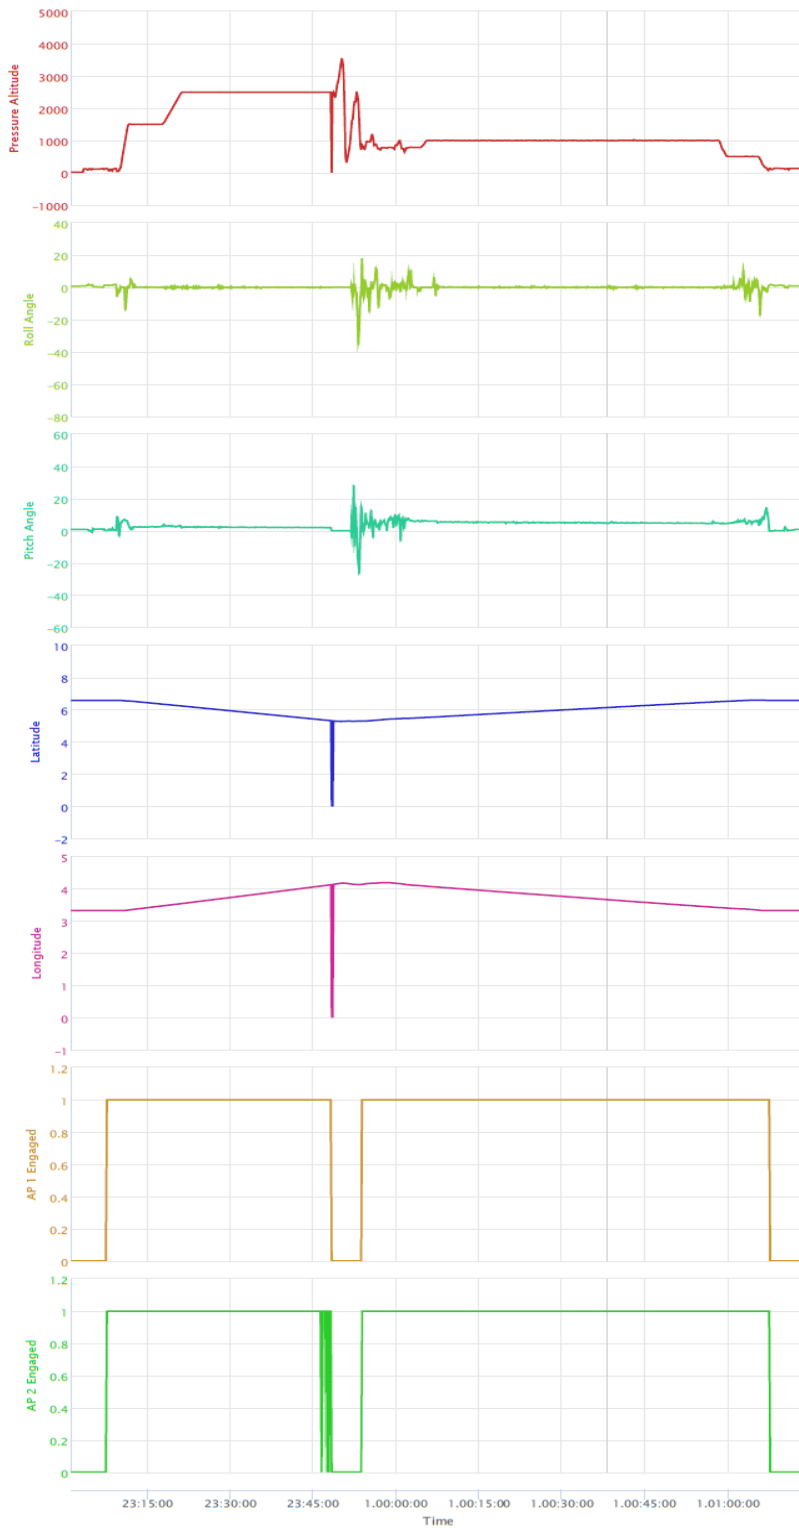
According to FDR data, simultaneous with the attempts to re-engage the AFCS, the aircraft climbed to about 3,500 ft within a period of 1 min and 40 s, followed by a rapid descent to 330 ft in 45 s. FDR shows that the aircraft commenced another climb to 2,500 ft in the next 2 mins within which period, several pitch and roll control inputs were recorded; pitch angle varied between 28° pitch up and 12° pitch down before a maximum

25° pitch down motion was recorded, simultaneous with the maximum recorded roll angle of 37° to the right.

Some flight data recorder parameters were analysed as contained in the plots below.

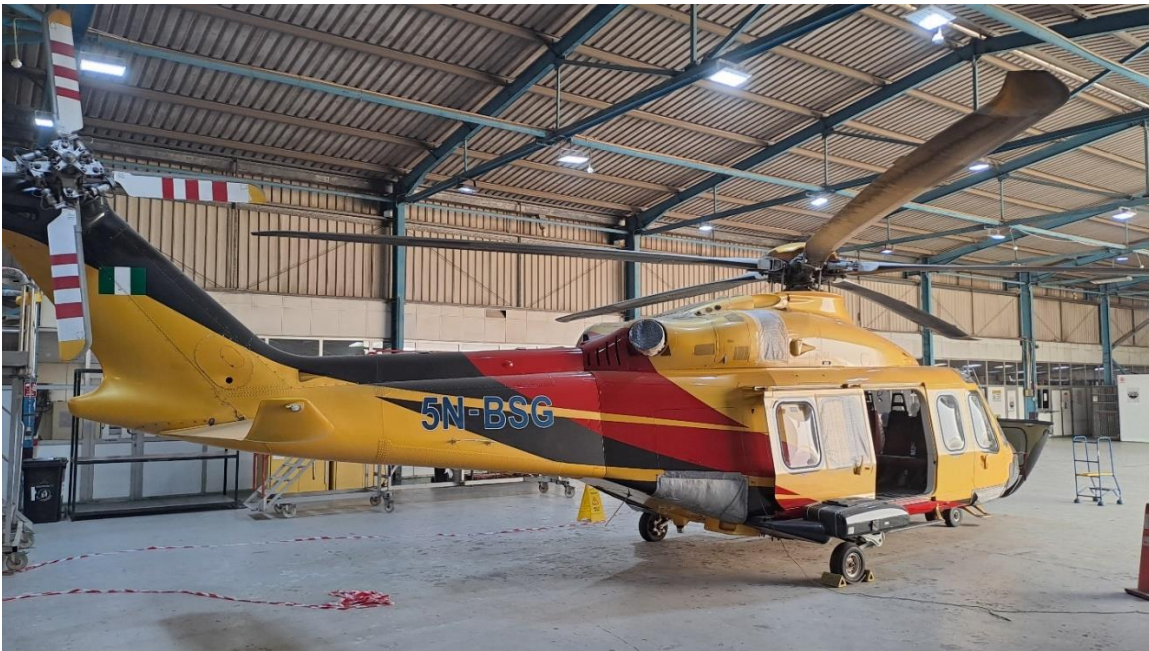
**Figure 1: The aircraft parked in the hangar after the occurrence**

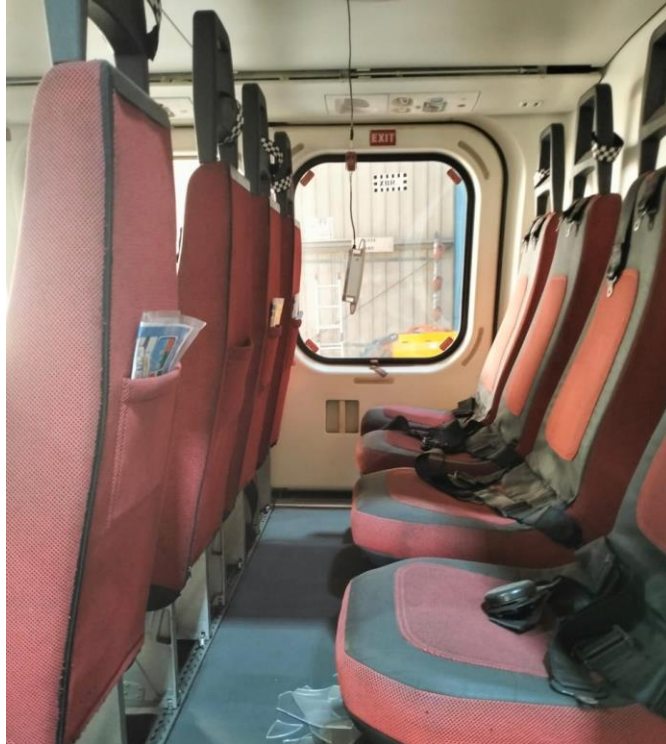
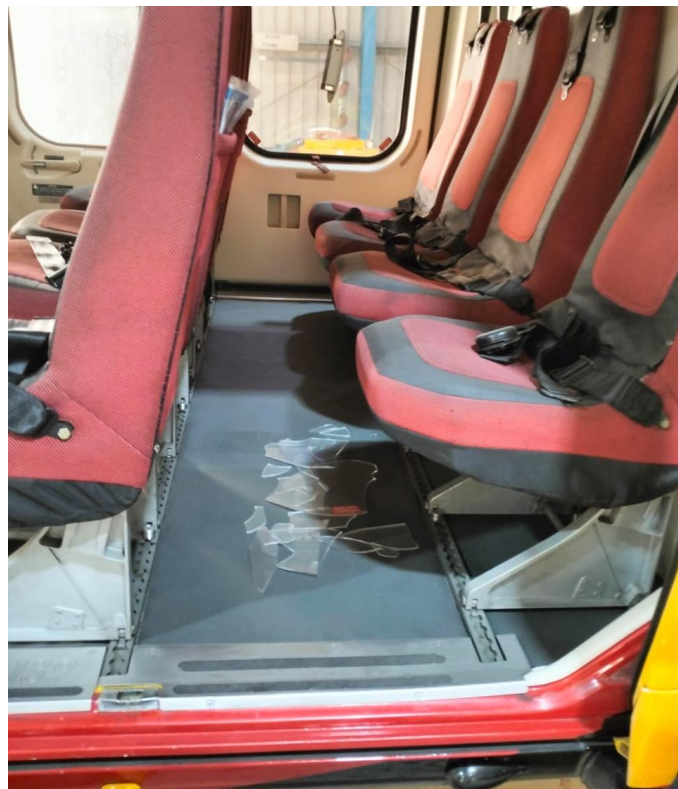
1. Two cabin windows were blown out in flight, and missing on ground.
2. Debris from a broken third window was found in the cabin.
3. A main rotor blade had a broken glass shrapnel stuck to the blade root.
4. The main rotor lightning conductor was broken.
5. A cabin light lens and transparent light cover were broken.

**Figure 2: Views of the cabin post occurrence showing some damage**
