**PRELIMINARY REPORT ON SERIOUS INCIDENT INVOLVING CHALLENGER 601-3R AIRCRAFT OWNED AND OPERATED BY MATTINI AIRLINE SERVICES LTD. WITH NATIONALITY AND REGISTRATION MARKS N580KR WHICH OCCURRED AT IBADAN AIRPORT, OYO STATE ON 26TH JANUARY, 2024**

<b>Registered owner and operator:</b>	Mattini Airline Services Ltd.
<b>Aircraft type and model:</b>	Challenger 601 – 3R
<b>Manufacturer:</b>	Bombardier Inc.
<b>Date of manufacture:</b>	1994
<b>Nationality and registration marks:</b>	N580KR
<b>Serial number:</b>	5148
<b>Location:</b>	Clearway, N07 <sup>0</sup> 21' 00", E003 <sup>0</sup> 58' 12" about 236 m from the end of Runway 22, Ibadan Airport, Oyo state
<b>Date and time:</b>	26th January 2024 at about 11:55 h

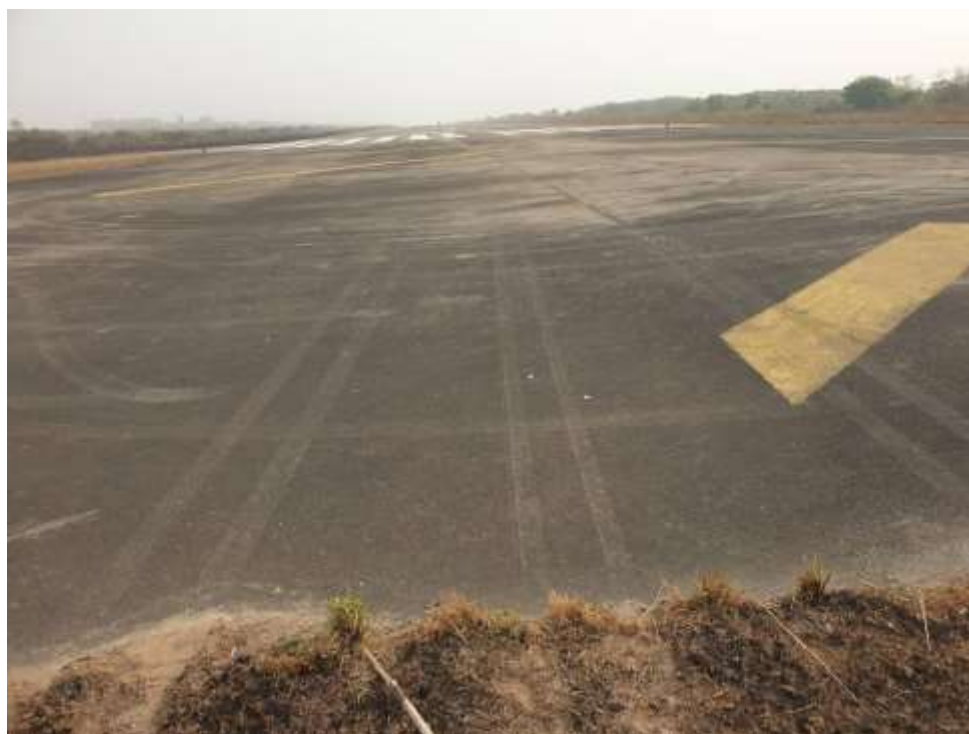
Conspicuous tyre marks were observed at a distance of about 214 metres to the end of runway 22. Shortly after, the aircraft started veering to the right in order to avoid a direct collision with the approach lights on runway 04.

**Figure 1: A view of the Runway 22 End Safety Area showing the aircraft tracks**

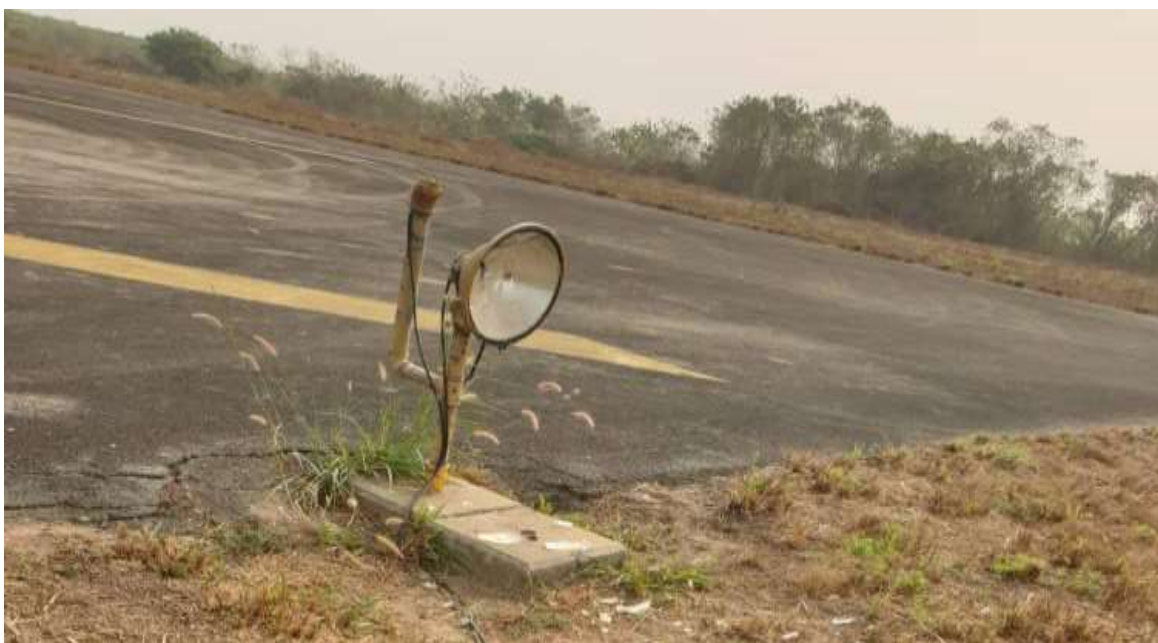
**Figure 4: Front view of the broken approach light on runway 22 end**

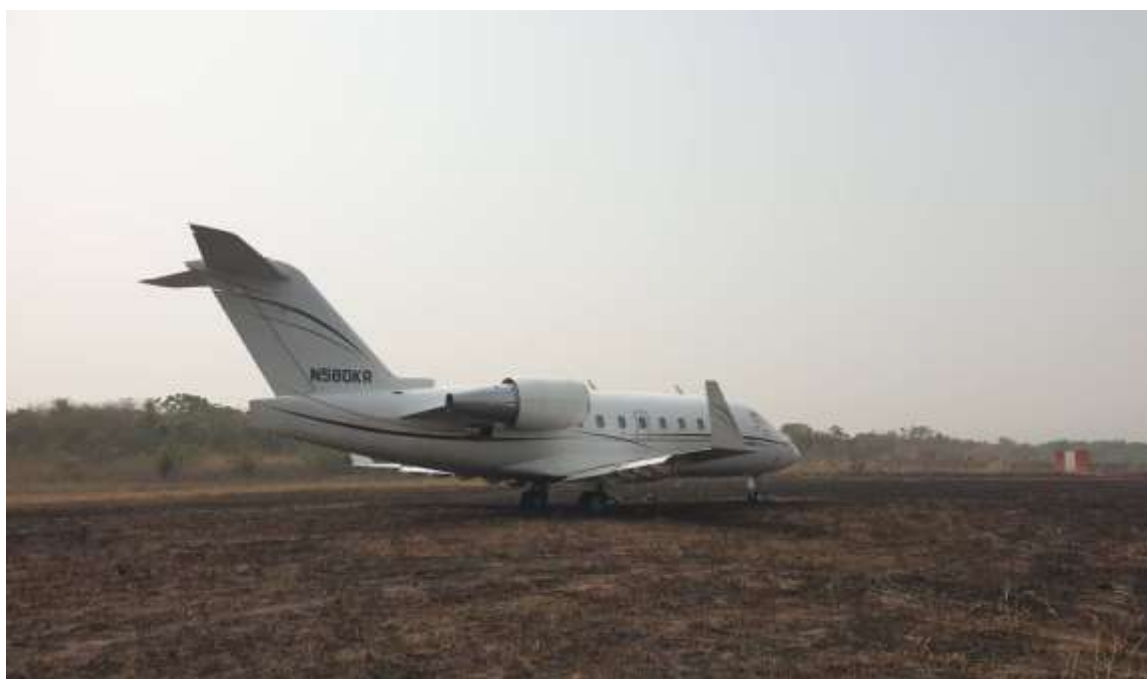
The aircraft was intact with no visible damage, except the dent on the leading edge of the left-wing.

**Figure 5: The aircraft where it stopped**

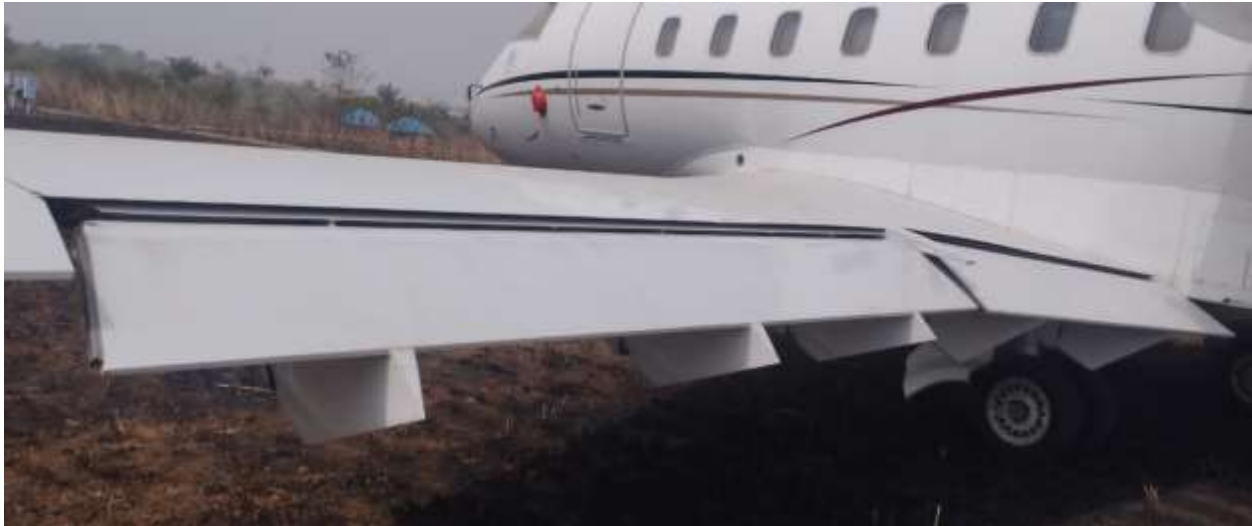
7. Post Occurrence inspection revealed that flap surface position was in agreement with the flap selector.
8. The aircraft had a valid Certificate of Airworthiness.

**Figure 6: The left-wing Flap surface position on landing**

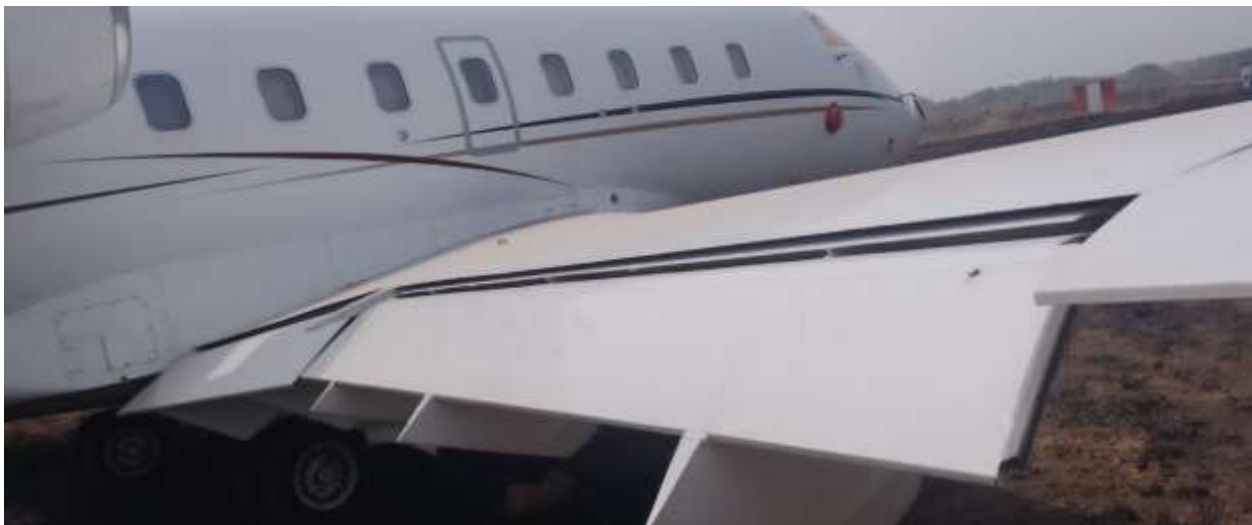
**Figure 7: The right-wing flap surface position on landing**

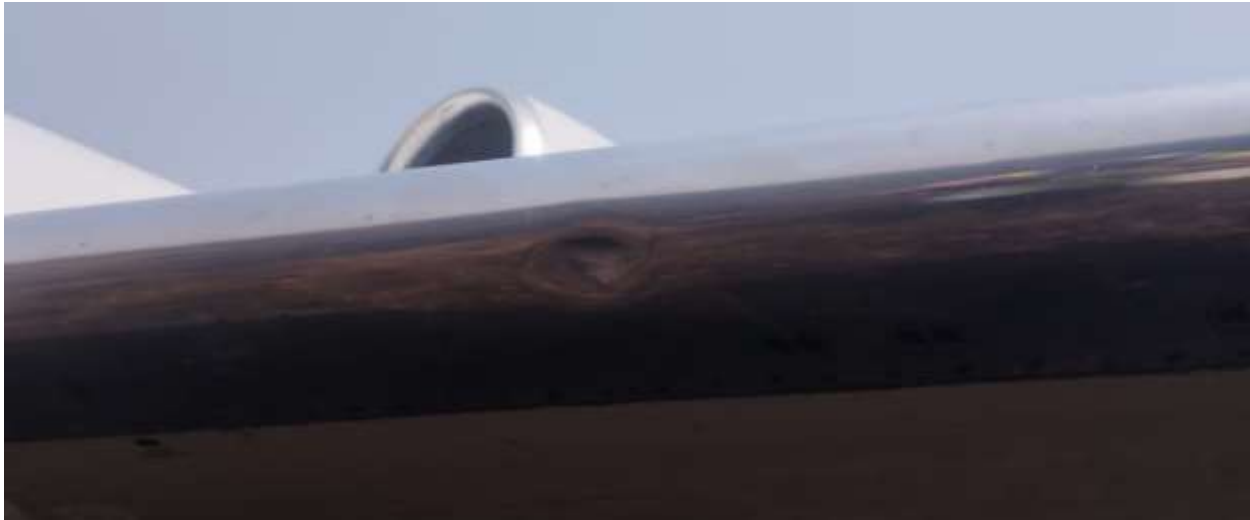
12. The mid-section of the left-wing leading edge impacted one approach light.
13. One of the approach lights was broken and a dent with dimension (2x1.5x.25 inches) was produced on the leading edge surface.

**Figure 8: Dent created about the mid-section of left wing leading edge surface**

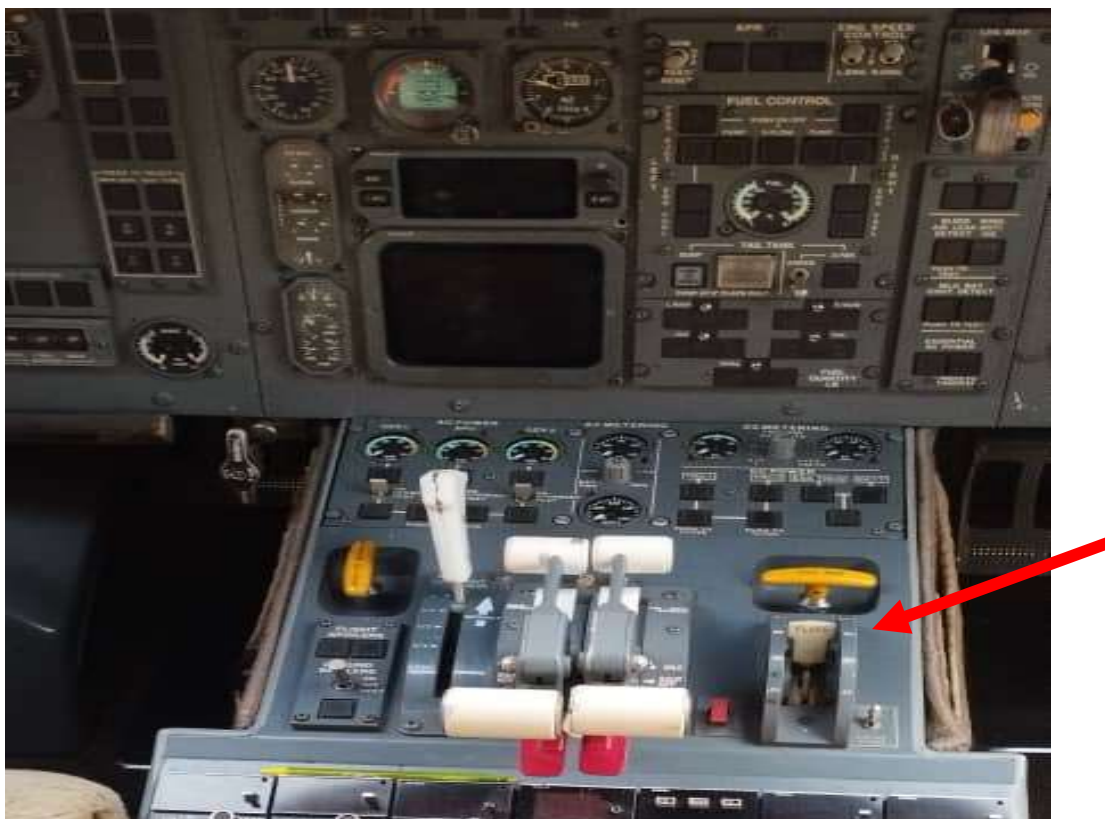
5. The crew stated that the flap selector was stuck at 20<sup>0</sup> detent after the aircraft has been configured for landing during the approach.
6. The crew did not report the flaps failure to the ATC.

**Figure 9: Flap handle Selector position on the flight pedestal**
