**PRELIMINARY REPORT ON ACCIDENT INVOLVING HAWKER 800XP  
AIRCRAFT OPERATED BY FLINTS AERO SERVICES LTD. WITH NATIONALITY  
AND REGISTRATION MARKS 5N-AMM WHICH OCCURRED AT IBADAN  
AIRPORT, OYO STATE ON 3RD NOVEMBER, 2023**

<b>Registered owner and operator:</b>	Flints Aero Services Ltd
<b>Aircraft type and model:</b>	Hawker 800XP
<b>Manufacturer:</b>	Raytheon Aircraft Company, USA
<b>Date of manufacture:</b>	1999
<b>Nationality and registration marks:</b>	5N-AMM
<b>Serial number:</b>	258286
<b>Location:</b>	220 m short of the threshold, Runway 22, Ibadan Airport, Oyo state
<b>Date and time:</b>	3rd November 2023 at about 20:18 h

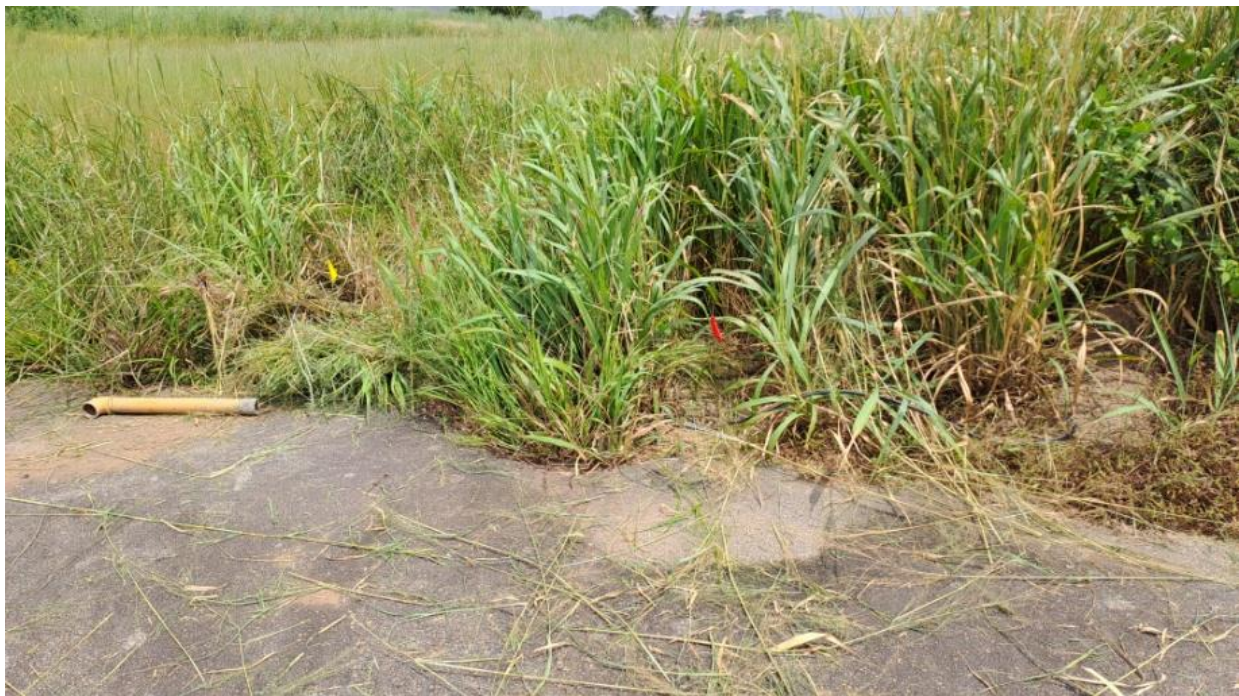
The aircraft veered right of centreline, travelling about 156 m before exiting the runway via the right runway shoulder into the grass verge. Tyre tracks indicate that number 1 tyre was deflated at some point along the aircraft's path on the runway. There was no evidence of braking action. The aircraft came to a stop a distance of about 184 m from the threshold, runway 22.

**Figure 1: A view of the aircraft tracks from the paved area**

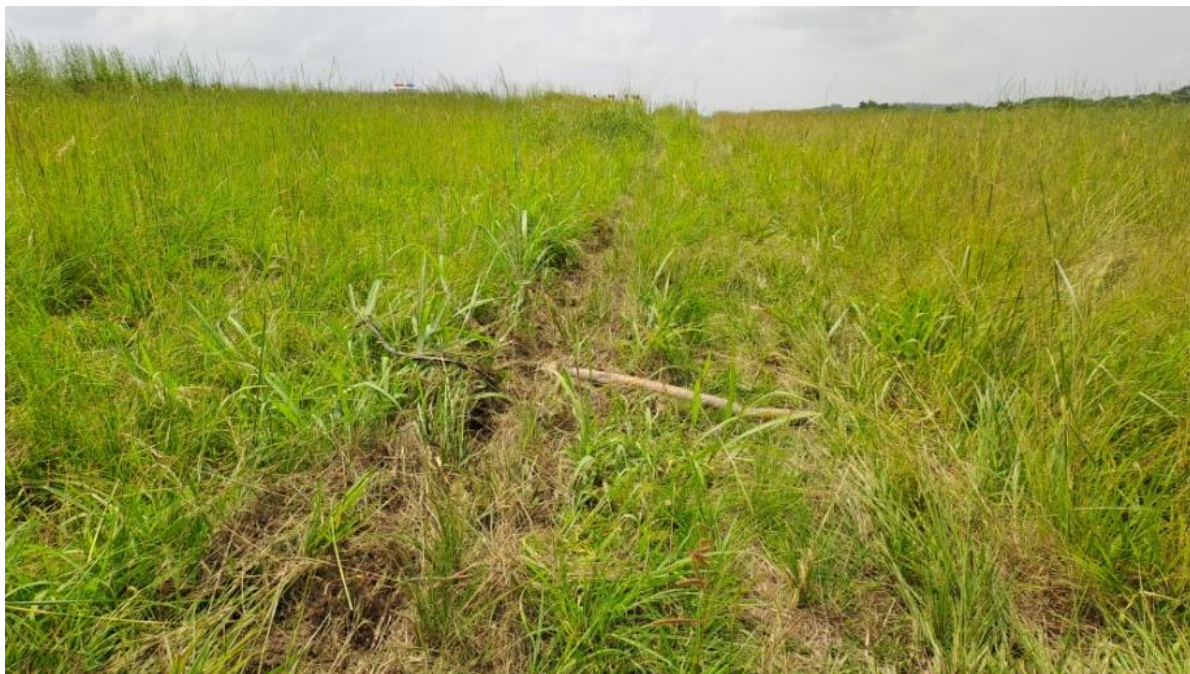
The aircraft touched down in the grass verge on the extended centreline of runway 22, about 220 m from the threshold. It travelled in a relatively straight direction through the grass verge impacting several rows of approach lights until it emerged unto the

**Figure 2: A view of the aircraft tracks from the grass verge. Runway 22 is just beyond the horizon**

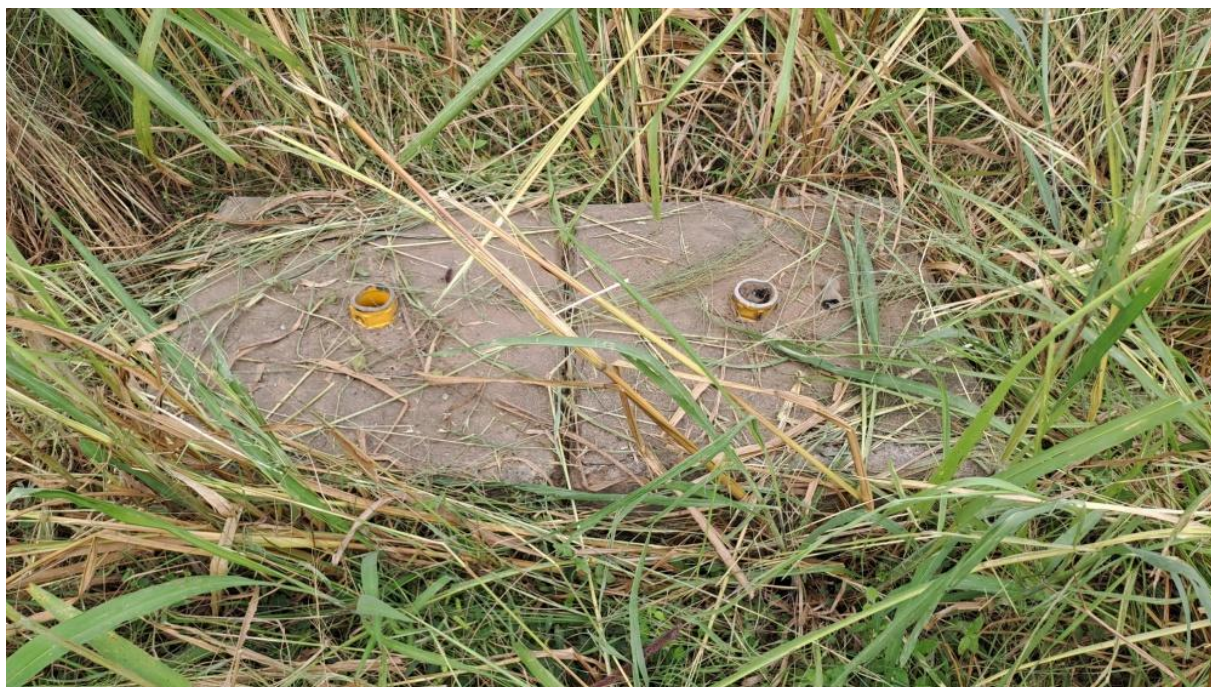
Several runway approach light fittings were destroyed on impact with the aircraft along its trajectory through the grass verge short of the runway 22 threshold.

**Figure 3: Some of the decapitated runway approach light fittings**

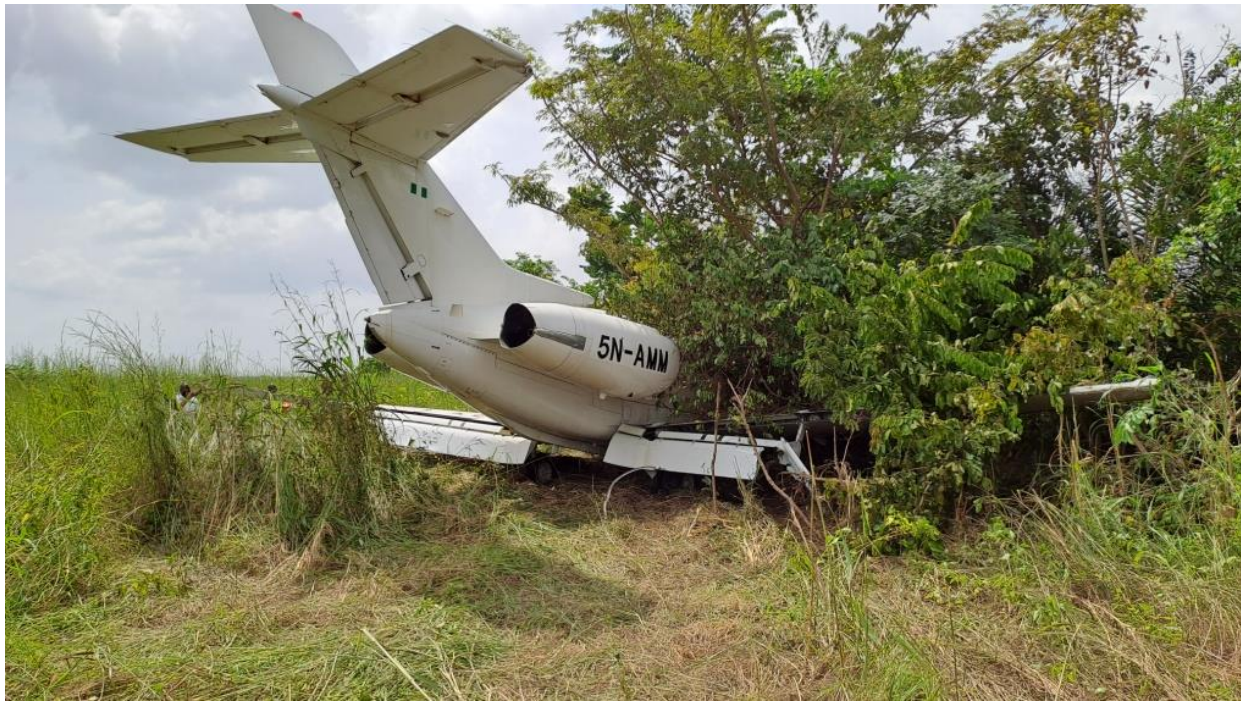
Subsequently, the aircraft entered the paved area and veered right of the centerline, runway 22. At about 156 m from the threshold, the aircraft crossed the right runway shoulder and continued into the grass verge for a distance of about 184 m before coming to a stop, partially impeded by vegetation. Number 1 tyre was found deflated and the nose landing gear collapsed.

14. There was no evidence of braking action from the tyre tracks on the runway.
15. The aircraft traveled into the grass verge a distance of about 220 m and was stopped by vegetation about 184 m from runway 22 threshold, and about 28 m beyond the right runway shoulder.

**Figure 4: The aircraft where it stopped**

1. The Nigerian Airspace Management Agency (NAMA) should ensure that it strictly observes the airport operational hours as published in the relevant Aeronautical Information Publication (AIP) and not permit extensions beyond the airport limitations.
2. The Nigerian Civil Aviation Authority (NCAA) should ensure that Flints Aero Services Limited operates within the limits of the approval given to it, in accordance with Section 18.2.4.3 of the Nigerian Civil Aviation Regulations 2015.
3. Flints Aero Services Limited should ensure that its flight crew have sufficient experience in night-time flight operations.
4. Federal Airports Authority of Nigeria (FAAN) should ensure that the overgrown grass verge on either side of runway 04/22 is immediately cleared.

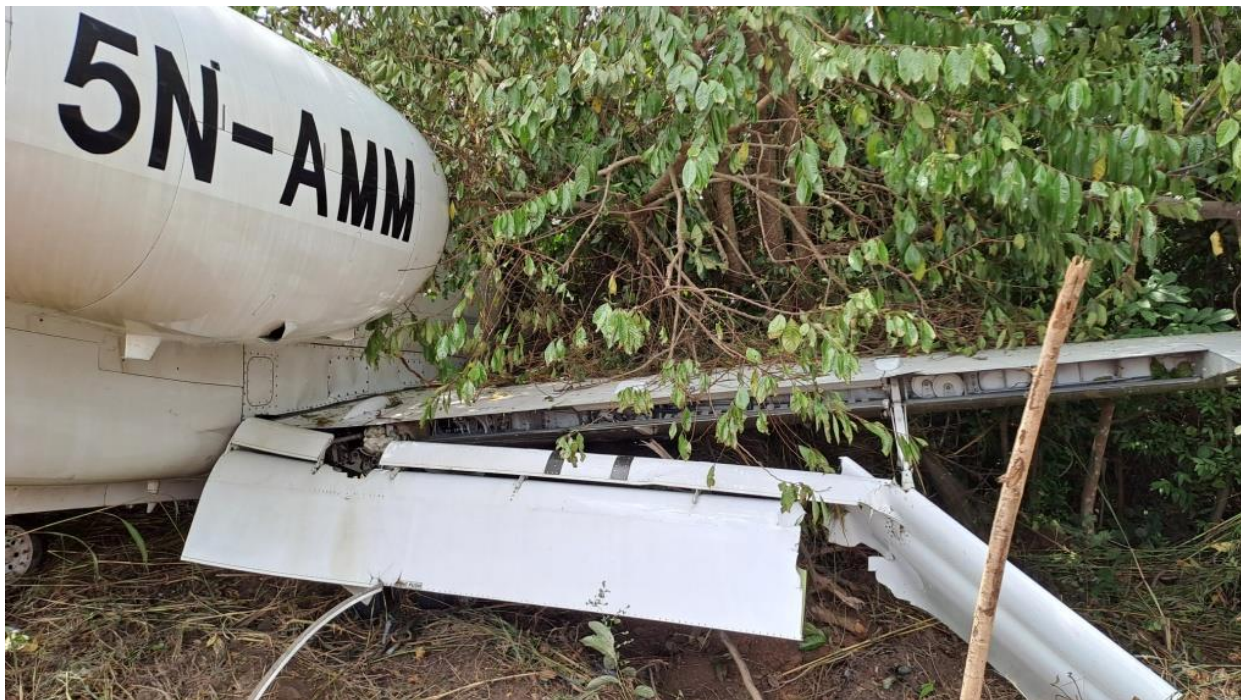
16. Post-incident inspection of the aircraft confirmed substantial damage to the fuselage, the landing gear and flaps.
17. The CVR and FDR were recovered in good condition and recordings were intact after the occurrence.

**Figure 5: Damage to the right wing flaps**

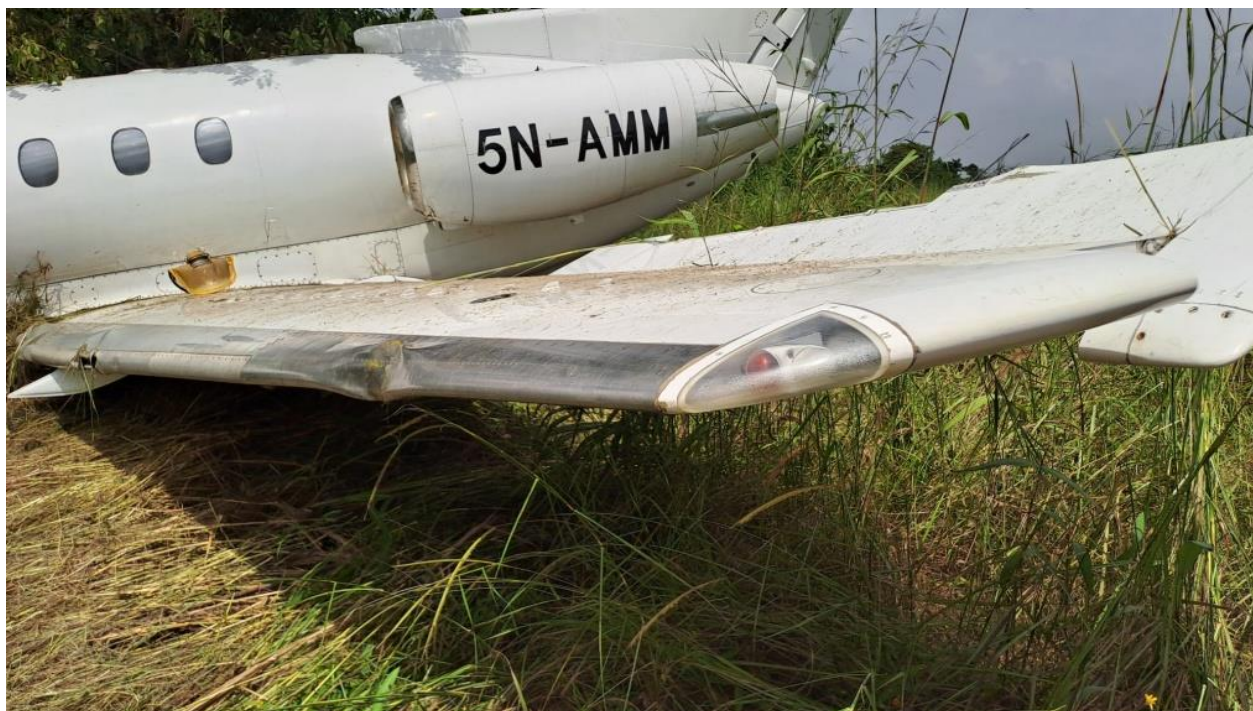
**Figure 6: Damage to the left wing leading edge and a fragment of the approach lighting fixture**

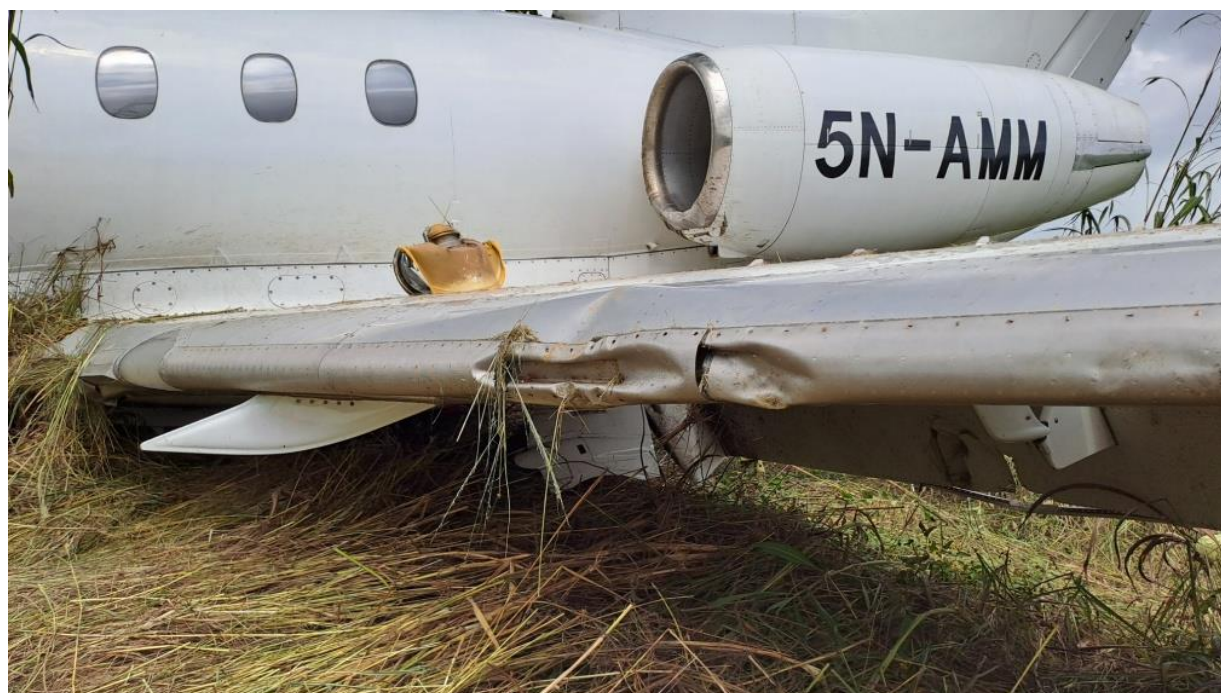
**Figure 7: Close-up of damage to the left wing leading edge**
