PRELIMINARY REPORT ON THE SERIOUS INCIDENT INVOLVING AN EMBRAER ERJ 145 AIRCRAFT OPERATED BY UNITED NIGERIA AIRLINES WITH NATIONALITY AND REGISTRATION MARKS 5N-BWW WHICH OCCURRED ON RUNWAY 18L MURTALA MUHAMMED INTERNATIONAL AIRPORT, LAGOS ON 31ST MAY, 2023

Registered operator:	United Nigeria Airlines Limited
Aircraft type and model:	Embraer ERJ 145LR
Manufacturer:	Yabora Industria Aeronautica, S.A.
Date of manufacture:	January, 2002
Nationality and registration marks:	5N-BWW
Serial number:	145553
Location:	Runway 18L, Murtala Muhammed International Airport, Lagos
Date and time:	31st May 2023 at about 16:04:41 h

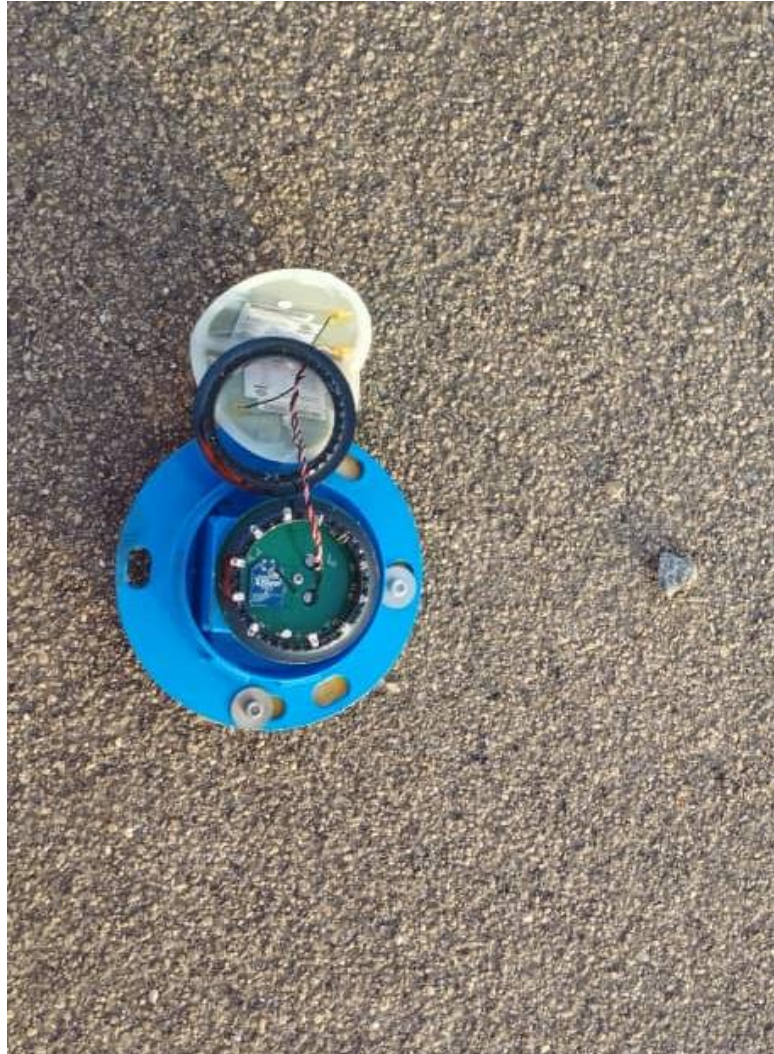
Two taxi-way edge lights were broken.

Figure 1: Picture of broken taxiway edge light

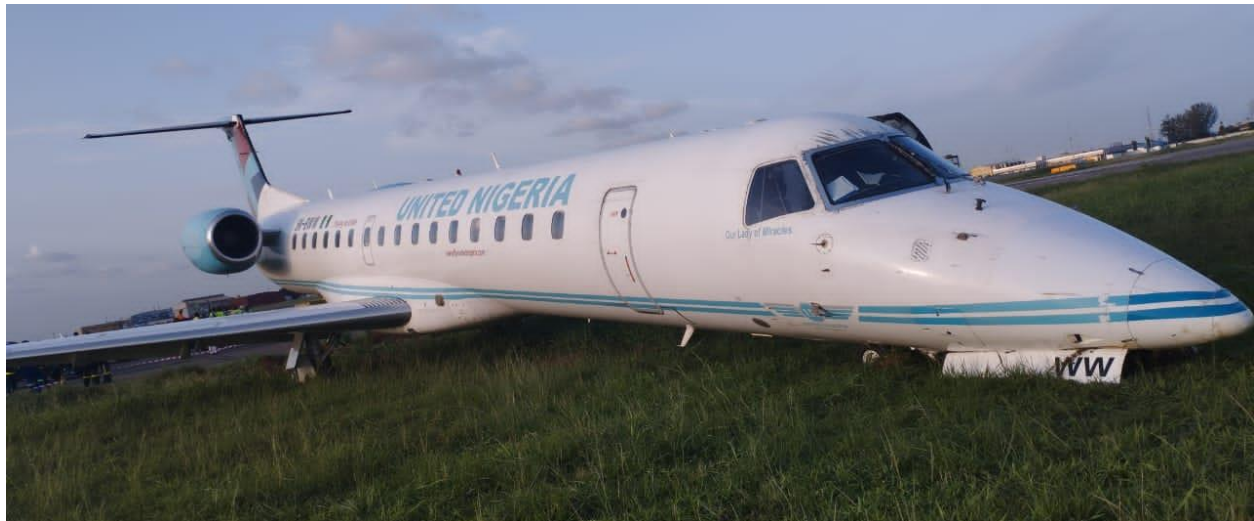
During landing roll, the aircraft veered to the right of runway 18L centreline for a distance of about 936 m from the runway threshold to the runway shoulder and continued onto

the grass verge. It further moved on the grass verge, crossed a drainage channel onto the paved way at Link B3, a distance of about 1,760 m and continued onto the grass verge on the other side of the link. The aircraft then crossed another drainage channel and having travelled a total distance of about 1,860 m from the runway threshold, came to a stop. In the process, the aircraft nose landing gear assembly collapsed.

Figure 2: The aircraft where it stopped on the grass verge

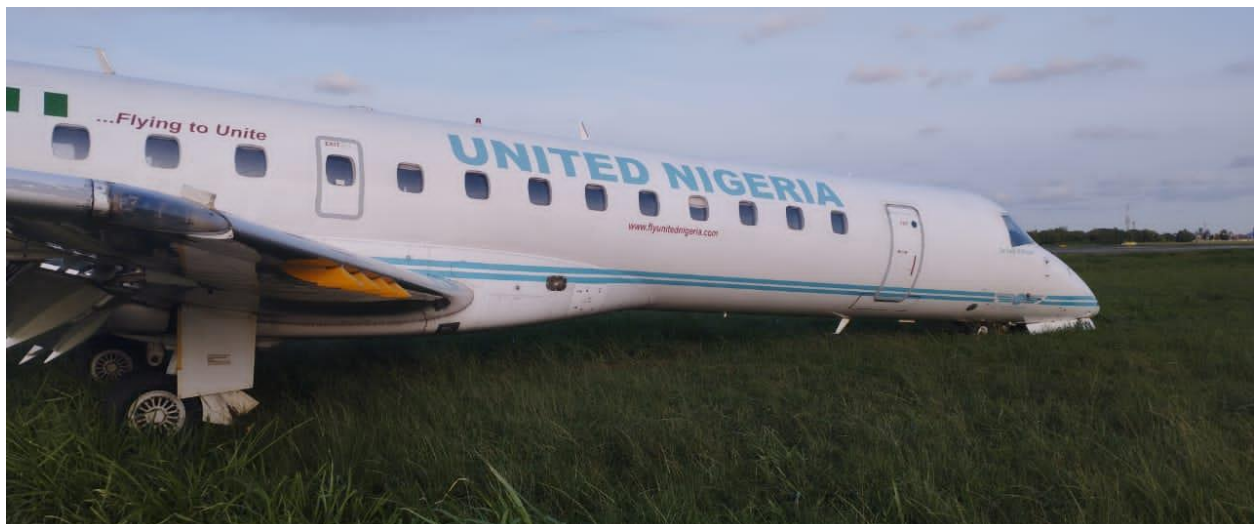
Figure 3: Picture of the final position of 5N BWW after the occurrence.

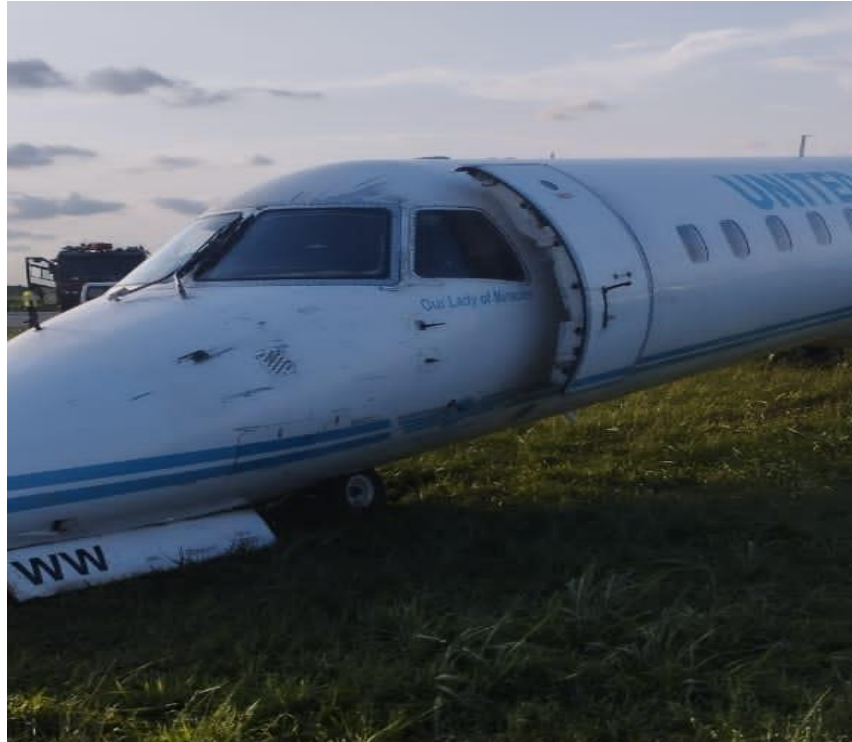
Figure 4: The collapsed nose wheel landing gear

United Nigeria Airlines should ensure compliance with Embraer Service Bulletin (SB) 145-32-0099 (current revision 03, dated April 8, 2005). The SB recommended upgrading the nosewheel steering hydraulic manifold, which required inspecting specific dimensions that were considered critical for the proper operation of the O-ring seals within the EHSV to ensure that they were within tolerance limits.
