**PRELIMINARY REPORT ON SERIOUS INCIDENT INVOLVING A BOMBARDIER CRJ900 AIRCRAFT WITH NATIONALITY AND REGISTRATION MARKS 5N-BXR OWNED AND OPERATED BY FLYFORVALUE AVIATION LIMITED AT PORT HARCOURT INTL. AIRPORT, RIVERS STATE ON 14TH NOVEMBER 2023**

<b>Registered owner and operator:</b>	Flyforvalue Aviation Limited (Value Jet)
<b>Aircraft type and model:</b>	Bombardier CRJ900
<b>Manufacturer:</b>	Mitsubishi Heavy Industries Ltd.
<b>Date of manufacture:</b>	2006
<b>Nationality and registration marks:</b>	5N-BXR
<b>Serial number:</b>	15065
<b>Location:</b>	Grass verge adjacent Link A5, Runway 21, Port Harcourt Airport, Rivers state
<b>Date and time:</b>	14th November 2023 at about 15:18 h

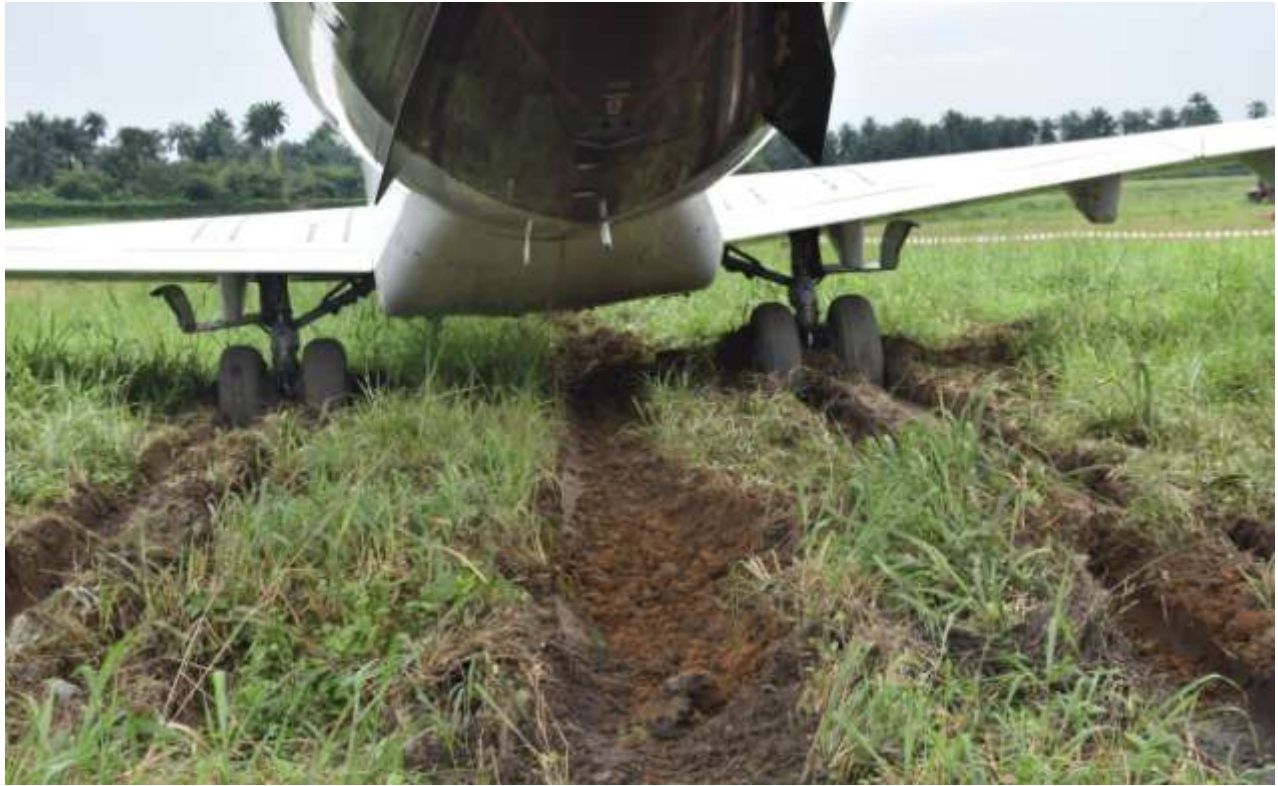
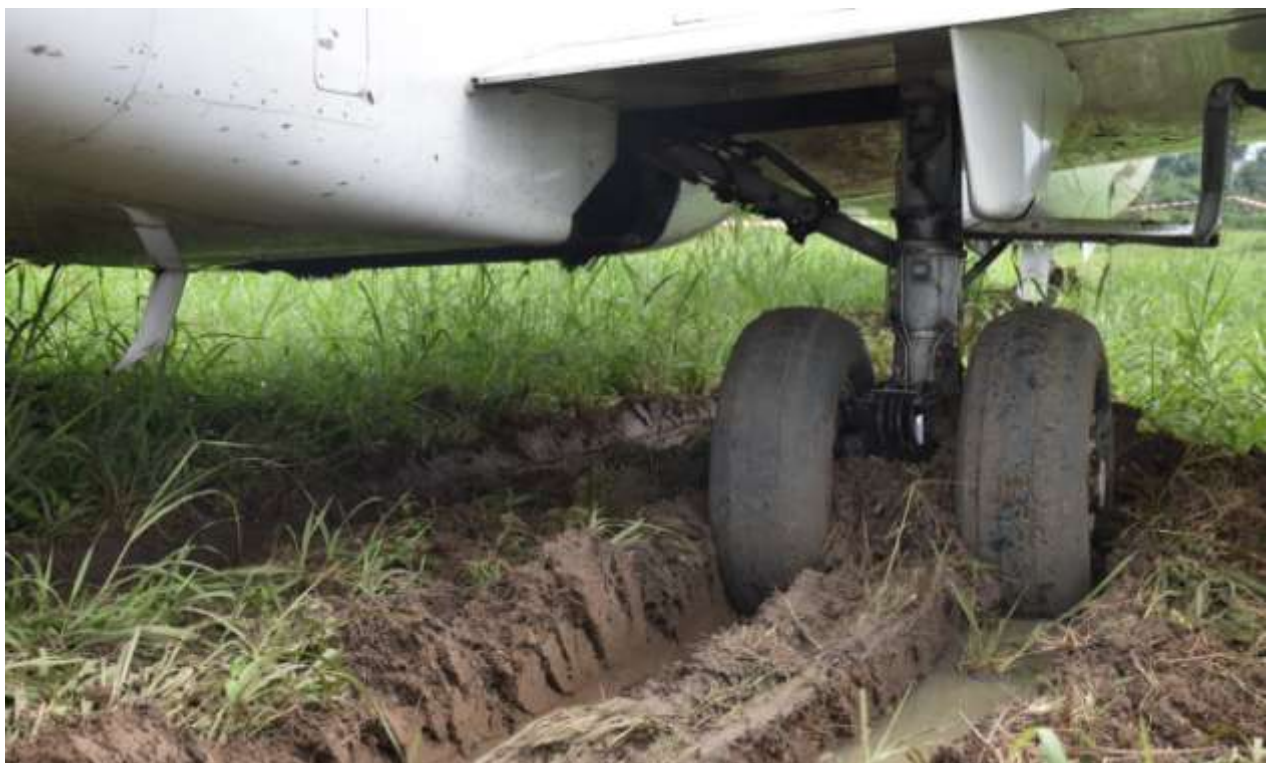
The extent of damage is yet to be determined. However, all landing gear particularly the nose wheel were embedded in mud.

**Figure 1: Some views of the aircraft landing gear where it stopped**

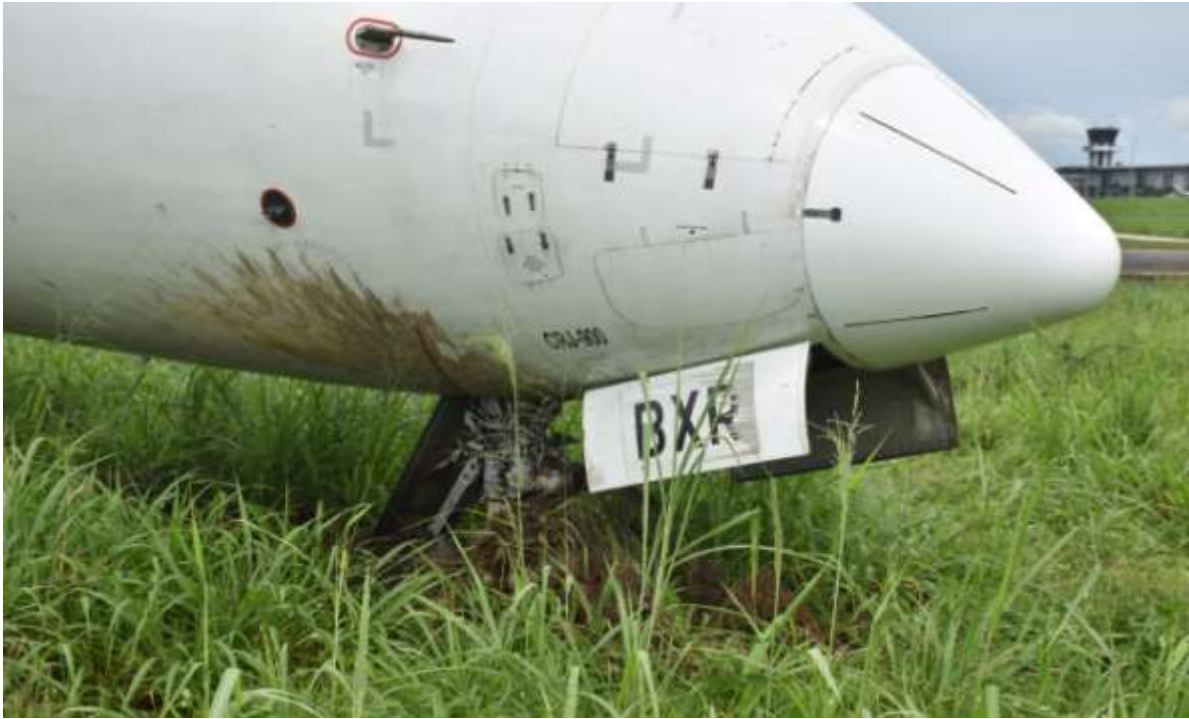
A drainage channel at the end of runway 21 was damaged where the aircraft crossed it en route the grass verge adjacent Link A5.

Tyre marks on the runway leading to the final position of the aircraft showed that the aircraft impacted and damaged a drainage duct and uprooted some embedded power cables.

**Figure 2: The damaged drainage duct (In the foreground)**

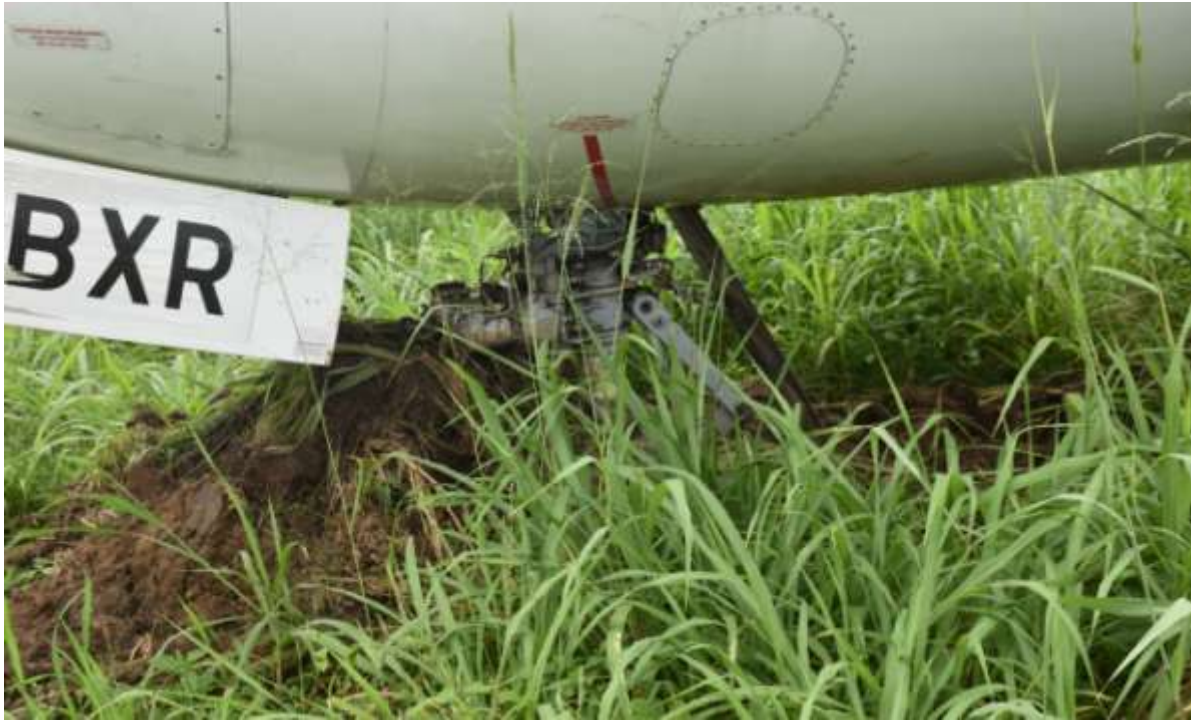
**Figure 3: Close up view of the nose landing gear**
