5N-BKI

PRELIMINARY REPORT ON THE SERIOUS INCIDENT INVOLVING AN MD-82 AIRCRAFT OPERATED BY DANA AIRLINES LIMITED WITH NATIONALITY AND REGISTRATION MARKS 5N-BKI, WHICH OCCURRED ON RUNWAY 18L MURTALA MUHAMMED INTERNATIONAL AIRPORT, LAGOS ON 23 APRIL 2024

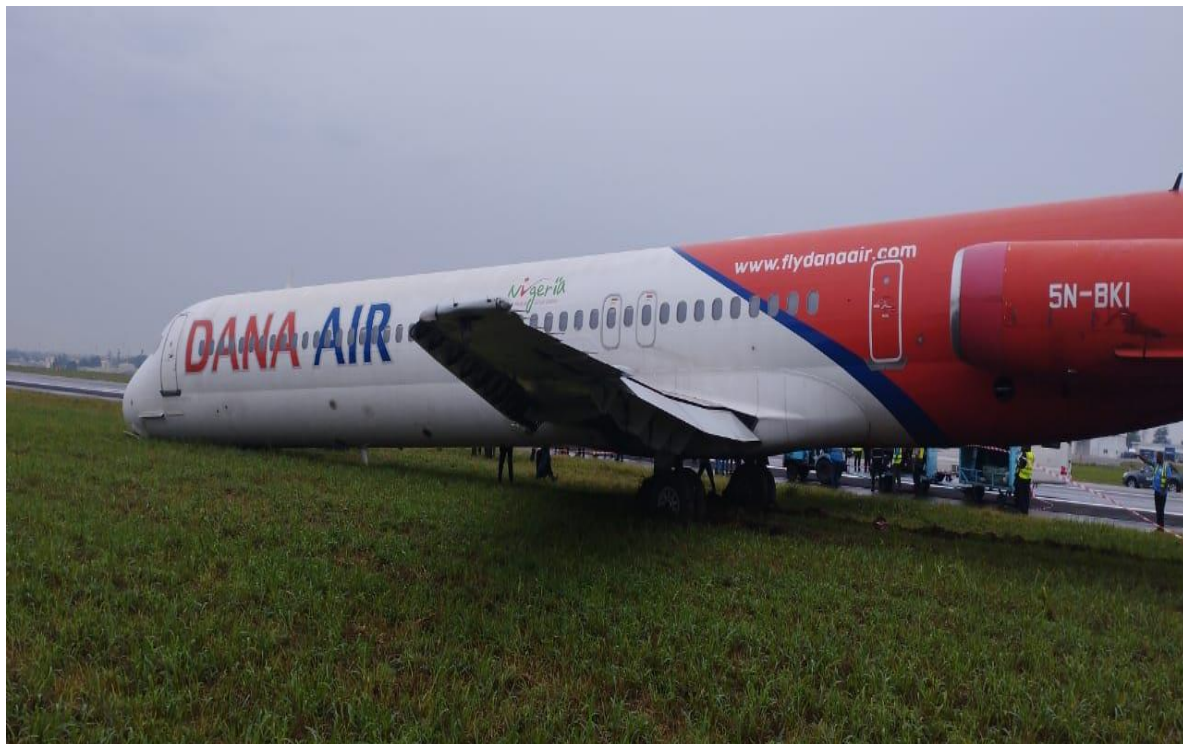
Figure 1: DAN0352 at its Final Stop Position

The crew stated that on reaching 80 knots during the Landing Roll, the Nose Landing Gear (NLG) collapsed, the aircraft lost directional control, veered off to the left of the runway centreline, and exited the runway at about 2,094 m from the threshold. It continued in the grass verge, crossed the paved Link 6, and came to a stop at about 2,343 m from the threshold of runway 18L, 36 m from the runway centreline.

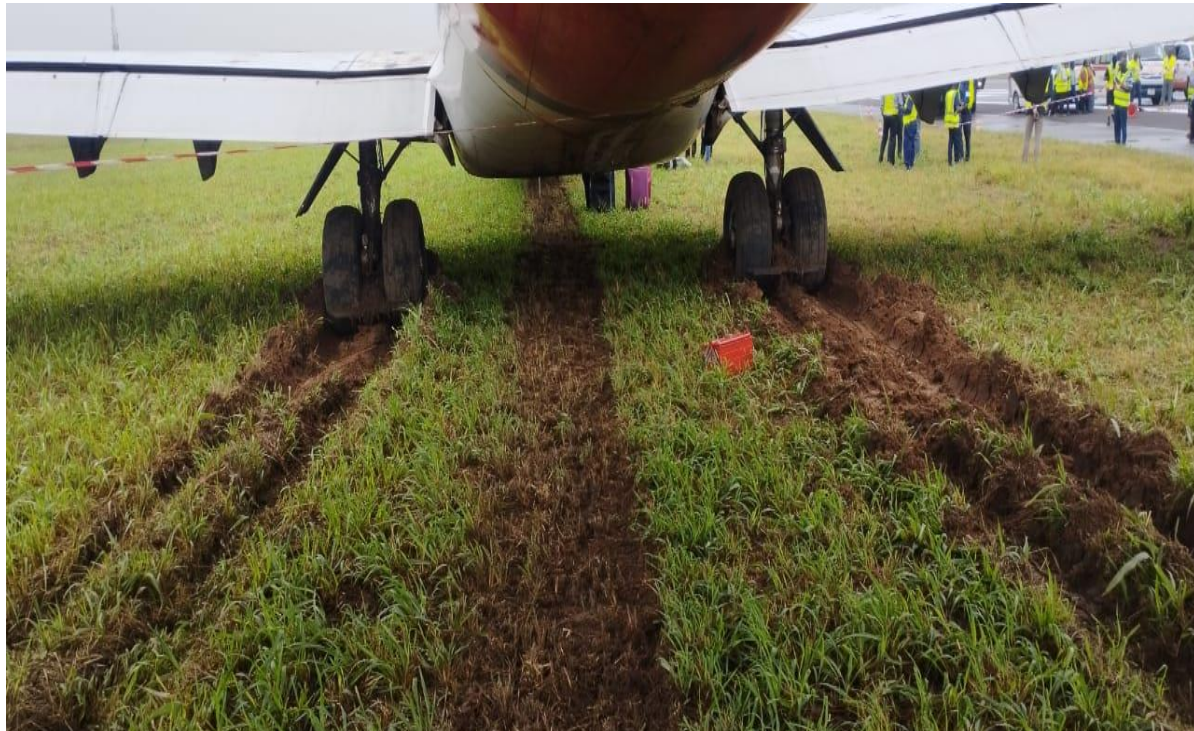
Figure 2: Track of Wheels on Grass Verge

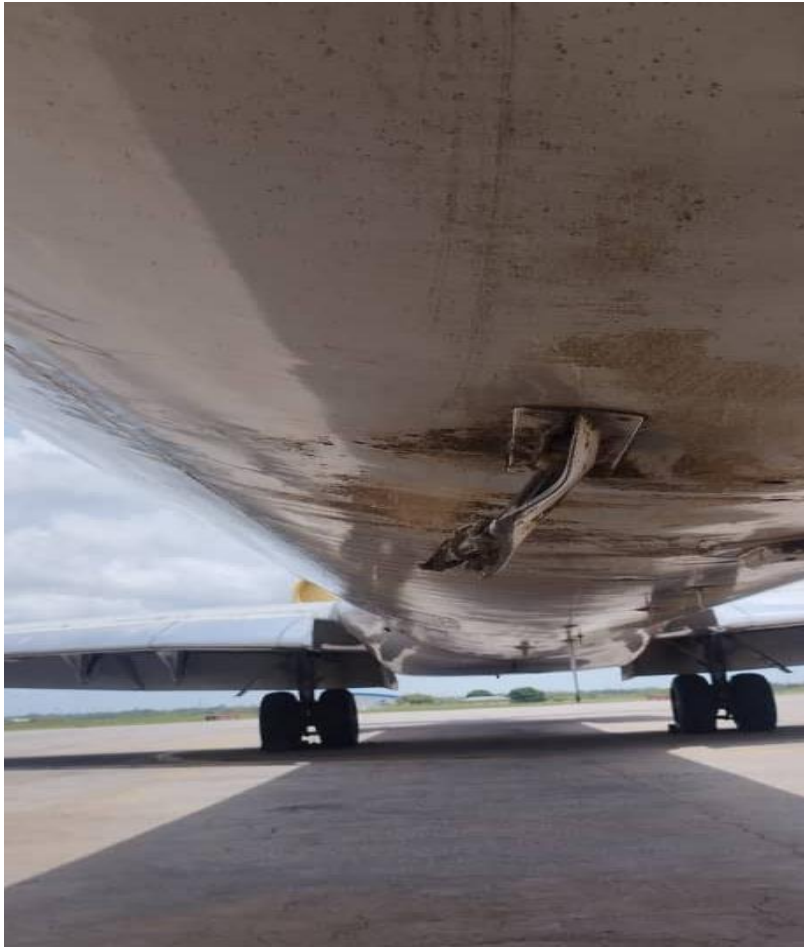
1. Distress to lower forward skin
2. The NLG lights were broken.
3. The Galley Drain was deformed.
4. An Antenna was broken.
5. The NLG Wheel Well Aft Door was damaged.

Figure 3: Damaged Galley Drain & Antenna

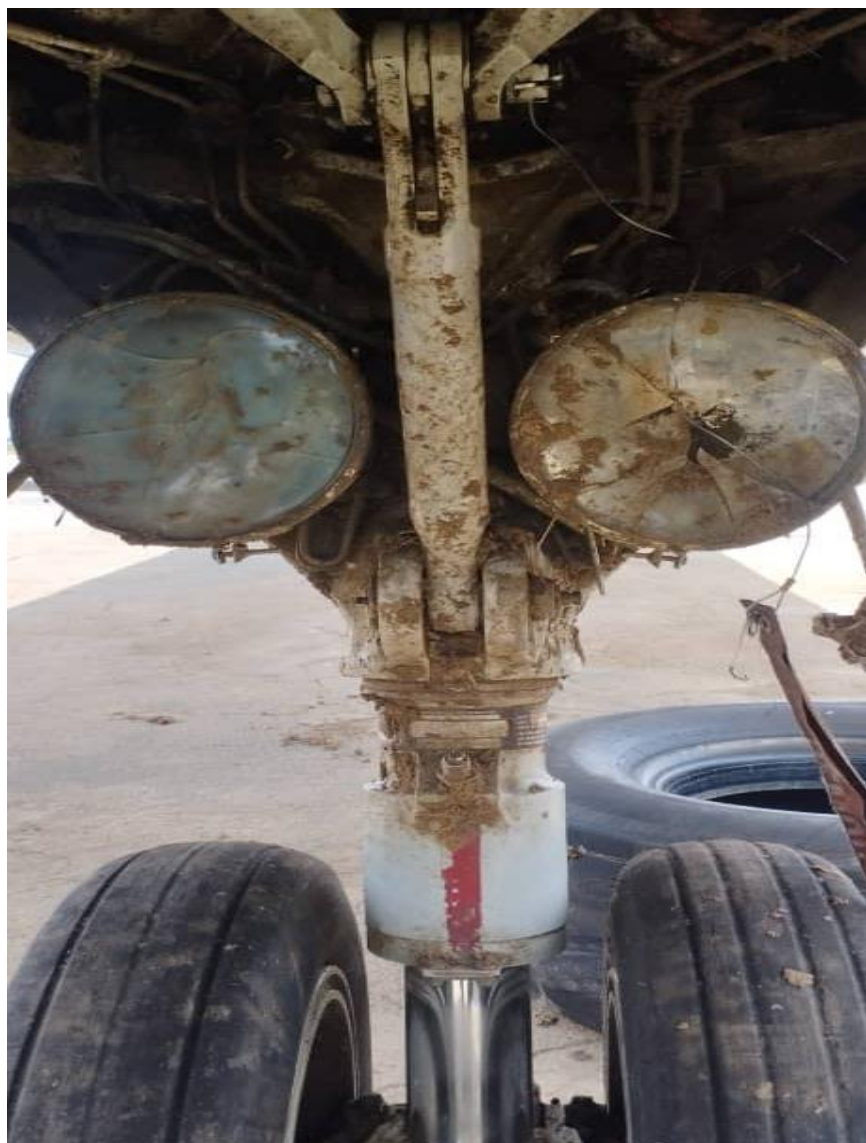
Figure 4: Damaged nose landing gear light
