AIRCRAFT ACCIDENT REPORT

AASL/2021/02/16/F

Final Report on Serious Incident involving a Boeing 737-500 aircraft with nationality and registration marks 5N-SYS operated by Azman Air Services Limited which occurred on Runway 18R, Murtala Muhammed Airport Lagos; Nigeria on 16 February 2021.

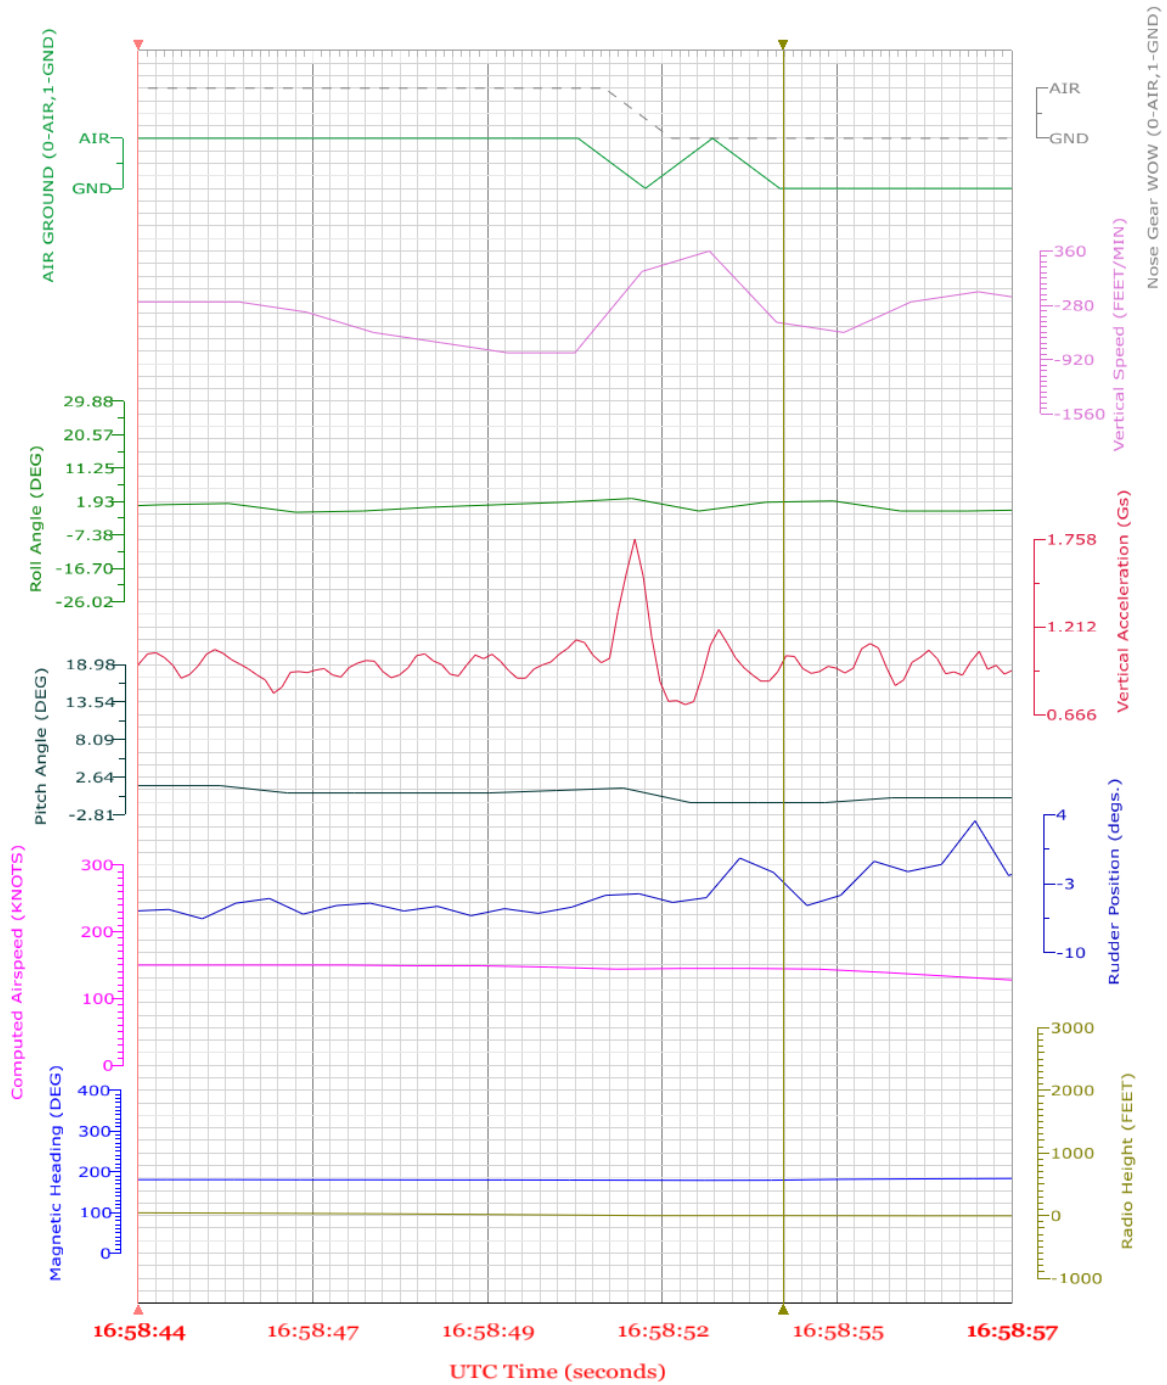
Figure 3: FDR Plot showing the touchdown sequence

The FDR plot of Touchdown sequence shows a spike in AIR-GRD indicating a likely bounce of the main landing gear. This corresponds with a spike in vertical Acceleration to a value of 1.758 G at point of first touchdown. The second main landing gear touch down occurs 2 secs later, at about 145 knots. pitch angle at touchdown is 1.7 degrees with a 2.8-degree roll angle. In addition, main gear touchdown, followed by nose gear 1 second later, likely indicating a positive landing.

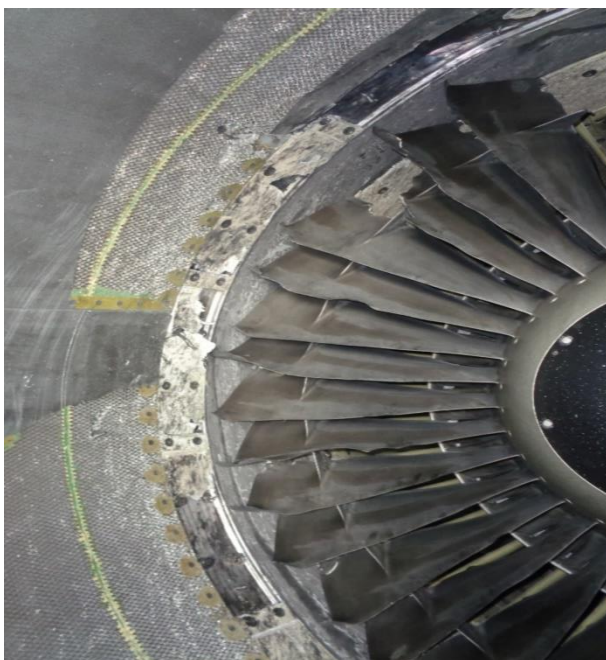
The aircraft touched down after Link Alpha 2 of runway 18R and all the main wheel tyres burst. Flying debris from the burst tyres got into the No. 1 engine and the aircraft stopped on the runway after Alpha 3. The tyres were heavily worn-out exposing the canvass. Large reverted rubber tyre debris was found stuck in the left trailing edge flap. Several inlet fan blades on No. 1 engine were found damaged.

Figure 5: Damaged fan blades of number 1 engine caused by ingestion of debris from the burst tyre

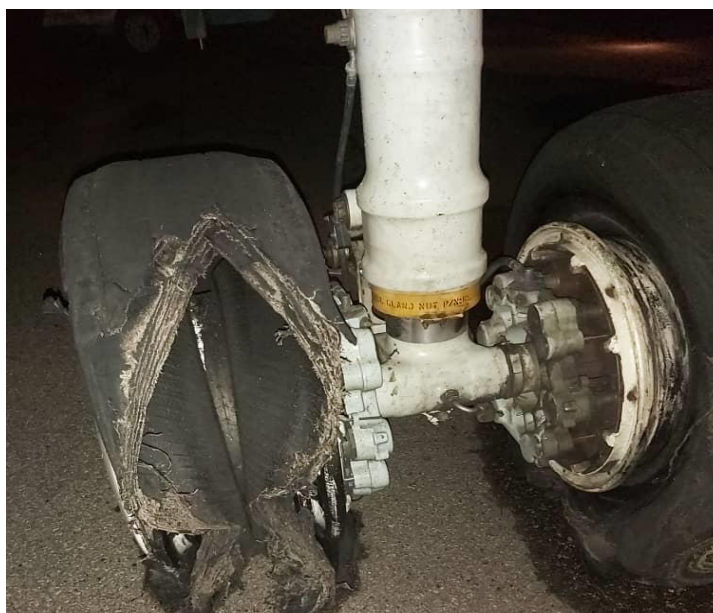
Figure 6: Damaged No. 1 & 2 main wheel tyres

The investigation deduced that the PF's brake application produced the reverted rubber condition causing tyre debris during landing roll suggesting that applying light pressure on the brake pedal (as advised in the Chapter 14, B737 Airplane Flight Crew Operations Manual- ANTI SKID INOP. Deferred Items - landing Procedures Review under this condition) was not duly followed. Therefore, the PF's excessive brake application was unhelpful considering the prevailing conditions of the aircraft and the contaminated (wet) runway surface.

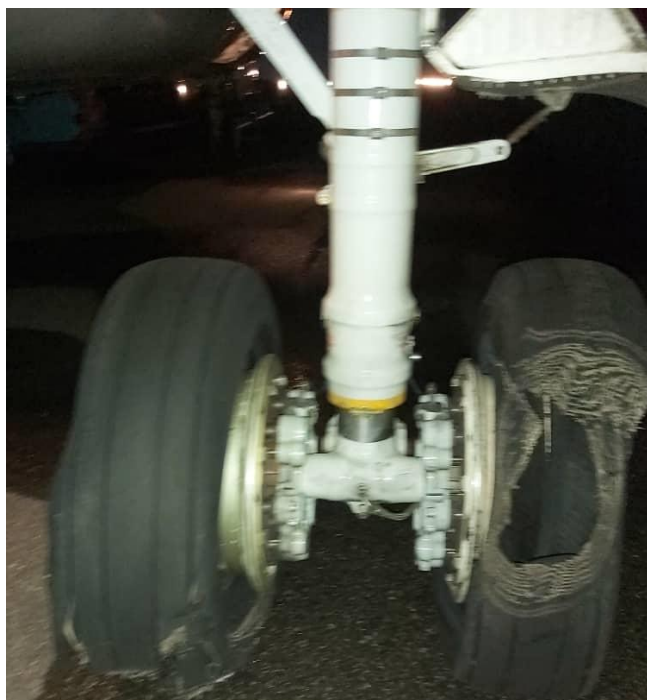
Figure 7: Rear view of damaged no. 3 & 4 main wheel tyres

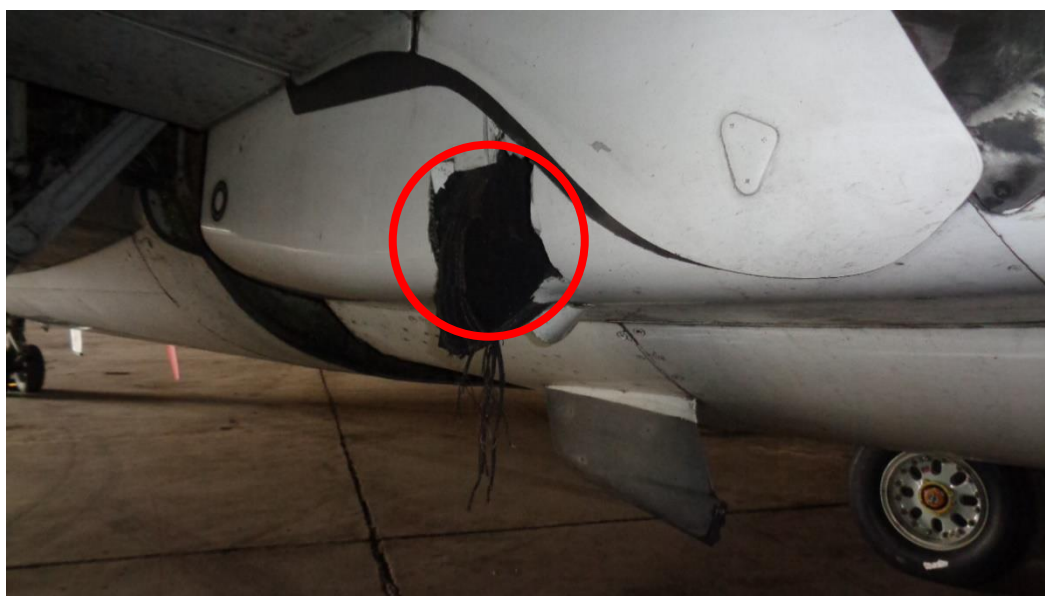
Figure 8: Tyre debris stuck in the flap track fairing
