AIRCRAFT ACCIDENT REPORT

CHL/2022/06/13/F

Nigerian Safety Investigation Bureau

Final Report on the Serious Incident involving De Havilland Twin Otter DHC-6-400 Aircraft with nationality and registration marks 5N-SHE operated by Caverton Helicopters Limited which occurred during landing at Forcados Airstrip, Delta State on 13 June 2022.

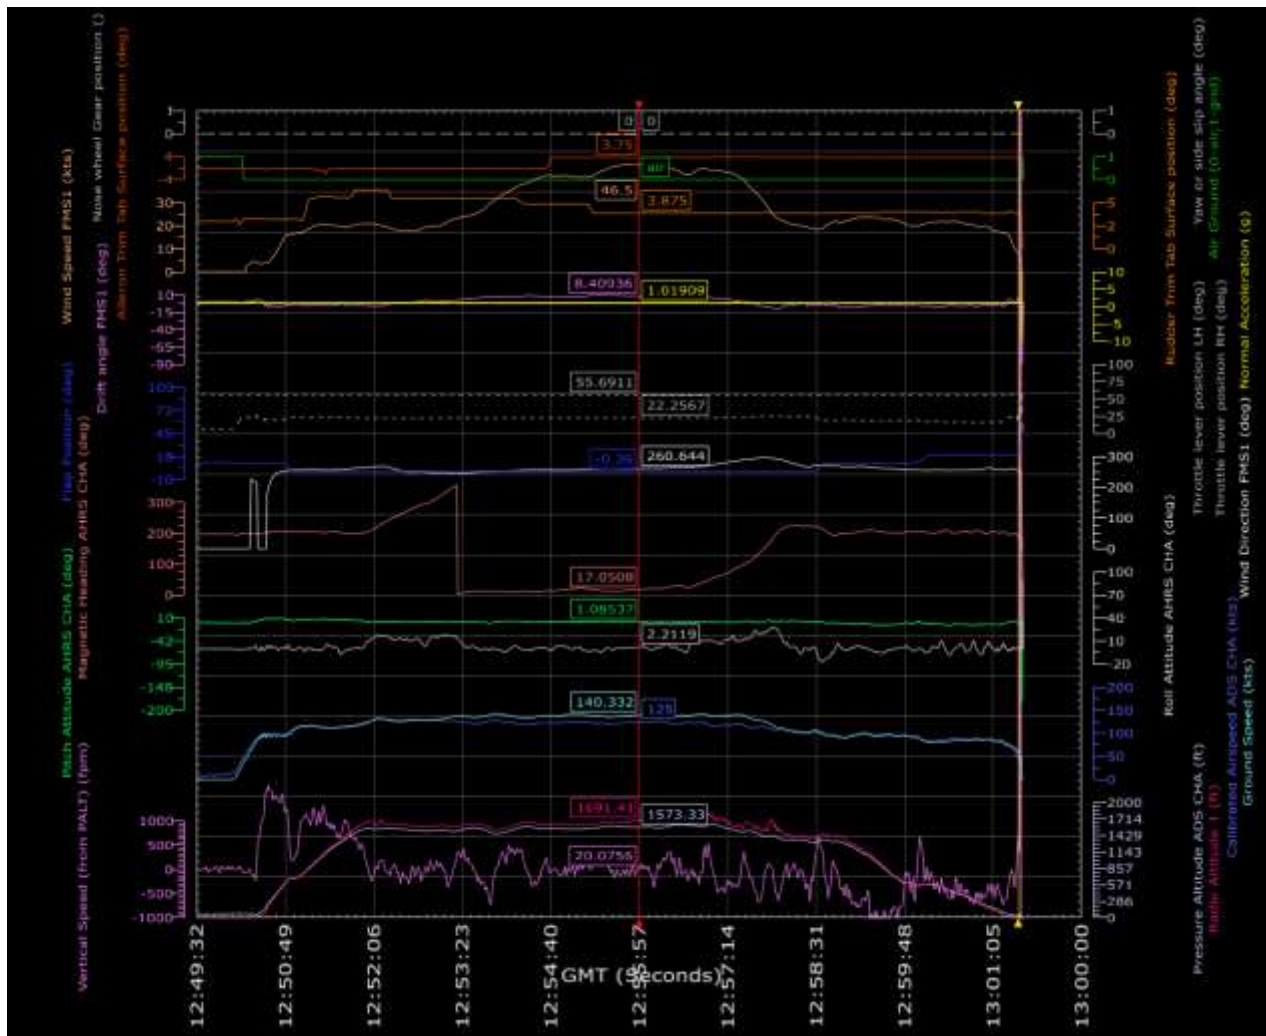
Figure 3: Representative plot for the third sortie

from the runway axis within a short time interval. These rapid heading excursions indicate significant yaw oscillations during the flare and the initial landing roll.

The pattern of heading changes is consistent with late or reactive crosswind control inputs. Directional stability was not effectively maintained through touchdown and the subsequent rollout phase.

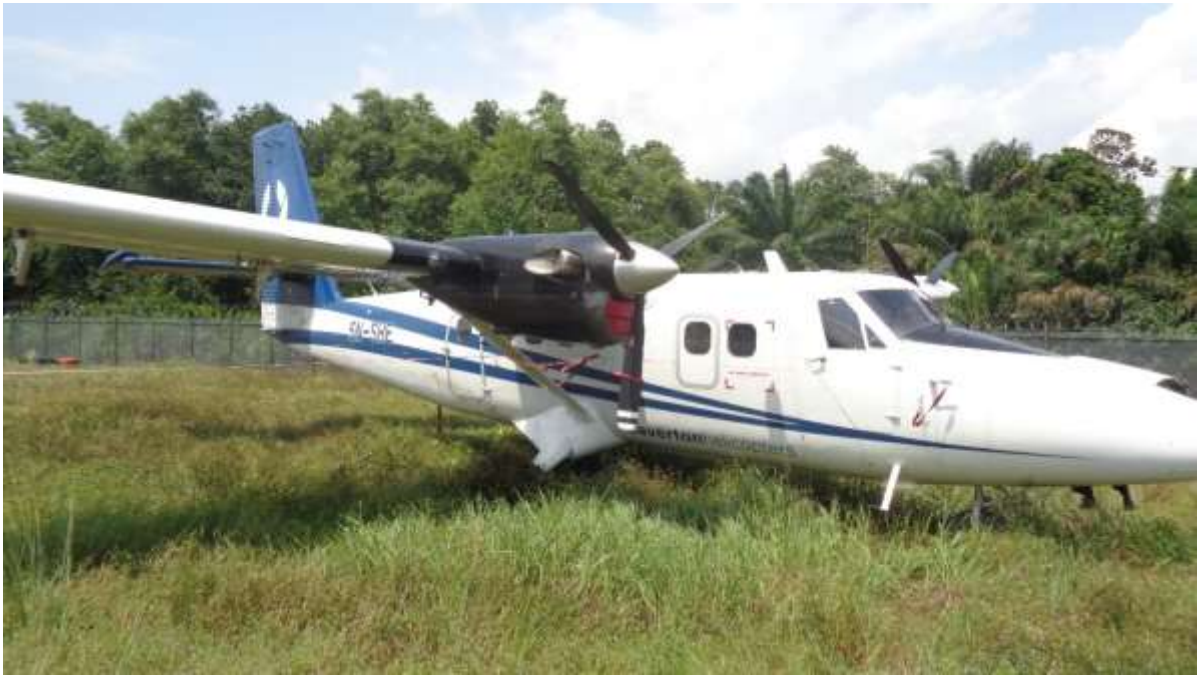
The aircraft touched down about 62 m from Runway 20 threshold to the right of the centreline and subsequently veered to the left where it departed the paved surface at a point approximately 238.7 m from the runway threshold. It then travelled an additional 34.05 m across the grass verge before colliding with a shelter pole used for the Fire Tender. The aircraft continued and finally came to a stop after being stuck in mud.

Figure 5: The aircraft stuck in the grass-verge

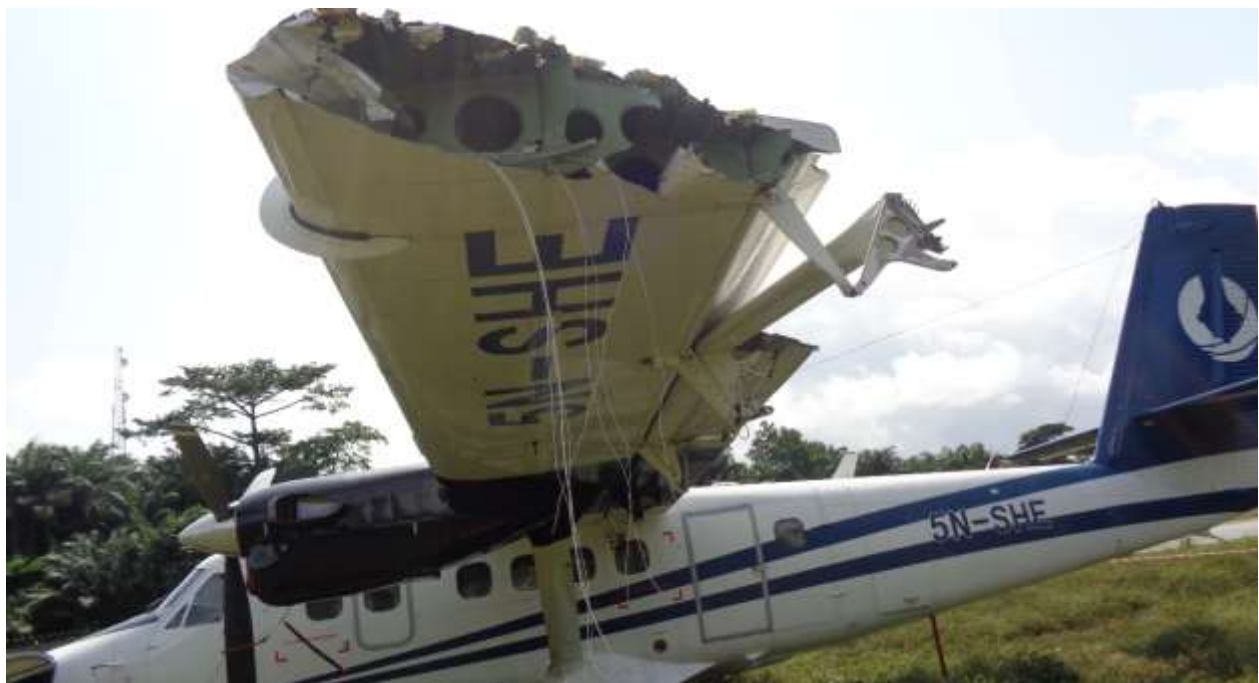
1. The left wing tip (outboard section) was sheared off; the navigation and strobe lights were detached.
2. The left wing flap and aileron were damaged and severed from the wing after collision with the shelter pole.

Figure 6: Damaged left wing of 5N-SHE

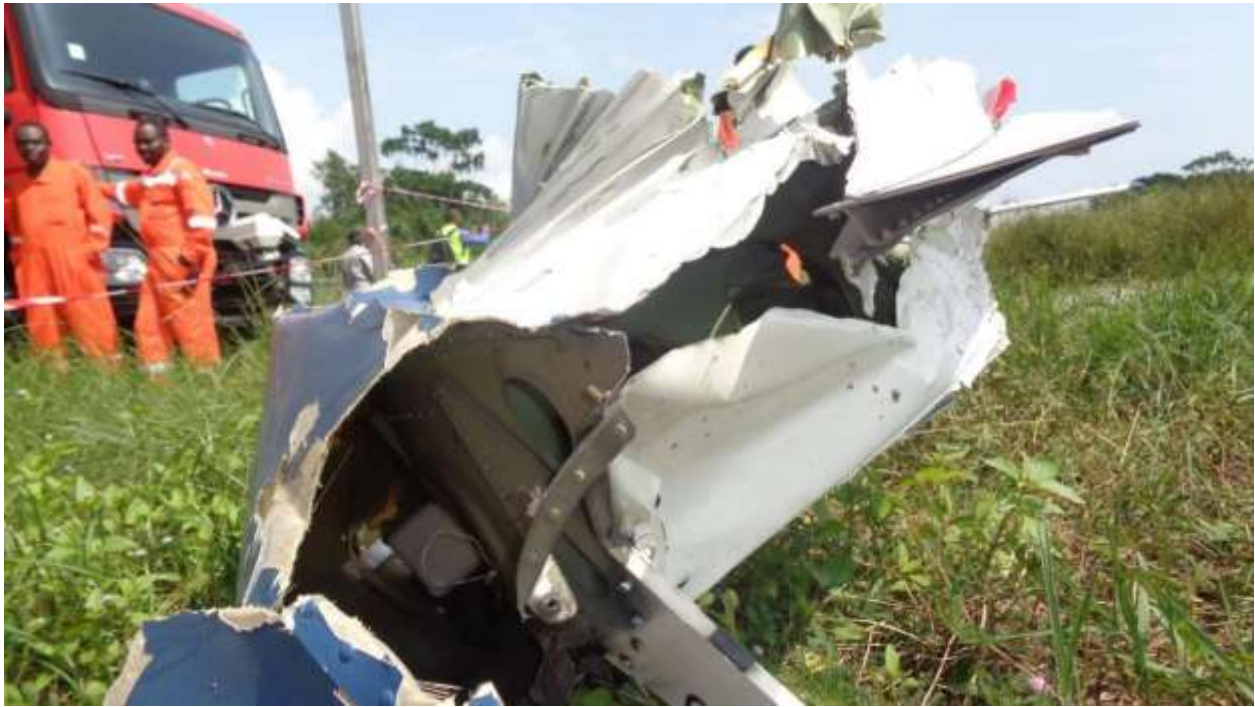
Figure 7: The Left wing tip area of the aircraft

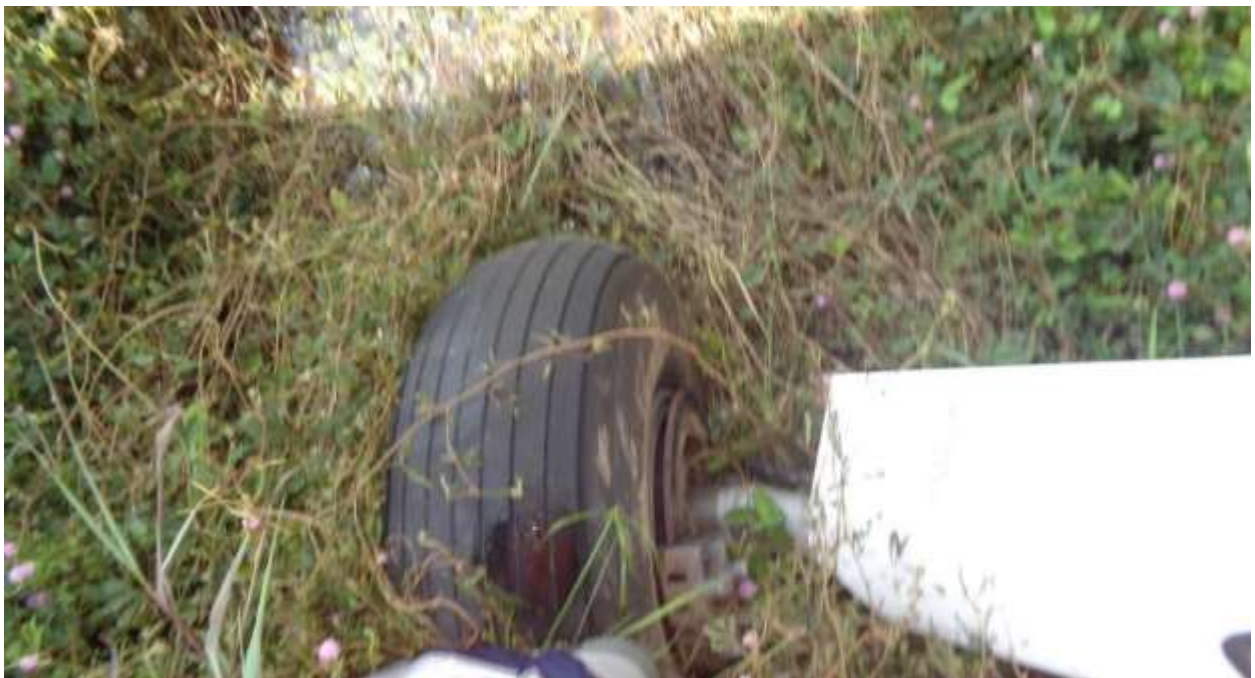
Figure 8: The right main wheel stuck in grass-verge

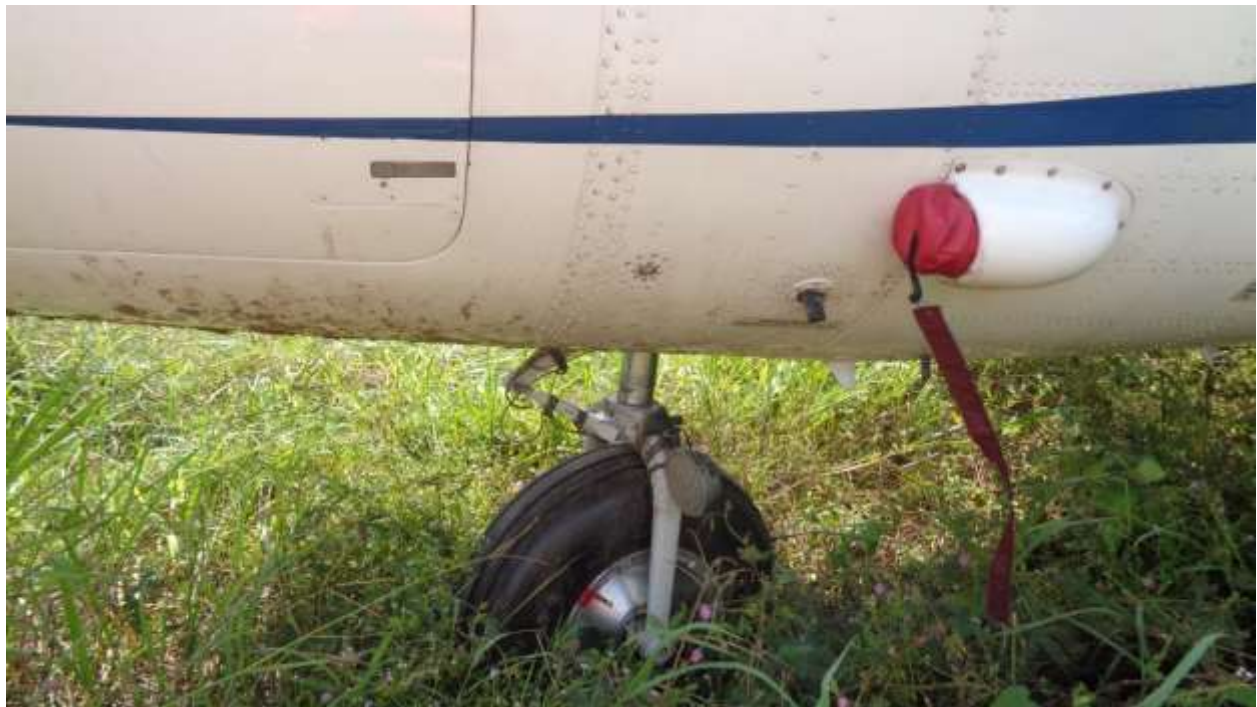
Figure 9: Nose wheel stuck in the grass-verge

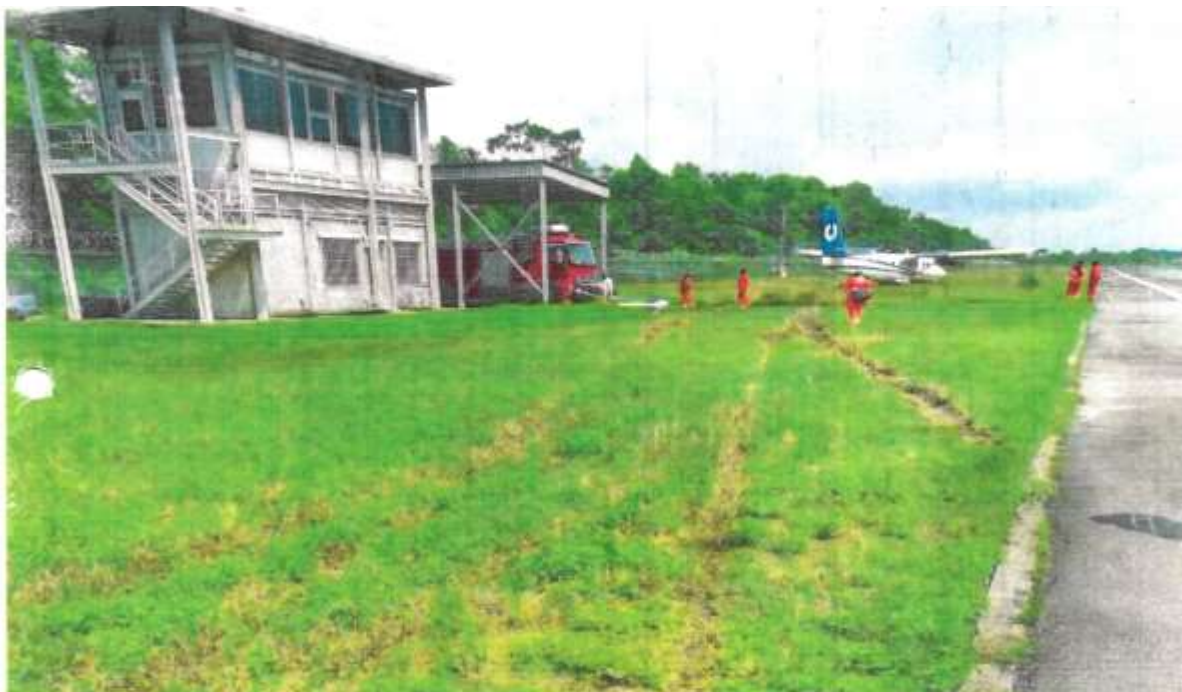
Figure 10: Wheel tracks on the grass verge
