# AIRCRAFT ACCIDENT REPORT

DANAL/2021/03/14/F

**Final Report on the Serious Incident involving a Dornier 328-100 aircraft with nationality and registration marks 5N-BUN operated by Dornier Aviation Nigeria AIEP (DANA) Limited, which occurred at Murtala Muhammed Airport, Lagos on 14 March 2021.**

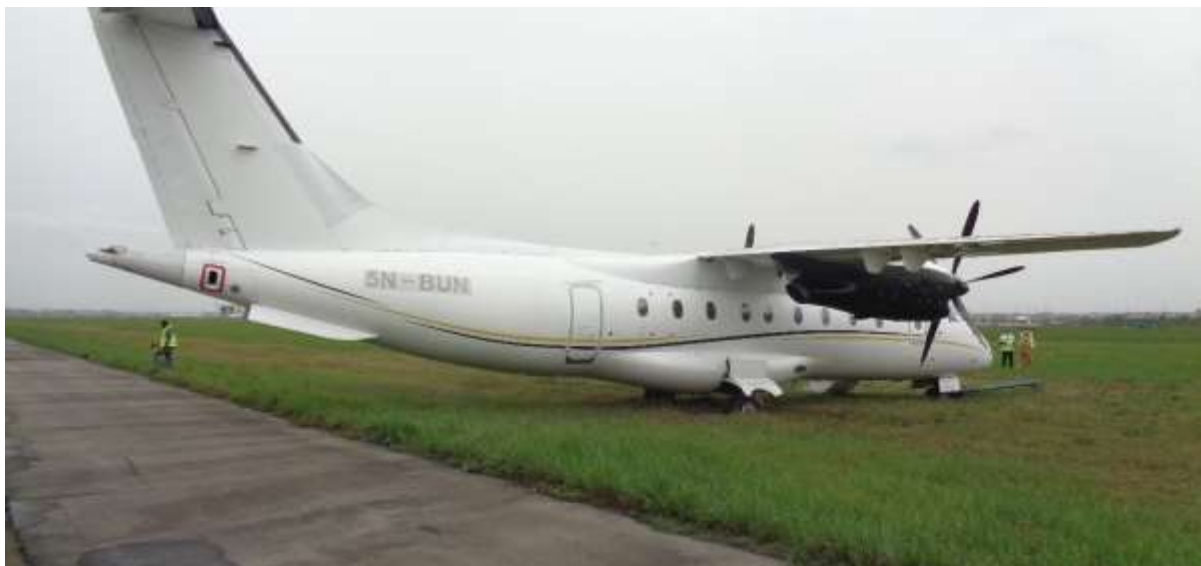
the Co- pilot handed over control at speed below 60 knots decelerating. The PF further stated that at about 50 knots, the Captain noticed a sudden veering of the aircraft to the right and called for "CONDITION LEVERS MIN" position. He regained control of the aircraft momentarily. Thereafter, the aircraft veered to the right again, exited the runway onto the grass verge and stopped.

**Figure 1:** The aircraft after the occurrence

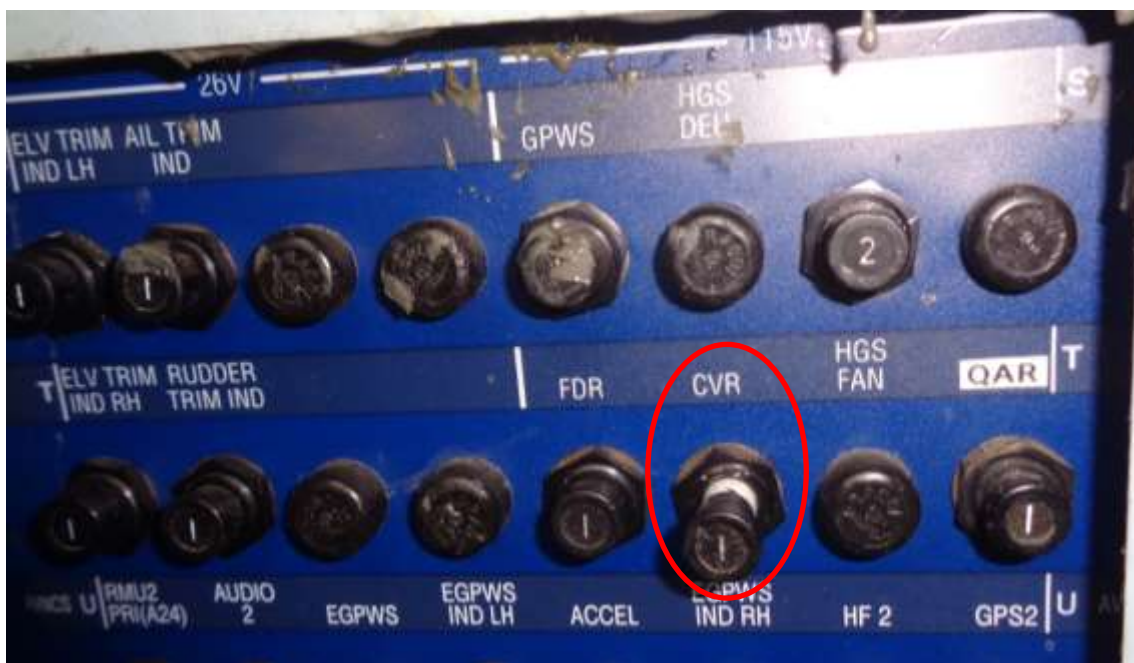
The CVR continued to record audio after engine shut down following the starting of the APU. Hence, the recording of the occurrence on the P/A, Co-pilot, Pilot and CAM were overwritten. The CVR information on the combined crew audio and CAM channels was preserved.

**Figure 2:** The right side CB panel showing the pulled CVR circuit breaker
