Preliminary Report on the Accident involving a Cessna 172E aircraft with nationality and registration marks 5N-ASR, operated by Skypower Express Airways Nigeria Limited, which occurred during approach to Runway 17 at Sam Mbakwe International Cargo Airport, Owerri (DNIM), on 16 December 2025

Operator:	Skypower Express Airways Nigeria Limited
Owner:	YOMED Nigeria Limited
Aircraft type and model:	Cessna 172E
Manufacturer:	REIMS Aviation S. A., Reims, France, under licence from Cessna Aircraft Company, USA
Year of manufacture:	1968
Nationality and registration marks:	5N-ASR
Serial number:	FR172-00366
Location:	About 270 m from the threshold on the Approach Path of RWY 17, DNIM, at coordinates 5°26' 28.8384" N, 7°12'9.8028" E.
Date and time:	16 December, 2025 at about 20:02 h

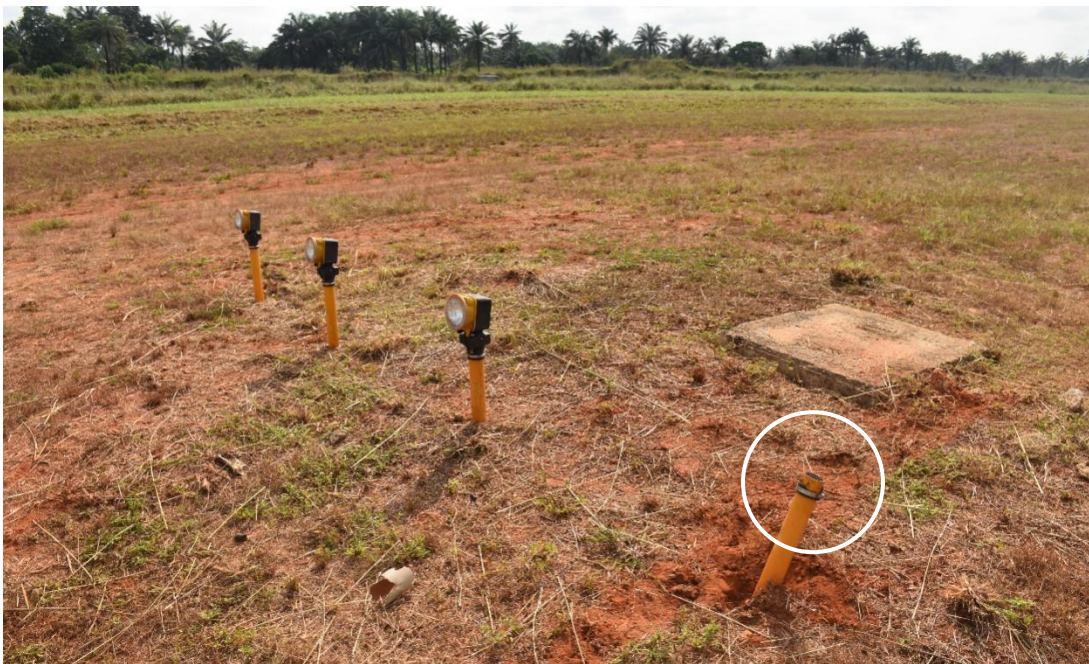
Nine approach lights on the Approach Path of Runway 17 were damaged.

Figure 1: A damaged approach light on Row 11

Impact marks show that the aircraft impacted the three rows of the approach Lights, damaging nine Approach Lights in all.

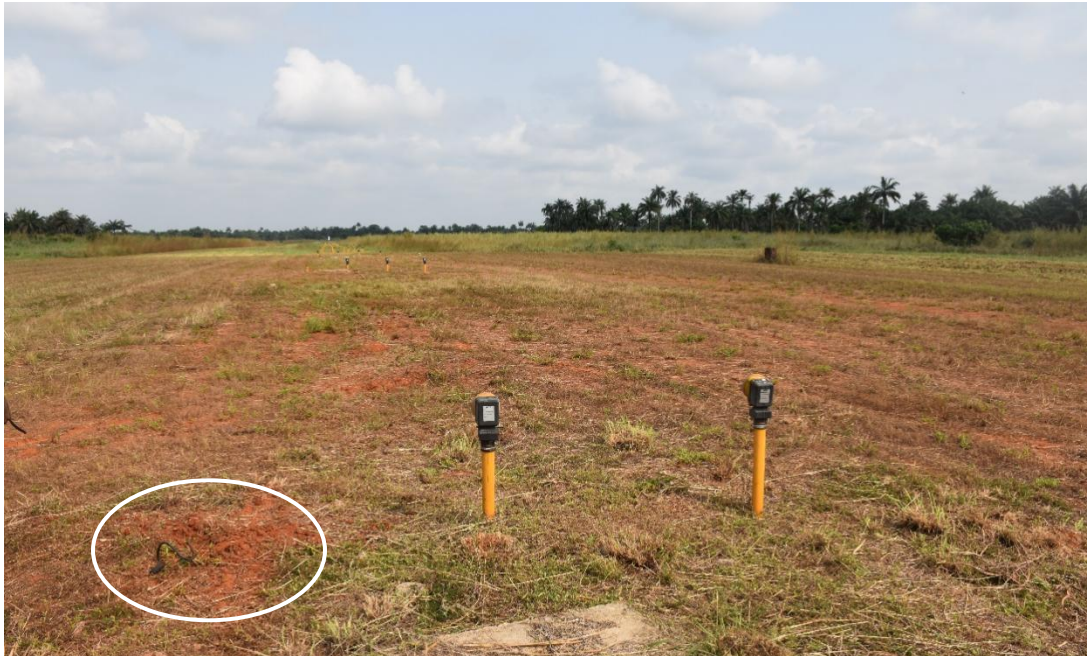
Figure 2: Another damaged approach light on Row 10

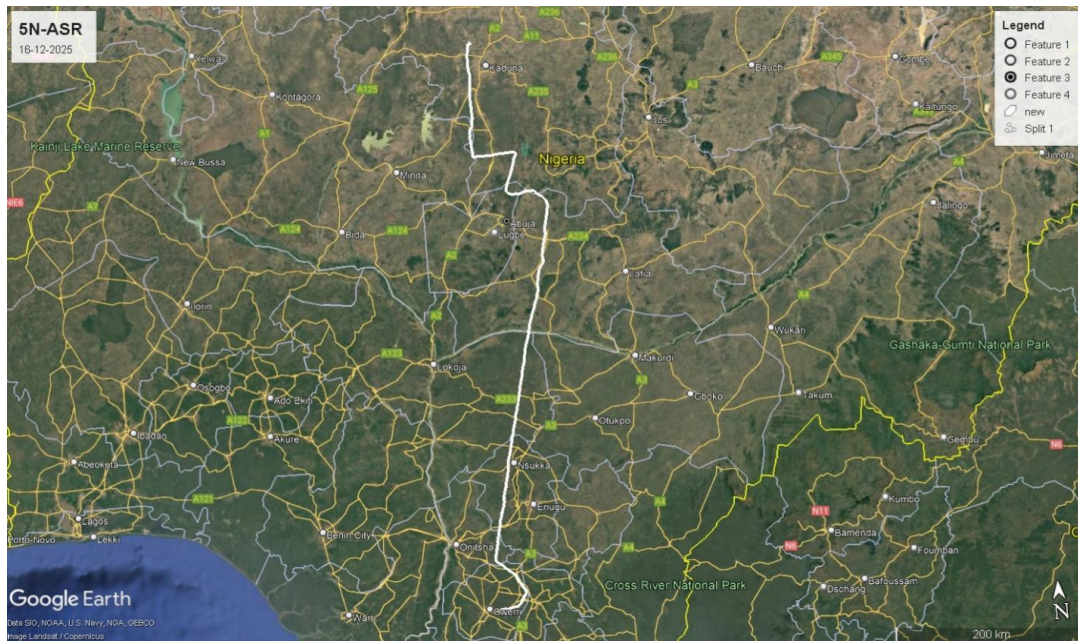
It shows that the aircraft departed Runway 05 at Hassan Usman Katsina International Airport (DNKA), Kaduna at 15:16:44 Z. The last recorded point was at coordinates latitude 5°26' 28.8384", longitude 7°12'9.8028" at 19:13:40 Z, 270 m short of Runway 17 on the extended centerline at Sam Mbakwe International Cargo Airport, Owerri.

Figure 3: GPS track from DNKA to crash point (DNIM)

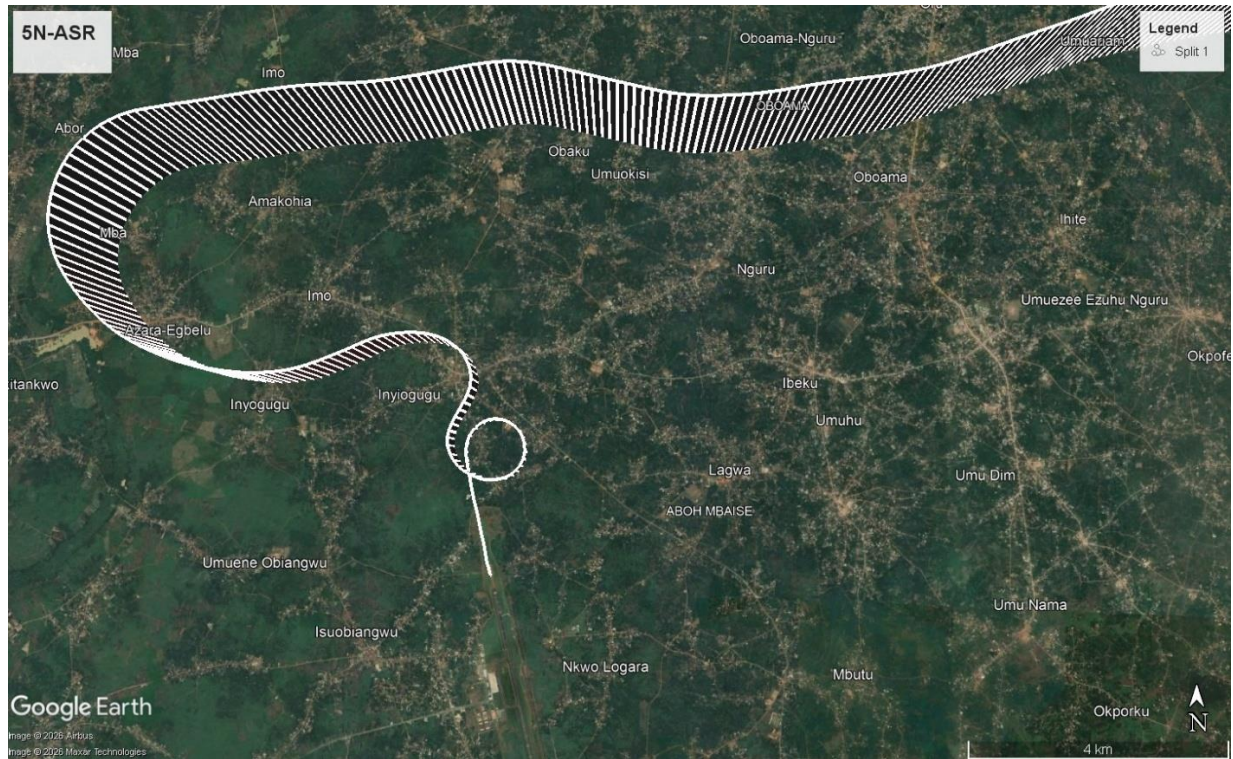
Figure 4: Final Portion of the flight

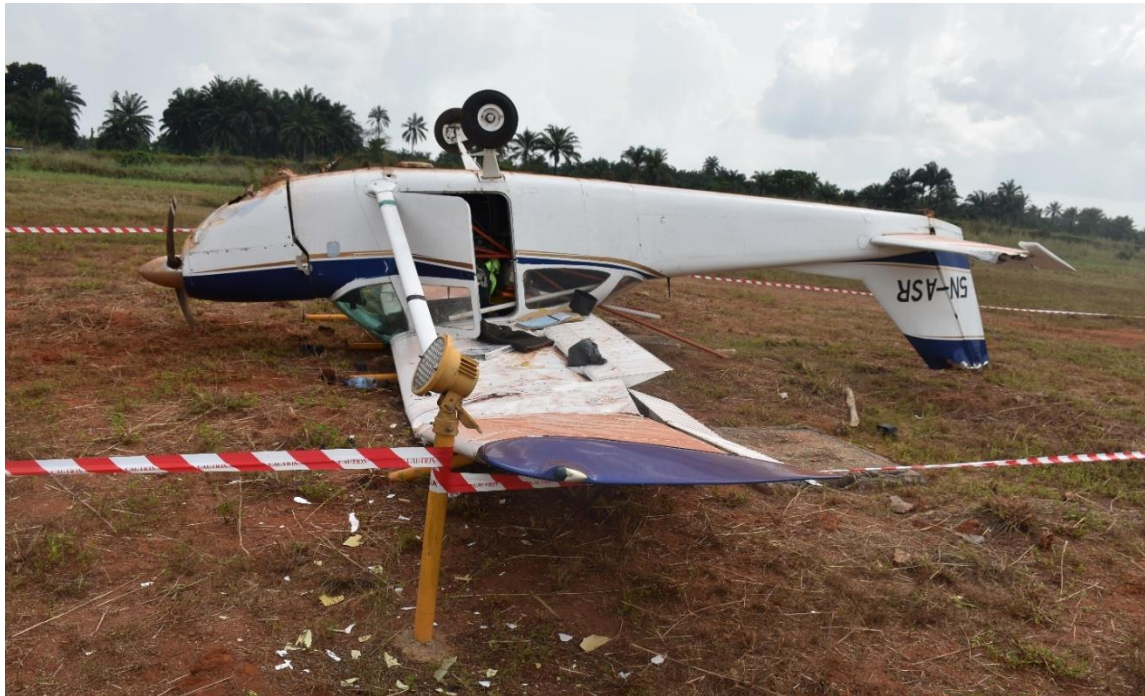
The aircraft was found relatively intact, overturned onto its wings and with its nose pointing away from Runway 17 and towards the Approach Path. Five approach lights were trapped underneath the wreckage.

The Right Wing was found bent downward at about a 30-degree angle, beginning about 2.3 m from the Wing Root. The left Wing was dented and twisted slightly downward at the Leading Edge Wingtip. Approach Light Poles had punctured both Wings tanks. There was no evidence of fluid spillage, such as aviation fuel, hydraulic fluid, or engine oil. The Flaps were in the Fully Extended Position; the Left Aileron was found in the UP position, while the right aileron was in the DOWN position.

Figure 5: Aircraft final position viewed from the right side

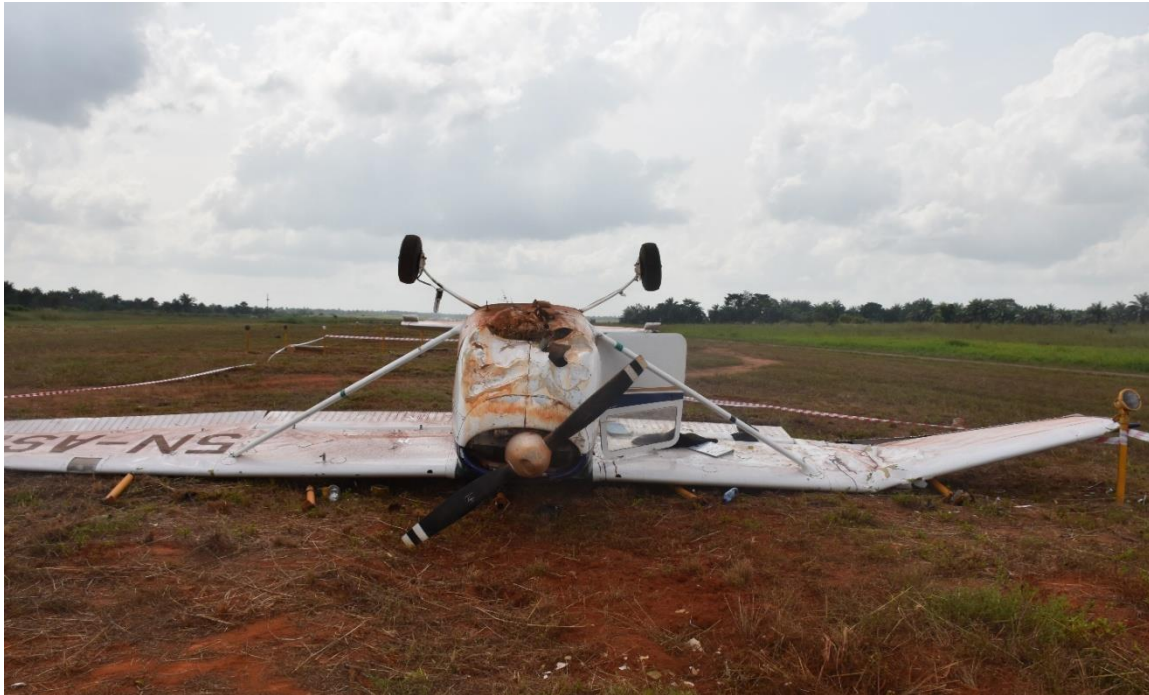
The aircraft wreckage was found about 270 m from the threshold of Runway 17, at the coordinates 5°26' 28.8384"N, 7°12'9.8028"E, about 24 m from the edge of the access road.

Figure 6: Aircraft at its final position

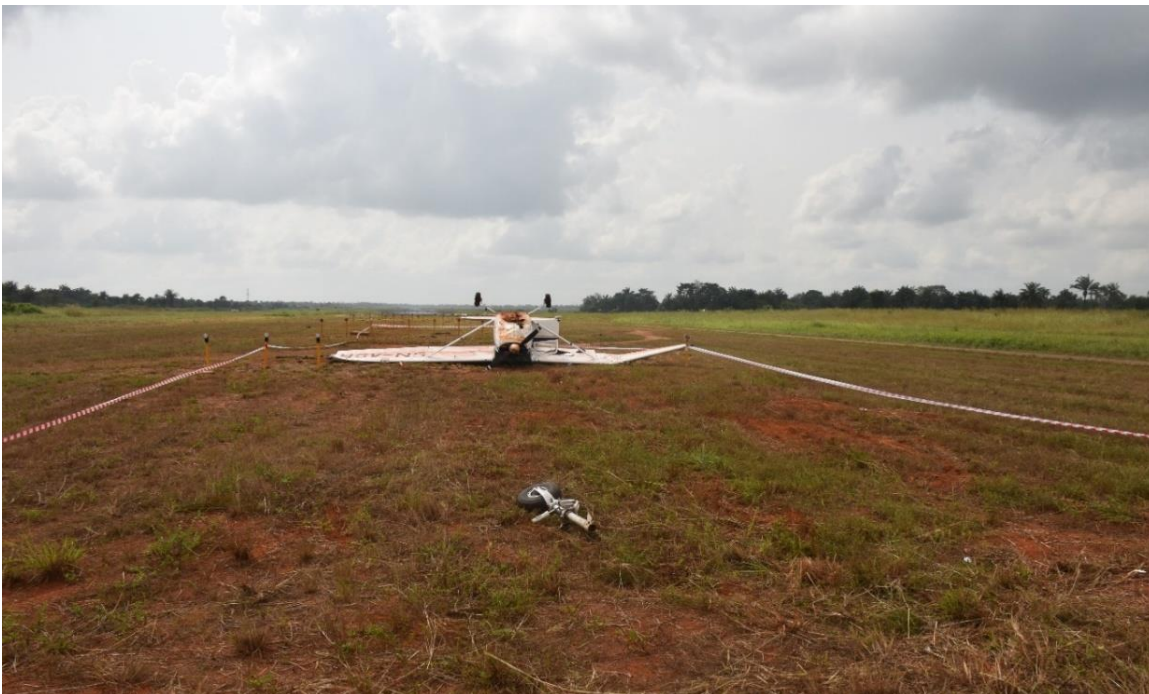
The tip of the vertical stabilizer was damaged by impact with the ground after the aircraft overturned, and served to prop the aircraft in its inverted position. The Right Horizontal Stabilizer was dented on its Leading Edge towards the Wingtip, with paint

Figure 7: Some views of the aircraft at the occurrence site

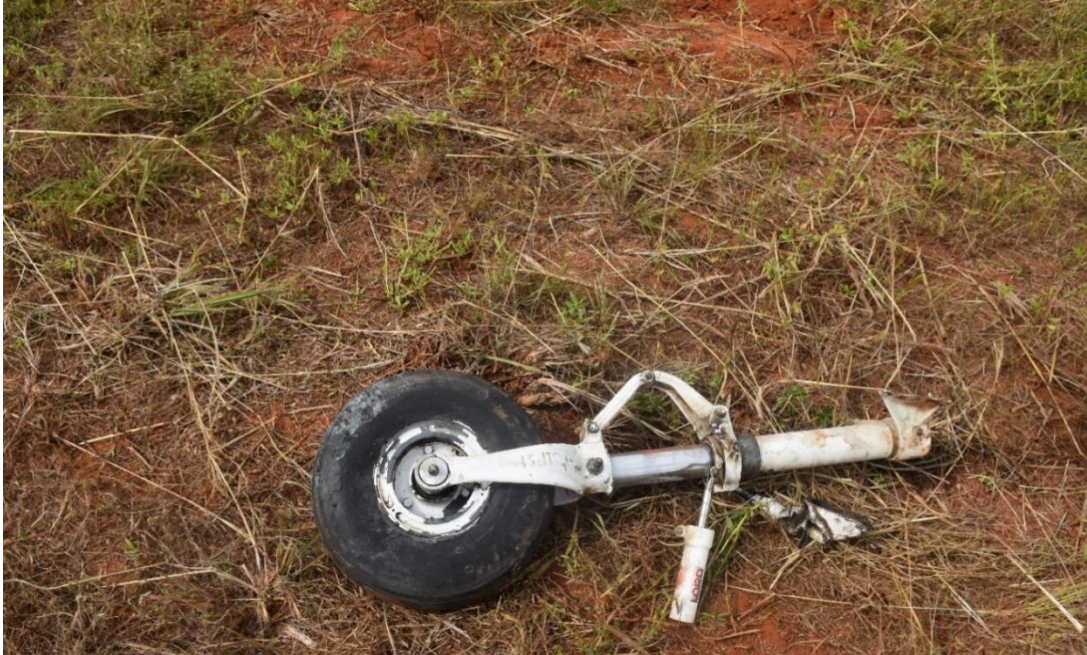
The Nose Landing Gear, detached from the Engine Firewall, and was found 17 m away from the main wreckage. The skin of the lower engine cowling at the point of detachment of the nose landing gear was torn and dented due to impact with terrain.

Dislodged earth and dried grass were found embedded in the torn skin. The Nose and Main Landing Gear Tyres remained inflated.

Figure 8: The detached nose landing gear

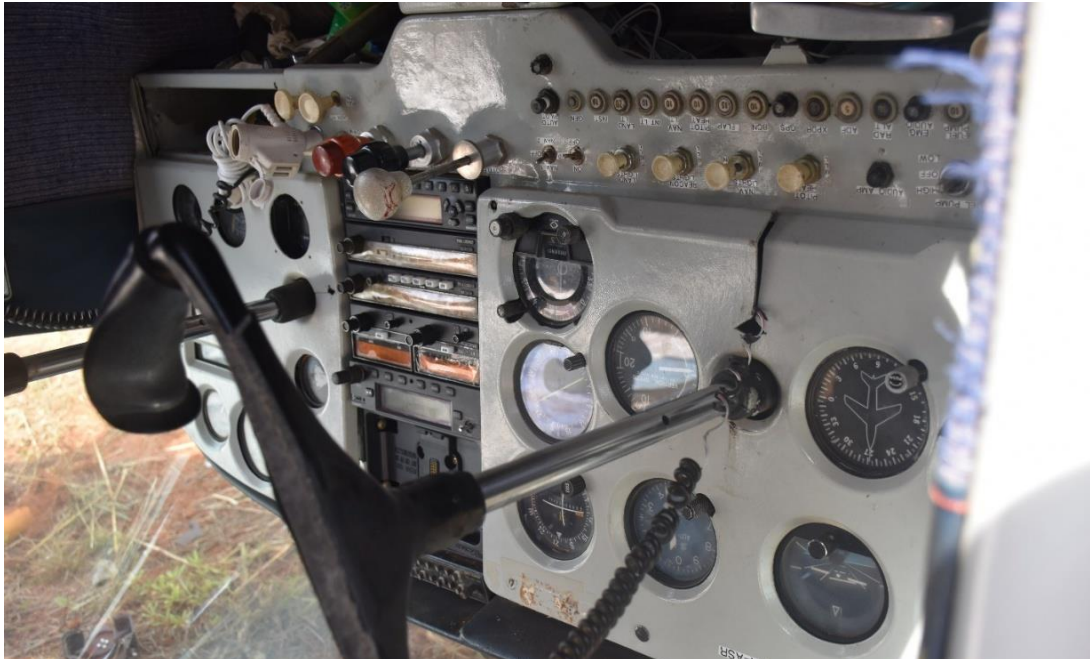
Figure 9: A view of the instrument panel in the overturned aircraft

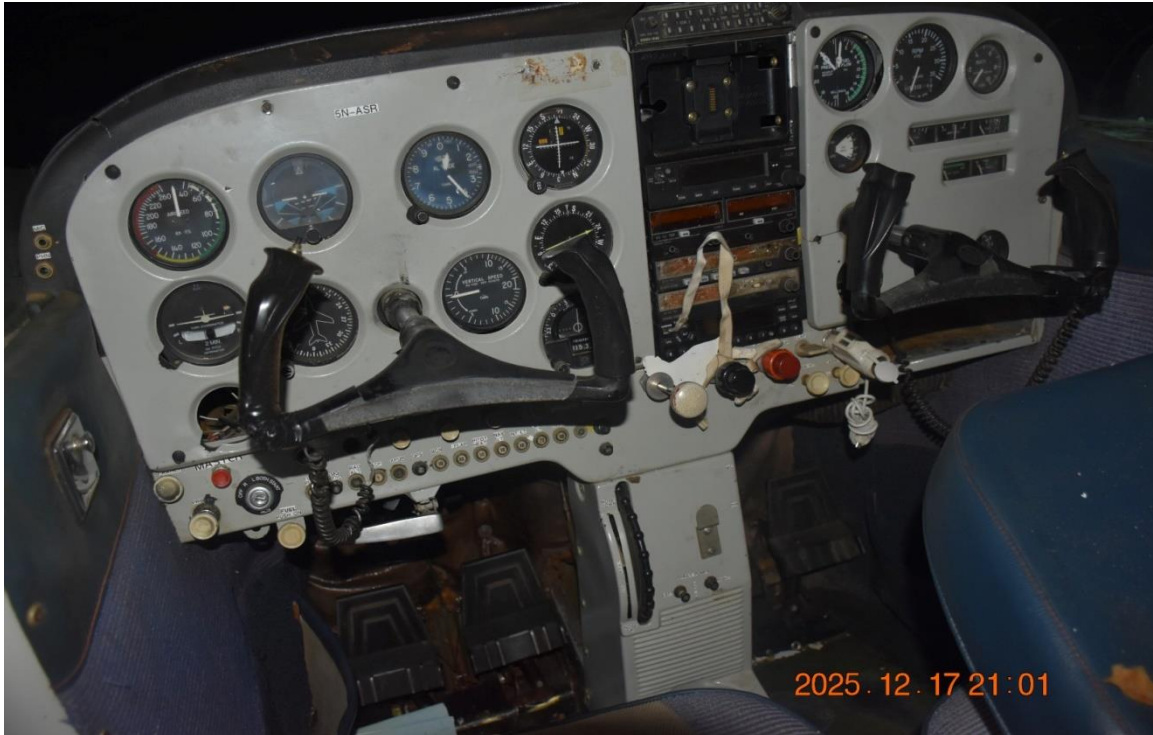
The Right-Side Cabin Door was found open, while the Left-Side Cabin Door was found closed and latched from the inside. The inspection of the Cabin showed that the Front Seats remained attached to the Seat Rails while the Rear Seats had detached from the Floor Attachment Points. The Rear Passenger Seats were attached to the aircraft floor at four points, two fore and two aft. The Fore Attachment points were found fractured transversely along the diameter of the Bolt Holes, while the aft attachment points were found whole, although the Mounting Bolts were not found.

The Windshield was found intact. The right section of the Rear Windows had been punctured by Banner Towing Equipment located inside the Cabin. The left section of the Rear Windows, as well as the passenger-side window, was broken.

Figure 10: The aircraft cockpit area
