Preliminary Report on the Derailment of train number AK 1 (Abuja-Kaduna) with locomotive number CDD5c2 2701, operated by Nigerian Railway Corporation which occurred at Km 49 Kubwa-Asham section, Kagarko Local Government Area, Kaduna State, on 26 August 2025.

Train operator:	Nigerian Railway Corporation
Track operator:	Nigerian Railway Corporation
District:	Abuja Kaduna Train Service (AKTS)
Occurrence category:	Train derailment
Location:	Asham Train Station, Abuja–Kaduna rail line, Coordinate 9°25'04"N, 7°21'36"E
Train number:	AK 1
Service route:	Abuja – Kaduna (AK1)
Type of operations:	Passenger
Departure station:	Idu Station, Abuja
Destination station:	Rigasa Station, Kaduna
Persons on board:	618
Crew on Board:	Driver, assistant driver, conductors/guards, security, service staff
Injuries:	21
Date and Time:	26 August 2025 at 11: 09 h.
Front Locomotive number:	CDD5c2 2701
Rear Locomotive number:	CDD5c1 W0004
Passenger Coaches:	Eight coaches

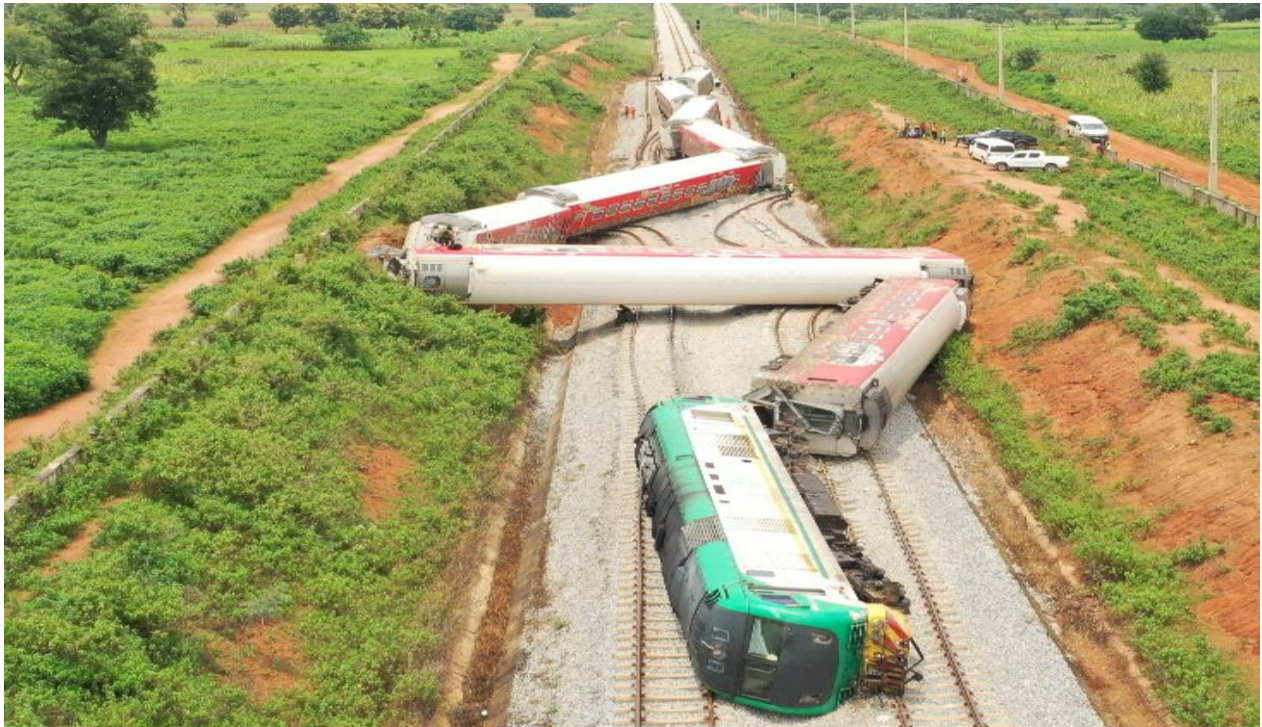
At approximately 11:09 h, the train derailed with the forward locomotive and two adjoining coaches overturned, the last coach and the rear locomotive remained on the track. The derailment caused significant damage to the track infrastructure, including rails, sleepers, and the switching mechanism.

Figure 2: The Accident site view from the plan

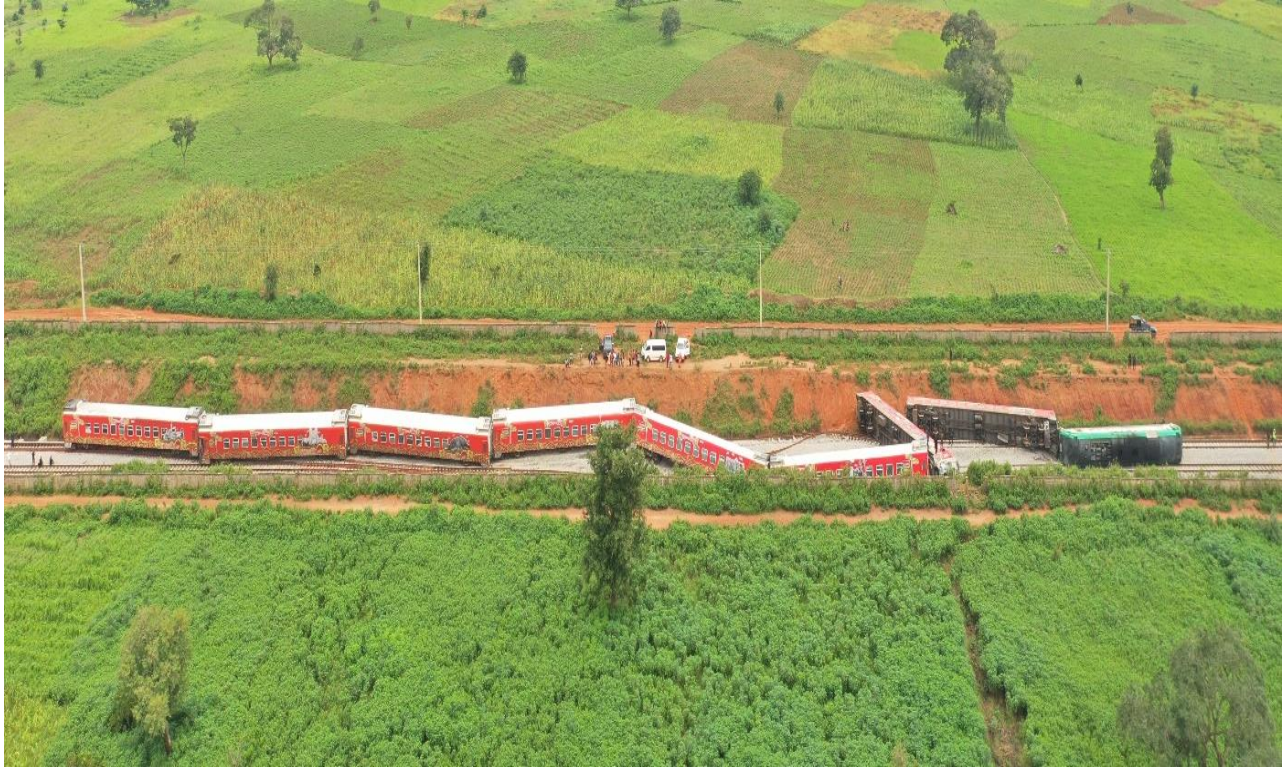
**Figure 3:** The side view from the Accident site

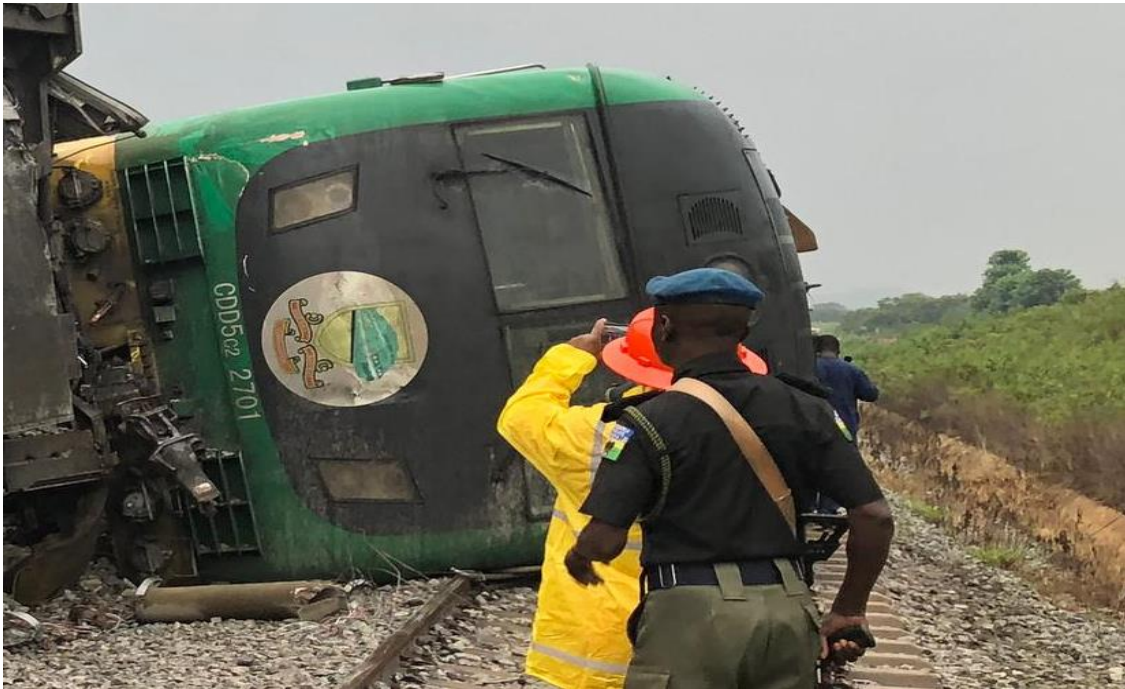
1. The forward locomotive (CDD5c2 2701) and two adjoining coaches (SC 0002T and SC 0004T) derailed and overturned
2. Five coaches (SC 0006T, SC 0008T, SC 00010T, E 0002S, and EB 0002S) derailed and remained standing
3. The switch and turnout mechanism (point clip) broke
4. Coach SC 0008T, which derailed while standing, sustained damage to the battery box and brake disk.
5. Coach SC 0002T, which overturned, sustained damage to the coupler.
6. The locomotive, which also overturned, sustained damage to the tank, traction motor cover, and dampers.
7. On Line 1, a total of 300 concrete sleepers and 1,200 fasteners were damaged.
8. On Line 2, 140 concrete sleepers and 560 fasteners were damaged.

Figure 4: The overturned forward Locomotive

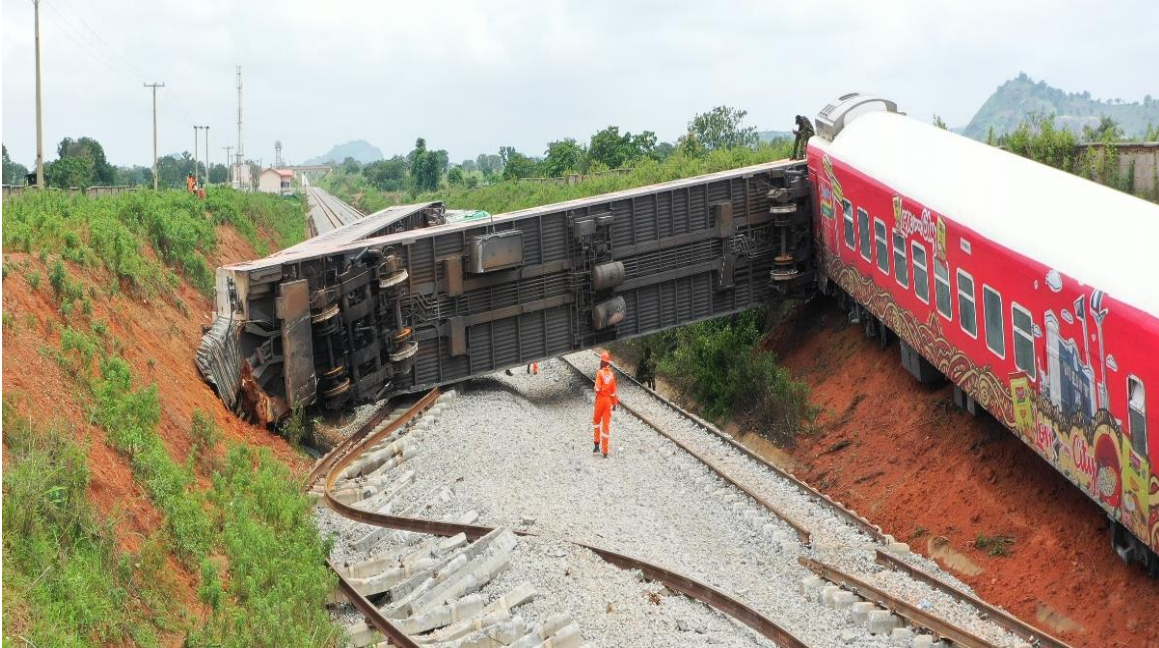
Figure 5: The overturned coaches.

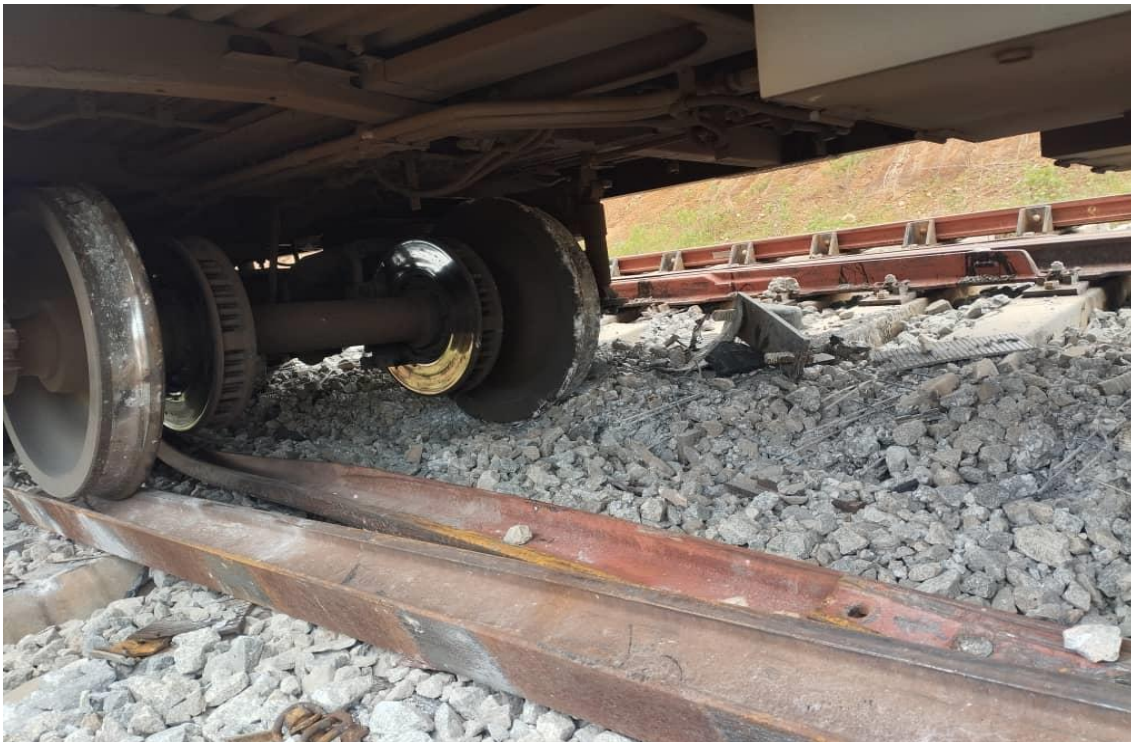
Figure 6: The point at which the Train derailed

7. At 10:45 h, the train departed Kubwa Station for Asham Station en route to Rigasa Station.
8. The train derailed shortly after passing the track switch point at Asham Station.

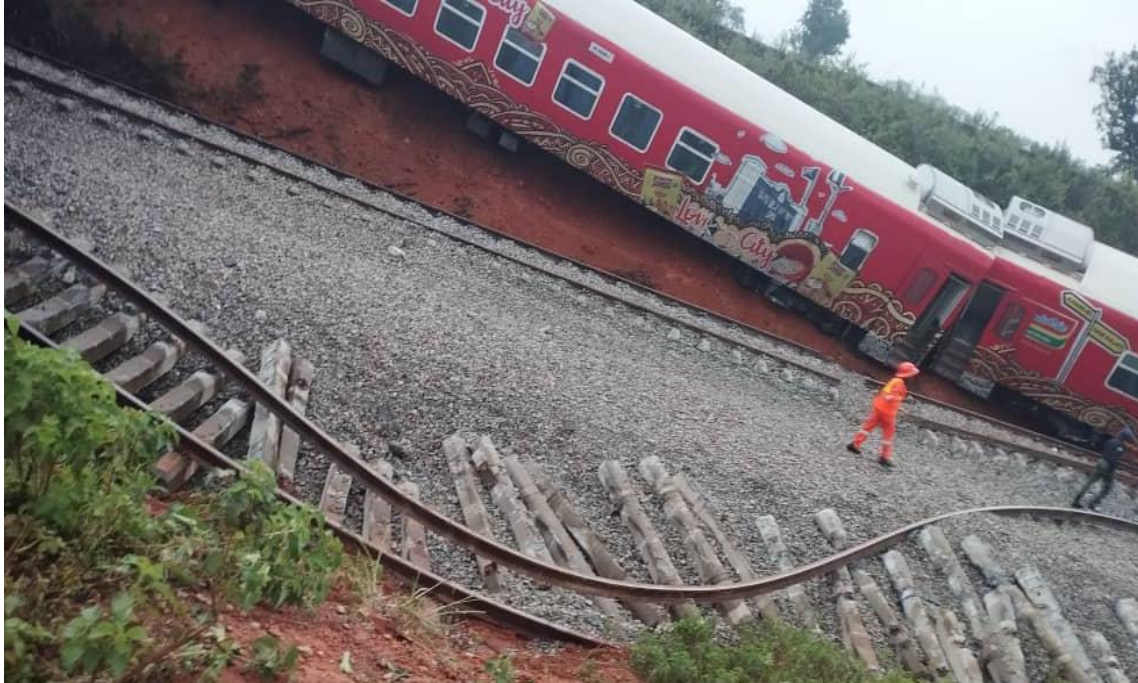
9. At the point and crossing, 165 crossing concrete sleepers, together with various fasteners, bolts, and nuts, were damaged, along with the edge of the switch rail and two signal lights.

Figure 7: Damaged railway track, sleepers and displaced ballast after the Accident

9. The forward locomotive and seven adjoining coaches derailed.
10. The occurrence was the second derailment at Asham Station within 13 months.
11. Some sleepers at Asham Station that had been damaged in the previous occurrence were only patched.

The Nigerian Railway Corporation should ensure that all sleepers affected by derailments are replaced to guarantee track stability and prevent further derailments.

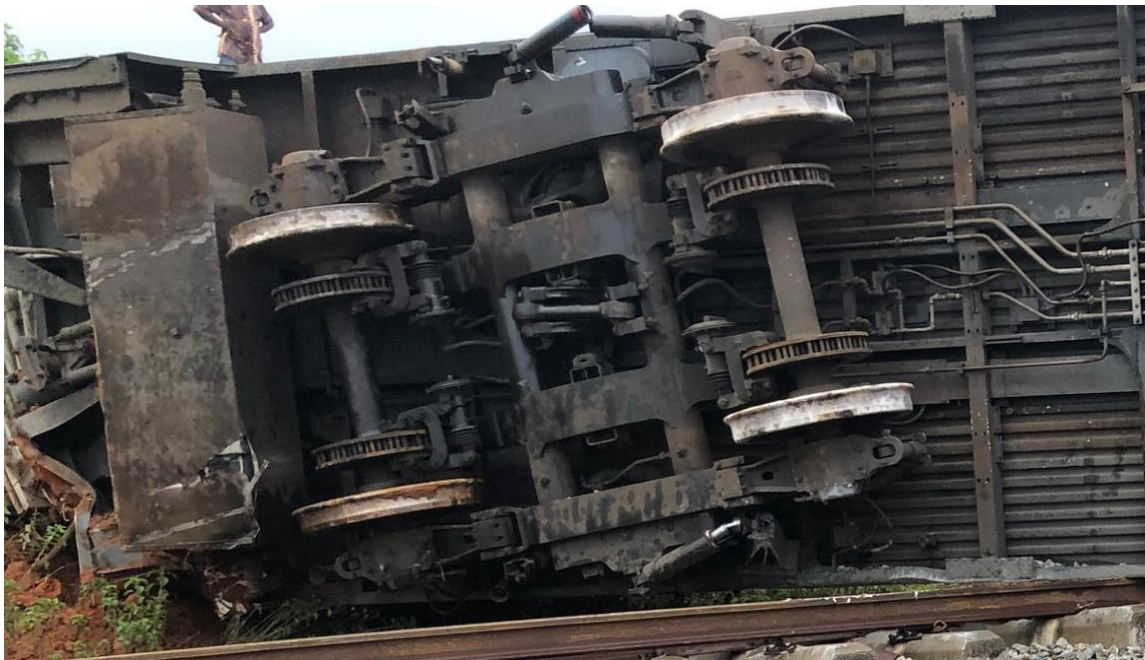
Figure 8: The overturned coach laying across the railway track after the Accident

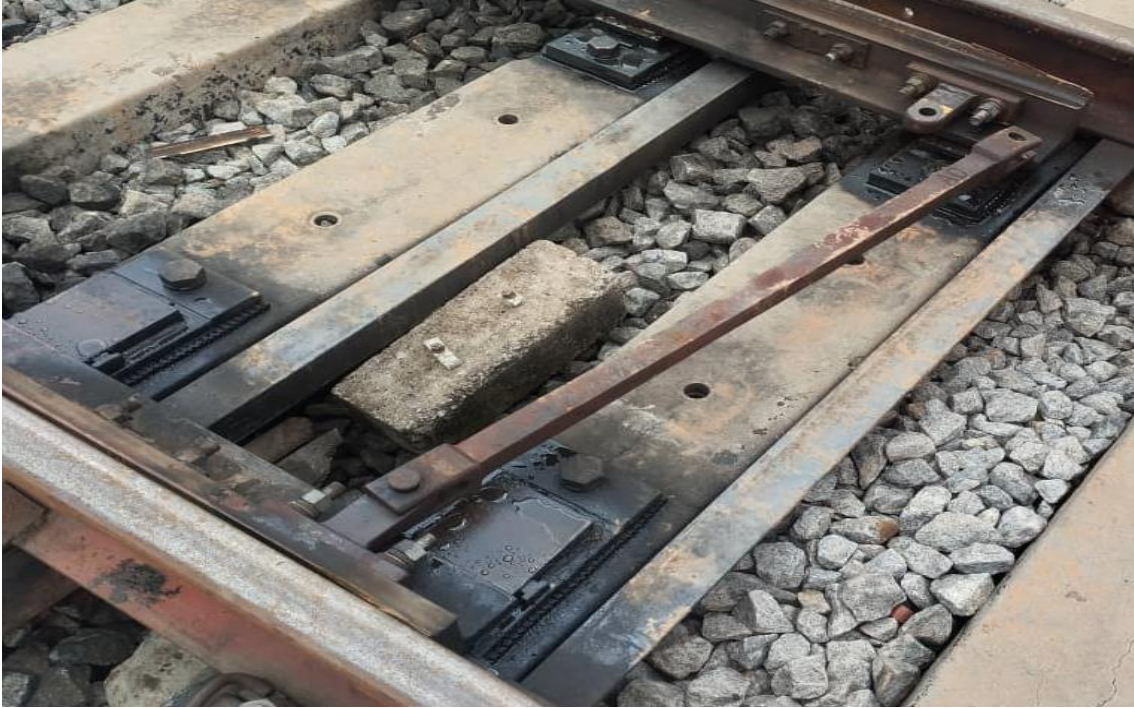
Figure 9: The change point at Asham Station

Asham station has northern and southern switch point, and the track change at the station is manually operated for now, as the electrical switch was unserviceable as at the time of occurrence.

12. The Asham Station automatic crossing point switch mechanism was found unserviceable.
13. The switched point was manually operated and locked with the point clip

The Nigerian Railway Corporation should consider replacing all point switches at Asham Station and along the Abuja–Kaduna route with Original Equipment Manufacturer (OEM) parts to ensure reliability and safety in switch operations, thereby reducing the risk of accidents.

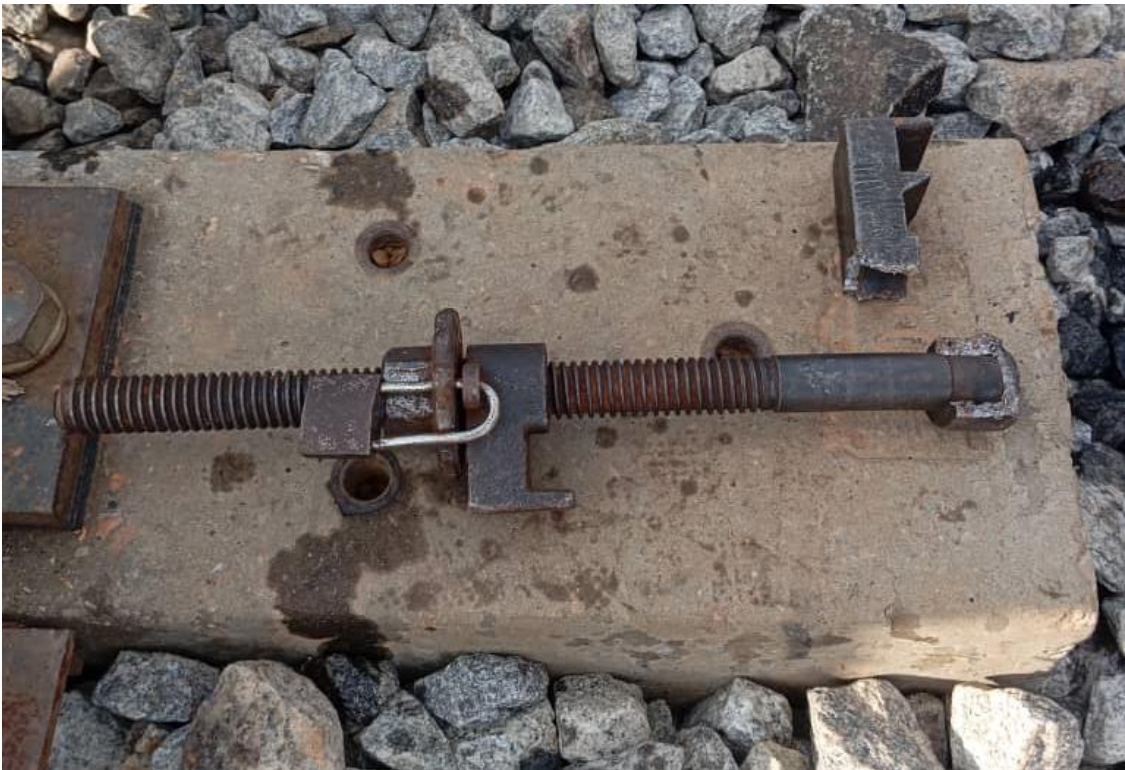
Figure 10: Broken point clip

14. The point clip was broken.
15. NRC personnel had only initial training and no formal refresher training.
16. Operational and maintenance equipment, including spare OEM parts, were not readily accessible.
