PRELIMINARY REPORT ON THE SERIOUS INCIDENT INVOLVING DORNIER 328-100 AIRCRAFT OPERATED BY DORNIER AVIATION NIGERIA AIEP (DANA) LIMITED WITH NATIONALITY AND REGISTRATION MARKS 5N-DOX WHICH OCCURRED AT PORT HARCOURT MILITARY AIRPORT ON 23RD JANUARY, 2019

Registered Owner:	Dornier Aerospace International (DASI) GMBH, 6020 Innsbruck, Austria
Registered Operator:	Dornier Aviation Nigeria AIEP (DANA) Limited, Kaduna
Aircraft Type and Model:	Dornier 328 - 100
Manufacturer:	Fairchild Dornier Luftfahrt GMBH, Germany
Date of Manufacture:	1997
Registration Marks:	5N-DOX
Serial Number:	3073
Location:	Port Harcourt Military Airport, Port Harcourt
Date and Time:	23 rd January, 2019 at about 10:03 h

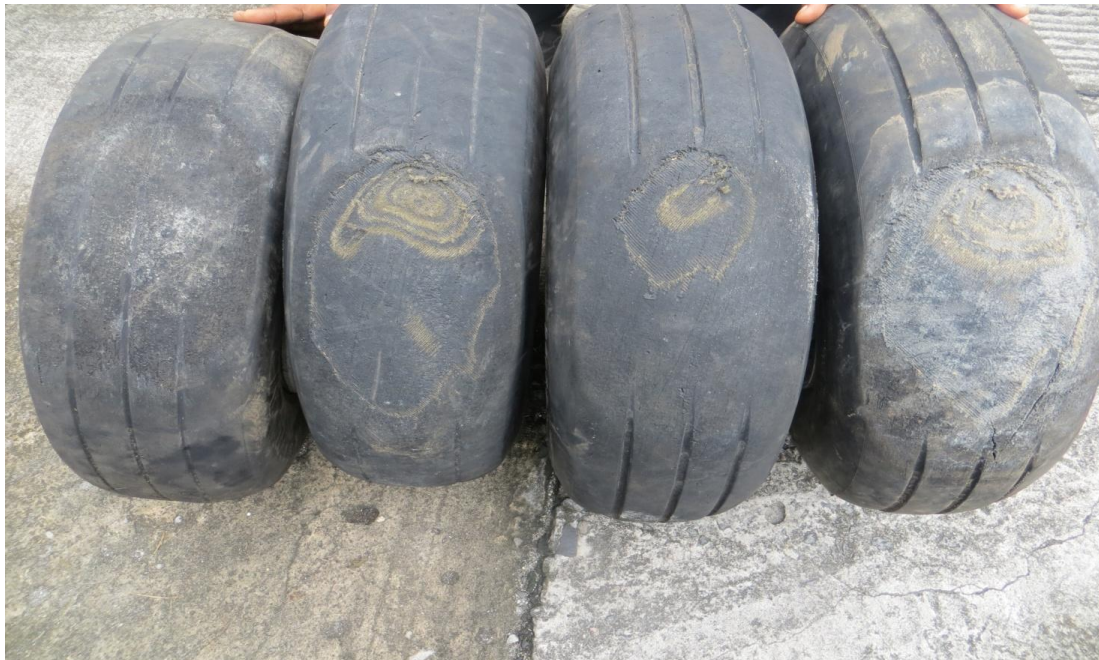
The aircraft was structurally intact although the main wheel tyres were flat-spotted as a result of the braking action.

Figure 1: Photo showing the aircraft's flat spotted main wheel tyres

- I. "L/H engine propeller will not come out of feather" and the corrective action taken was "L/H PCU replaced IAW Do 328 MM 61-21-00. OPS, Rig check, Leak check, OK".
- II. "#1, #2, #3, #4 tires flat spotted" and the corrective action taken was "Replaced #1, #2, #3, #4 main wheel ASSYS IAW Do 328 MM SC 32-41-10".

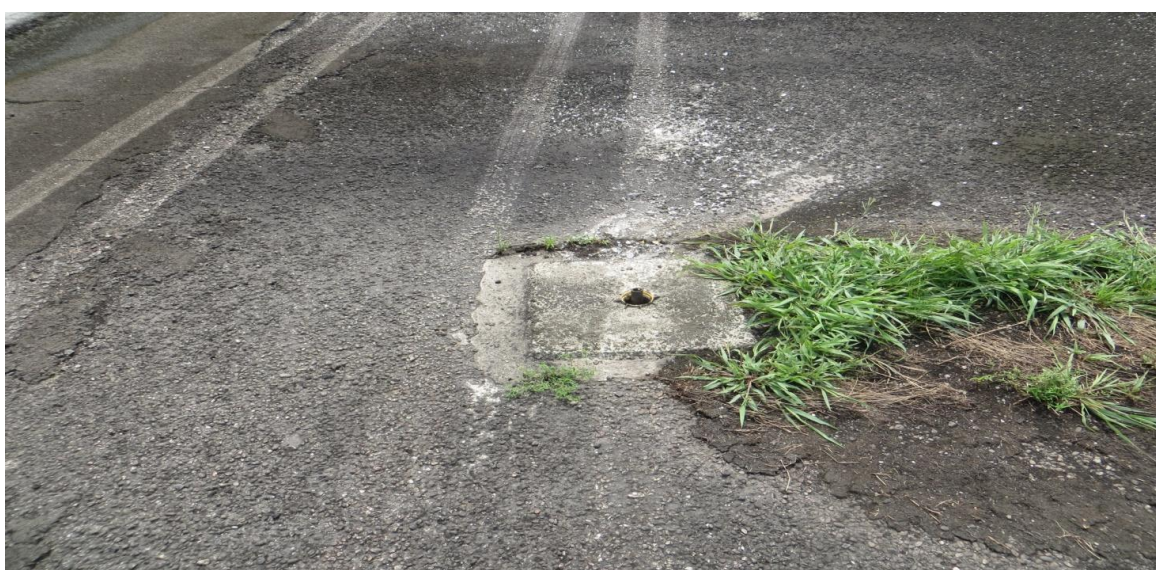
The No. 4 right main tyre impacted and broke a runway edge light before the aircraft entered the grass verge.

Figure 2: Photo showing the damaged runway edge light

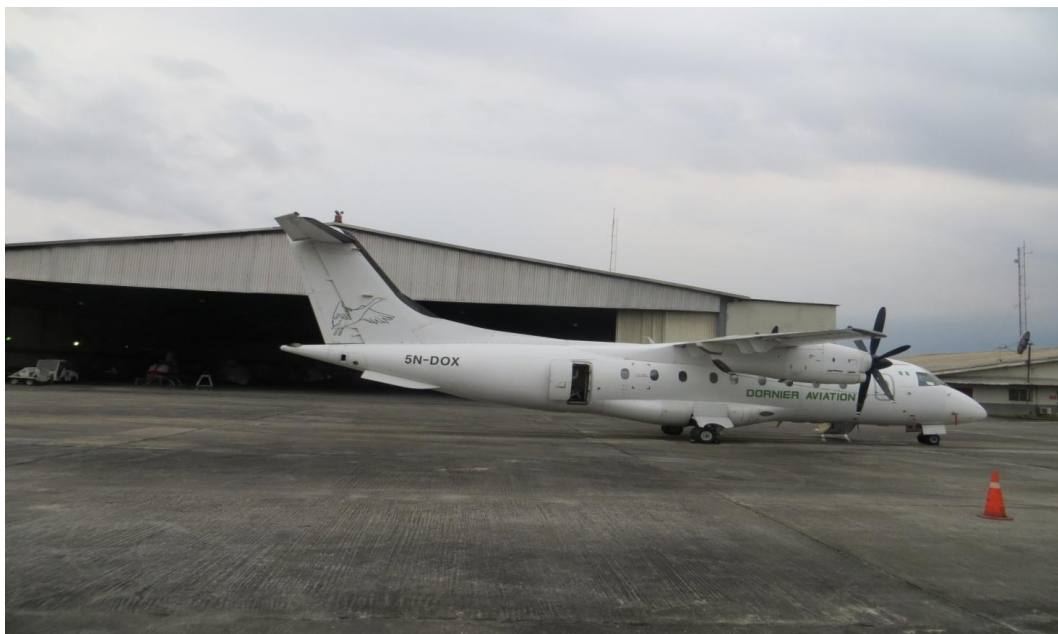
Figure 3: Photo showing the incident aircraft

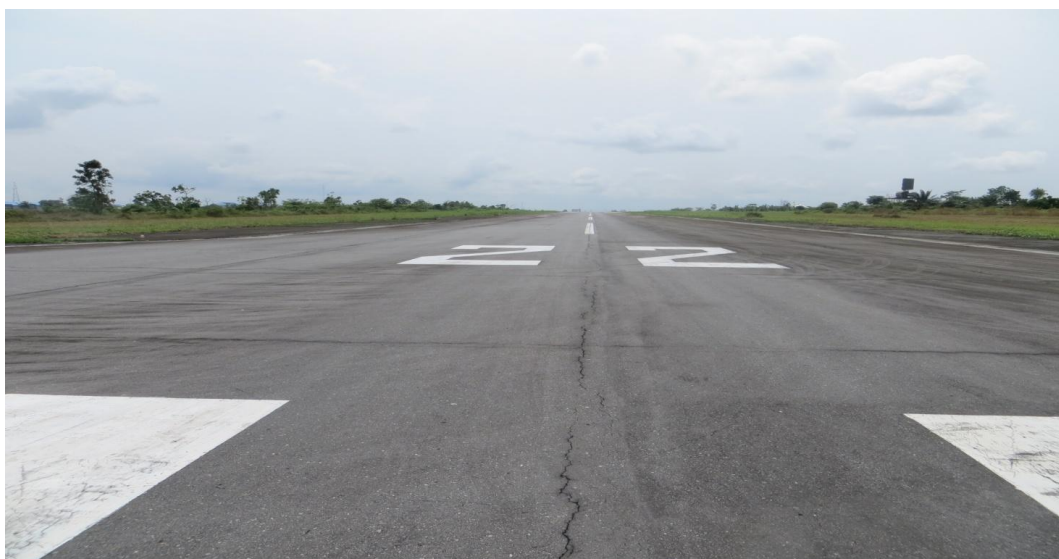
Figure 4: Photo showing the Threshold of runway 22

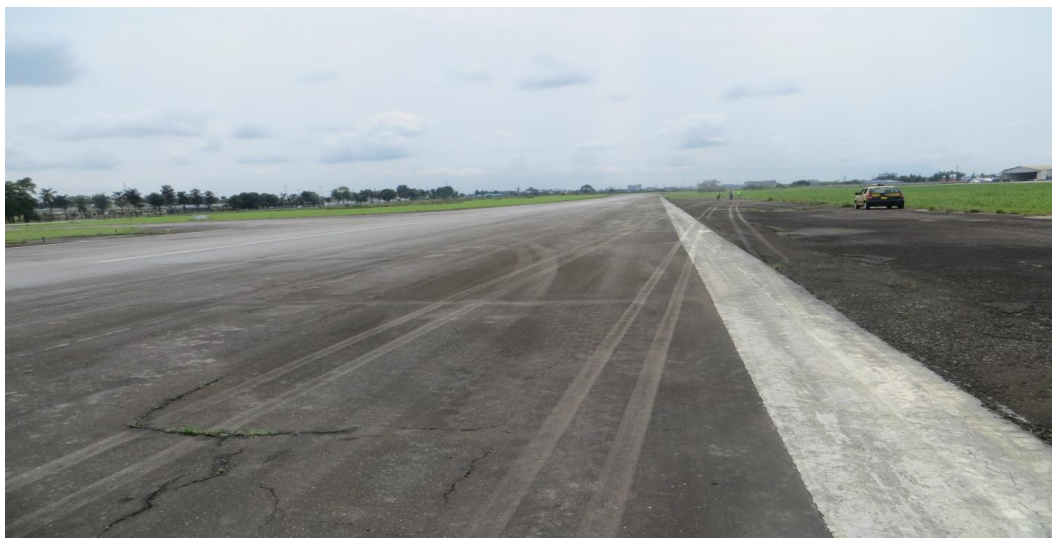
The aircraft exited Runway 22 at a distance of about 1, 190 metres from the threshold and travelled on the runway shoulder for a distance of about 105 metres, during which the No.4 right main tyre impacted and broke a runway edge light at about 98 metres before it entered the grass verge and covered a distance of about 262 metres. The aircraft travelled an additional distance of about 259 metres on the apron and stopped at about 3 metres to the airport perimeter fence by the Aero Contractor’s ramp.

Figure 5: Photo showing the aircraft's tyre marks on the runway and the exit point

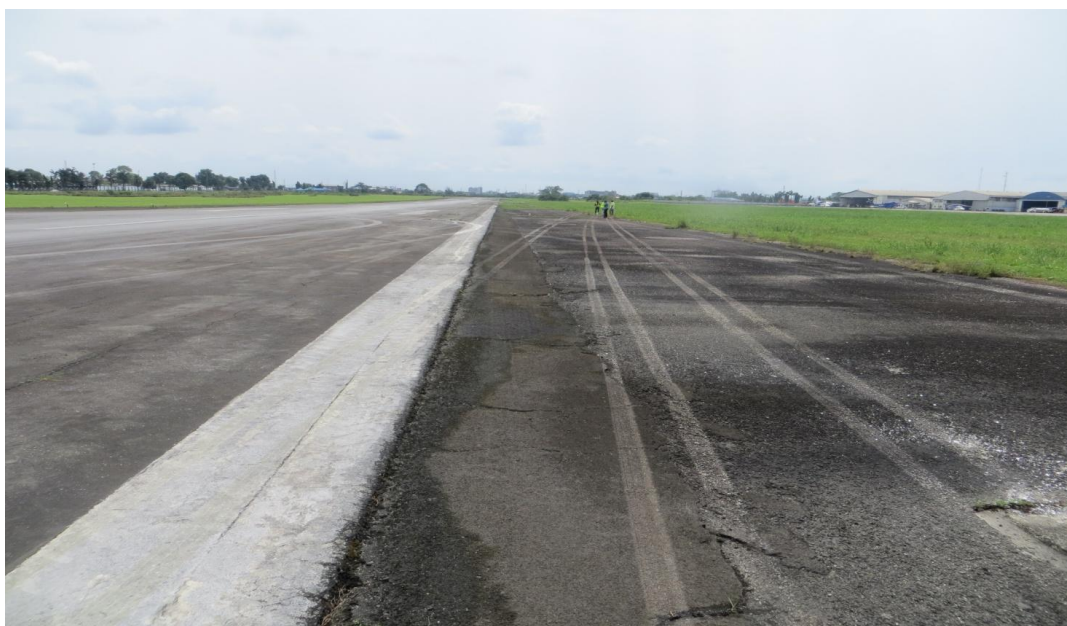
Figure 6: Photo showing the aircraft tyre marks on runway shoulder

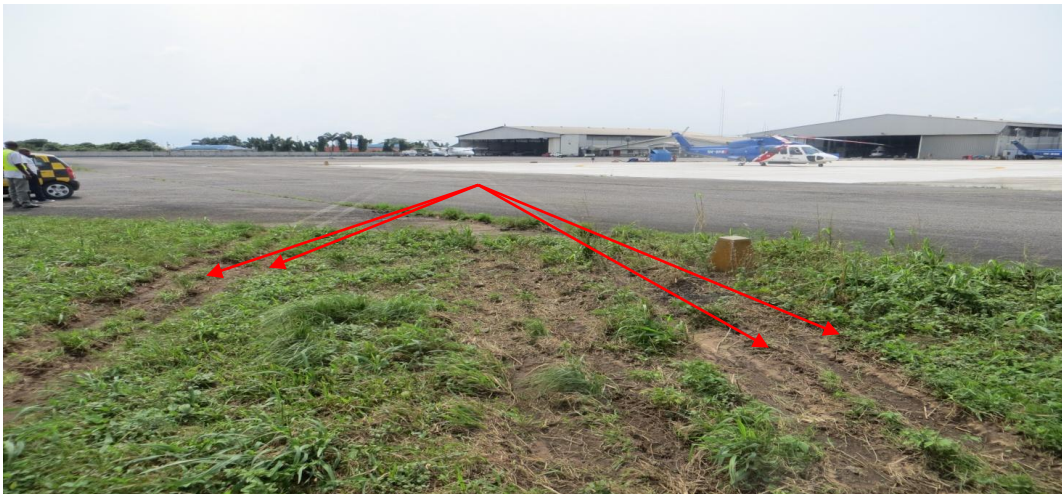
Figure 7: Photo showing the aircraft's tyre marks on the grass

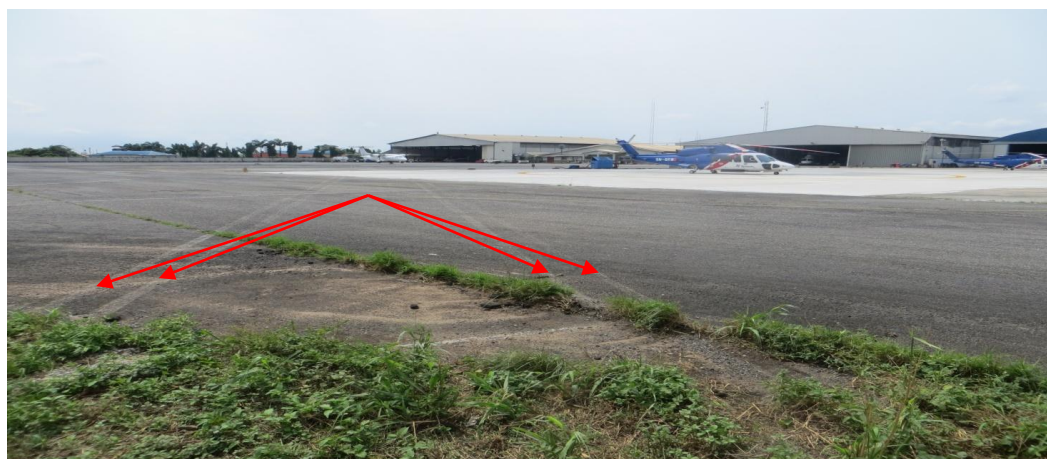
Figure 8: Photo showing the aircraft's tyre marks on the Apron

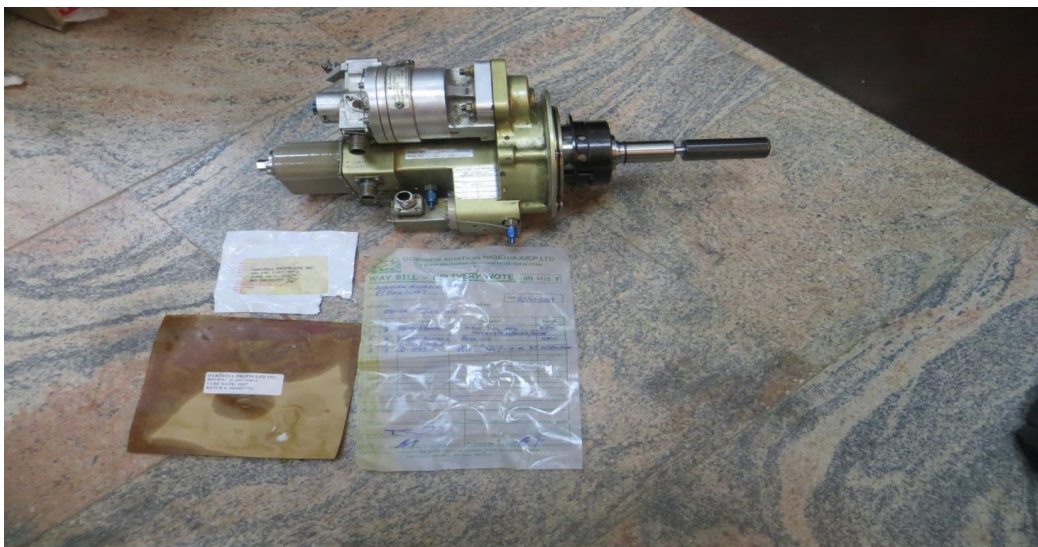
At 10:03 h, the aircraft landed to the right of the runway centre line. The crew further stated that during the landing roll, with the power levers at ground idle position, torque on Engine Number 1 was 27% and increased to a maximum of 34%. The torque on Engine Number 2 decreased below 10%. The aircraft veered further to the right of the runway centre line and could not be controlled with rudder application. According to the First Officer, the crew shared responsibilities in accordance with the company's Standard Operating Procedure (SOP); the Captain took over control while the First Officer engaged the emergency brake, set both condition levers to minimum and feather positions in an attempt to stop the aircraft.

Figure 9: Photo showing the defective left engine PCU

- Analysis of the FDR data.
- Awaiting Original Equipment Manufacturer (OEM) tear down report on defective Left Engine PCU.
