PRELIMINARY REPORT ON SERIOUS INCIDENT INVOLVING BOEING 737-500 AIRCRAFT BELONGING TO AZMAN AIR SERVICES LIMITED WITH REGISTRATION MARKS 5N-AIS WHICH OCCURRED DURING APPROACH TO PORT HARCOURT INTERNATIONAL AIRPORT ON 3RD JANUARY, 2019

Registered Owner and Operator:	Azman Air Services Limited
Aircraft Type and Model:	Boeing 737-5L9
Manufacturer:	Boeing Aircraft Company
Date of Manufacture:	September, 1998
Registration Number:	5N-AIS
Serial Number:	29235
Location:	On Approach to Port Harcourt International Airport
Date and Time:	3 rd January, 2019 at about 10:55 h (All times in this report are local time (UTC +1) unless otherwise stated)

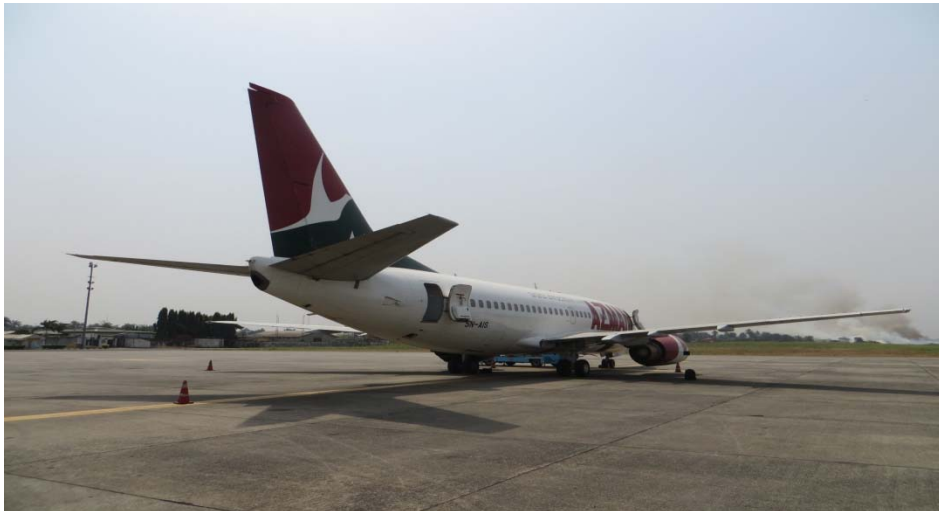
The aircraft was not damaged

Figure 1: The aircraft after the incident
