**PRELIMINARY REPORT ON SERIOUS INCIDENT INVOLVING BRISTOW HELICOPTERS NIGERIA LTD EMBRAER 135 AIRCRAFT WITH NATIONALITY AND REGISTRATION MARKS 5N-BSN WHICH OCCURRED AT PORT HARCOURT MILITARY AIRPORT (NAF BASE), PORT HARCOURT ON THE 9TH OF MARCH 2020**

<b>Registered Owner and Operator:</b>	Bristow Helicopters (Nigeria) Limited
<b>Aircraft Type and Model:</b>	Embraer EMB-135ER
<b>Manufacturer:</b>	Empresa Brasileira de Aeronautica SA, Brasilia
<b>Year of Manufacture:</b>	1999
<b>Nationality and Registration Marks:</b>	5N-BSN
<b>Serial Number:</b>	145198
<b>Location:</b>	Port Harcourt Military Airport (NAF Base)
<b>Date and Time:</b>	9th March, 2020

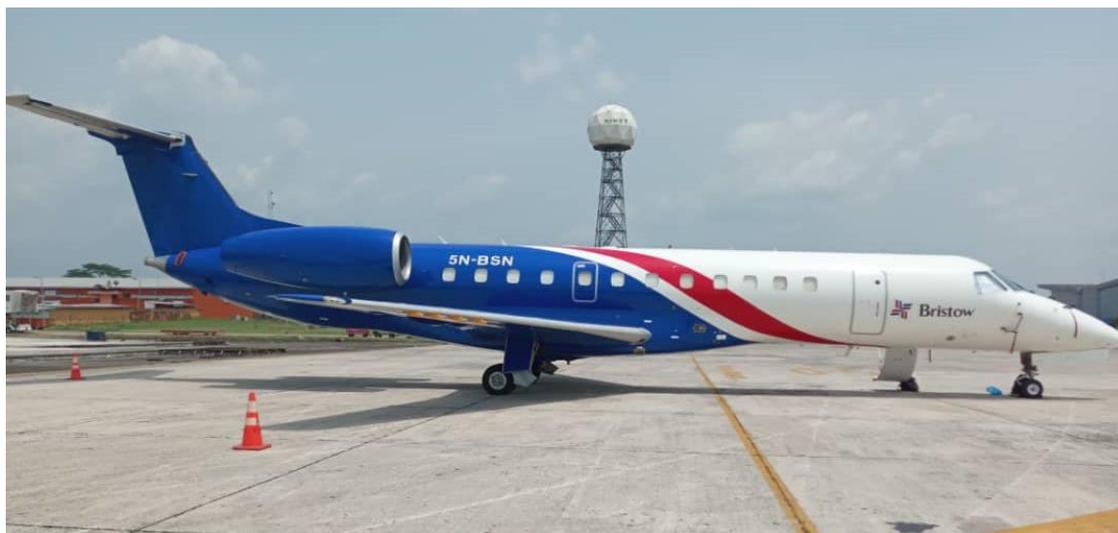
**Figure 1:** 5N-BSN parked on the Apron at DNPO after occurrence

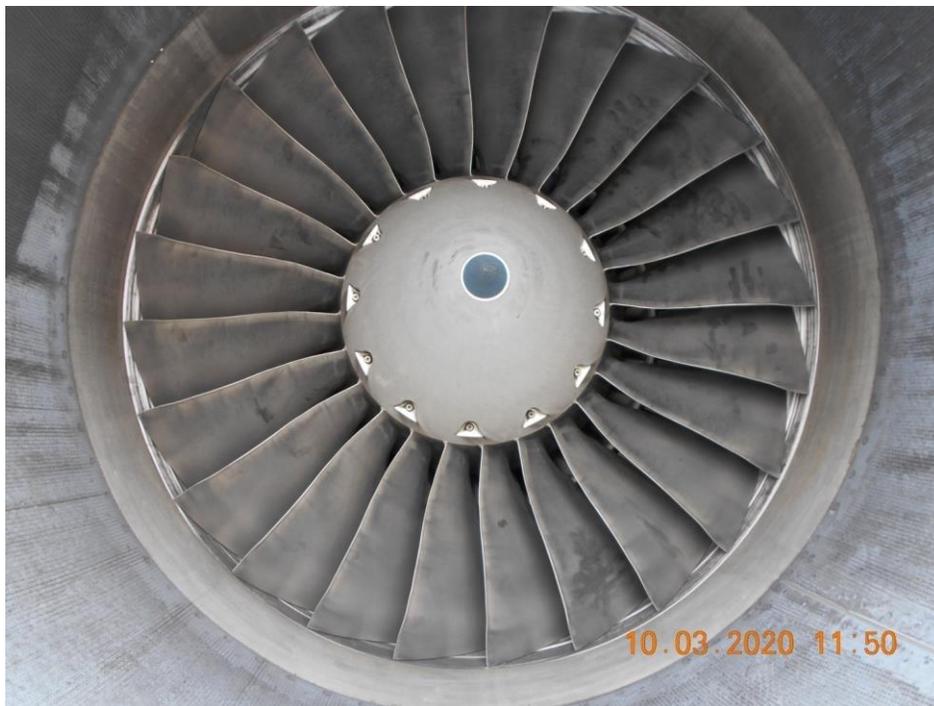
**Figure 2:** Engine Number 1 after the incident

Some debris were found on the left engine tail pipe.

13. The Airport Rescue and Fire Fighting Services (ARFFS) were on stand-by Port Harcourt International airport before the arrival of 5N-BSN.
14. Debris were found in the left engine tail pipe.

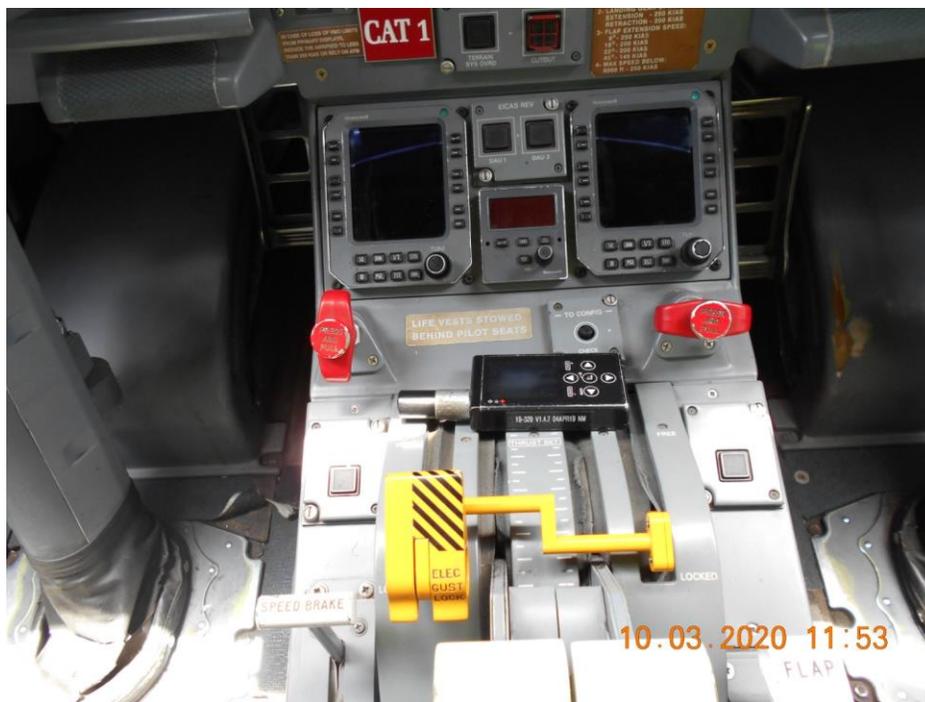
**Figure 3:** Position of engine number 1 fire handle at post occurrence inspection
