# PRELIMINARY REPORT

**Accident Investigation Bureau**

**Report on the Serious Incident involving BAe 125-800B aircraft with nationality and registration marks 5N-B00 operated by Gyro Aviation Limited which occurred at Port-Harcourt Nigeria on 16th July, 2020.**

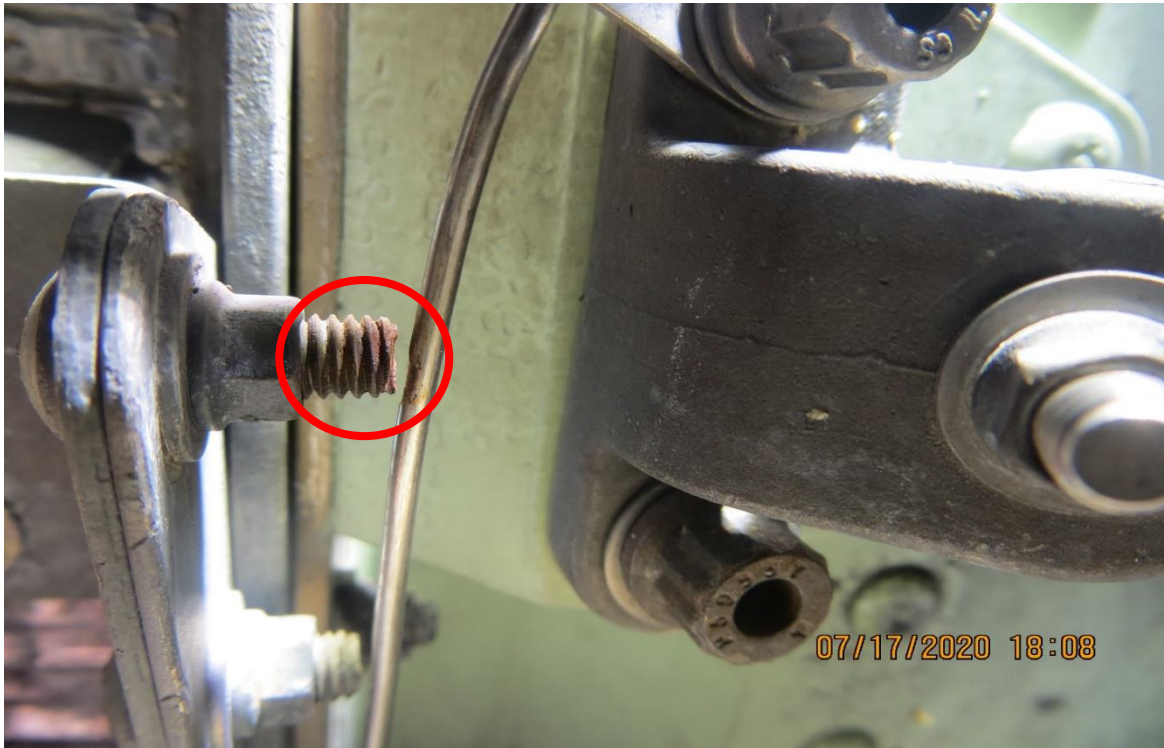
Post flight inspection of the engine by the crew revealed no fire damage or any sign of fire (smell or otherwise).

Visual examination of the number 1 engine revealed an evidence of intermittent contact between the fire detecting circuits (fire wire) and a part of the engine.

**Figure 2:** Point of contact between the fire detecting circuits (fire wire) and a part of the engine
