PRELIMINARY REPORT

Accident Investigation Bureau

Preliminary Report on Accident involving a Bell 206B III Helicopter with nationality and registration marks 5N-BQW operated by Quorum Aviation Limited (QAL) which occurred at Opebi Area, Lagos On 28th August, 2020

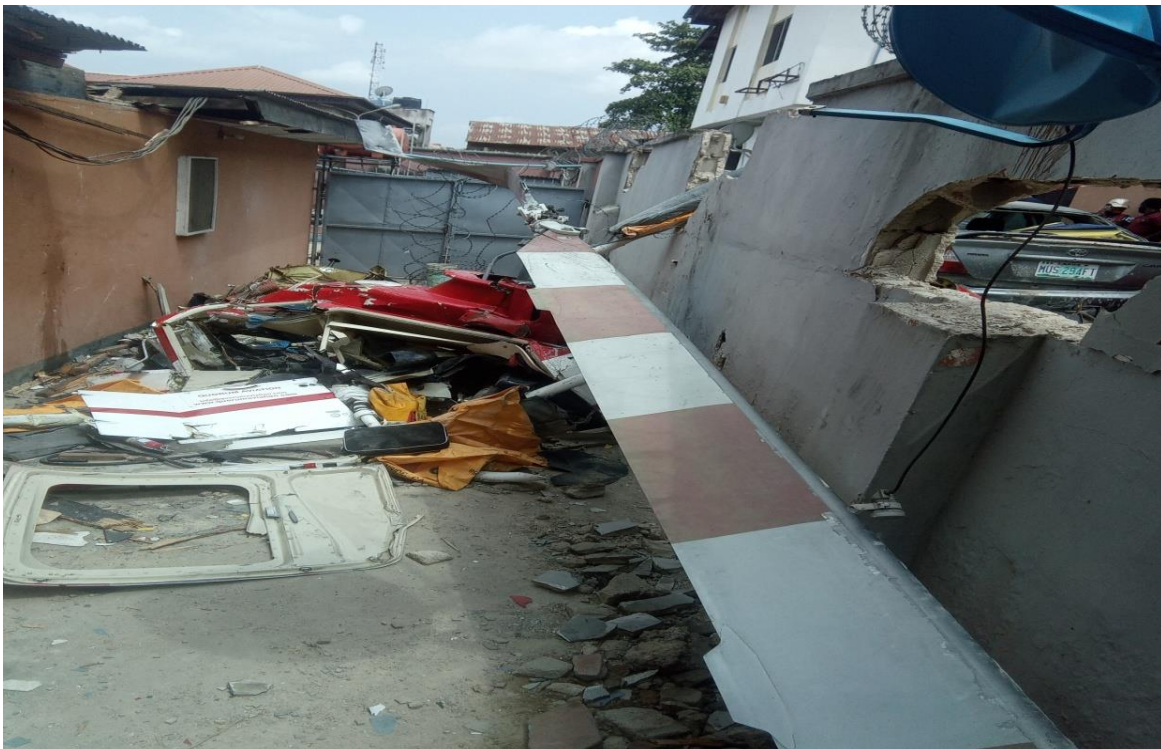
The helicopter crashed into the roof of a building and a wall fence impacting two vehicles parked in the compound. The mast and main rotor blades were found intact during the post-crash inspection. Post occurrence examination revealed that the fuel tanks were empty.

Figure 1: The wreckage of 5N-BQW at the site of the crash
