PRELIMINARY REPORT ON SERIOUS INCIDENT INVOLVING DORNIER 328-100 AIRCRAFT OPERATED BY DORNIER AVIATION NIGERIA AIEP (DANA) LIMITED WITH NATIONALITY AND REGISTRATION MARKS 5N-BUN WHICH OCCURRED AT MURTALA MUHAMMED AIRPORT ON 14TH MARCH, 2021

Aircraft type and model: Dornier 328-100

Location: Runway 18L, Murtala Muhammed Airport, Lagos.

Date and Time: 14th March, 2021 at about 15:44 h

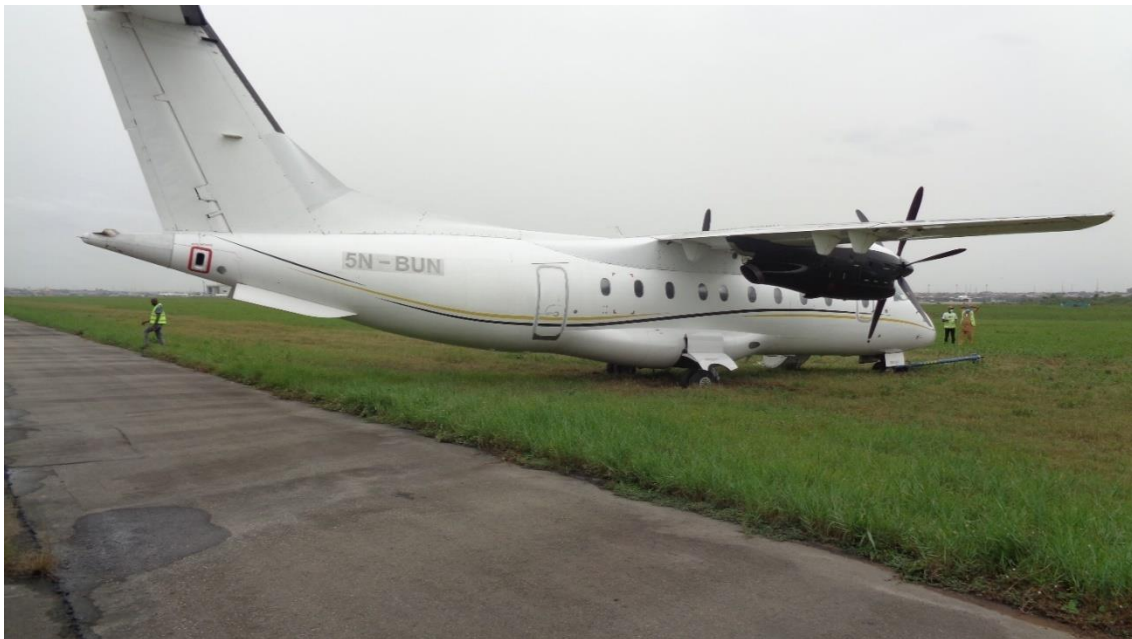
The Co-pilot further stated that at about 50 knots, the Captain noticed a sudden veering of the aircraft to the right and called for "CONDITION LEVERS MIN" position. He then regained control of the aircraft momentarily. Thereafter, the aircraft veered right again uncontrollably onto the grass lawn and stopped.

Figure 1: The incident aircraft in the grass verge after veering off the runway

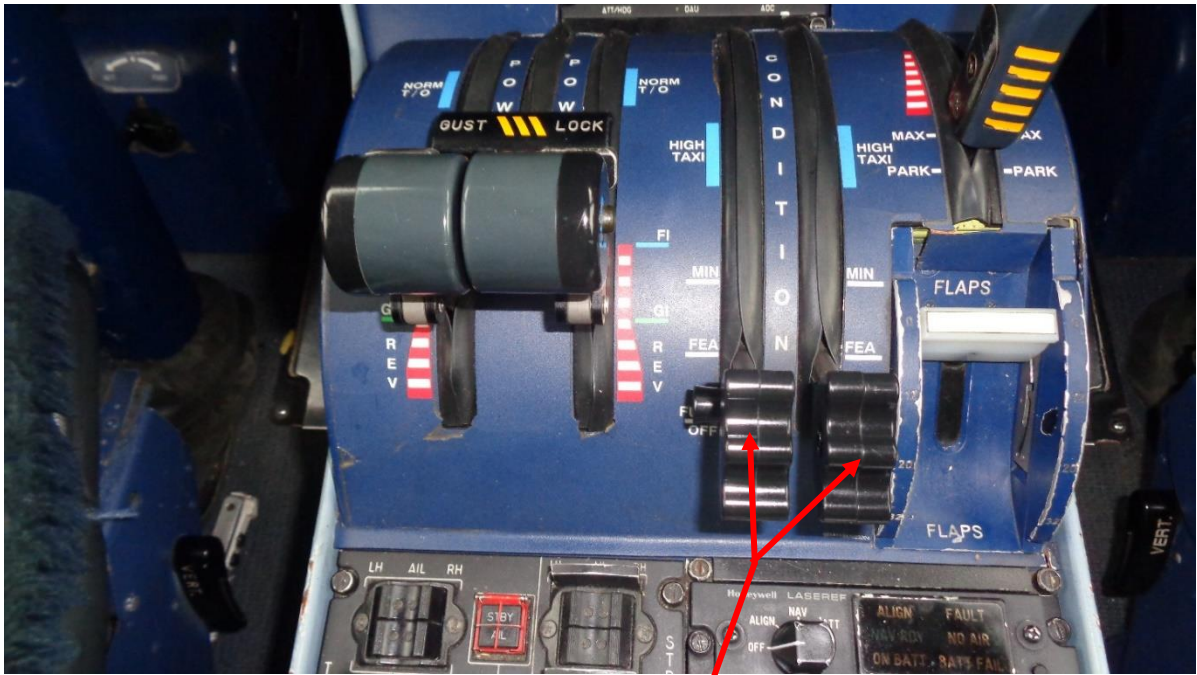
7. Captain requested control of the aircraft and the Co-pilot handed over control at speed below 60 knots and decelerating.
8. At about 50 knots, the Captain noticed a sudden veering of the aircraft to the right which he corrected. The Captain called for "CONDITION LEVER MIN" according to the Cockpit Voice Recorder.
9. Aircraft veered to the right again into the grass verge.
10. The aircraft stopped in the grass verge right of Runway 18L.
11. Control Tower raised the aircraft to confirm if operation was normal.
12. The crew and passengers disembarked normally without injury.

Figure 2: Condition levers position on the control pedestal
