Preliminary Report on ground collision between a lavatory service truck with fleet number 9/5 operated by Skyway Aviation Handling Co. Plc (SAHCO) and a parked Boeing 737-300 aircraft with nationality and registration marks 5N-DAB owned and operated by Max Air Limited which occurred at Nnamdi Azikiwe International Airport Abuja on 21st November 2021.

Registered owner and operator:	SAHCO PLC
Vehicle type and model:	Mallaghan Atego
Manufacturer:	Mercedes Benz
Year of manufacture:	2013
Registration marks:	9/5
Chassis number:	WDB970012L777472
Location:	Stand D8 Nnamdi Azikiwe International Airport Abuja (DNAA)
Date and time:	12:30 h local time

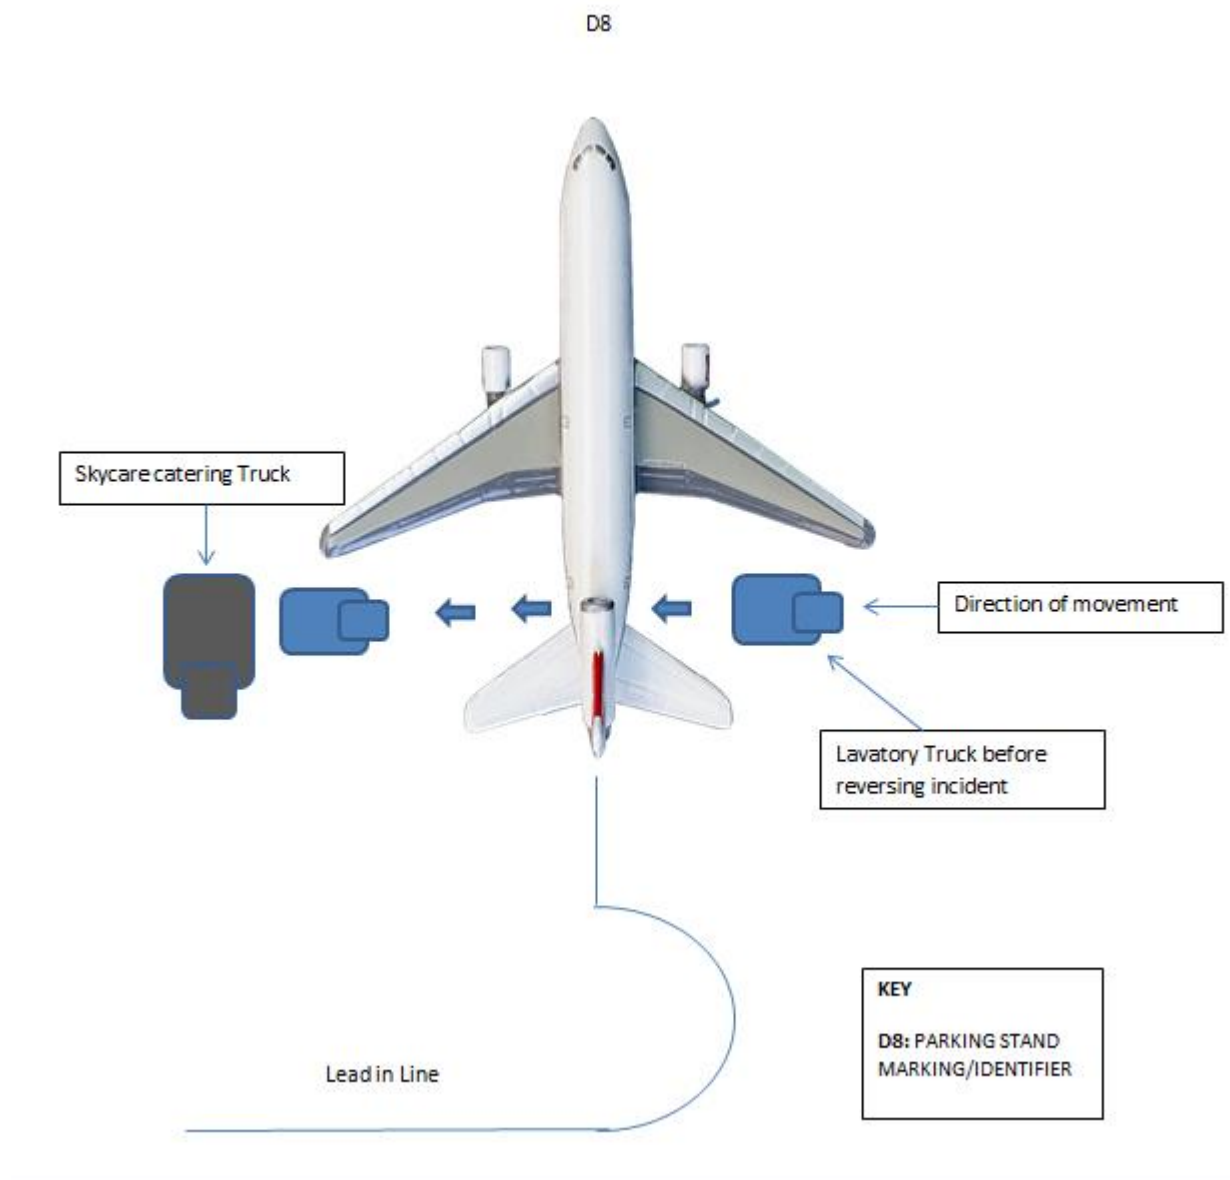
As the GSE driver attempted to reposition the truck, the lavatory truck speedily moved (in reverse), passed underneath the rear bulkhead section of the parked aircraft continued moving until it eventually hit and was stopped by Skycare catering Services truck on the left side of the Aircraft. According to the driver he attempted to apply brake pedal but instead applied the throttle pedal thereby speedily impacting the aircraft. The aircraft, lavatory service truck and the Skycare Service truck sustained various degrees of damages.

Figure 1: Sketch of the impact sequence

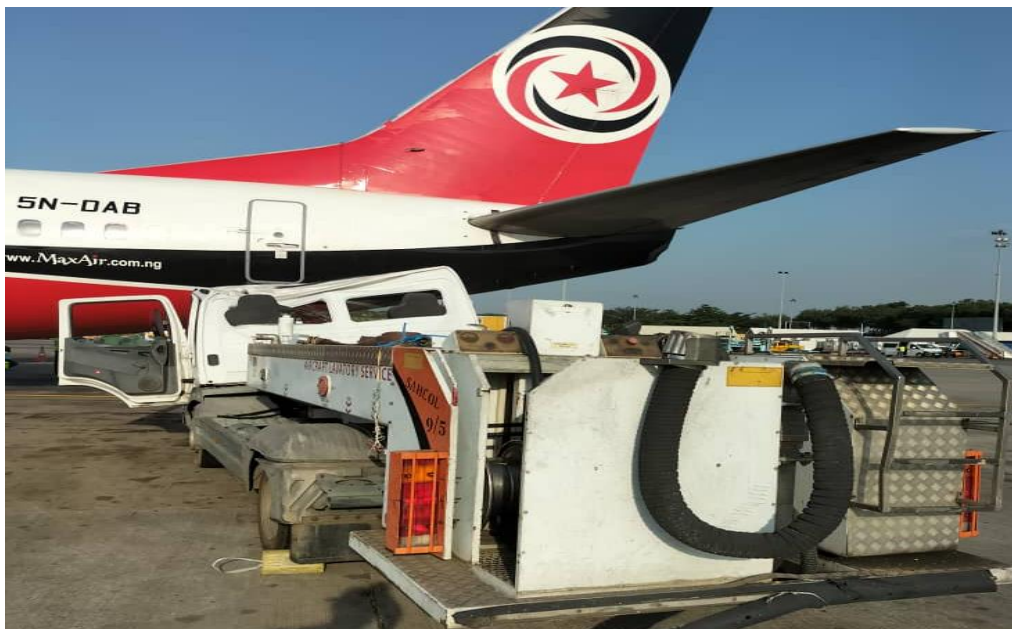
Figure 2: The aircraft and lavatory service truck after the occurrence

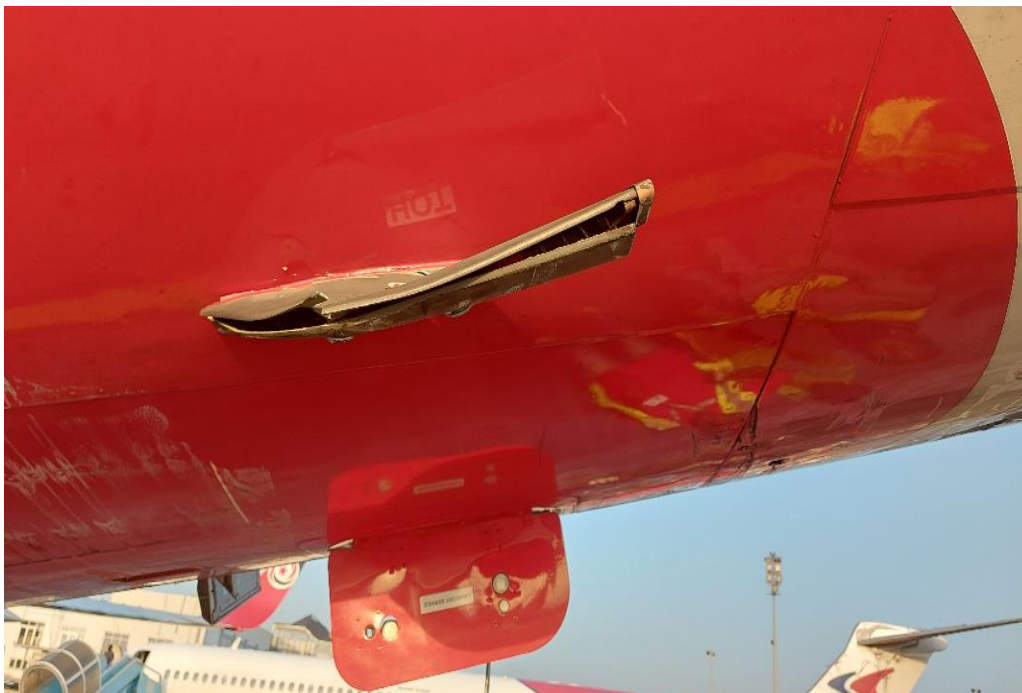
1. Three holes on the Aft section of the fuselage unpressurized area
2. Dents on the pressure bulkhead area

Figure 3: Dent around the rear pressure bulkhead area

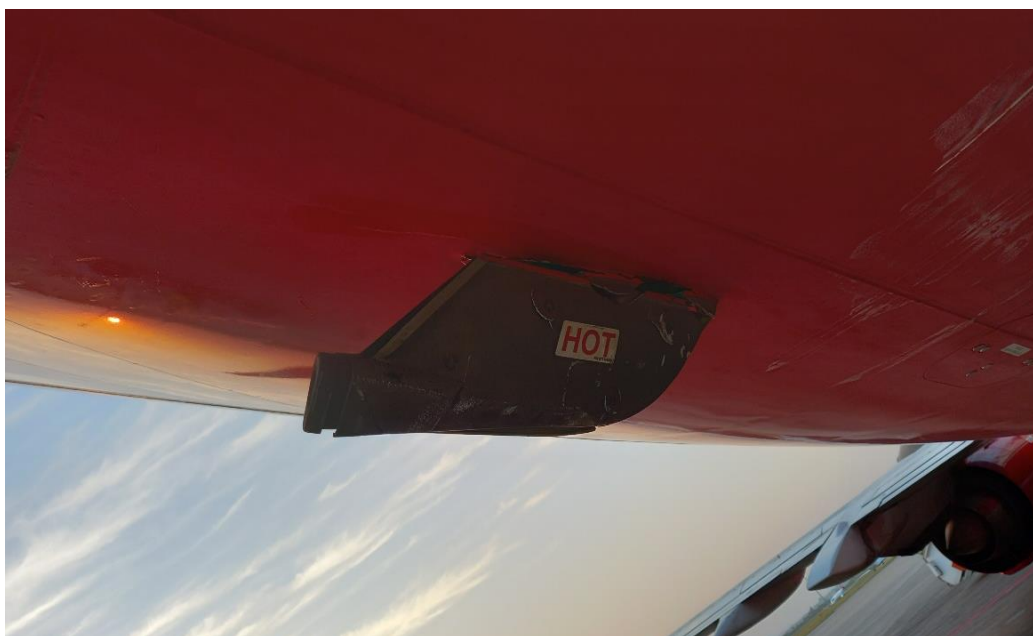
3. Broken rear outflow valve
4. Broken lavatory service door
5. Broken drain valve handle and a damaged rear galley drain mast

Figure 4: damaged rear galley drain mast

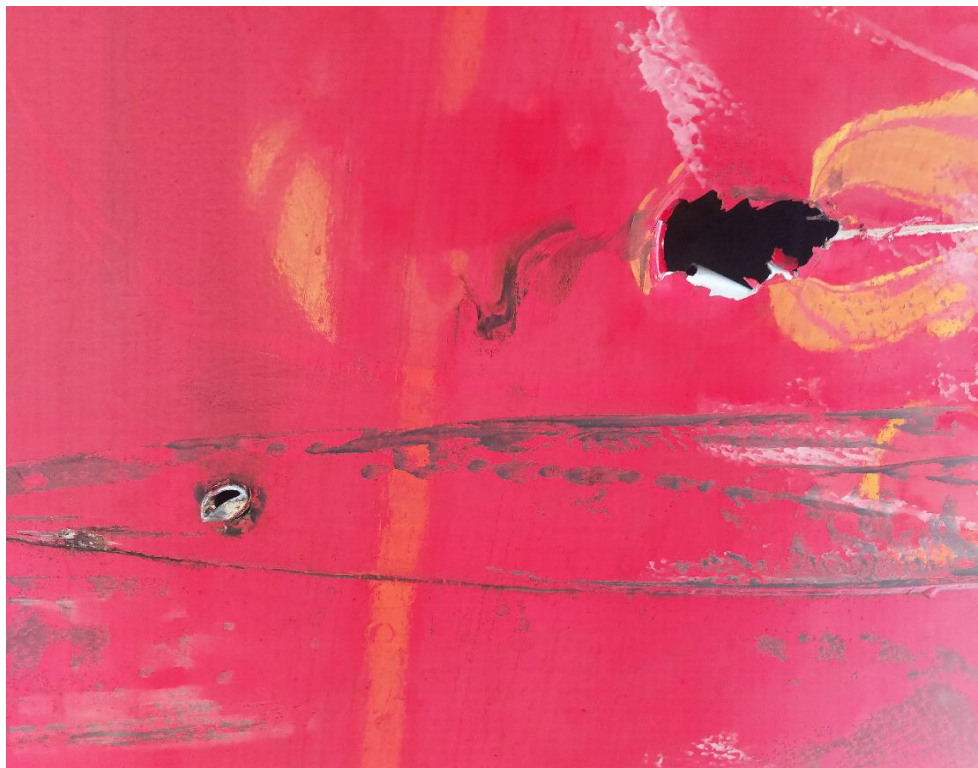
Figure 5: Three holes on the aft of the fuselage unpressurized area

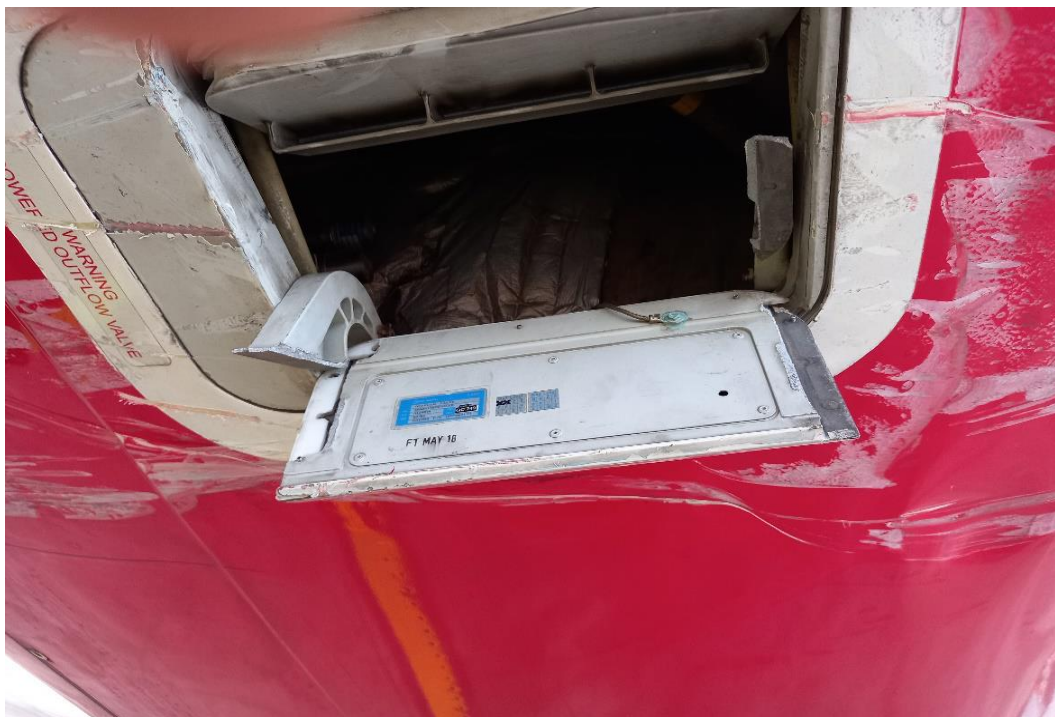
Figure 6: Broken outflow valve

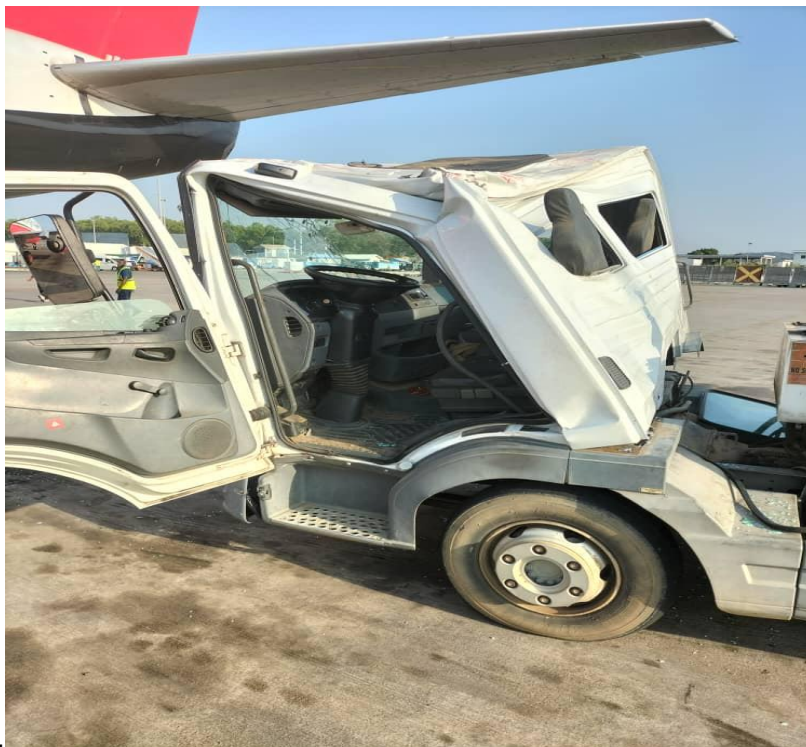
The lavatory service truck was substantially damaged

Figure 7: Damaged lavatory service truck after the incident

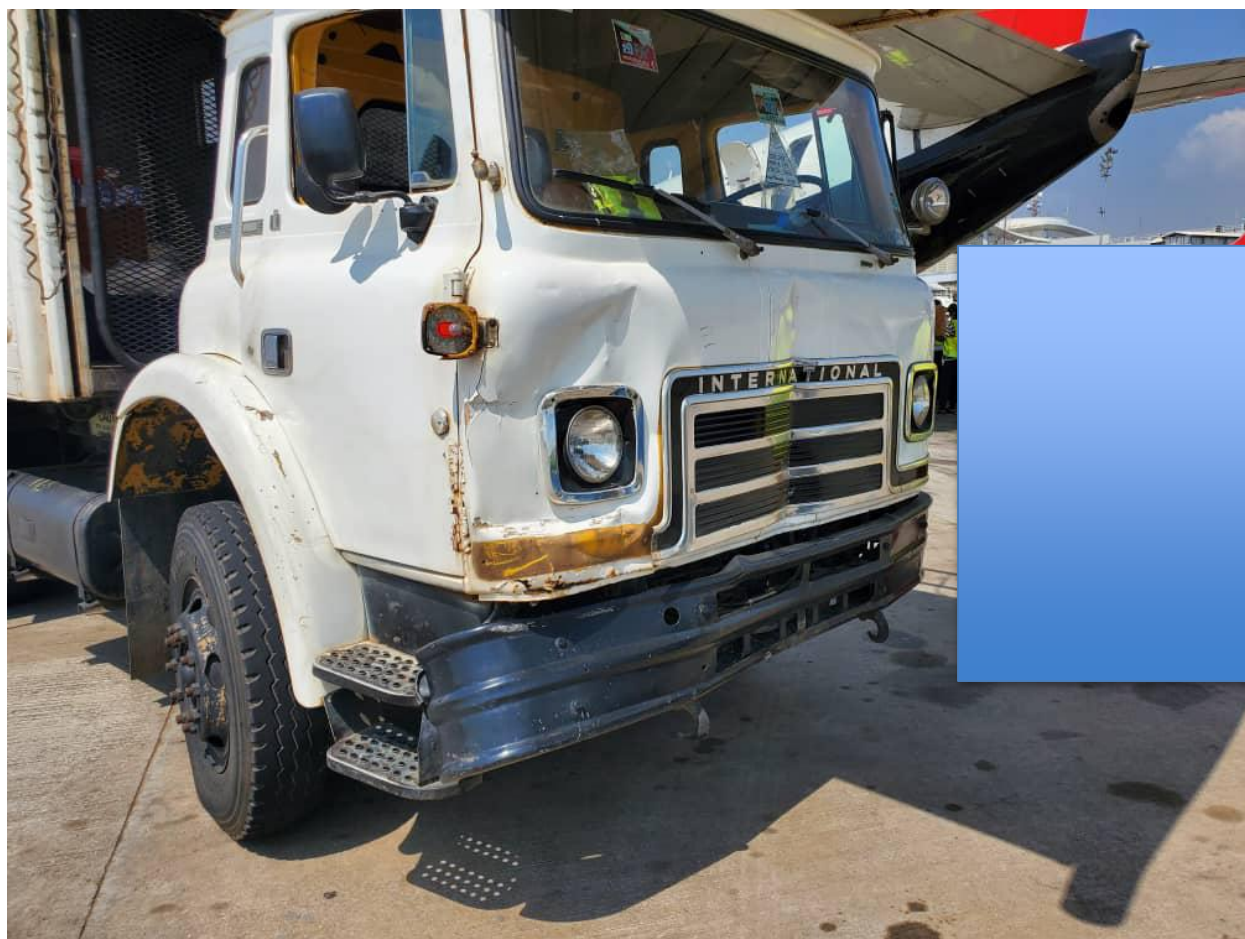
Figure 8: Dent on the Skycare catering vehicle

9. The GSE driver fell out of the lavatory bowser after impacting the Skycare Catering Service truck.
10. The Skycare Catering Service truck sustained minor damage.
