Preliminary Report on the Accident Involving a Bell 429 helicopter owned and operated by Nigeria Police Air Wing with Nationality and Registration marks 5N-MDA which occurred at Sir Abubakar Tafawa Balewa Airport Bauchi; Nigeria on 26th January, 2022.

Registered owner:	Nigeria Police Force
Operator:	Nigeria Police Air Wing
Aircraft type and model:	Bell 429
Manufacturer:	Bell Textron, Canada
Year of manufacture:	2012
Nationality and registration marks:	5N-MDA
Serial number:	57084
Location:	2.1 NM from the end of runway 35 outside the perimeter fence of Sir Abubakar Tafawa Balewa Airport Bauchi, Coordinate 10° 28' 6" N, 9° 44' 14" E
Date and time:	26 th January, 2022 at 19:47 h

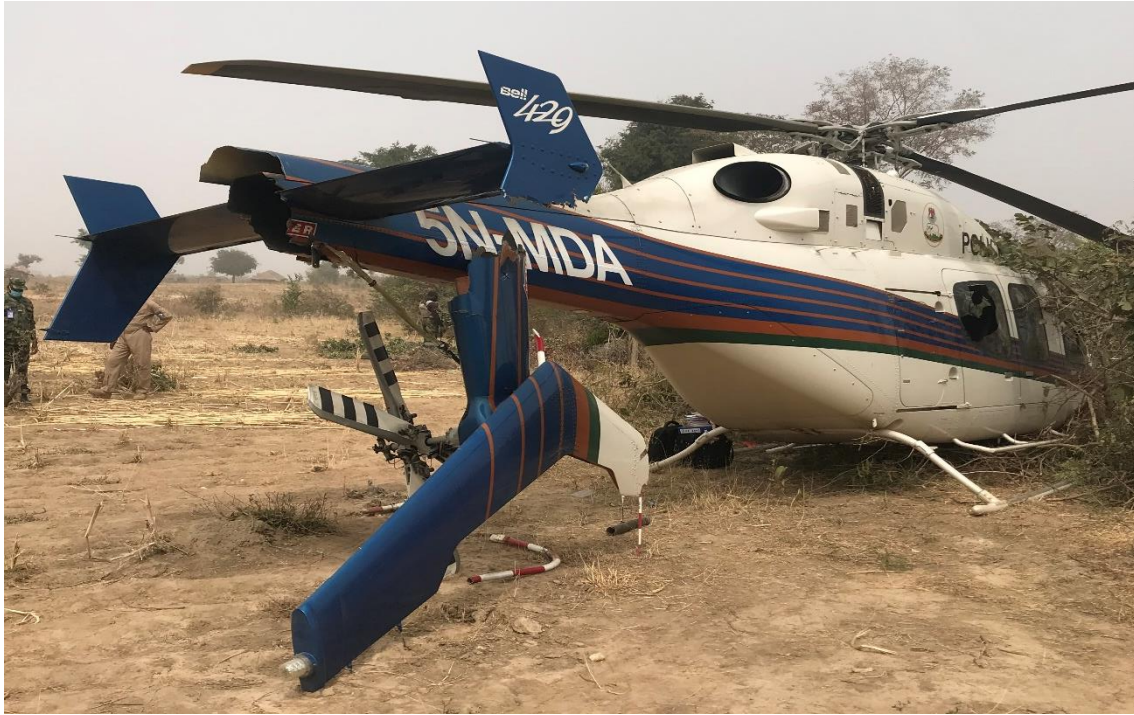
1. One Main Rotor Blade was damaged
2. The Tail Boom of the helicopter was sheared off
3. The Tail Rotor Shaft was broken
4. The Tail Rotor Blades had minor damage at their Leading Edges
5. The helicopter left side Skid collapsed
6. The right side aft passenger window was broken
7. The right side Vertical Stabilizer was broken

Figure 2: Right view of the helicopter post occurrence

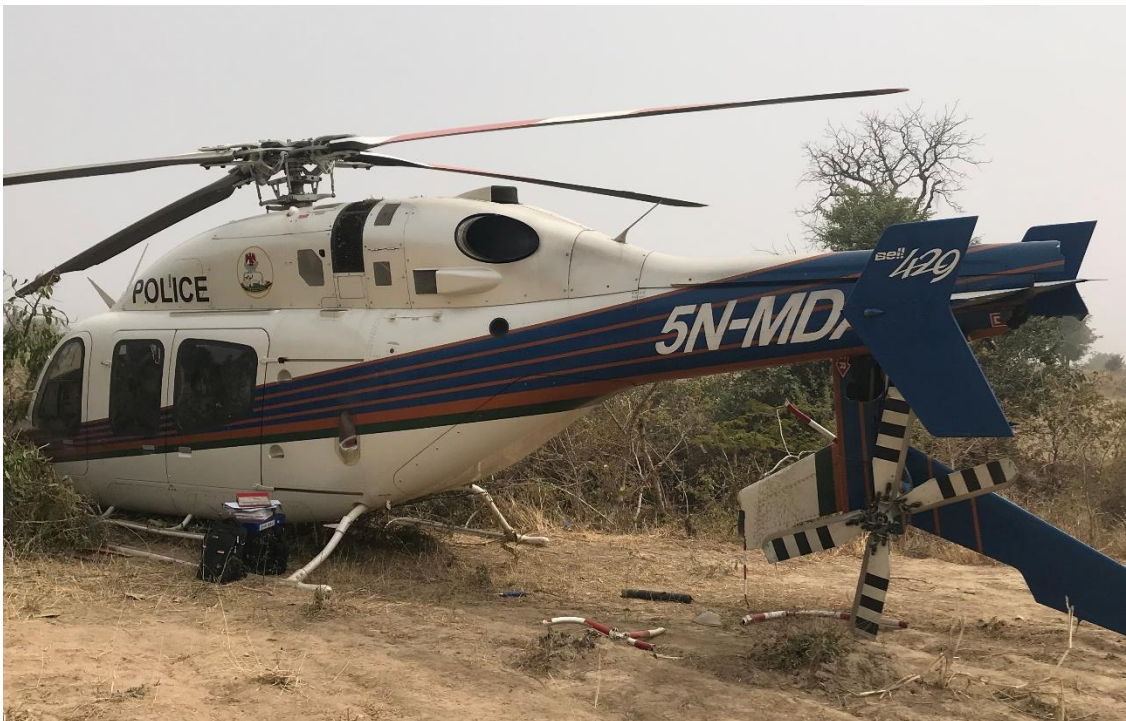
Figure 3: Left view of the helicopter post occurrence

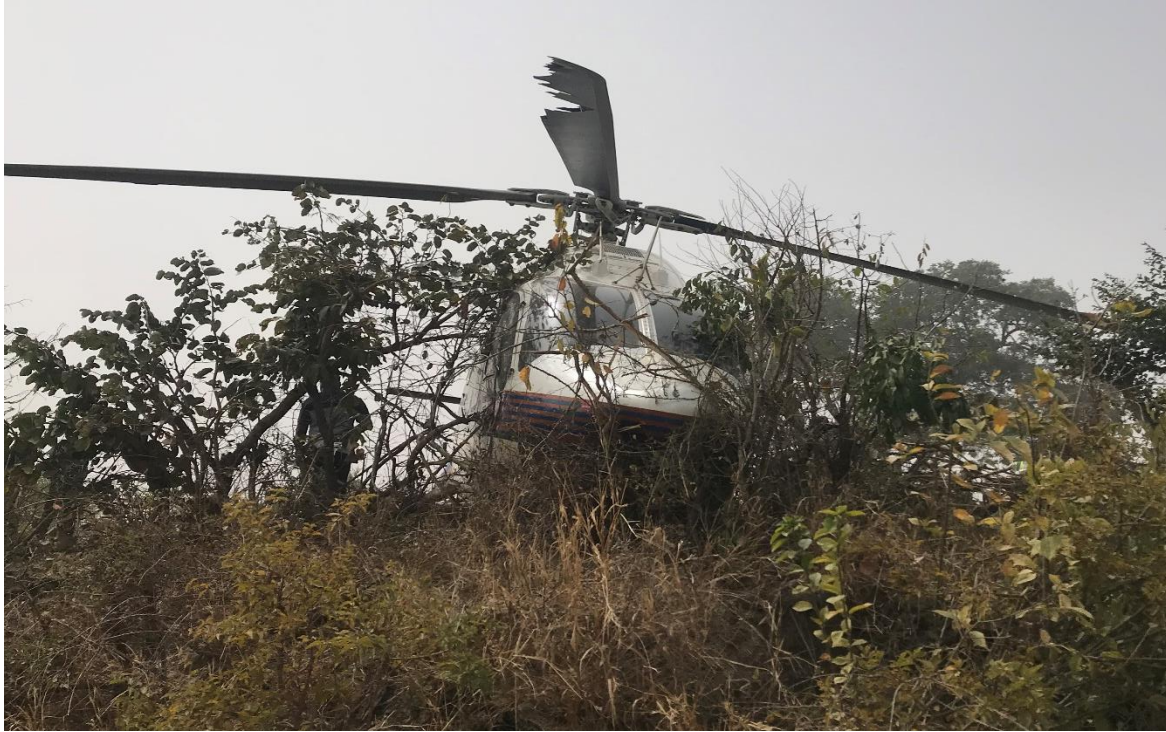
During approach the helicopter Main Rotor hit the top branches of the tree, while the Tail Rotor impacted a tree of about 5m high and crash landed on heading 359°. The helicopter came to a stop at a distance of 20.60 m from the tree.

Figure 4: Damaged Main Rotor Blade

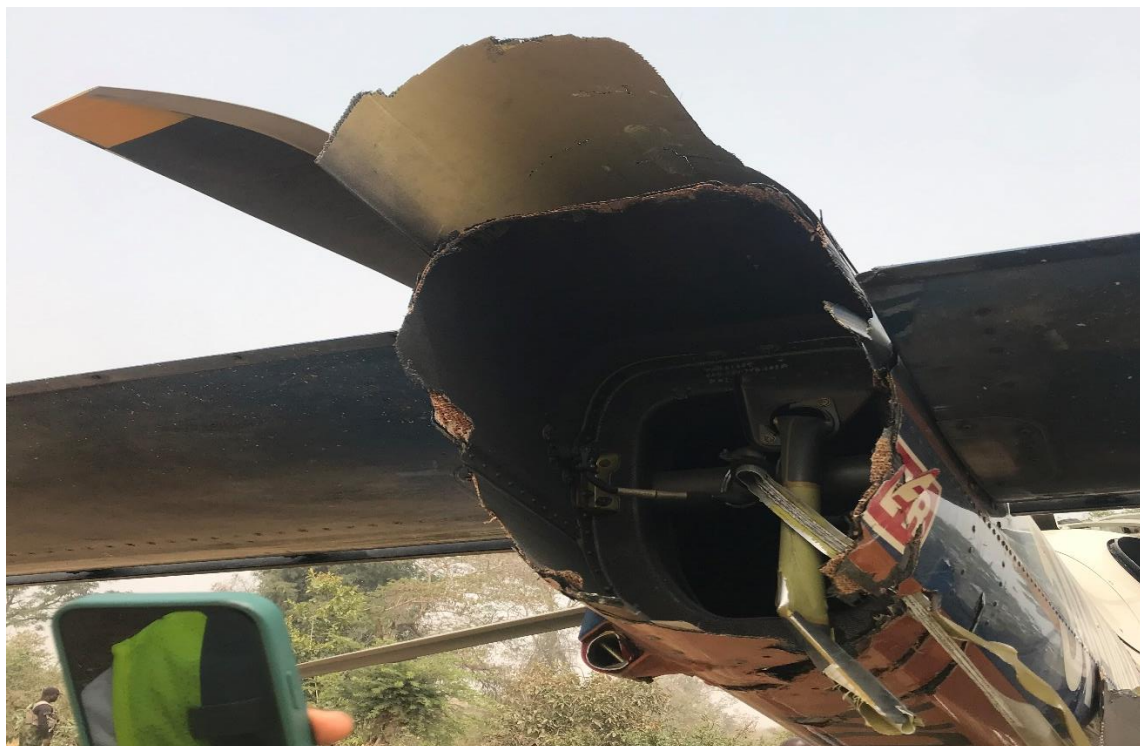
Figure 5: Damaged Tail Boom

15. The helicopter Tail Boom struck a tree and sheared off during the third landing attempt.
16. The accident occurred at about 19:47 h, night time in Instrument Meteorological Conditions (IMC).

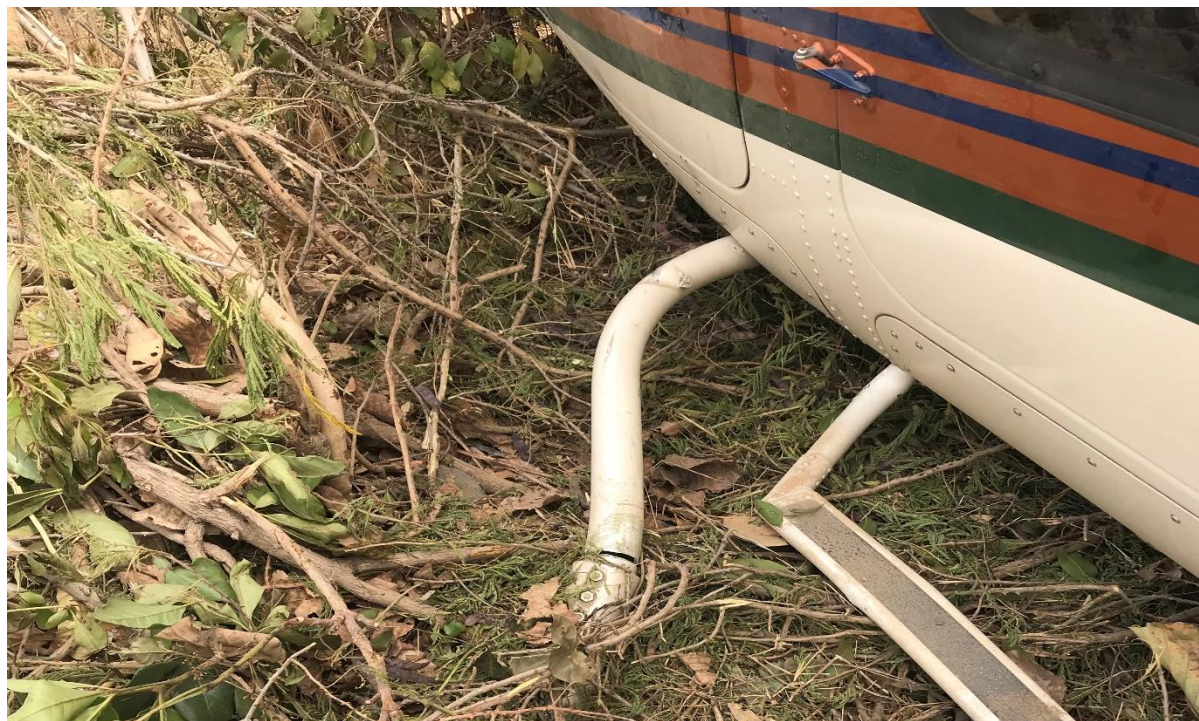
Figure 6: Collapsed left side Skid

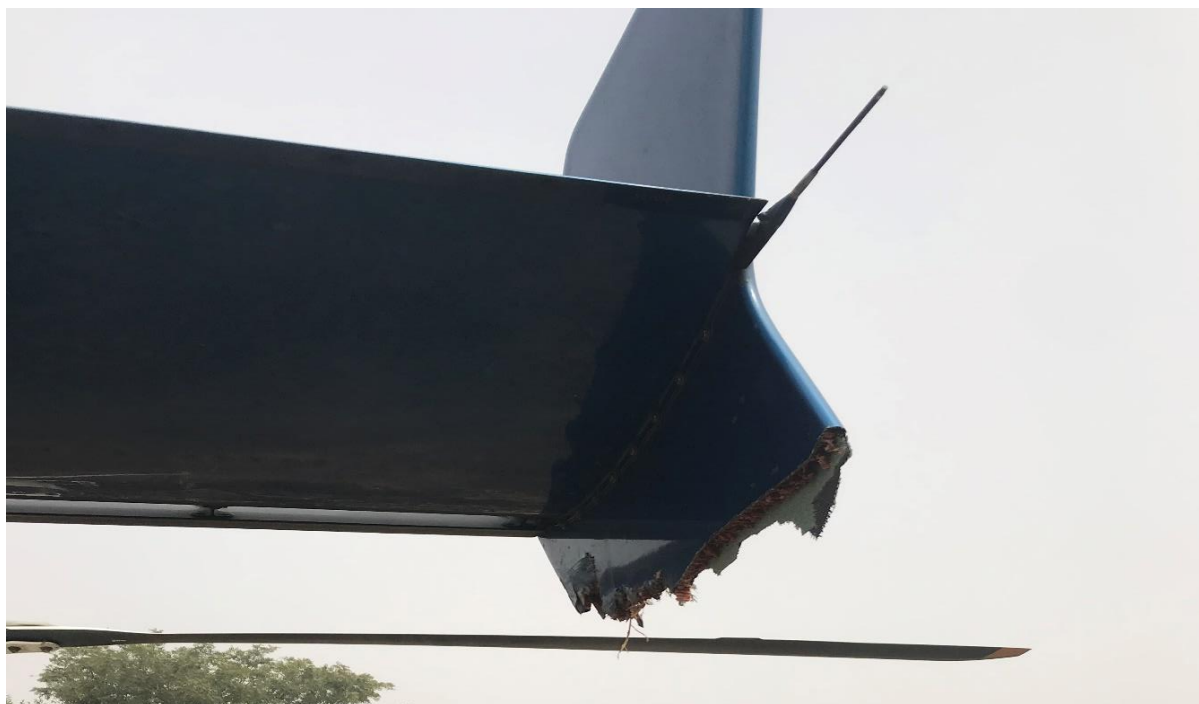
Figure 7: Damaged Vertical Stabilizer
