Preliminary Report on the Incident involving a Boeing 737-300 aircraft operated by Max Air Limited with nationality and registration marks 5N-ADB, which occurred at Lamido Aliyu Mustapha International Airport (DNYO) Yola, Nigeria on 21 July 2023

Operator:	Max Air Limited, Nigeria
Aircraft type and model:	Boeing 737-36Q
Manufacturer:	The Boeing Company, USA
Year of manufacture:	1999
Nationality and registration marks:	5N-ADB
Serial number:	30333
Location:	Lamido Aliyu Mustapha International Airport (DNYO) Yola, Runway 35
Date and Time:	21 July 2024 at about 17:57 h (All times in this report are local time, equivalent to UTC+1 unless otherwise stated)

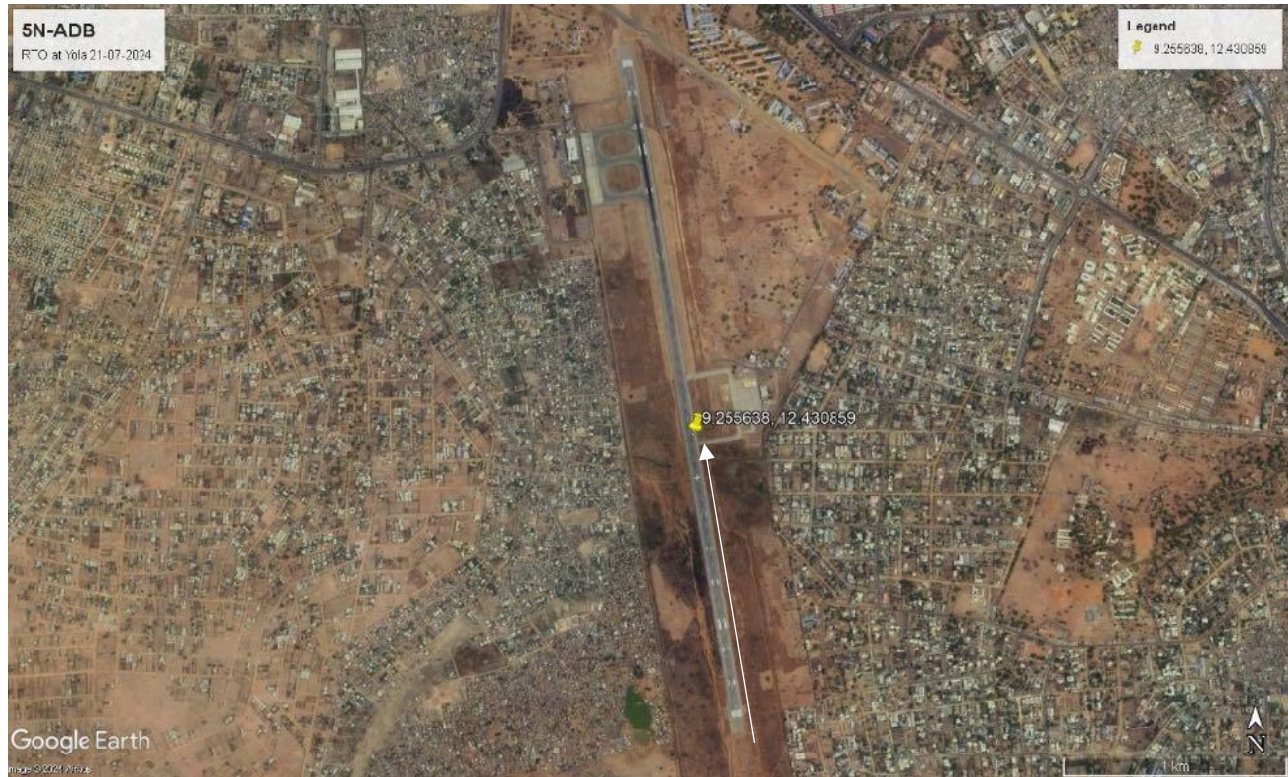
At 17:57 h, NGL 1649 was cleared for take-off Runway 35, with the prevailing wind as 270° at 07 kts. During the take-off roll, the flight crew observed that the auto-throttle disconnected, and the PF then set the take-off thrust manually before re-engaging the auto-throttle. The crew also observed that the desired engine thrust settings were not attained instantly. The PM then called out the aircraft speed, 90 kts. Thereafter, the aircraft buffeted at above 100 kts. A bang was heard, followed by a landing gear disagree annunciation for the Right Main Landing Gear. According to the PF, the thrust levers were then retarded at about 126 kt IAS (Indicated Air Speed) as part of Rejected Take-Off (RTO) procedure. The PM scanned the instruments and called out "stop, stop, right gear" and then proceeded to call out "speed brakes" as the speed brake lever was observed to be not fully actuated. The aircraft came to a stop 300 m from the end of the runway.

Figure 1: Point at which thrust levers were retarded (arrow shows direction of motion)

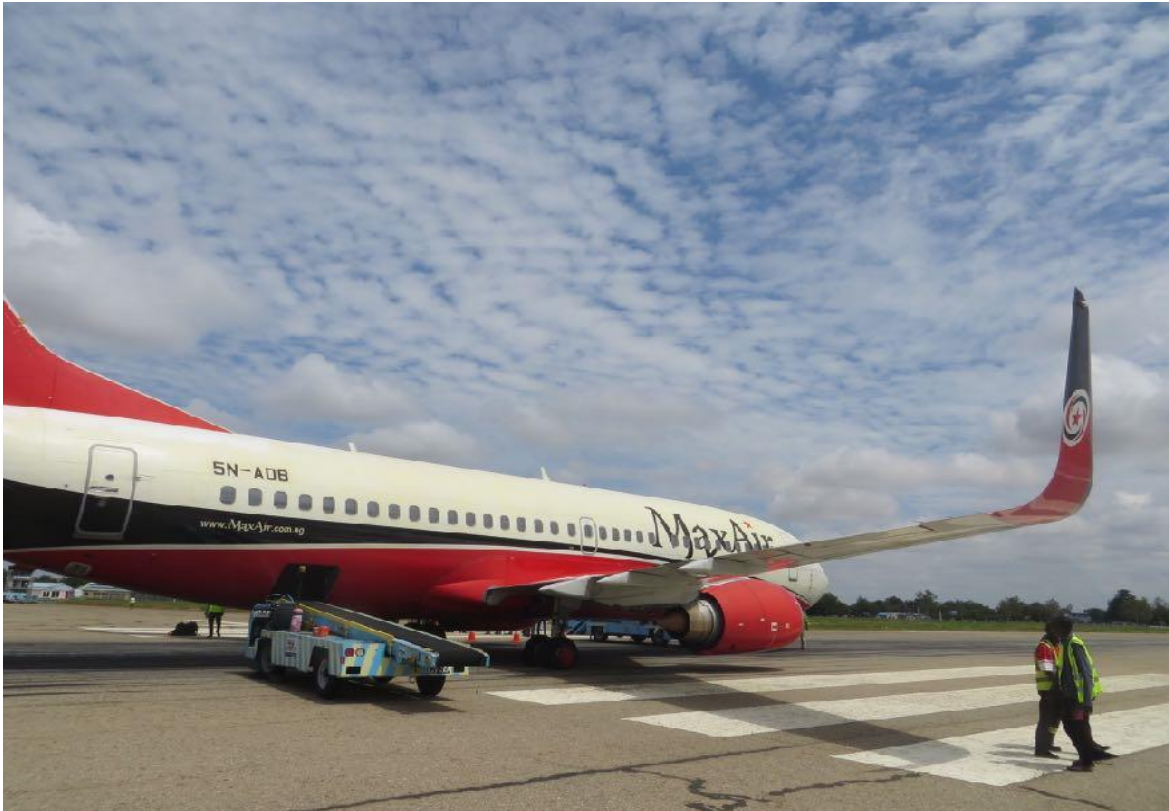
Figure 2: 5N-ADB post-occurrence at DNYO

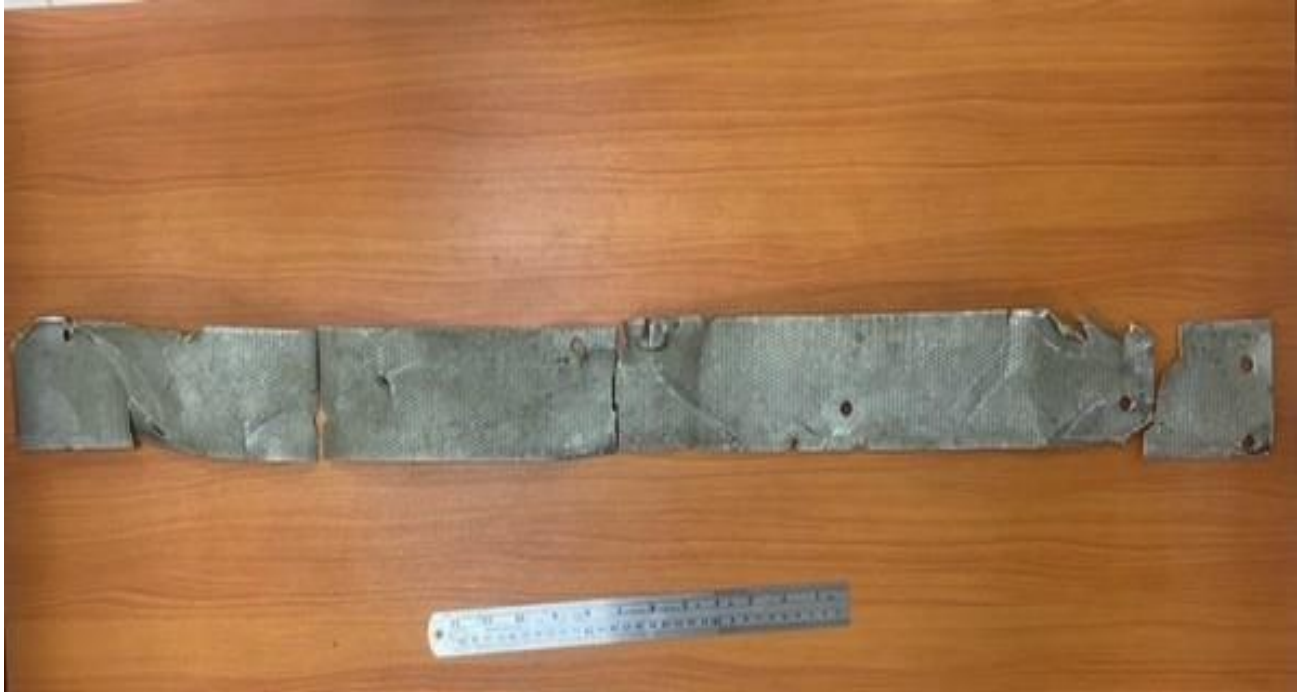
Foreign Object Debris (FOD) were recovered from the runway after 5N-ADB landed.

Figure 3: Foreign Object Debris recovered from the runway (ruler to show scale)

1. Identification and testing of the metallic sheet recovered from the runway.
2. Examination of failed tyres (Tyre No. 3 and Tyre No. 4.)
3. Determination of runway surface condition at DNYO.

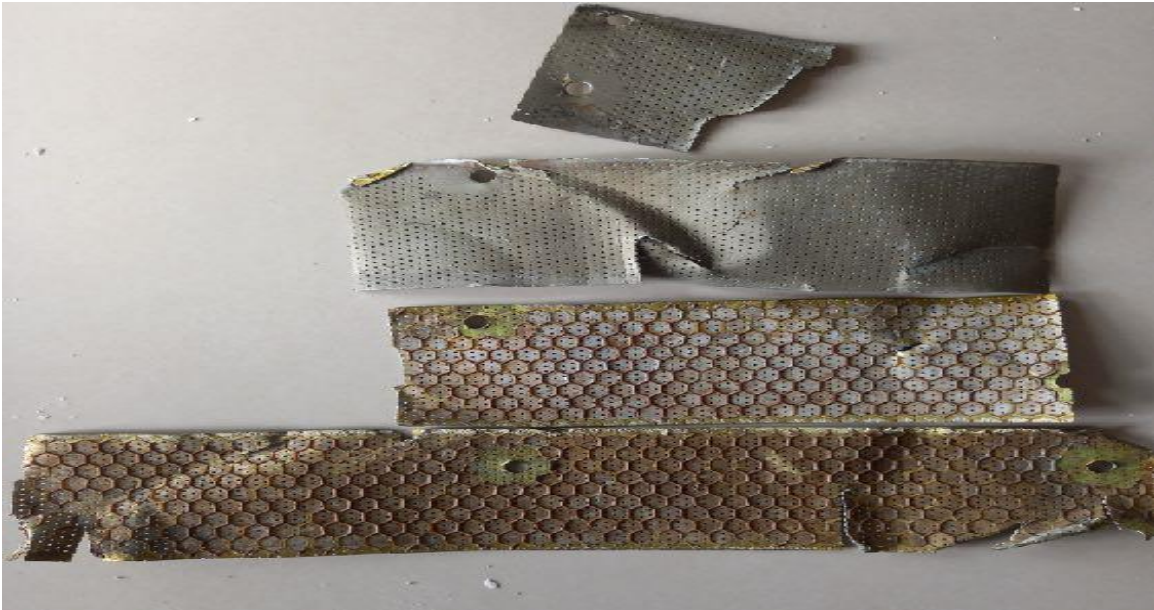
Figure 4: Alternate view of the FOD

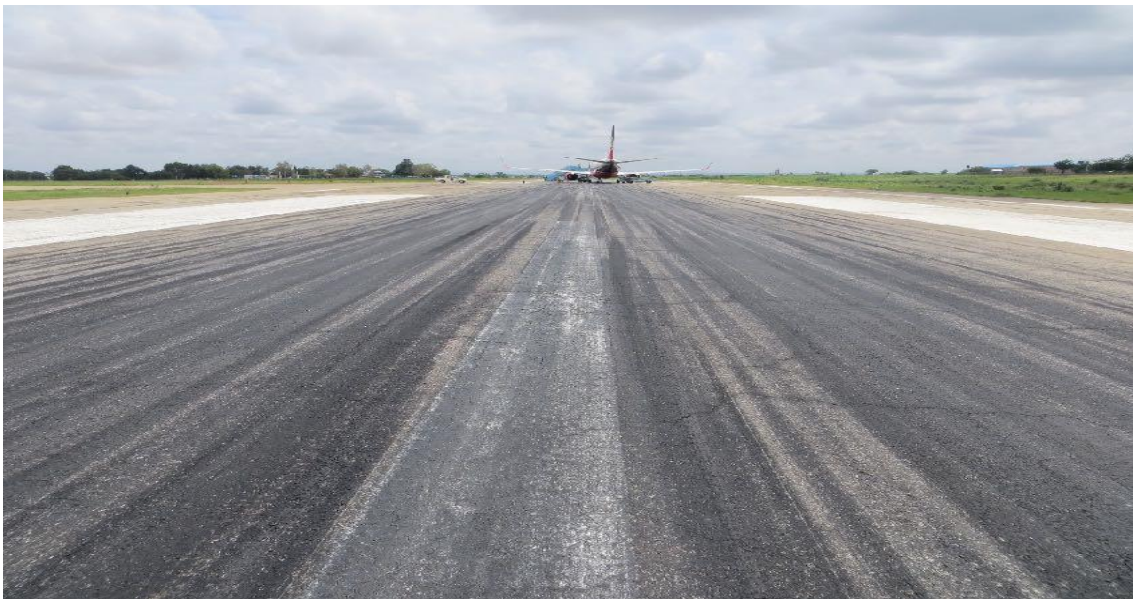
The runway is observed to be contaminated with rubberised deposits.

Figure 5: Rubberised deposits on the runway at DNYO

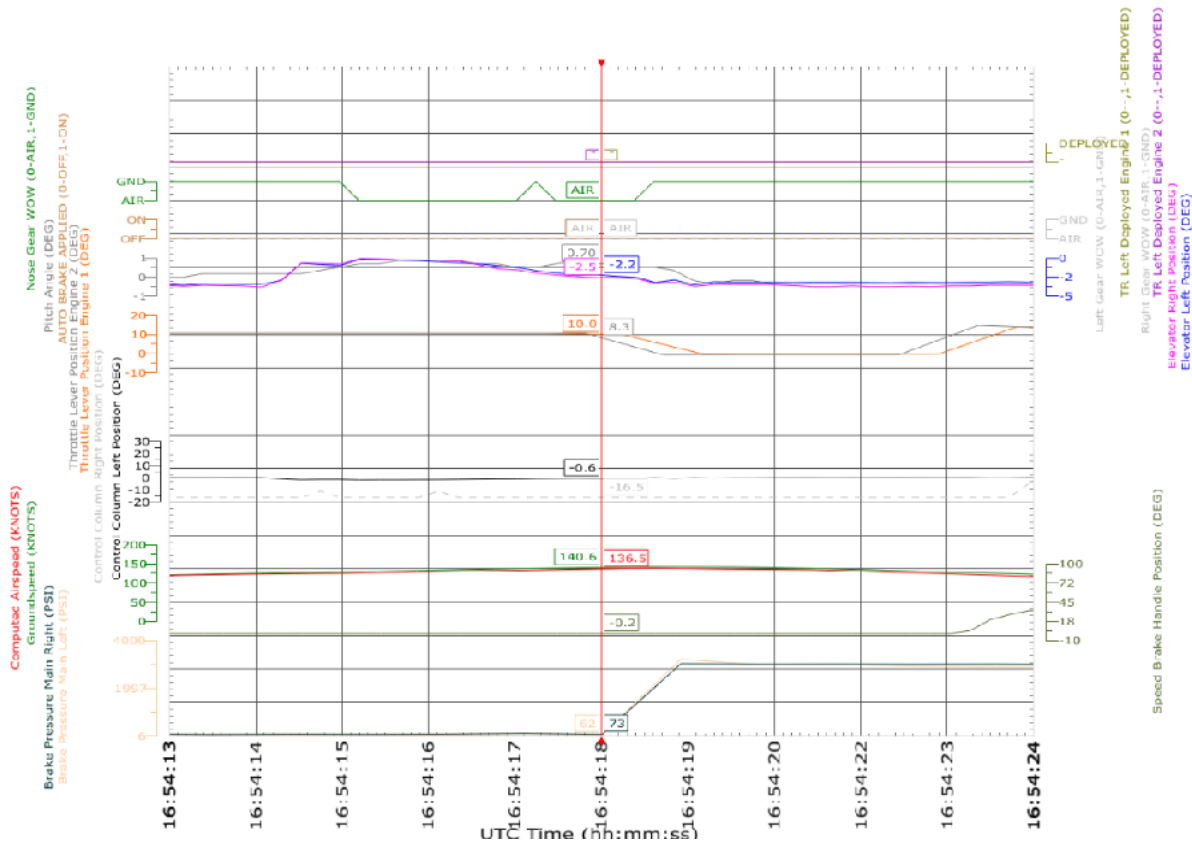
Figure 6: A representative plot from the FDR (at the point of initiation of RTO)

Flight data indicated that there was a disagreement on the Right Main Landing Gear indication at 122 kts CAS (Computed Air Speed), and the thrust levers were retarded 5 s after at 136 kts CAS. The brakes were applied, and thrust reversers were deployed.

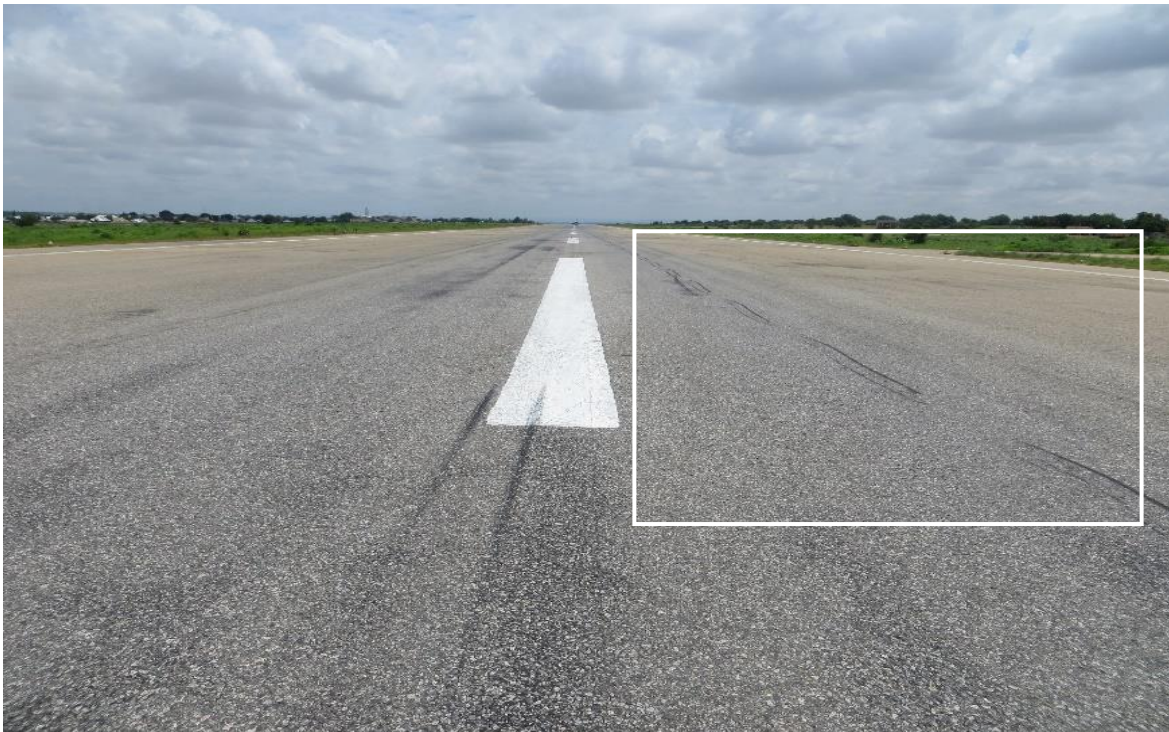
Physical evidence suggests that Number 3 Main Wheel tyre (the inboard tyre on the Right Main Landing Gear, MLG) failed about 1000 m from the Runway 35 threshold then Number 4 Main Wheel tyre burst. Number 1 and 2 Main Wheel tyres deflated as the aircraft came to a stop. The aircraft stopped 300 m short of the threshold of Runway 35.

Figure 7: Witness marks indicating Tyre Number 3 failure

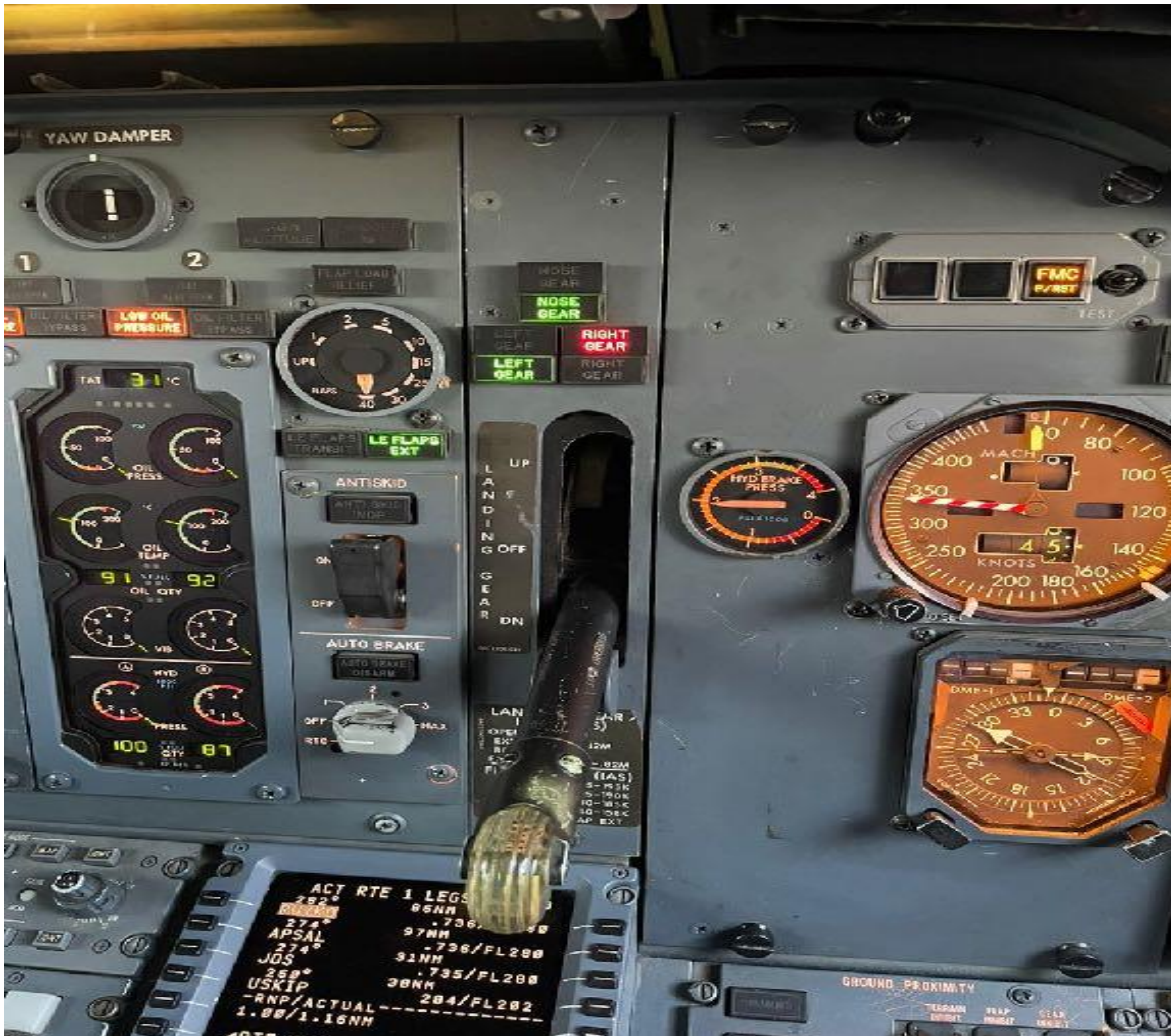
Figure 8: Landing gear indications in the cockpit

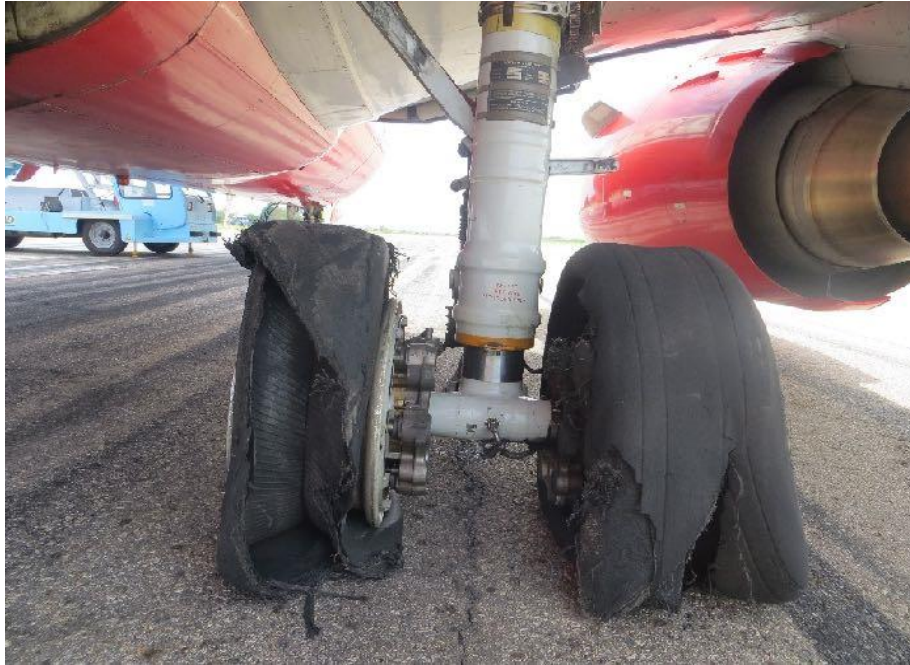
1. Number 3 Main Wheel tyre failed;
2. Number 4 Main Wheel tyre burst;
3. Numbers 1 and 2 Main Wheel tyres were deflated;
4. Binding of brake assembly No. 1 and 2;
5. The right MLG shock strut door was broken.

Figure 9: Failed Tyres Number 3 and Number 4

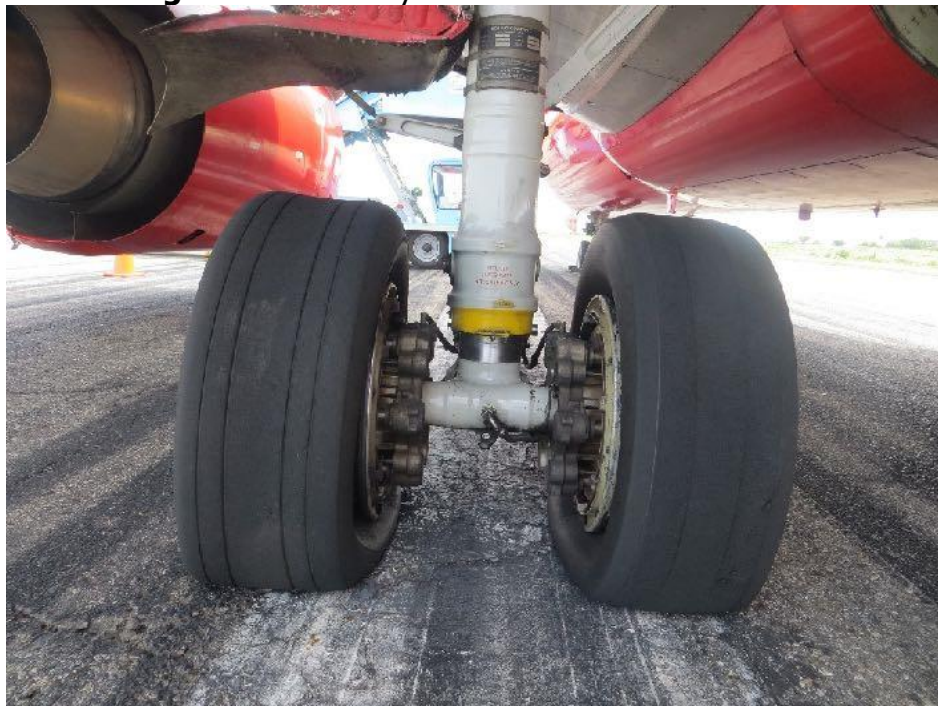
Figure 10: Deflated tyres Number 1 and Number 2

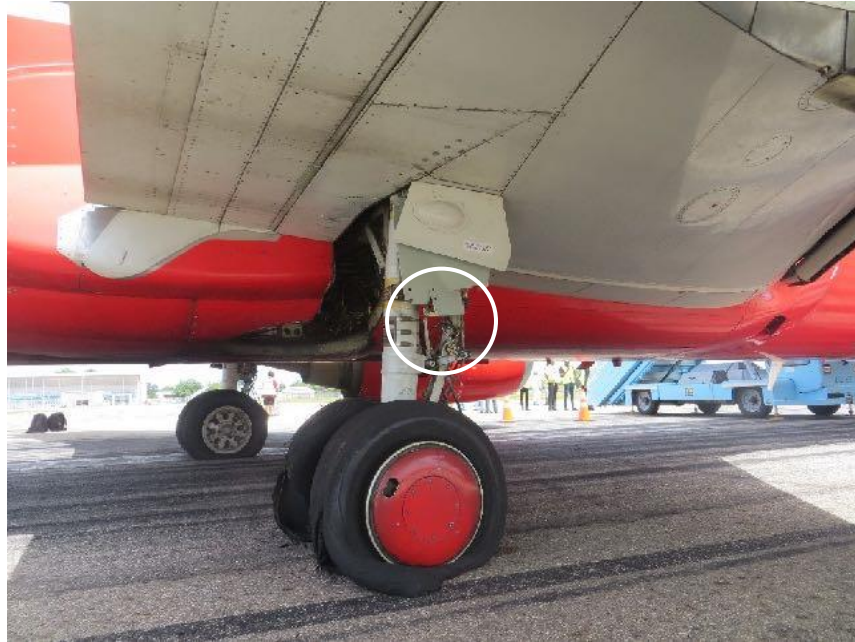
Figure 11: Torn section of Right MLG shock strut door

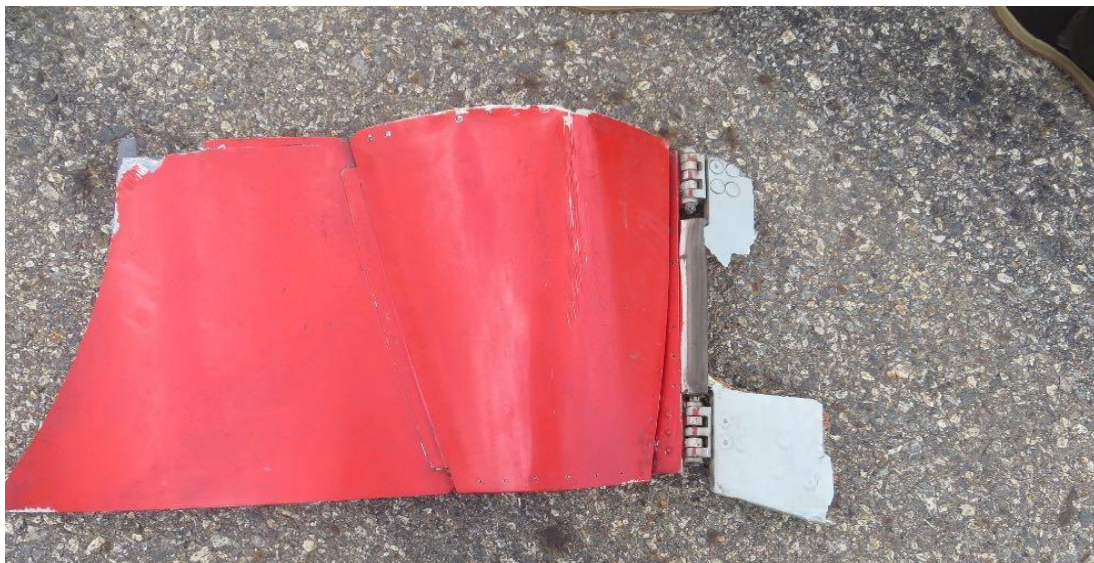
Figure 12: Detached piece of the R MLG shock strut door

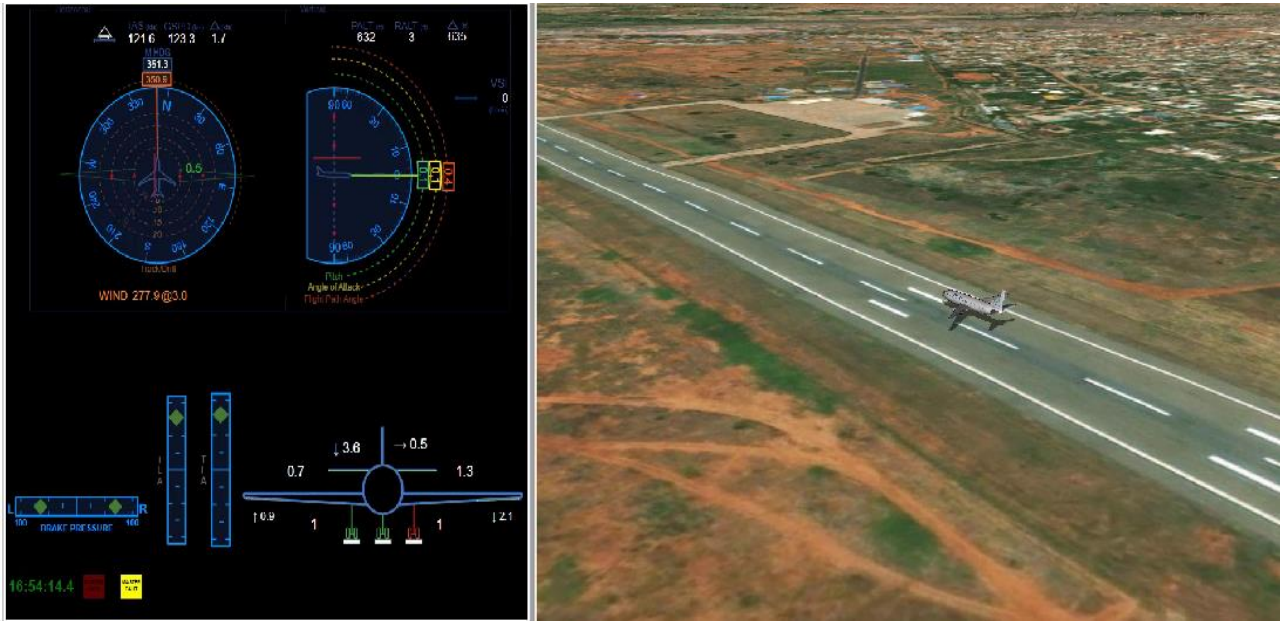
Figure 13: Right MLG disagree

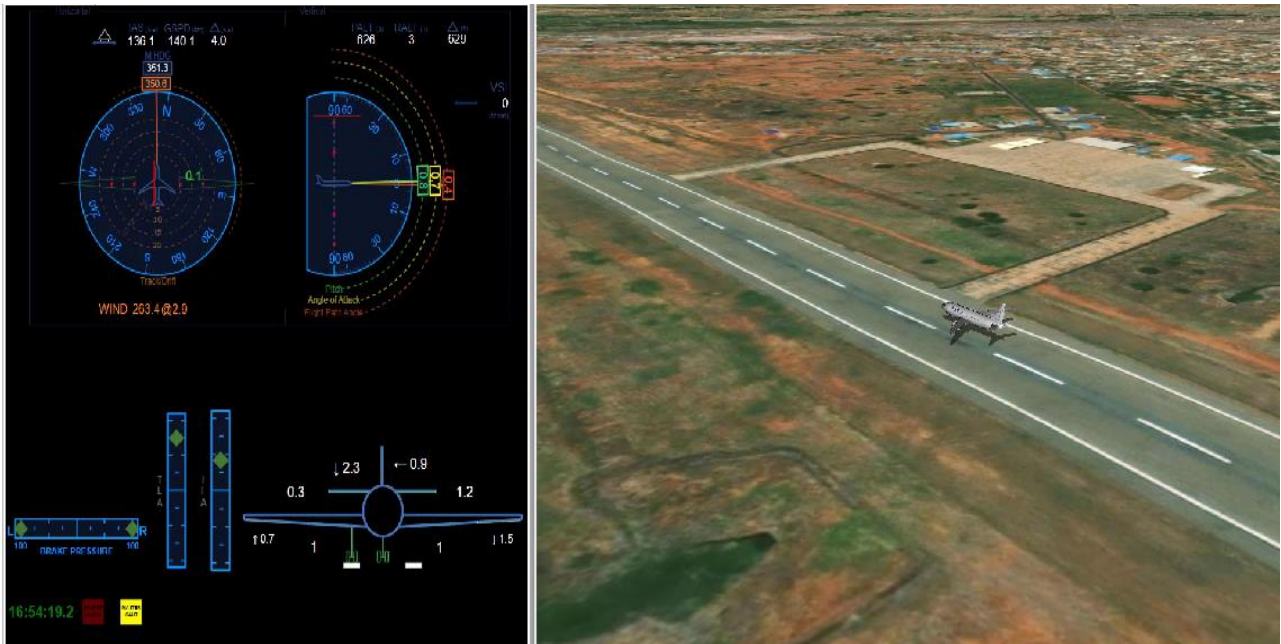
Figure 14: Commencement of RTO

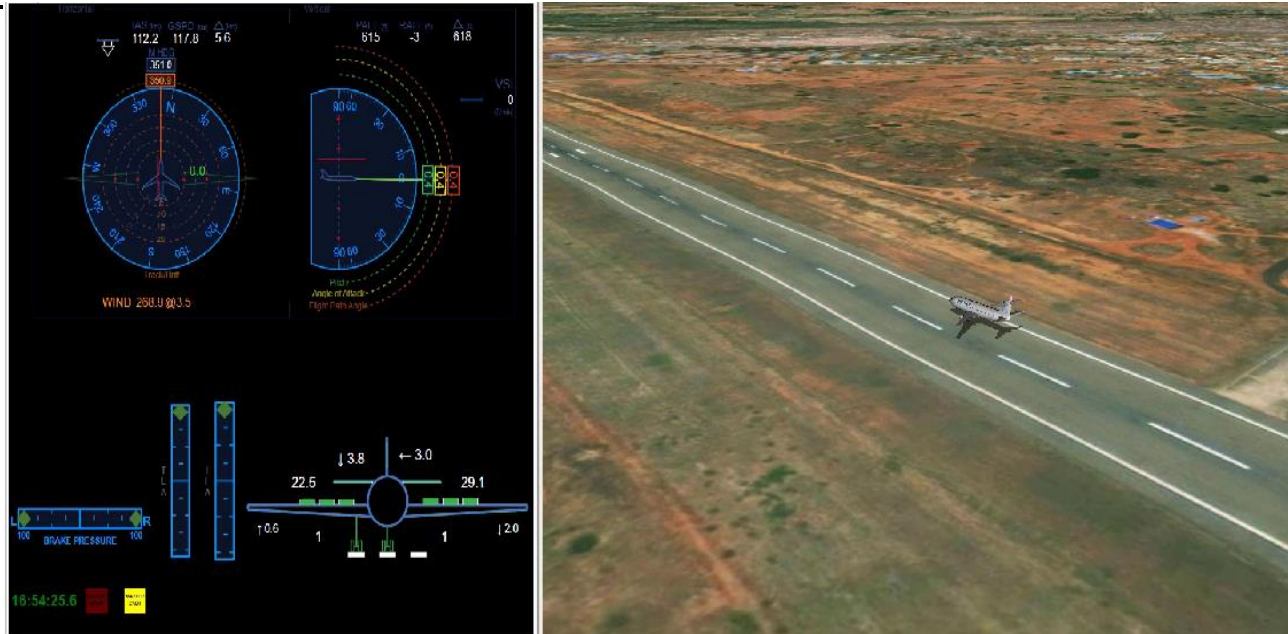
Figure 15: Deployment of reversers, brakes and speed brakes
