**PRELIMINARY REPORT ON THE SERIOUS INCIDENT INVOLVING AN ATR 72-600 AIRCRAFT WITH NATIONALITY AND REGISTRATION MARKS 5N-GAA OPERATED BY GREEN AFRICA AIRWAYS LIMITED WHICH OCCURRED AT GENERAL TUNDE IDIAGBON INTERNATIONAL AIRPORT, (DNIL) ILORIN NIGERIA ON 24 JULY 2024**

<b>Operator:</b>	Green Africa Airways Limited, Nigeria
<b>Aircraft type and model:</b>	ATR 72-212A (600)
<b>Manufacturer :</b>	ATR-GIE Avions de Transport Régional, France
<b>Year of manufacture:</b>	2012
<b>Nationality and registration marks:</b>	5N-GAA
<b>Serial number:</b>	1057
<b>Location:</b>	Runway 05, General Tunde Idiagbon International Airport (DNIL), Ilorin
<b>Date and Time:</b>	24 July 2024 at about 12:02 h (All times in this report are local time, equivalent to UTC+1 unless otherwise stated)

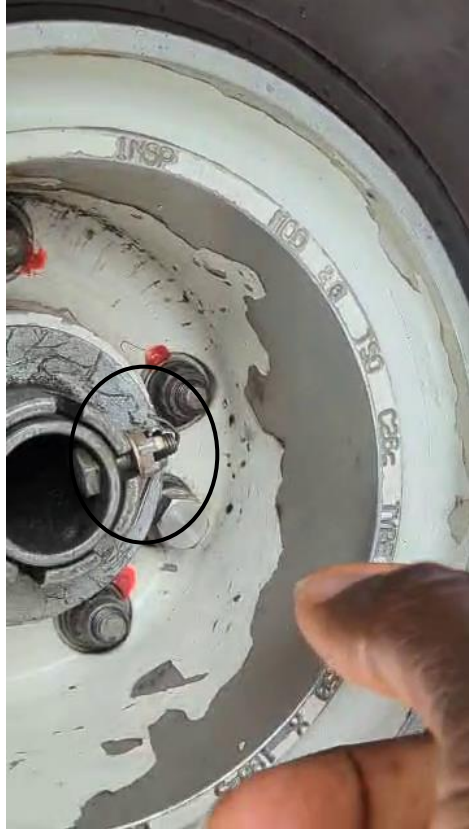
**Figure 2: Lock-nut**

A self-locking nut was observed to have shown signs of axial play upon replacing the nose wheel assembly after the occurrence. The nut was from the same batch as that installed prior to the wheel detachment. The batch was quarantined, and a nut was subsequently sourced from a different batch; the newly installed nut has yet to show signs of axial play.

12. A hardware component from the same batch installed on the aircraft on 17 July 2024 was found defective after a few landings.

1. Isolation of the batch of safety nuts that was initially installed.
2. A duplicate inspection post nose wheel installation is required.
3. Additional inspections of the nose wheel during pre-flight and turn-around.

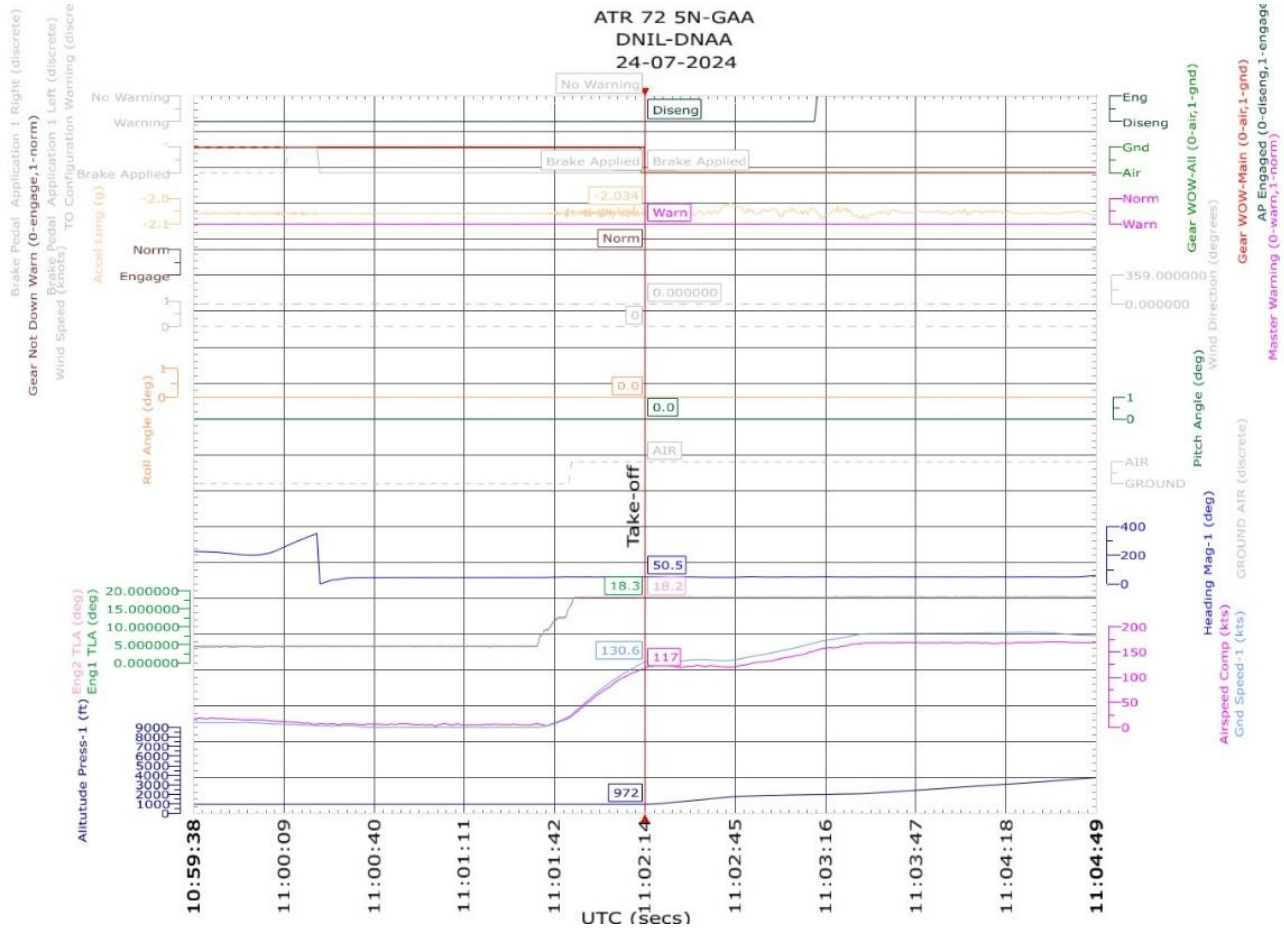
**Figure 4:** Pertinent flight parameters at takeoff from DNIL

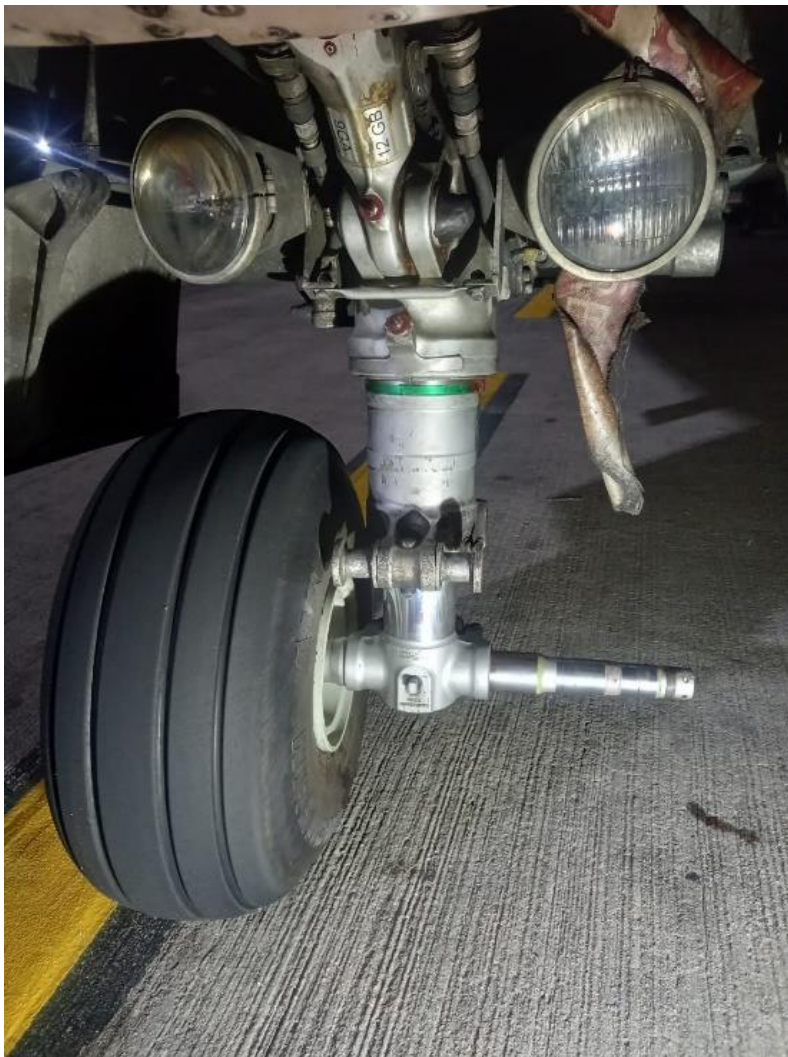
The left wheel of the Nose Landing Gear (NLG) was detached from the axle and has yet to be recovered. The wheel spacer was recovered near Link 1 at DNIL.

**Figure 5:** Nose wheel assembly of 5N-GAA post-occurrence

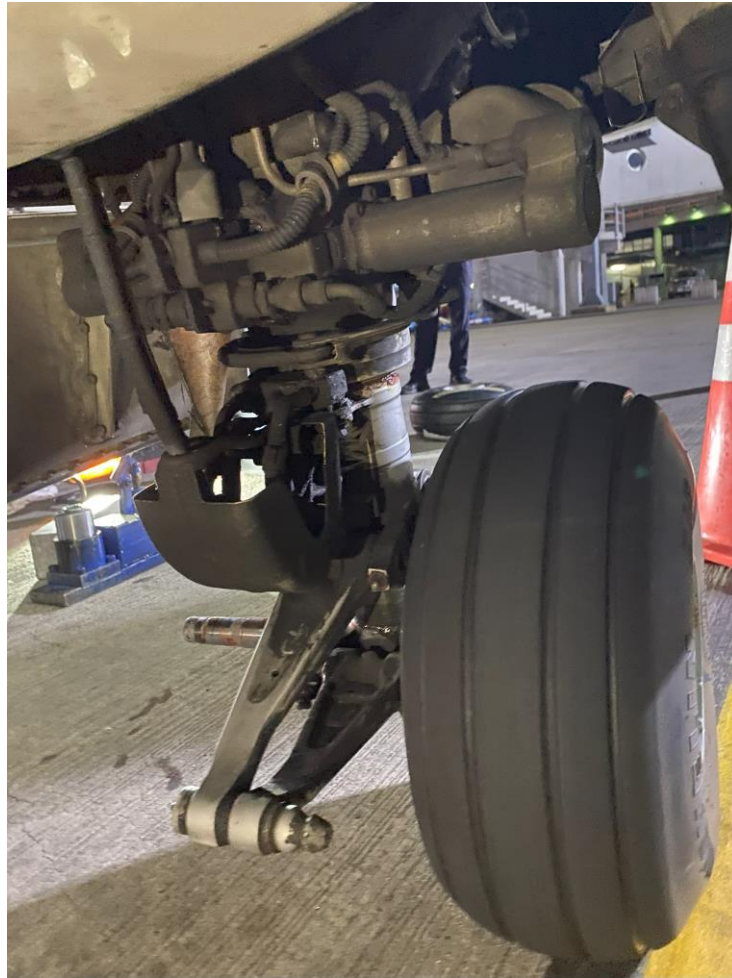
**Figure 6:** Nose wheel assembly of 5N-GAA

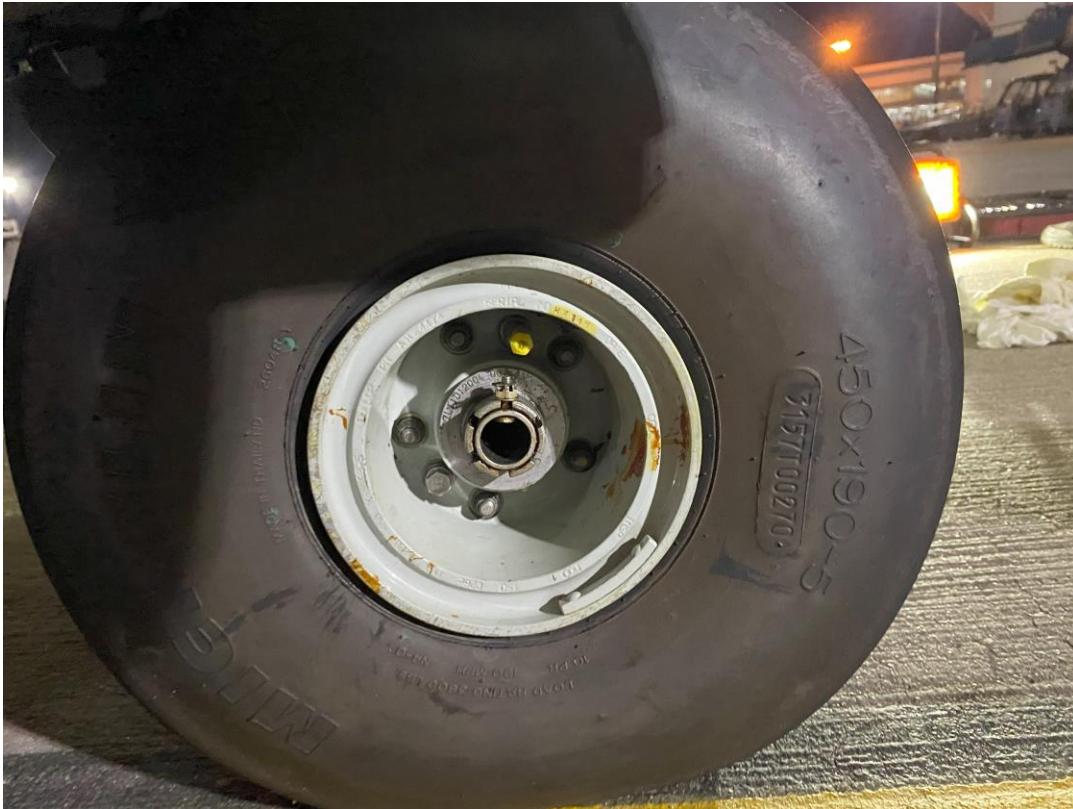
**Figure 7:** Right wheel of the NLG
