Preliminary Report on the Serious Incident involving a Hawker 800XP aircraft operated by Aero Tak Limited with nationality and registration marks 5N-JEF which occurred at Nnamdi Azikiwe International Airport, Abuja Nigeria on 10th July, 2023.

Registered owner:	Intercontinental Trade DMCC, UAE
Operator:	Aero Tak Limited
Aircraft type and model:	Hawker 800XP
Manufacturer:	Raytheon Aircraft Company, UK
Year of manufacture:	2002
Nationality and registration marks:	5N-JEF
Serial number:	258566
Location:	Nnamdi Azikiwe International Airport (DNAA), Runway 22 Coordinates: 09°00'25"N, 007°15'47"E.
Date and Time:	10 th July, 2023 at about 22:05 h <i>(All times in this report are local time, equivalent to UTC+1 unless otherwise stated)</i>

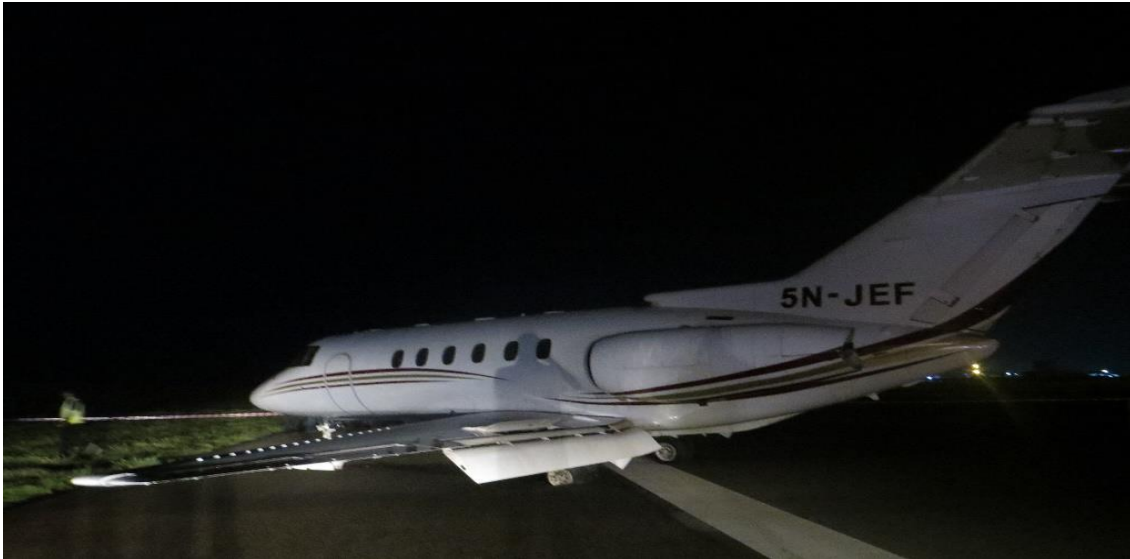
The aircraft was slightly damaged.

Figure 1: 5N-JEF after the incident

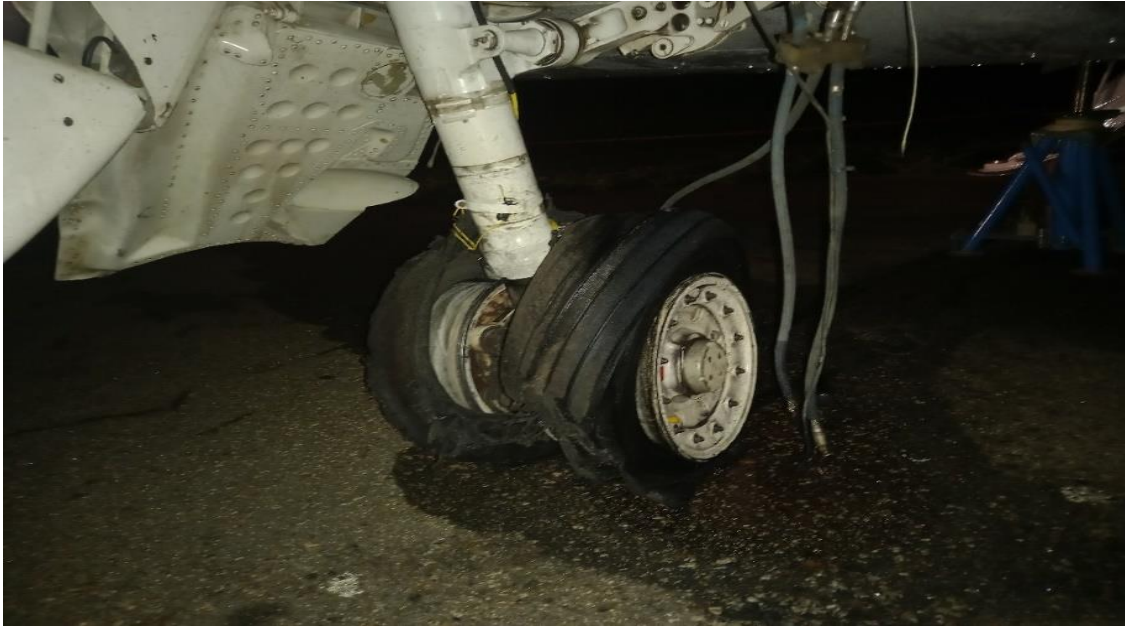
The aircraft came to a stop making a 140° turn to a magnetic heading north with both tyres of the left Main Landing Gear damaged. The passengers disembarked normally without injury.

1. Damaged wheel assemblies of the left Main Landing Gear (MLG).
2. Severed hydraulic lines of the left Main Landing Gear (MLG).
3. Worn out number 3 right main wheel tyre.
4. Abrasion on the number 1 nose landing gear tyre.
5. Hydraulic fuel leakage below the left Main Landing Gear (MLG).

Figure 2: Left Main Landing Gear

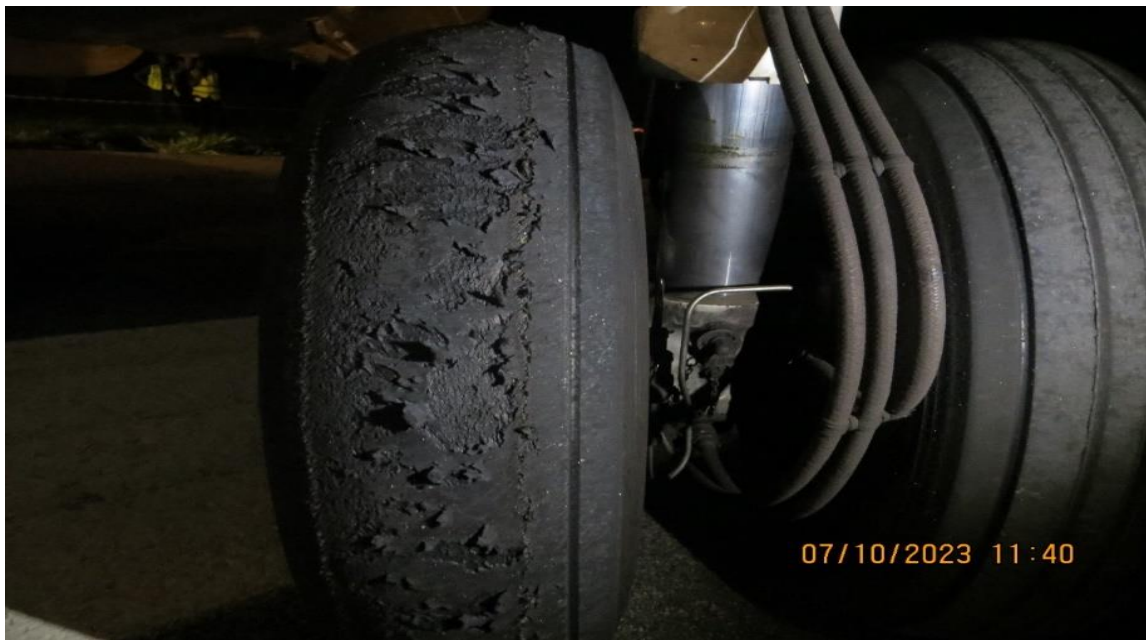
Figure 3: Tyres from the Right Main Landing Gear

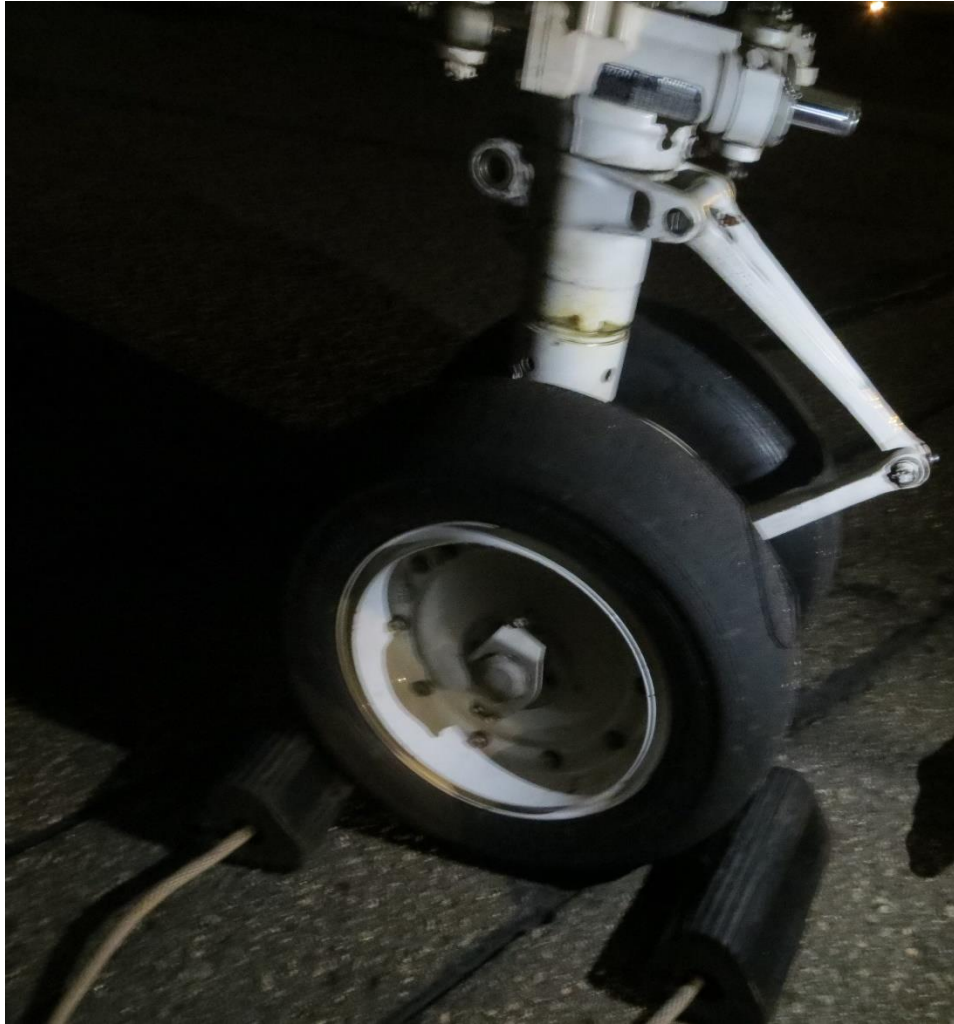
Figure 4: Nose wheel landing gear
