PRELIMINARY REPORT ON SERIOUS INCIDENT INVOLVING AIRBUS A330-223 AIRCRAFT BELONGING TO DELTA AIR LINES INC. WITH REGISTRATION N858NW WHICH OCCURRED AFTER TAKE-OFF FROM MURTALA MUHAMMED INTL. AIRPORT, LAGOS ON 13TH FEBRUARY, 2018

Registered Owner and Operator:	Delta Air Lines Inc.
Aircraft Type and Model:	Airbus A330-223
Manufacturer:	Airbus
Date of Manufacture:	2006
Registration Number:	N858NW
Serial Number:	0718
Location:	Murtala Muhammed Airport
Date and Time:	13th February, 2018 at about 2252hrs

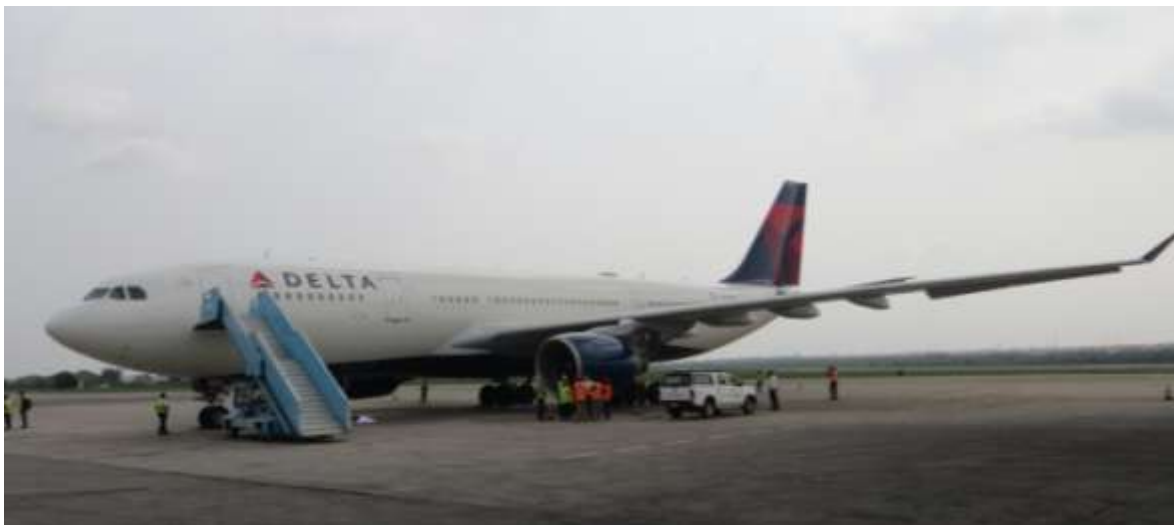
The aircraft was not damaged.

Figure 1: The aircraft after the incident

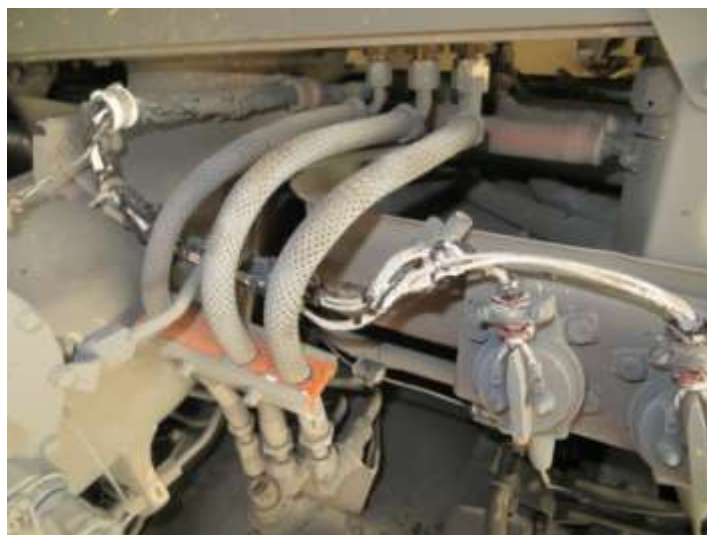
During physical examination of the event engine in-situ, there were evidences of fire, observed from charred wires within the engine cowling.

Figure 2: Charred wires within the engine cowling

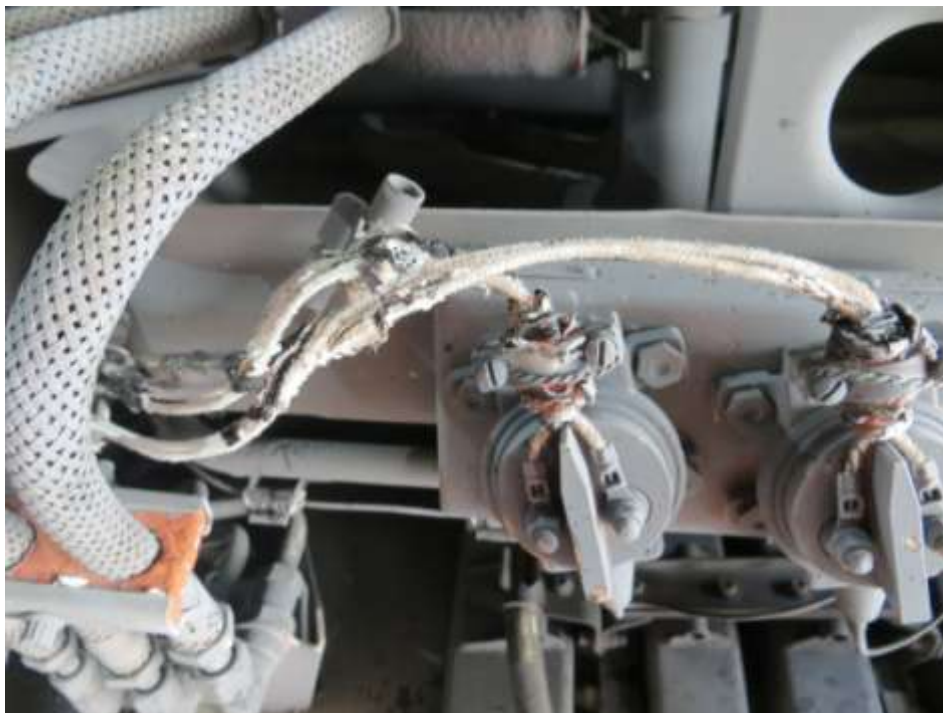
Figure 3: A close-up view of the charred wires

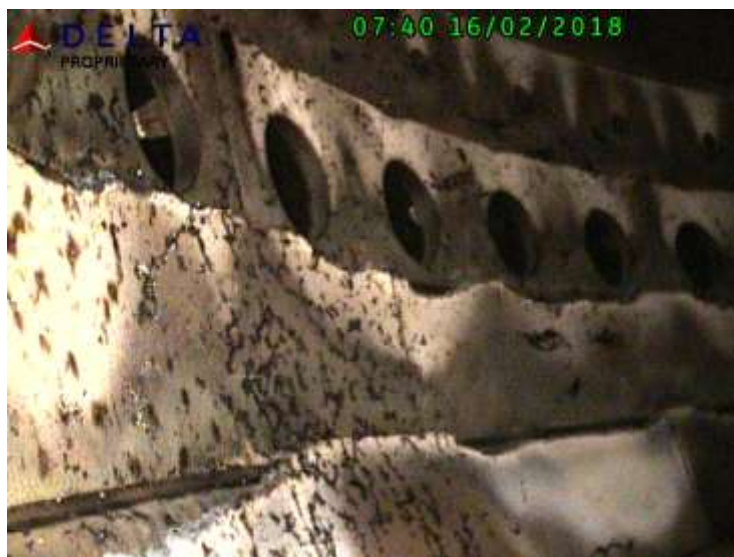
A borescope inspection was carried out on the left engine. It revealed some corrosion in the turbine section and combustion chambers.

Figure 4: A view of the interior of the combustion chamber showing corrosion

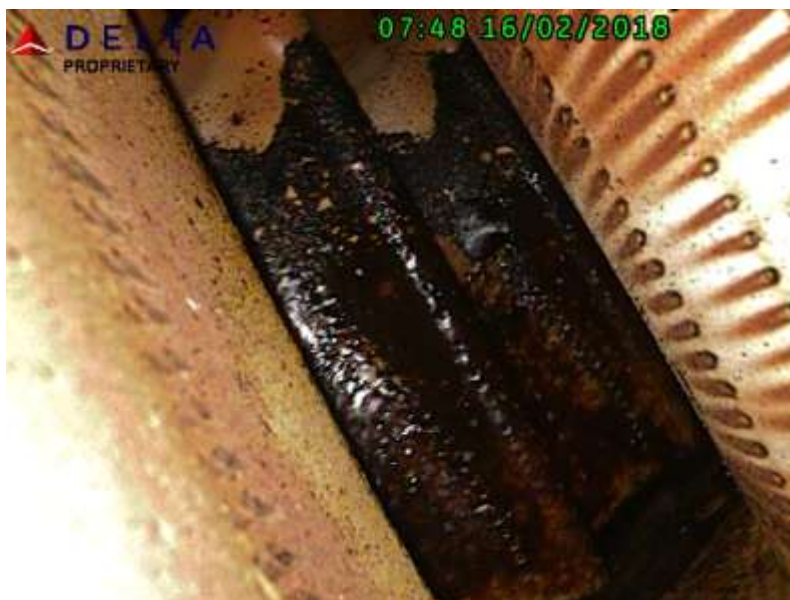
Figure 5: Picture showing corrosion in the turbine section
