PRELIMINARY REPORT ON THE ACCIDENT INVOLVING GULFSTREAM G200 AIRCRAFT BELONGING TO NEST OIL WITH REGISTRATION NUMBER 5N-BTF WHICH OCCURRED AT NNAMDI AZIKIWE INTERNATIONAL AIRPORT ABUJA ON 25TH JANUARY, 2018

OPERATOR:	NestOil Plc
AIRCRAFT TYPE:	Gulfstream G200
REGISTRATION:	5N-BTF
AIRCRAFT S/N:	180
DATE OF MANUFACTURE:	2007
LOCATION:	Runway 22, Nnamdi Azikiwe Int'l Airport Abuja
DATE/TIME:	25 th January, 2018 at 1520hrs

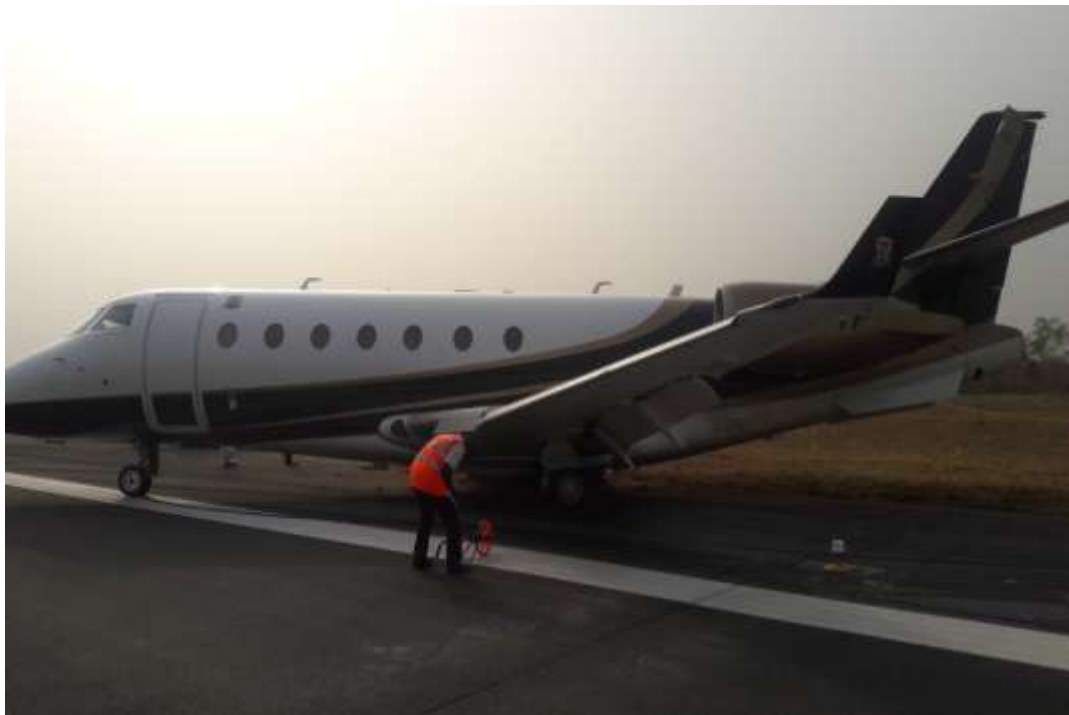
Figure 1: Picture showing final resting point of the aircraft

1. The crew are certified and qualified to conduct the flight
2. The aircraft was airworthy as at the time of the occurrence.
3. There was no reported adverse weather during approach and landing into Abuja
4. The aircraft lost directional control during the landing roll
5. The aircraft veered off and came to rest on the right shoulder of the runway.
6. The aircraft right main landing gear strut sheared off.

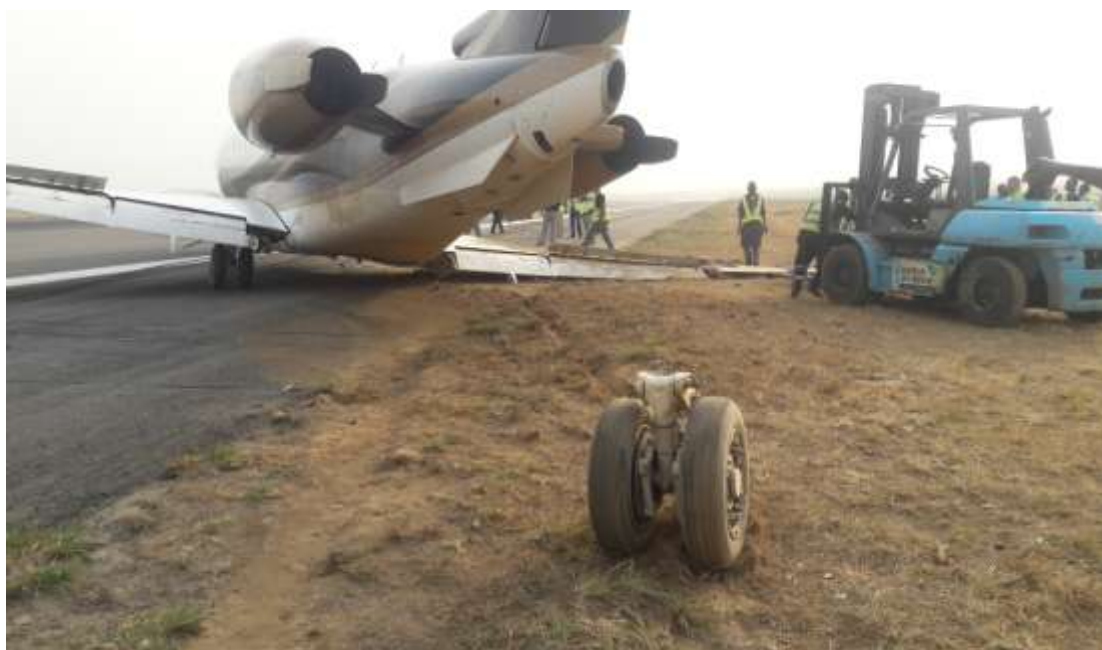
The aircraft right main landing gear sheared off from its attachment point.

Figure 2: Picture showing detached right main landing gear

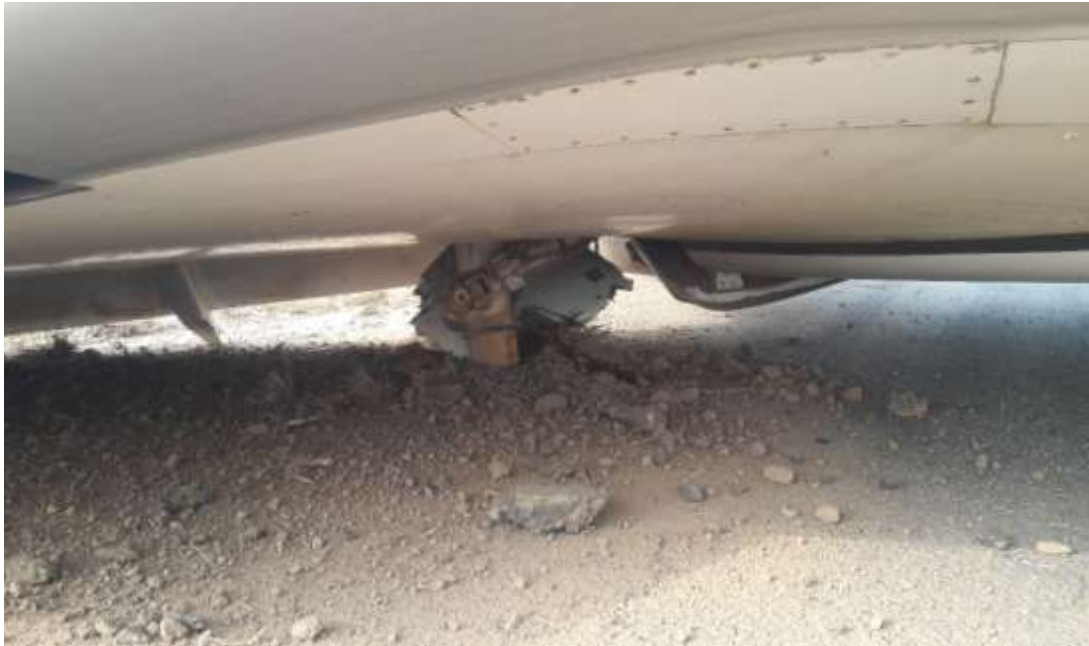
Figure 3: Picture showing right main landing gear detachment point at the under carriage

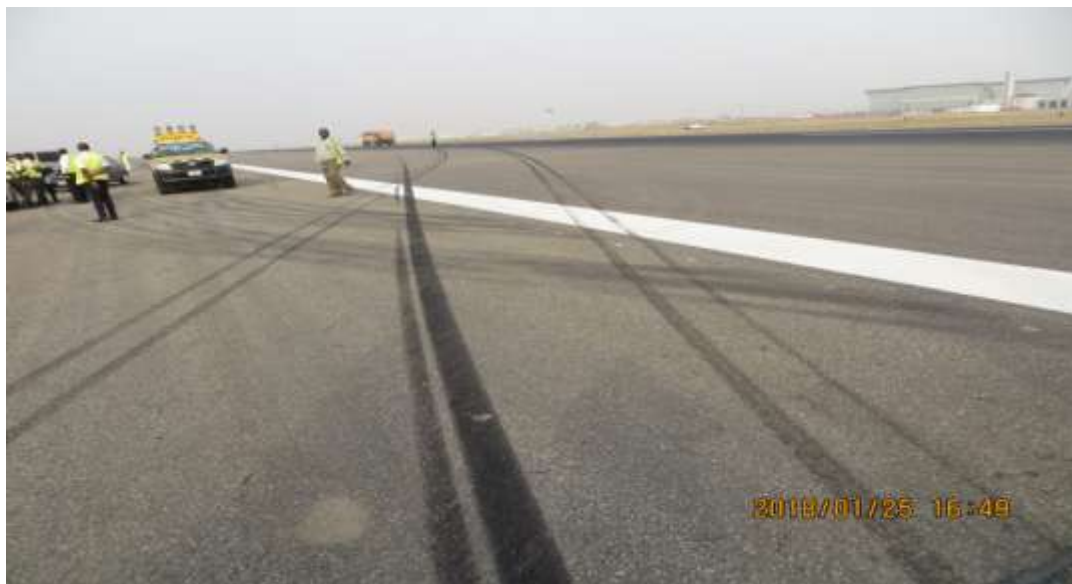
Figure 4: Picture showing tyre marks of the aircraft on the runway

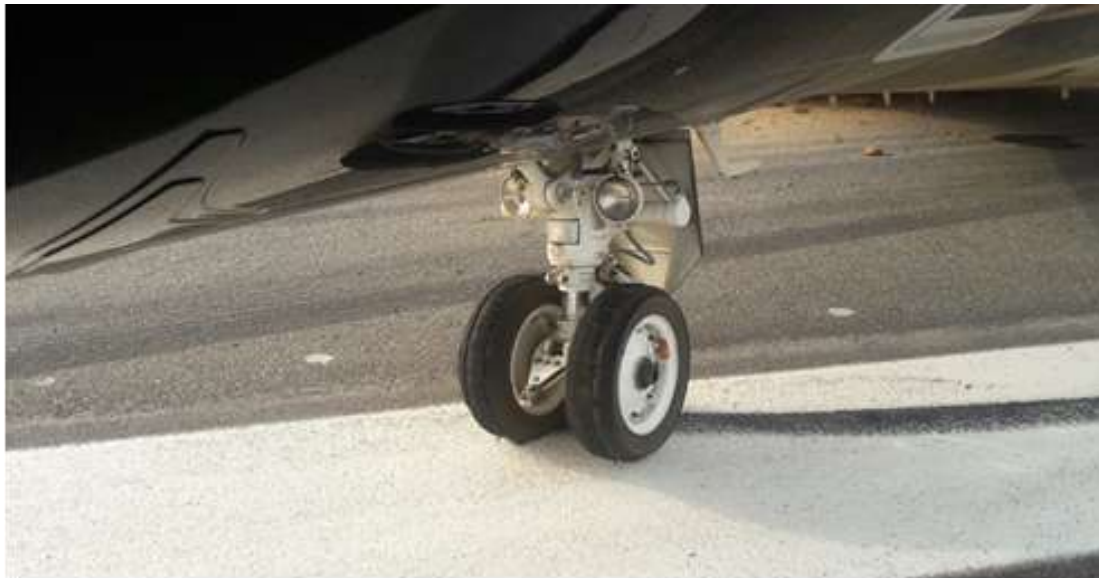
Figure 5: Picture showing the damaged nose wheel tyre
