**PRELIMINARY REPORT ON THE SERIOUS INCIDENT INVOLVING VIKING  
TWIN OTTER AIRCRAFT WITH NATIONALITY AND REGISTRATION MARKS  
5N-SHE OPERATED BY CAVERTON HELICOPTERS WHICH OCCURRED DURING  
LANDING ROLL AT FORCADOS AIRSTRIP, DELTA STATE ON 13TH JUNE, 2022**

<b>Registered owner and operator:</b>	Caverton Helicopters Limited
<b>Aircraft type and model:</b>	Twin Otter DHC-6-400
<b>Manufacturer:</b>	Viking Air Limited, Canada
<b>Date of manufacture:</b>	August, 2012
<b>Nationality and registration marks:</b>	5N-SHE
<b>Serial number:</b>	864
<b>Location:</b>	Forcados Airstrip with coordinates 05°21.30'N 005°20.93'E
<b>Date and Time:</b>	13th June 2022 at about 14:01 h. <i>All times in this report are local time (UTC +1) unless otherwise stated</i>

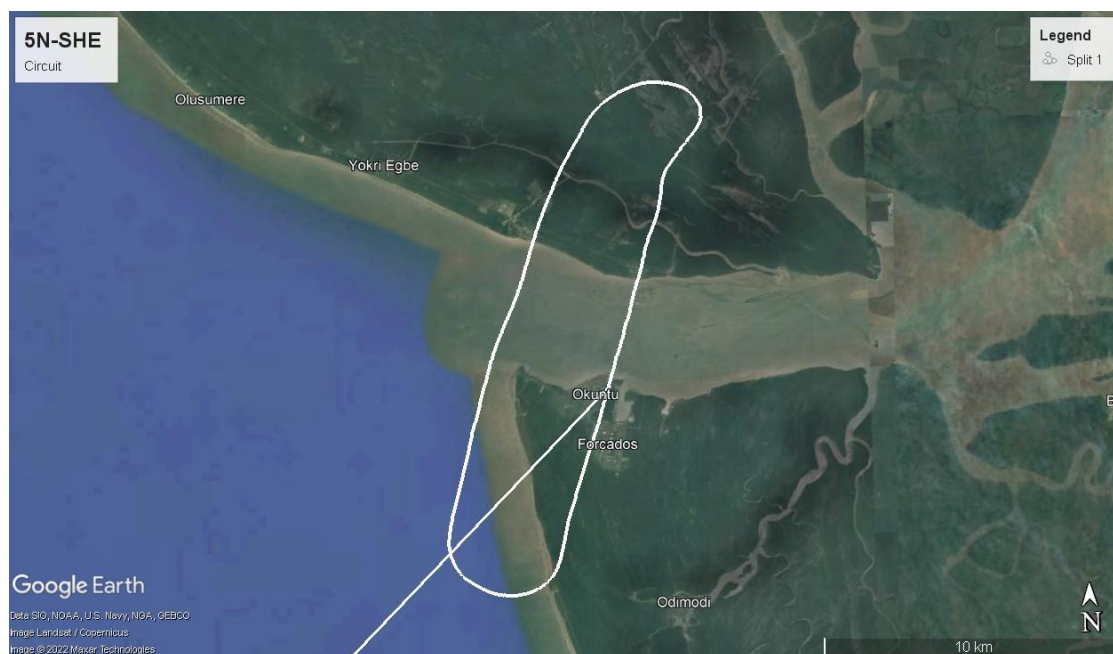
Figure 1: Flight Track

At 14:01 h, 5N-SHE landed on runway 20 and on landing roll, 5N-SHE veered off to the left centerline runway at about 182.7 m from the runway threshold, vacated left side shoulder at points between 238.7 m and 254.6 m from the threshold into the grass verge with the left main wheel crossing fire hydrant at 6.4 m.

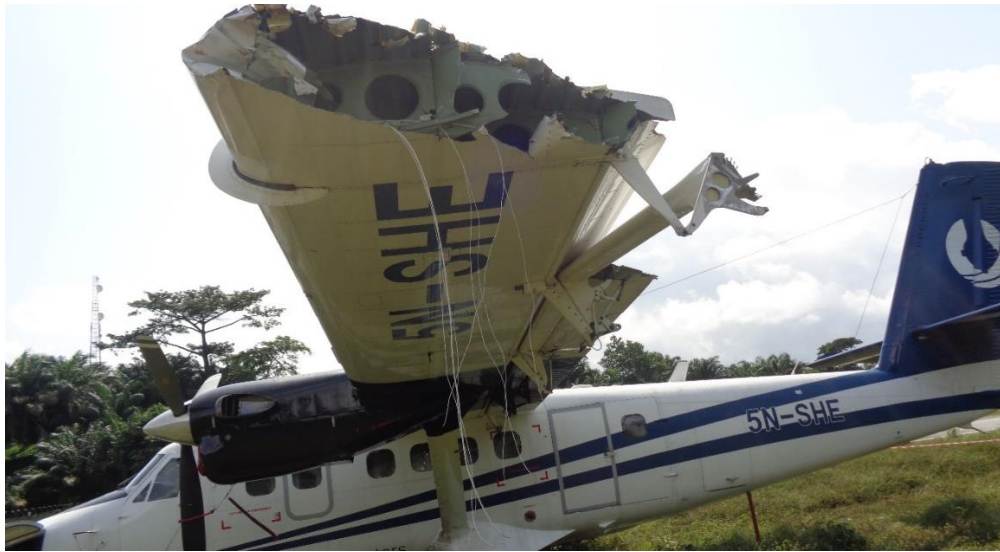
The aircraft continued towards the concrete fire truck driveway. In a slight right turn, the left Wing Tip area of the aircraft collided with the Fire Tender shelter pole, causing damage to the Wing Tip Fairing, Wing Tip Strobe Light and Navigation Light assembly. The aircraft thereafter got into grassy-mud, travelled 20 m and got stuck. The left Wing was substantially damaged as evident during post incident inspection with debris from the Wing found at various locations.

The left Wing Tip outboard area, left Wing Tip Navigation Light, Strobe Light and Wing Fore Flap Aileron were damaged and severed from the Wing upon collision with the pole of the shelter.

The damaged left Wing of 5N-SHE

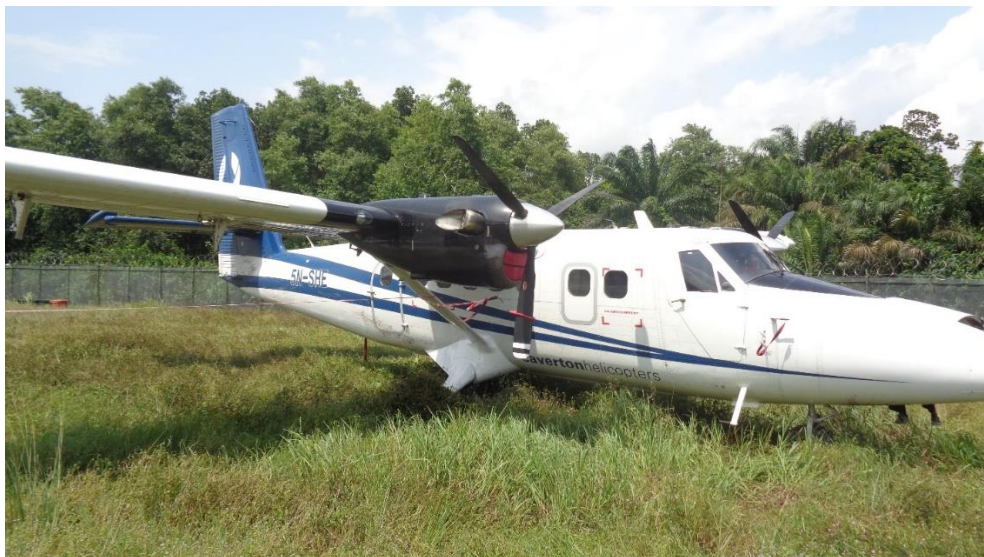
After touch-down, 5N-SHE veered-off to the left of runway 20 centreline at a distance of about 182.7 m (the left main wheel exited runway at a distance of 238.7 m from the threshold while and the right main wheel exited at a distance of 254.6 m. The aircraft travelled through the grass for a distance of about 34.05 m before colliding with the fire tender shelter poles. It continued for about 20 m from the concrete floor of the fire tender shelter where it got stuck in a grass mud.

The aircraft stuck in grassy-mud

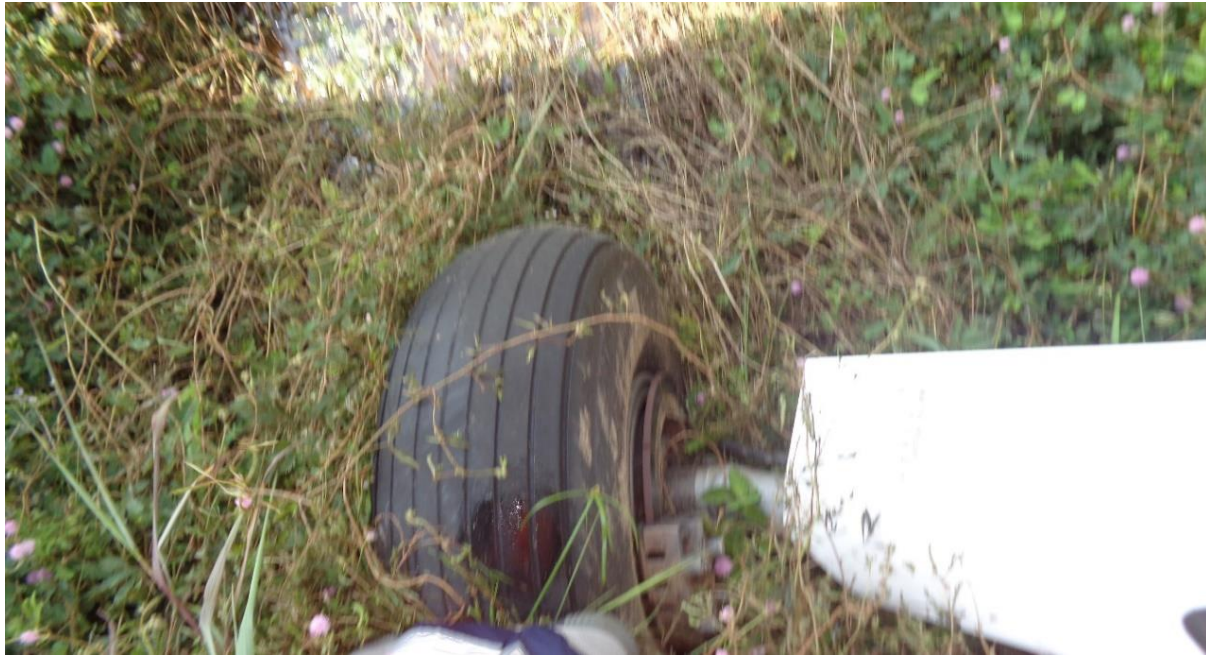
Right Main Wheel stuck in grassy-mud

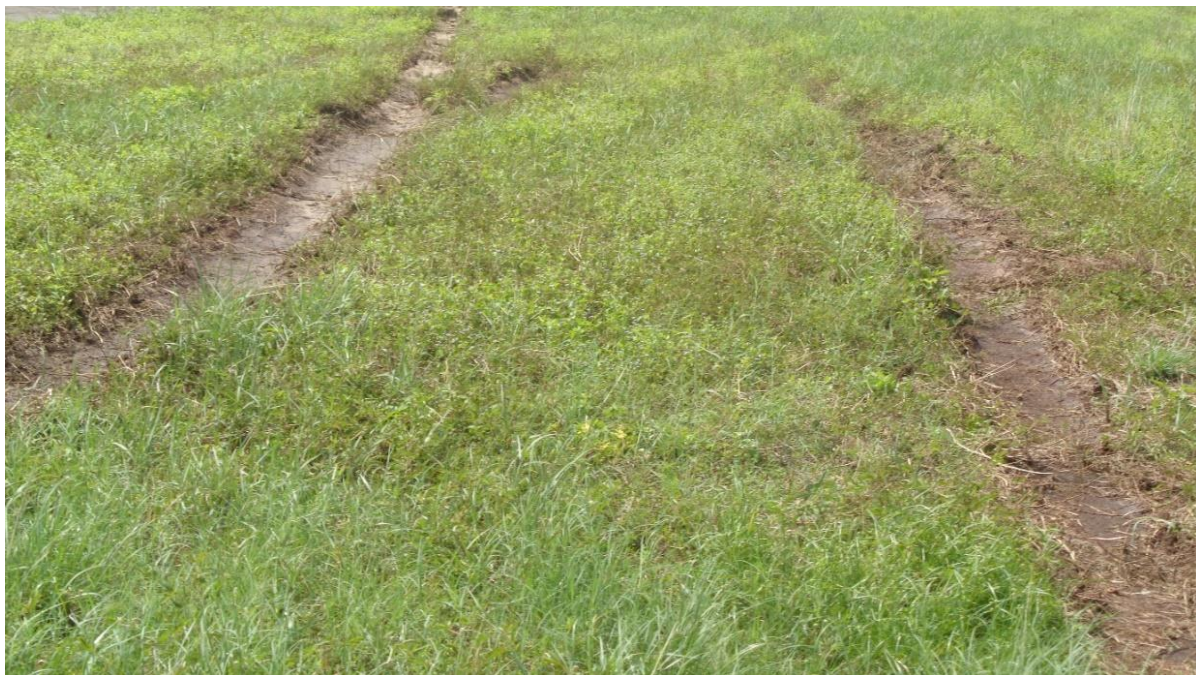
The Main Wheel track marks on the grass

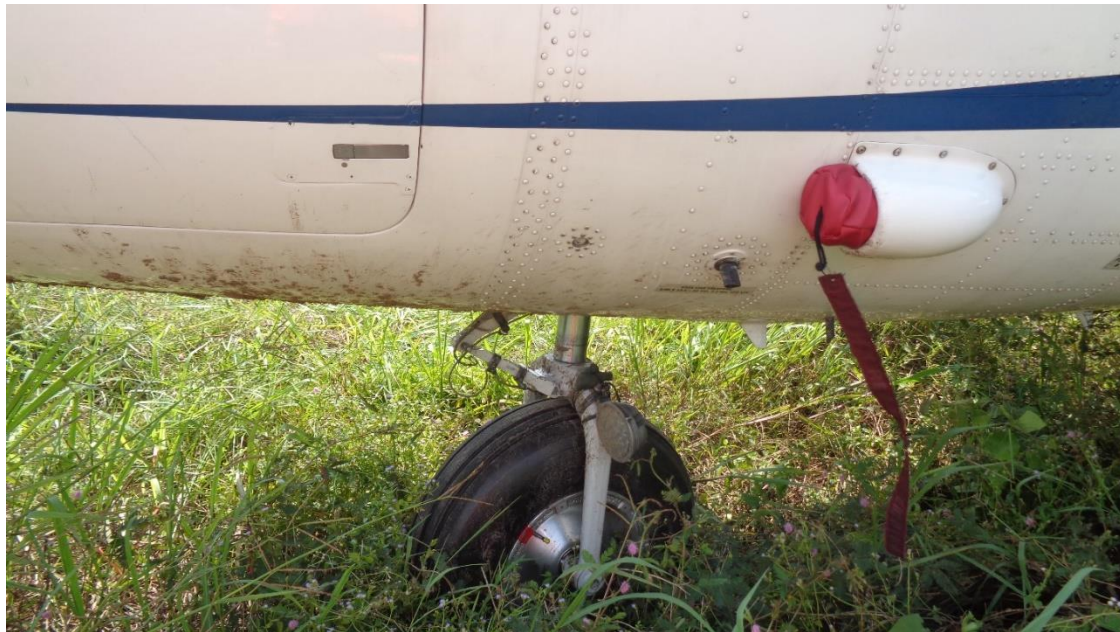
Picture of Nose Wheel stuck in the grassy-mud

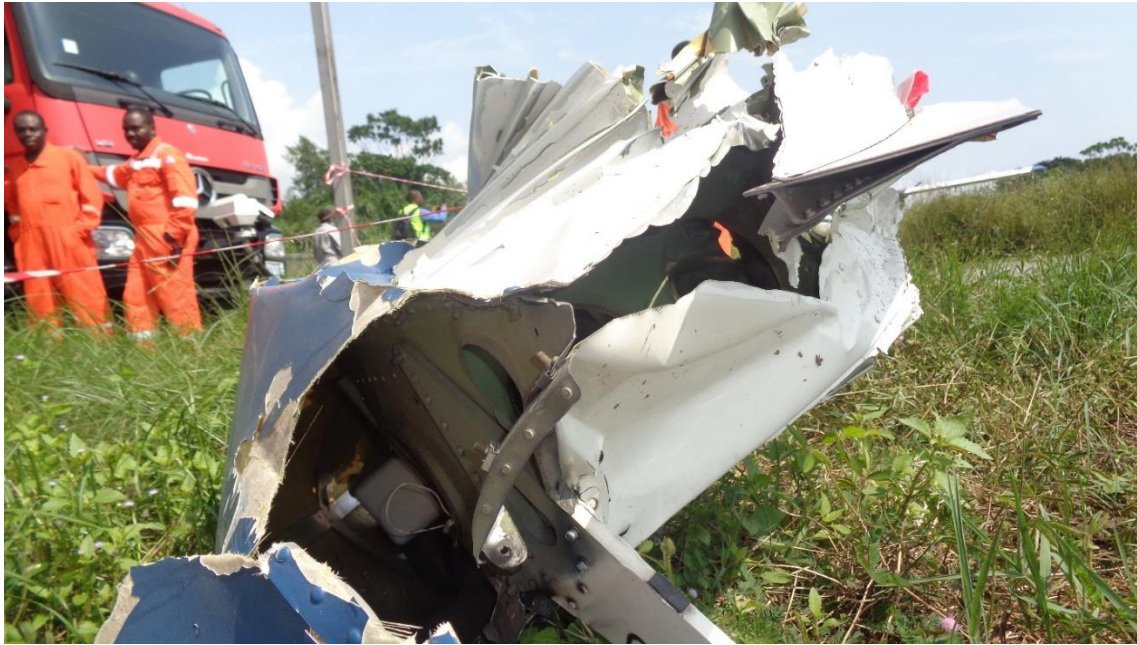
Picture of debris from damaged left Wing Tip assembly of the aircraft
