5N-CAG

Preliminary Report on the Serious Incident involving Beech Baron 58 aircraft operated by Nigeria College of Aviation Technology (NCAT), Zaria with nationality and registration marks 5N-CAG, which occurred on runway 05 at Kaduna International Airport, Kaduna Nigeria on 31st December, 2022

Registered owner: Nigerian College of Aviation Technology, Zaria
Operator: Nigerian College of Aviation Technology, Zaria
Aircraft type and model: Beech Baron 58
Manufacturer: Hawker Beechcraft LTD, Wichita, Kansas, USA
Year of manufacture: 1995
Serial number: TH-1756
Nationality and registration marks: 5N-CAG
Location: Runway 05 Kaduna International Airport, Kaduna
Date and Time: 31st December, 2022 at about 10:16 h
(All times in this report are local time, equivalent to UTC+1 unless otherwise stated)

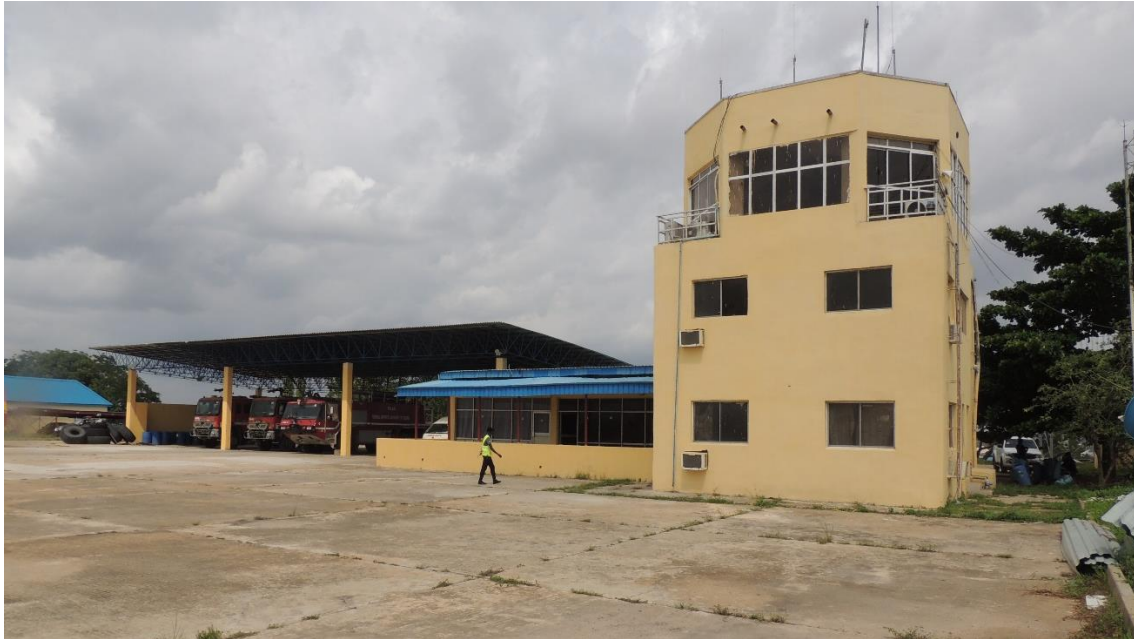
The control tower in Kaduna airport is temporarily located at the ARFFS watch room at the time of occurrence. The watch room provides limited viewing of the extreme end of runway 05.

ARFFS Watch room/ATC Tower

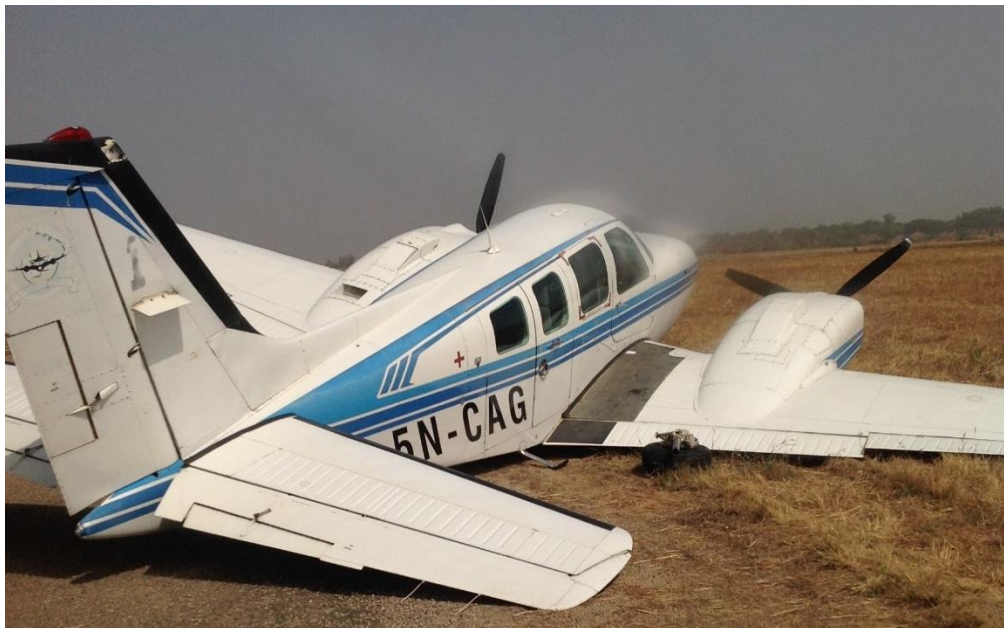
1. The right main landing gear torque link sheared-off
2. The right main landing gear inner cylinder separated from the outer cylinder
3. The right wing lower section of the tank tore-off
4. Two of the propeller blades of the right engine bend outward and the other bend rearward
5. The aircraft step broke-off

Figure 2: The aircraft after the occurrence

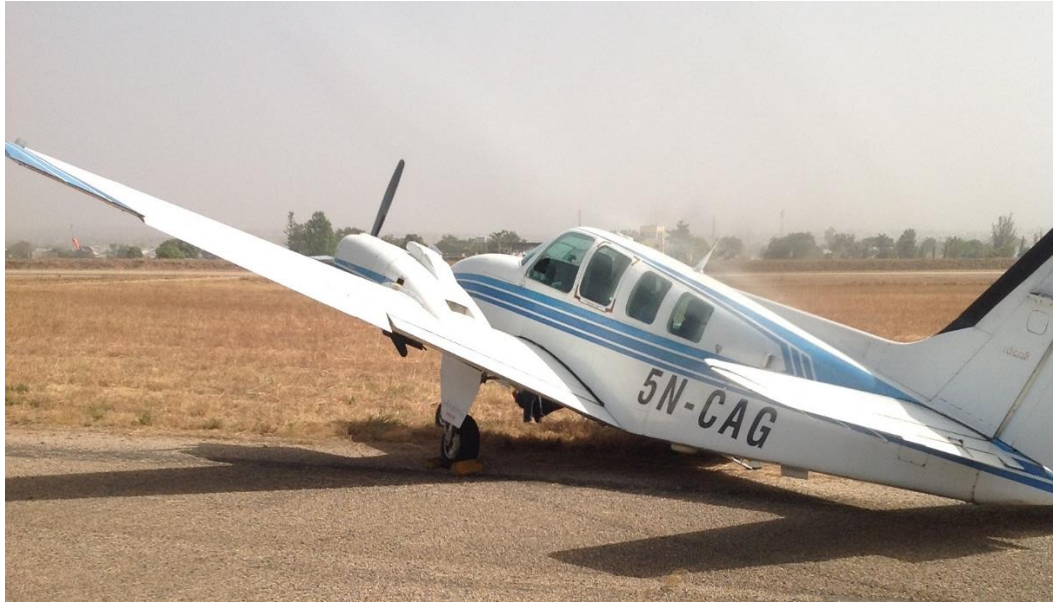
Figure 3: The aircraft after the occurrence

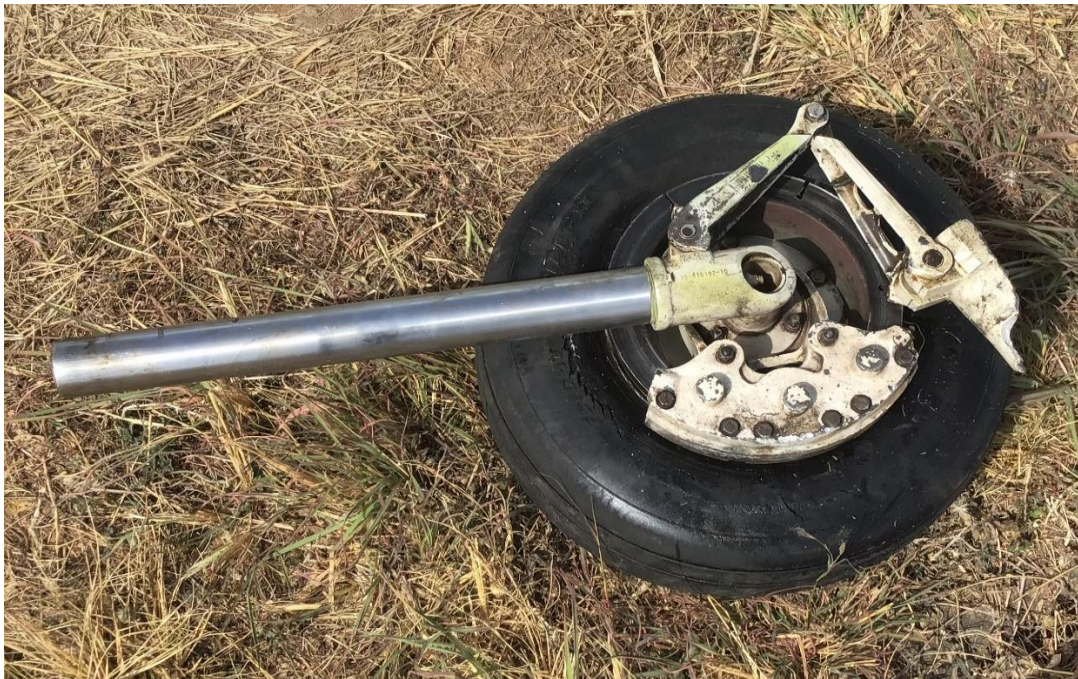
Figure 4: The sheared right main landing gear

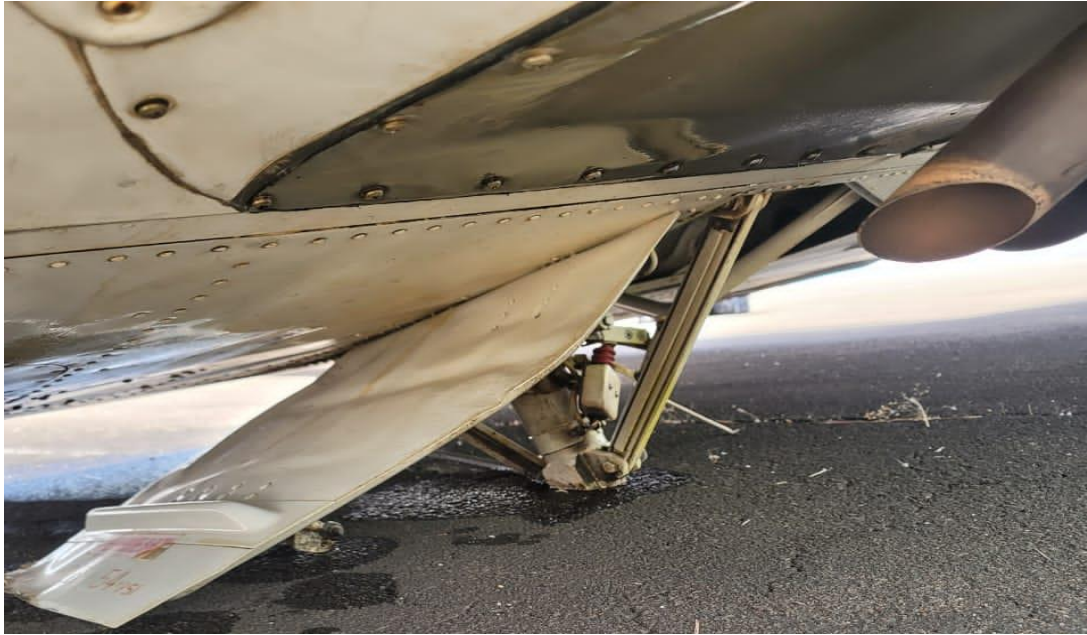
Figure 5: The remaining part of the landing gear attach to the aircraft

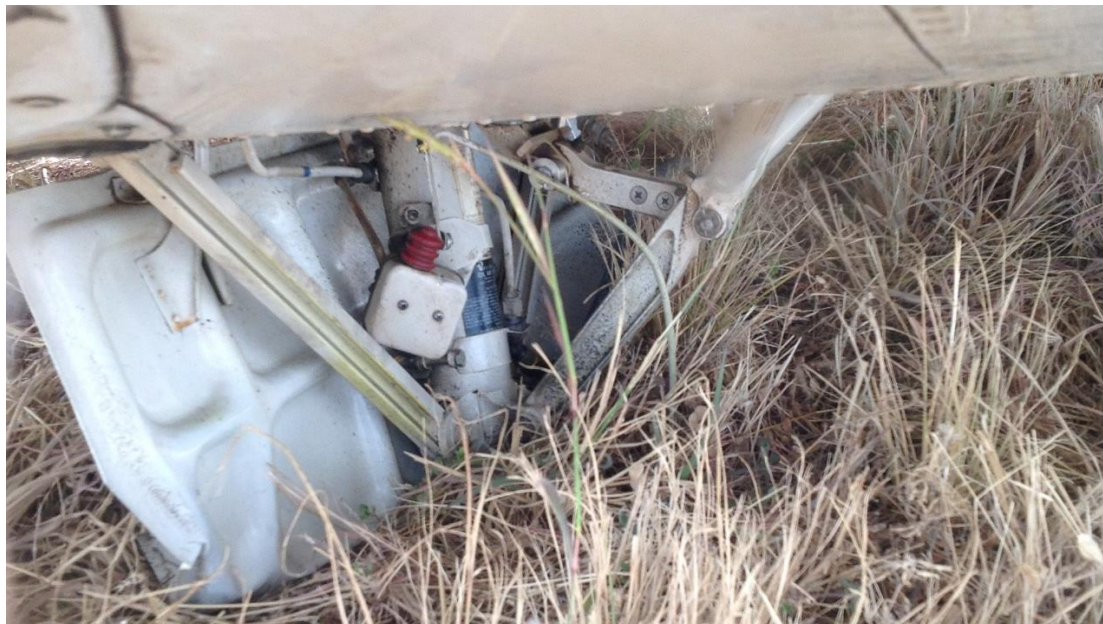
Figure 6: The remaining part of the landing gear attach to the aircraft

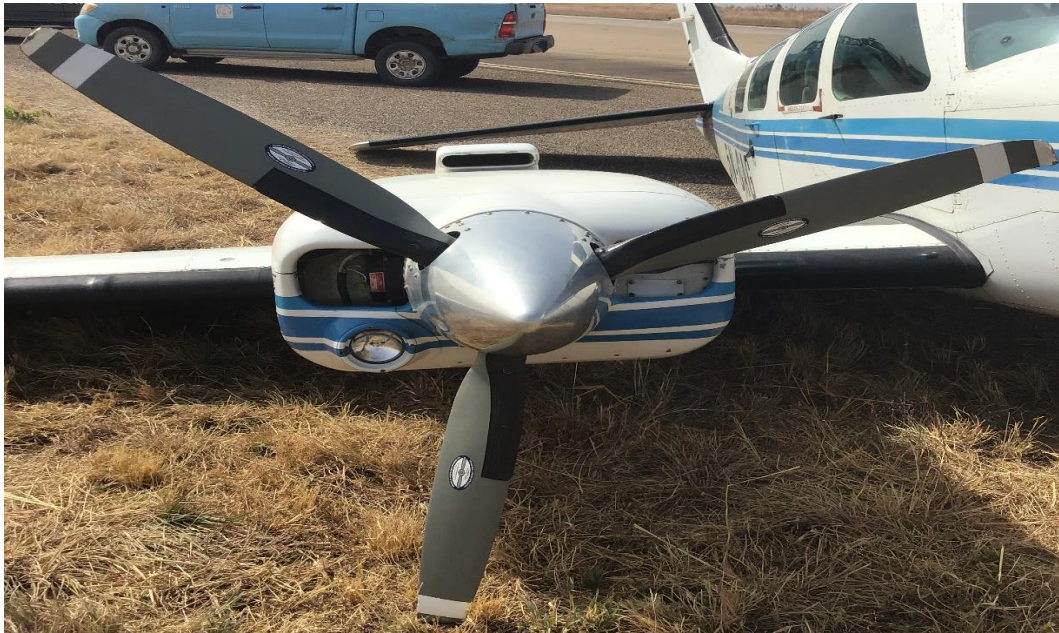
Figure 7: Bent propeller blade at the tip

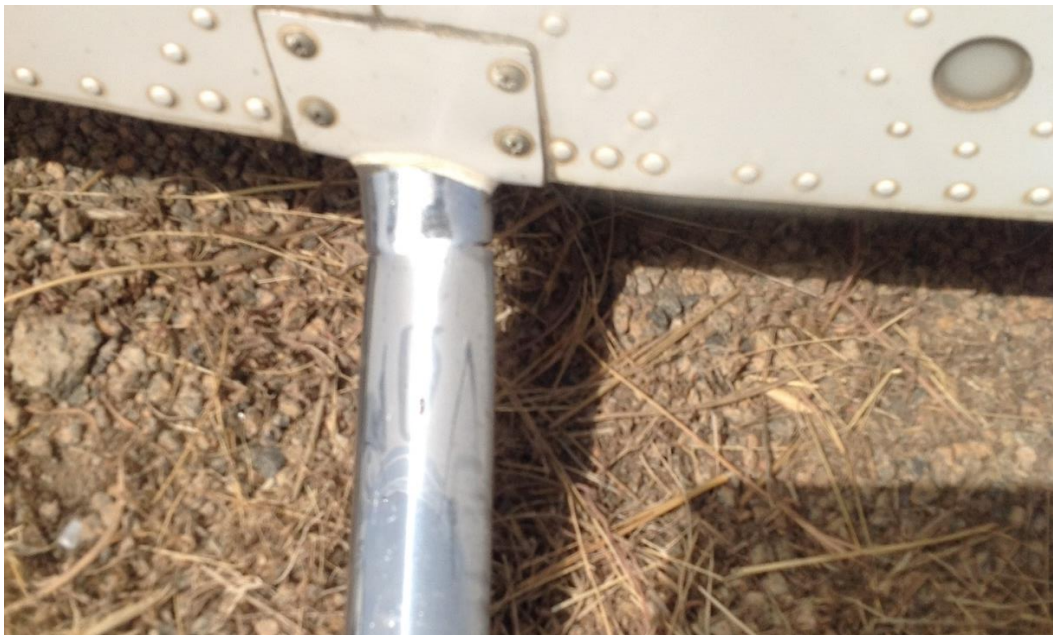
Figure 8: The broken step

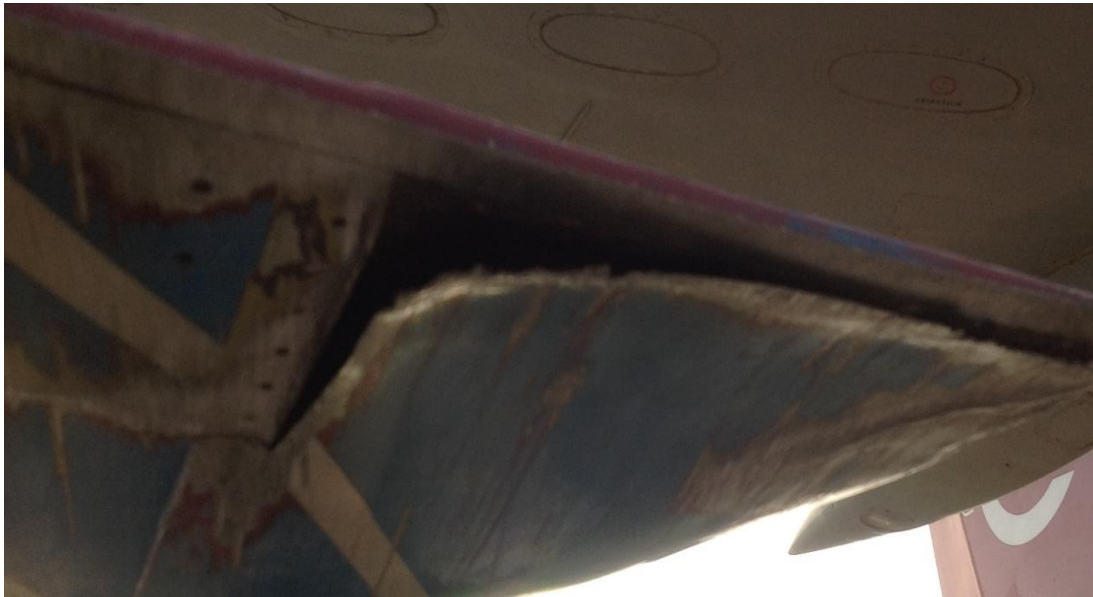
Figure 9: The torn right tank from the bottom

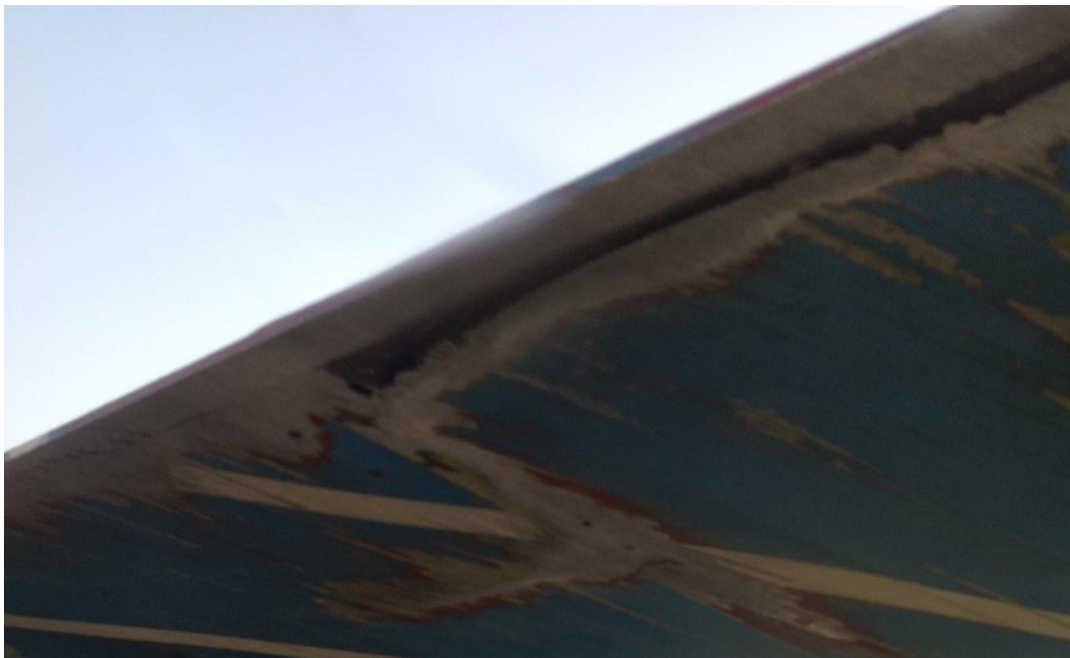
Figure 10: The torn right tank from the bottom

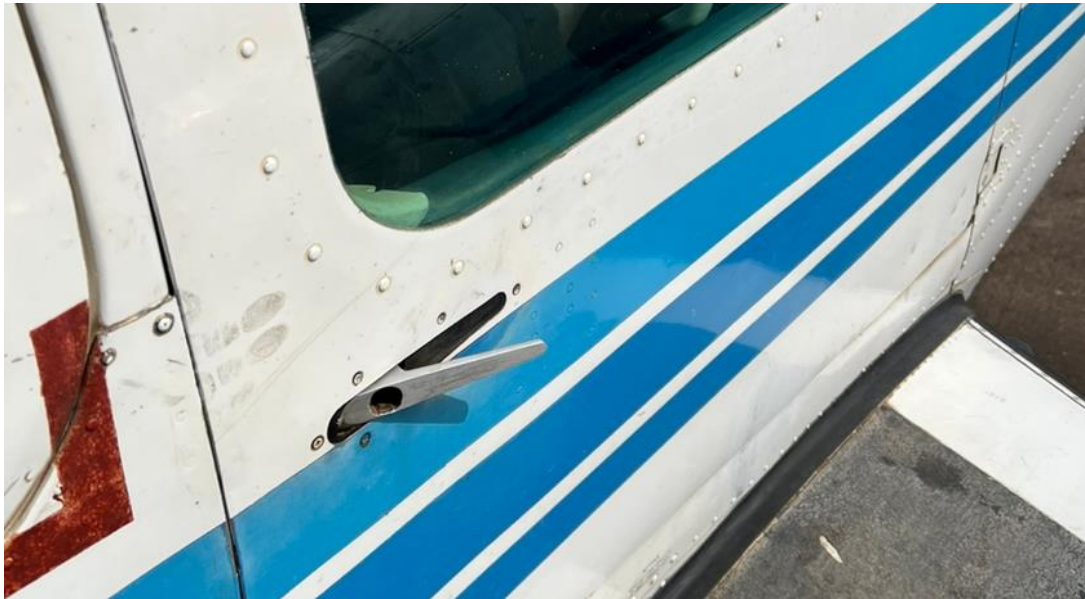
During post occurrence interview, the FI stated that there were previous instances of the door opening in flight. These incidences were not entered in the technical logbook.

Figure 11: The unclatched starboard door handle
